Inspection Photos

08/02/2019

Operator: BISON OIL & GAS II LLC # 10661

Location ID: 337304

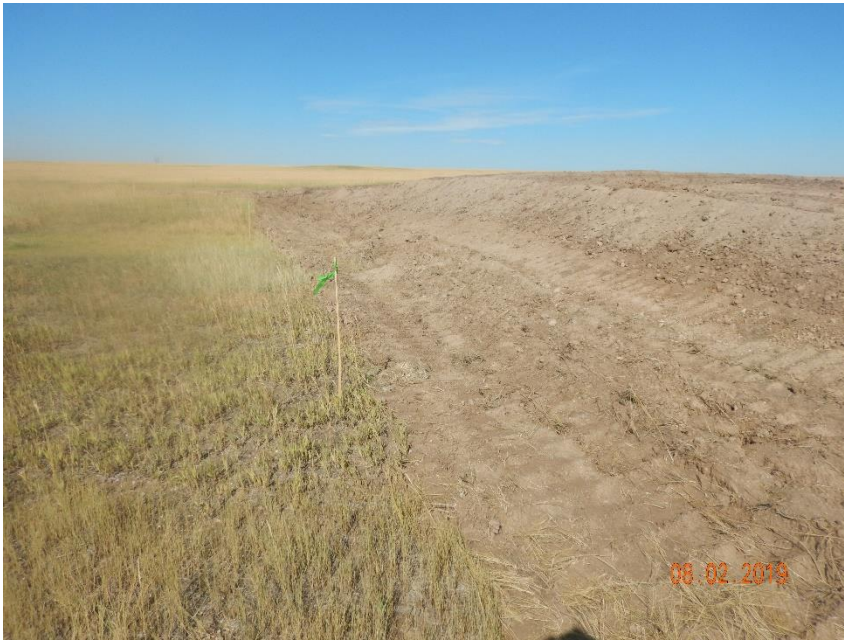
Photo 1: Photo taken from the south end of the location, facing west. Photos 1-4 provide an overview of the location and construction in process from west, northwest, northeast to east. Photos also show soil stockpiles have not yet been stabilized (soil salvage in process). Photos also shows operator has installed surface roughening (ripping) along perimeter of the disturbance. Surface roughening is a temporary BMP that needs to be used on conjunction with other BMPs. Surface roughening on the southern perimeter of the location appears to have been traveled over and is not longer in proper functioning condition.

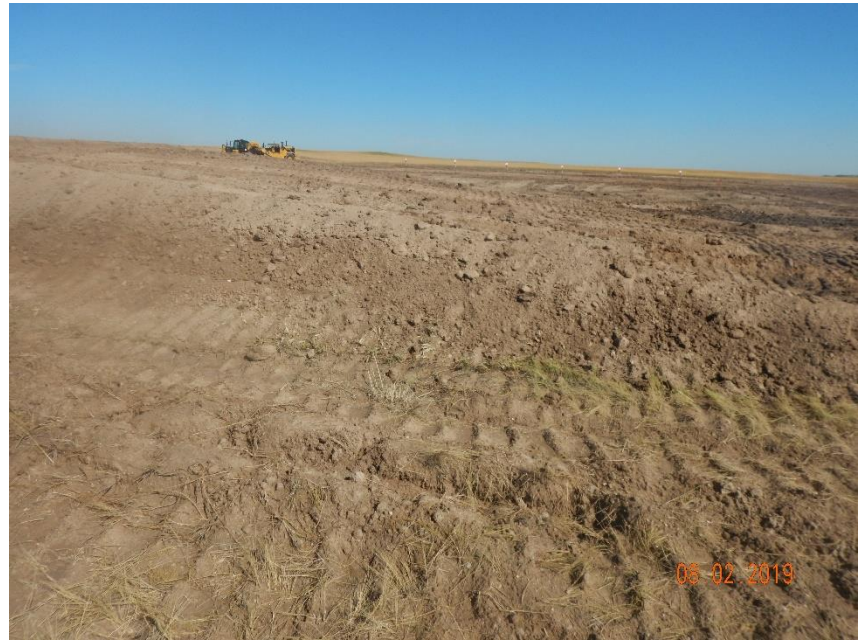
Photo 2: See comments under photo 1.

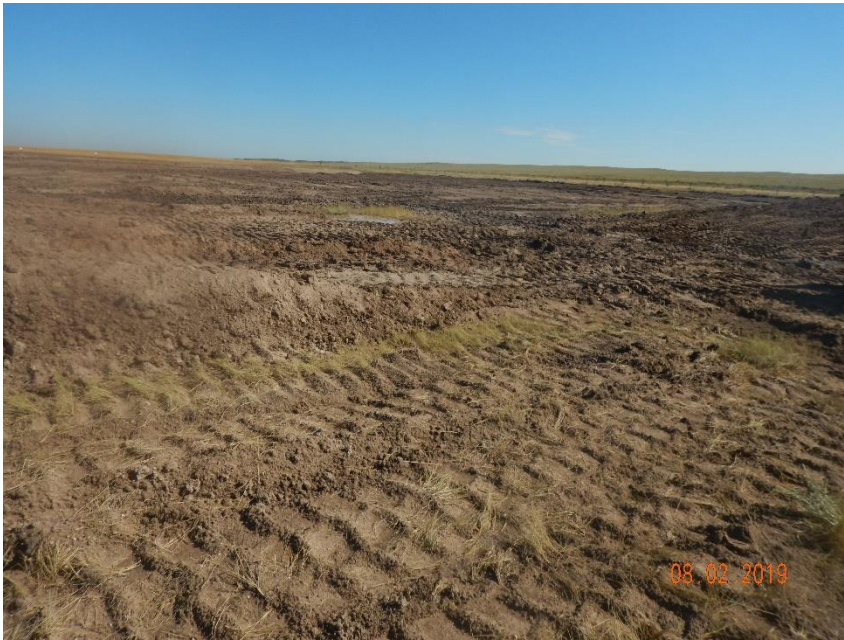
Photo 3: See comments under photo 1.

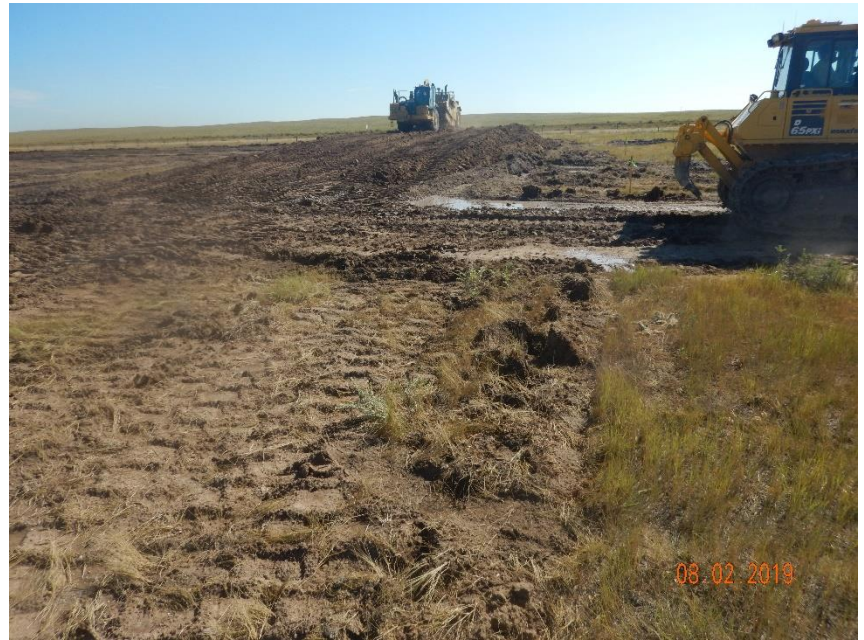
Photo 4: See comments under photo 1.

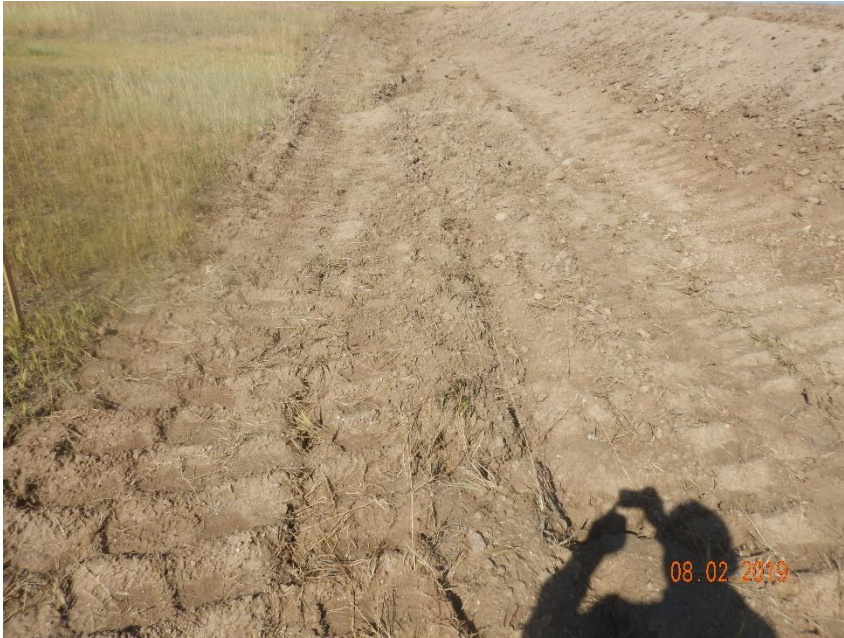
Photo 5: Photo taken from the south end of the location. Photo shows operator has installed surface roughening (ripping) along perimeter of the disturbance. Surface roughening is a temporary BMP that needs to be used on conjunction with other BMPs. Surface roughening on the southern perimeter of the location appears to have been traveled over and is not longer in proper functioning condition.

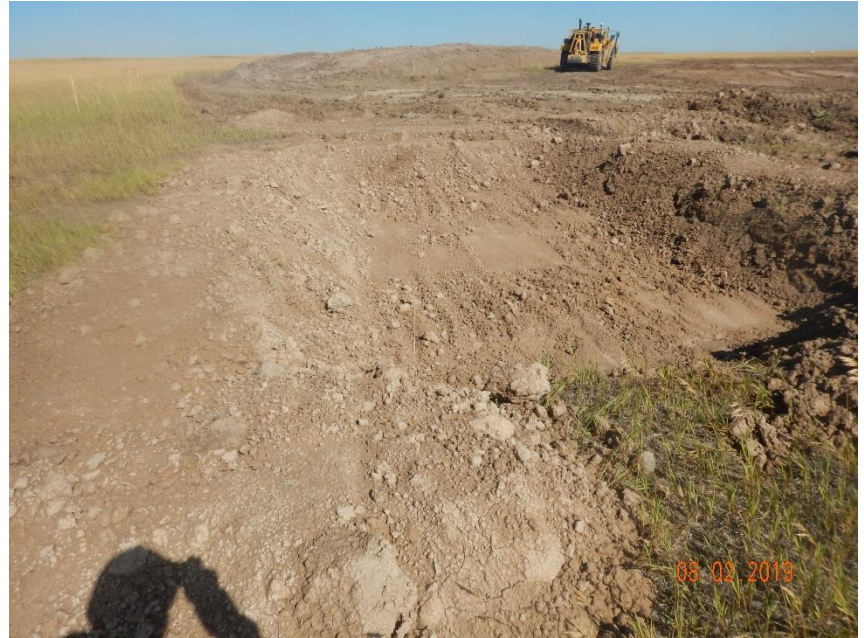
Photo 6: Photo taken from the south end of the location, facing west. Photo shows 1 of the 3 sediment traps constructed on the south end of the location. BMPs have not been constructed in accordance with good engineering practices; berms along perimeter have not been sufficiently consolidated, trap has not been constructed at an appropriate grade to mitigate stormwater degradation, BMP missing sufficient inlet and outlet protection.

BMP will need to be installed in accordance with good engineering practices per 1002.f(2).

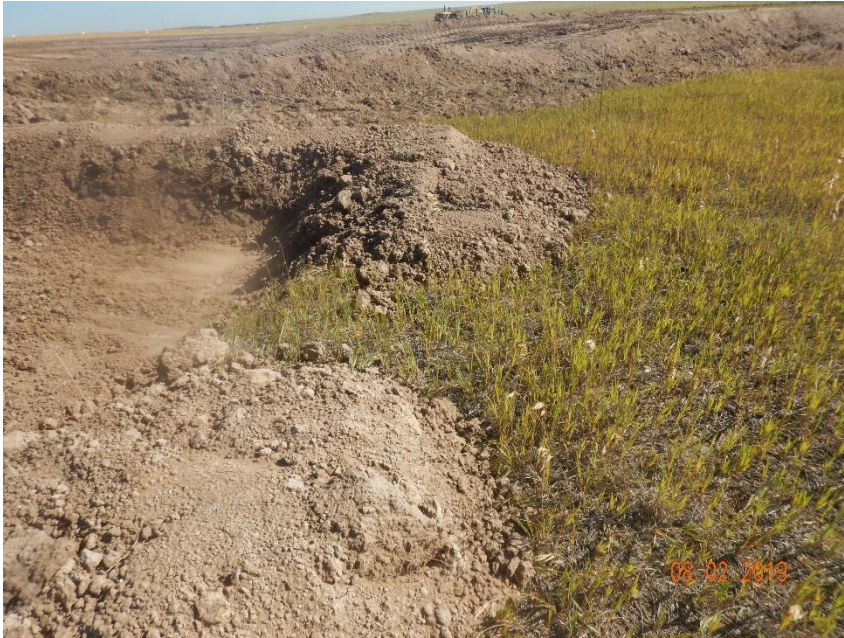
Photo 7: See comments under photo 6.

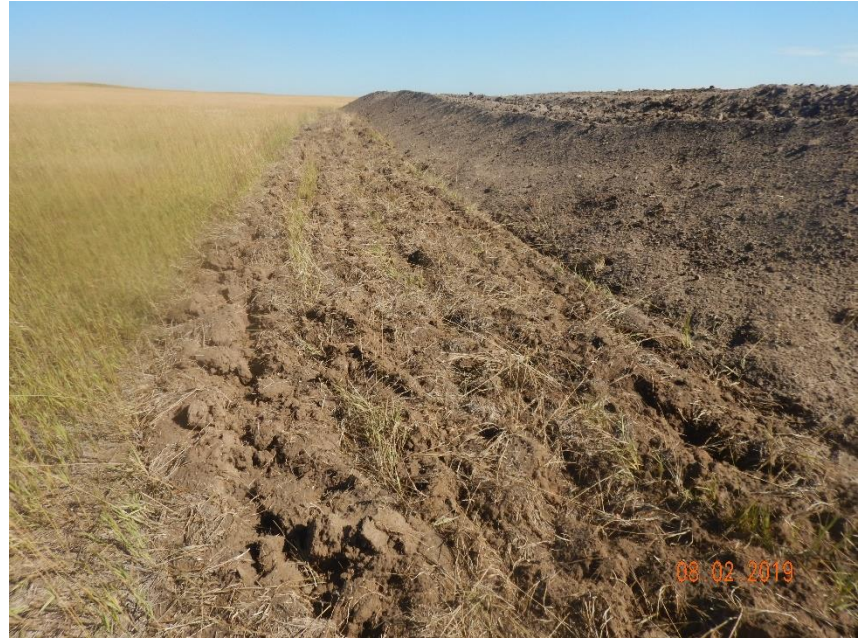
Photo 8: Photo taken from the west end of the location, facing north. Photo shows surface roughening BMP on the western perimeter of the location. Photo also shows soil stockpiles. Soil stockpiles have not been stabilized or BMPs installed in accordance with 1002.c

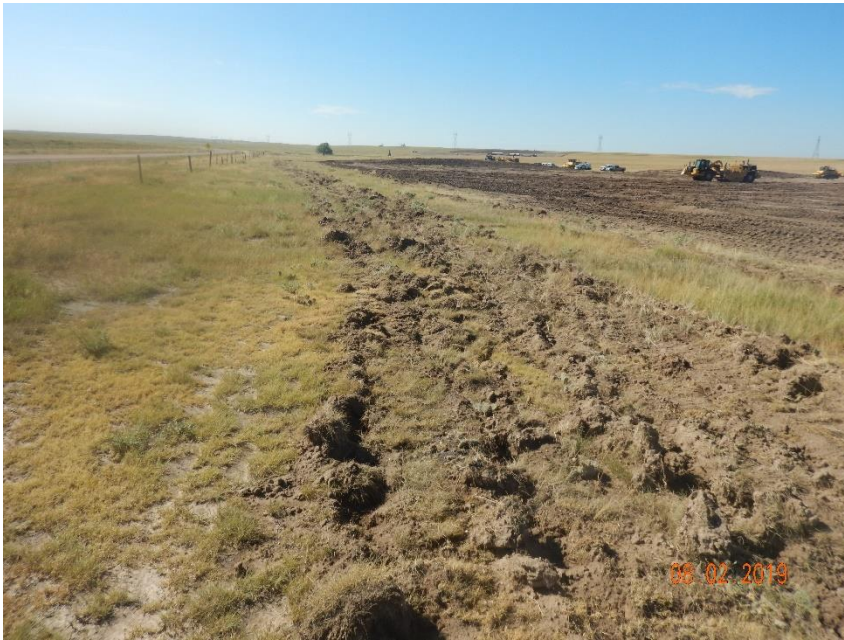
Photo 9: Photo taken from the east end of the location facing south. Photo of surface roughening BMP

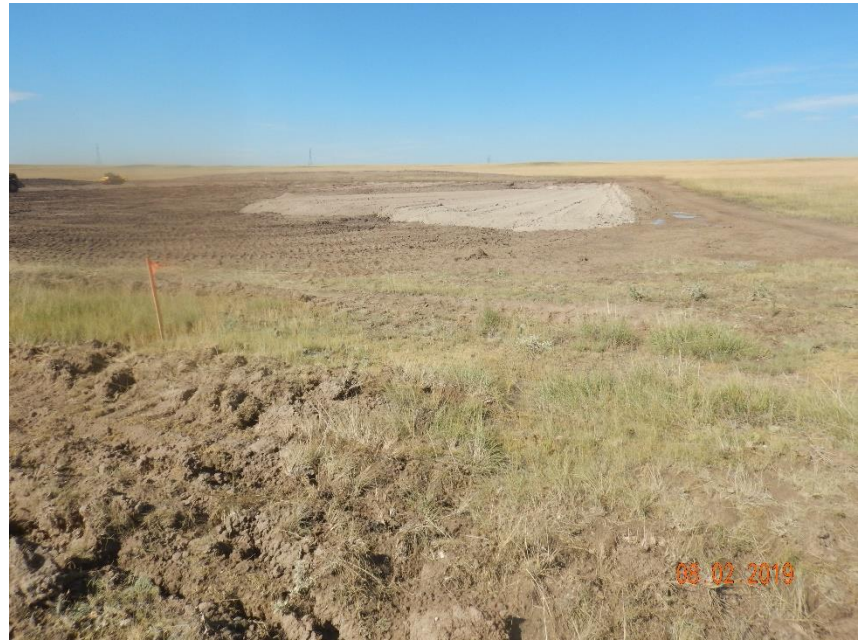
Photo 10: Photo taken from the east end of the location, facing west. Topsoil salvage and segregation in process over location. Photo shows areas of the east/northeast end of the location where all the topsoil has not yet been salvaged.

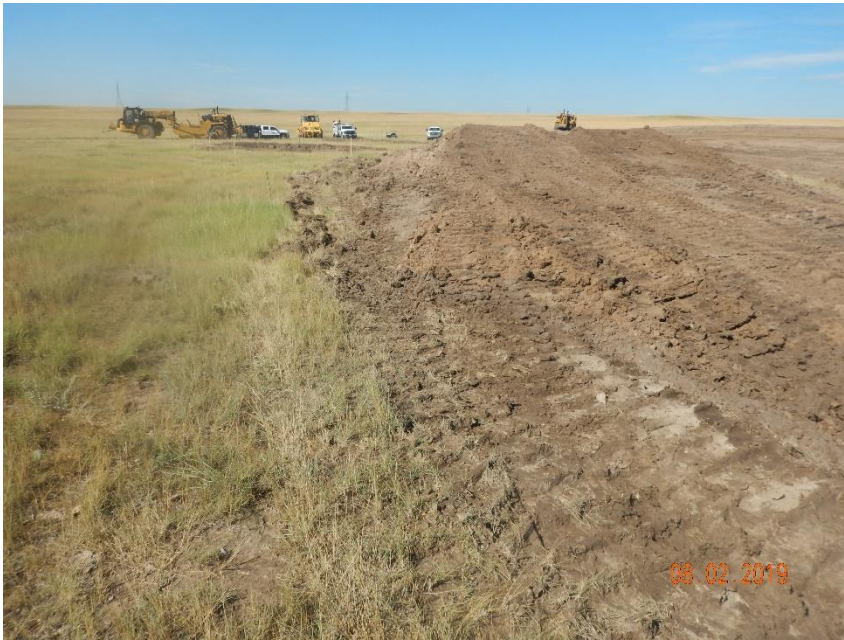
Photo 11: Photo taken from the southeast corner of the location, facing west. Photo shows areas of surface roughening on the southern perimeter that have been traveled over and is no longer in proper functioning condition

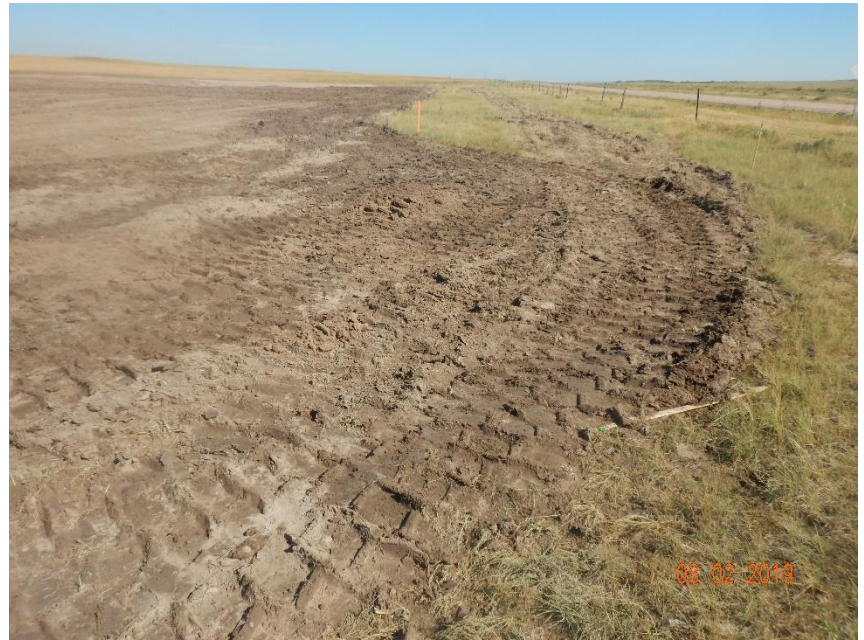
Photo 12: Photo taken from the southeast corner of the location, facing north. Photo shows areas of surface roughening on the southern perimeter that have been traveled over and is no longer in proper functioning condition

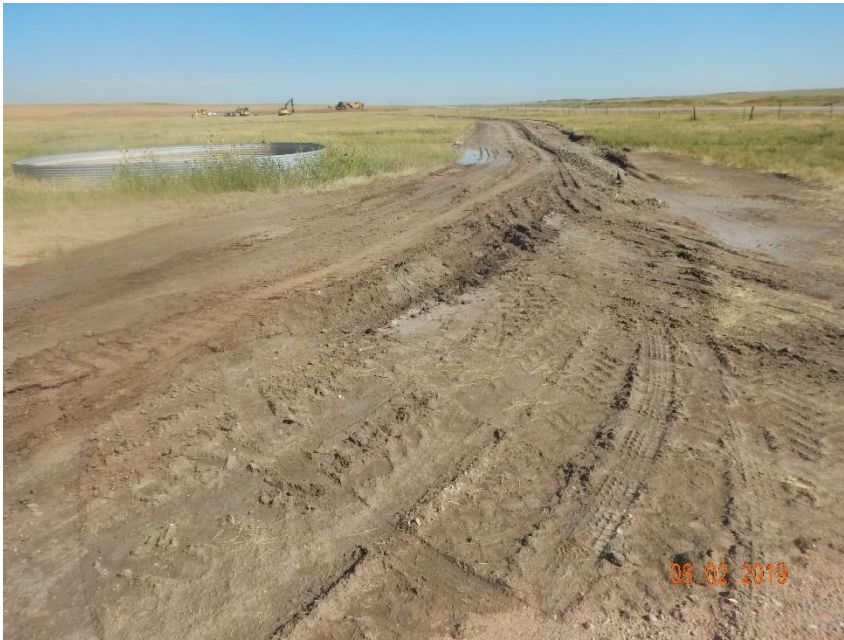
Photo 13: Photo taken from the access road, facing north. Road currently wet/muddy due to recent rain event. Vehicle tracking BMPs missing from access road. Additionally, access road appears to have been constructed across, and damming, a drainage. No BMPs (such as a culvert) has been installed to allow stormwater movement. Access road does not appear to have been constructed in such a manner to mitigate degradation or sediment transport per 1002.f and 1002.e.

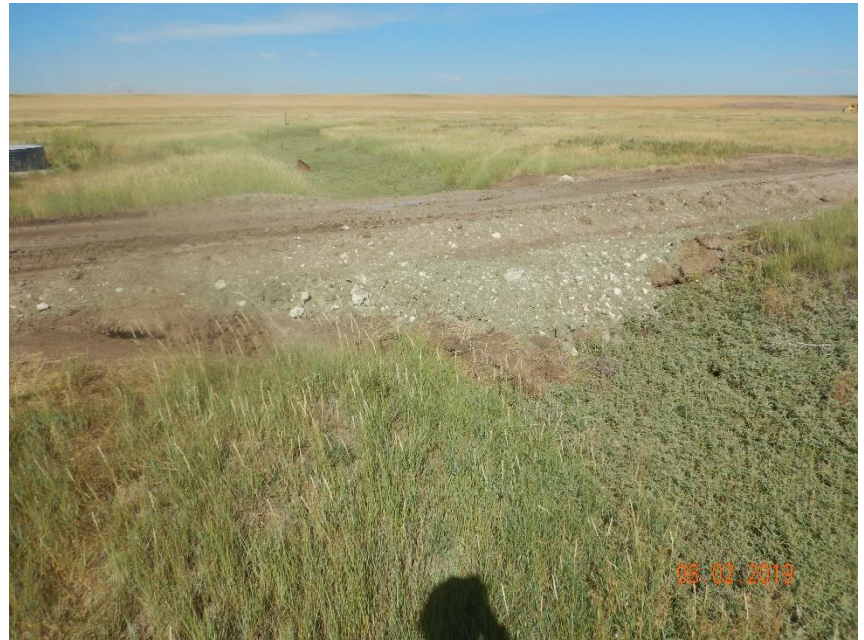
Photo 14: See comments under photo 13.
