Maralex Resources Inc.
API # 045-09853
Inspection # 696600432

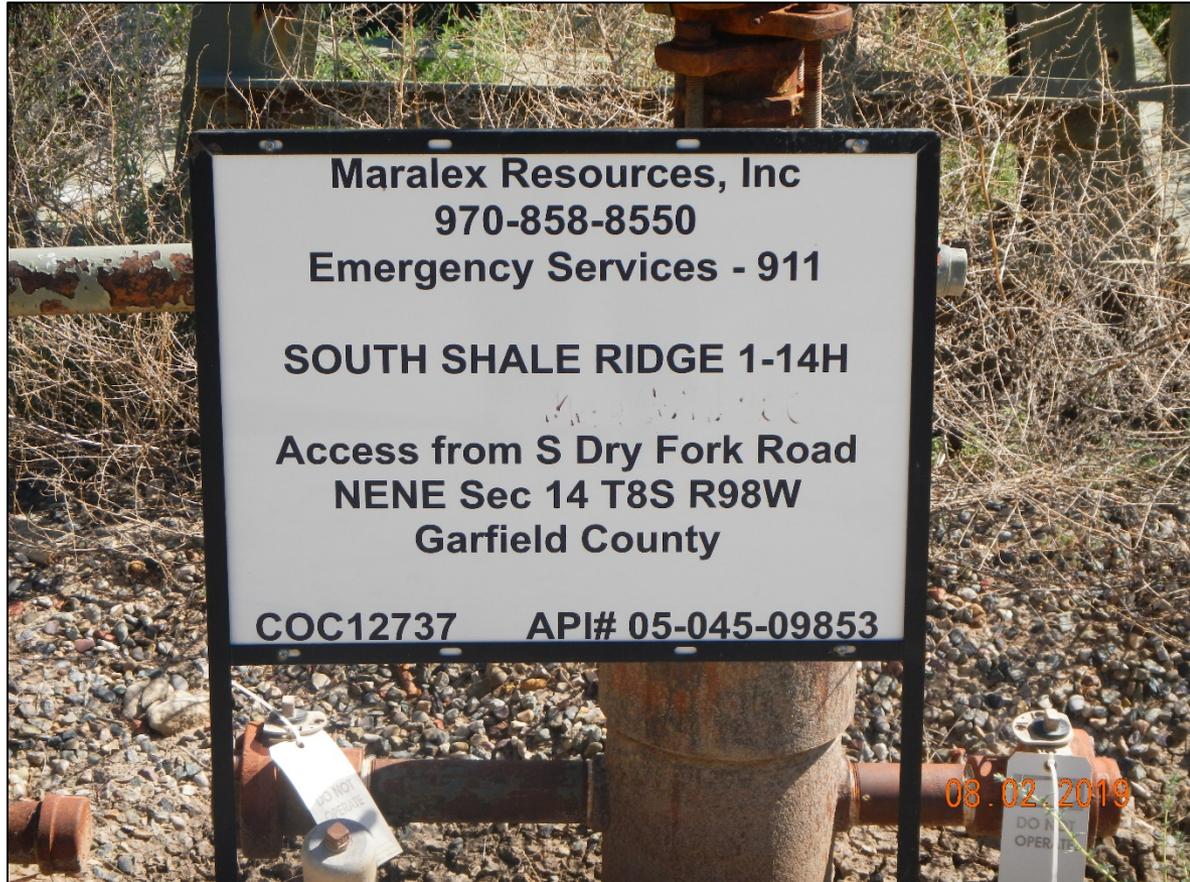
Photo #1 Sign is at the pump jack. No battery sign at entrance or tank battery

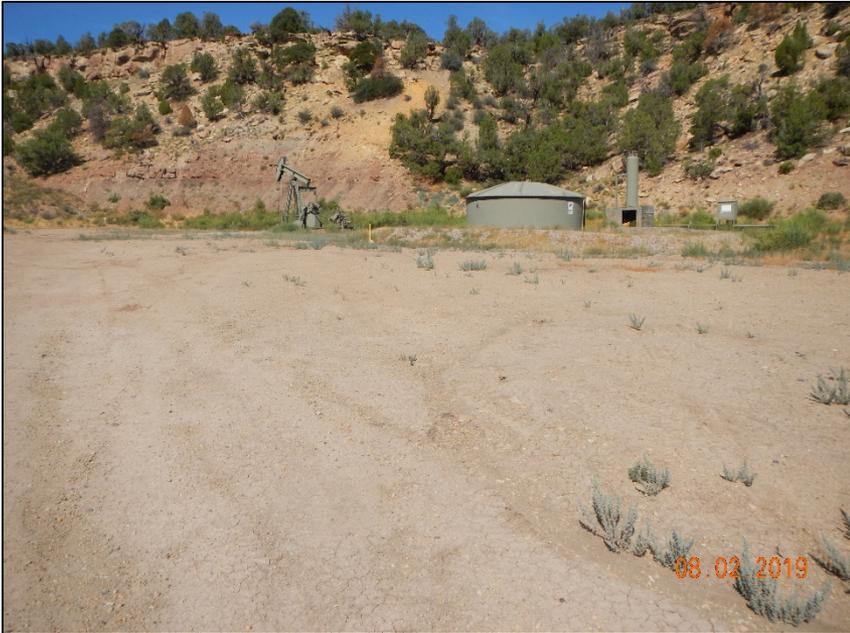
**Photo #2 Photo at entrance of location. Weeds on location.
Sediment moving off location.**

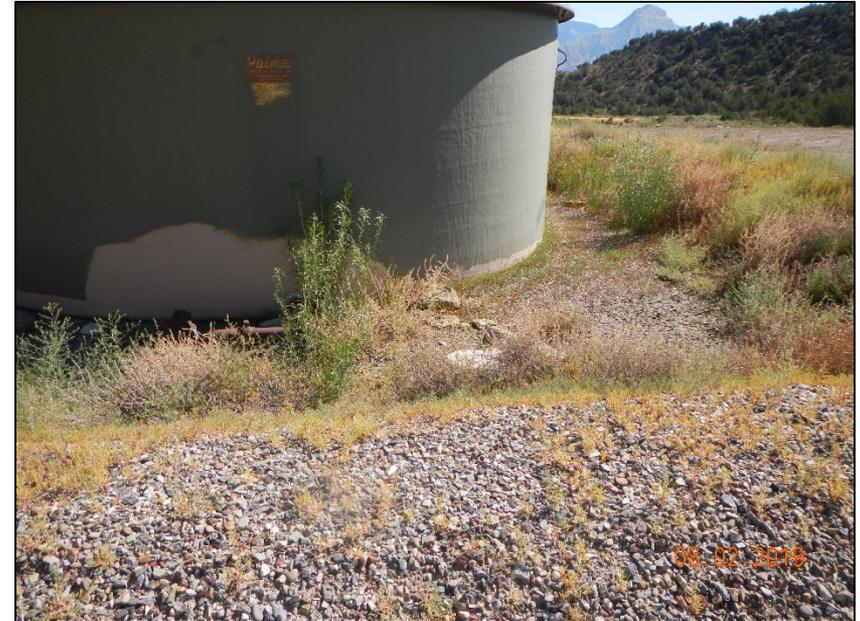
**Photo #3 Photo at Tank Battery. Weeds inside of tank
containment**

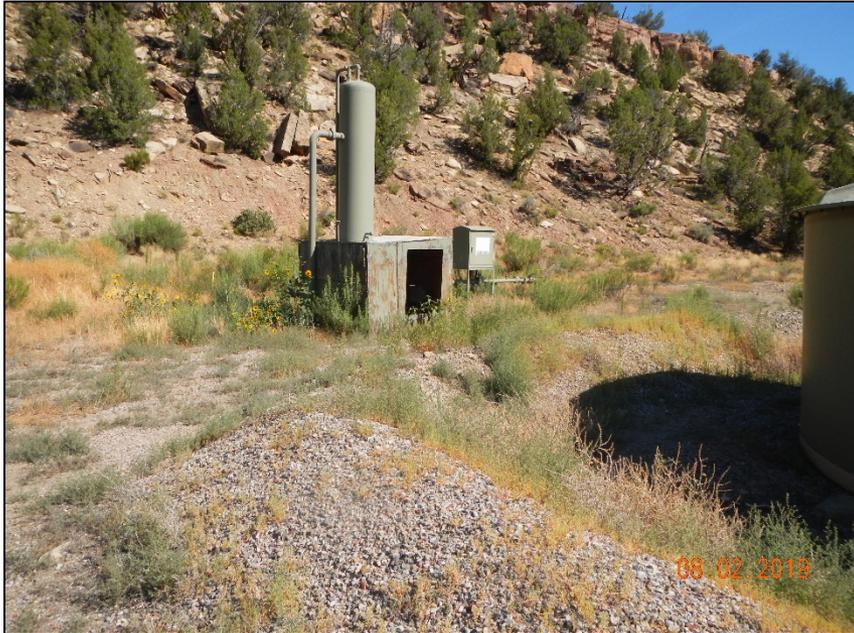
Photo #4 Photo from South side of location. Weeds on location and inside of tank containment.

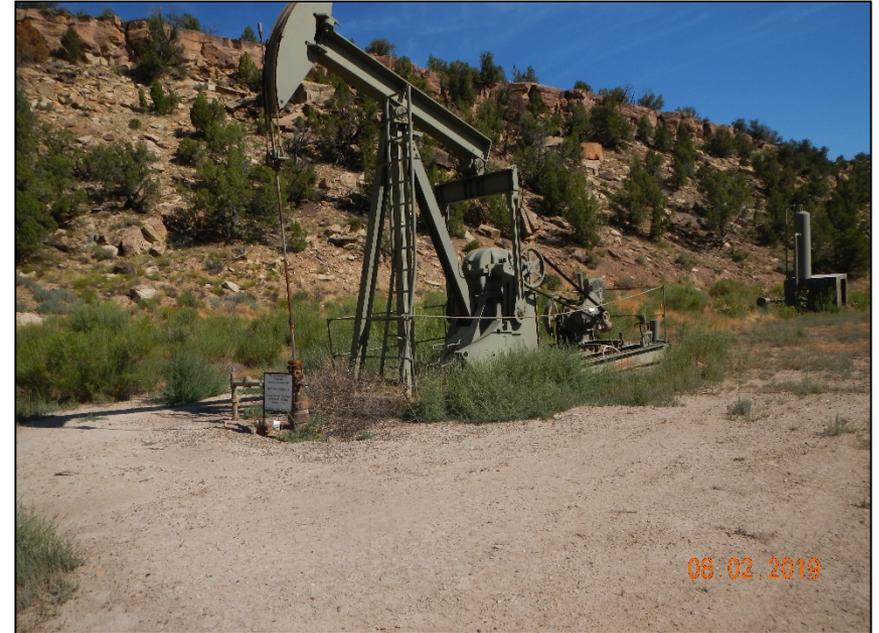
Photo #5. Photo of wellhead and pump jack.

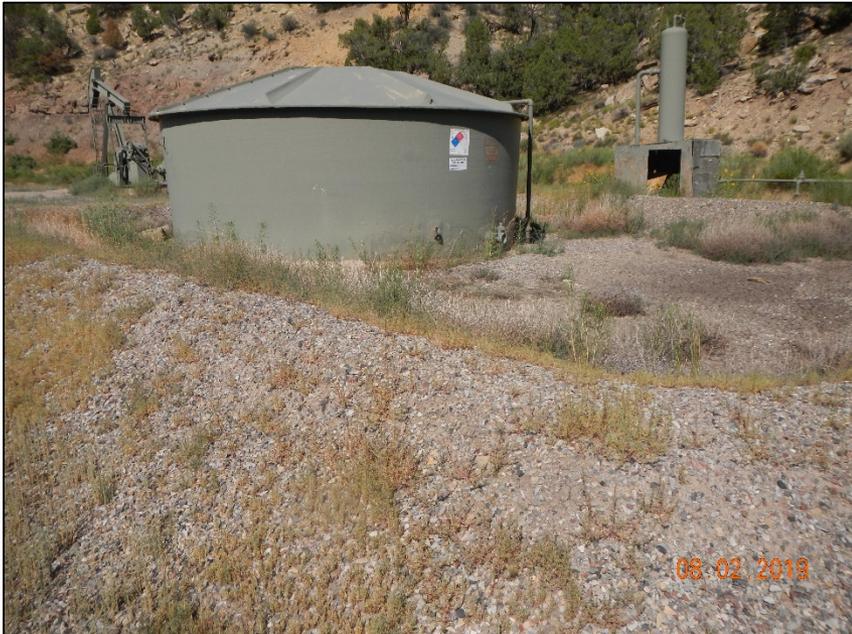
Photo #6 weeds on and around location

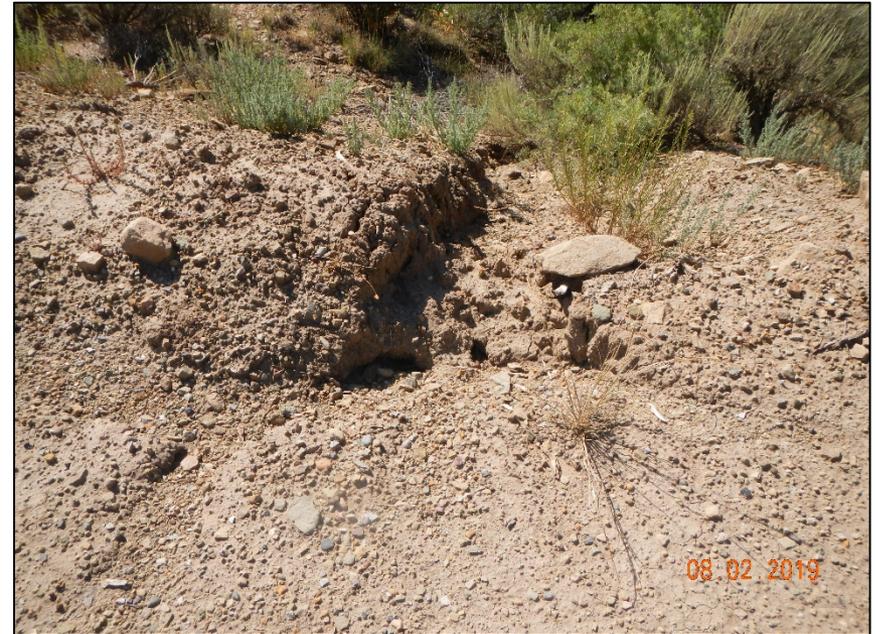
Photo #7 Erosion Channel off east side of location into drainage.

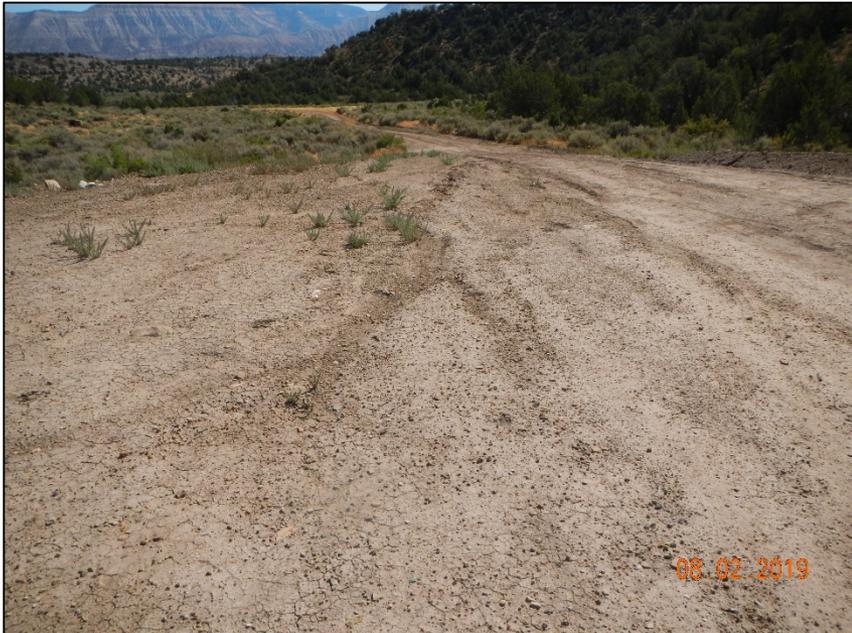
**Photo #8 Erosion sediment moving off location and down
Access road**

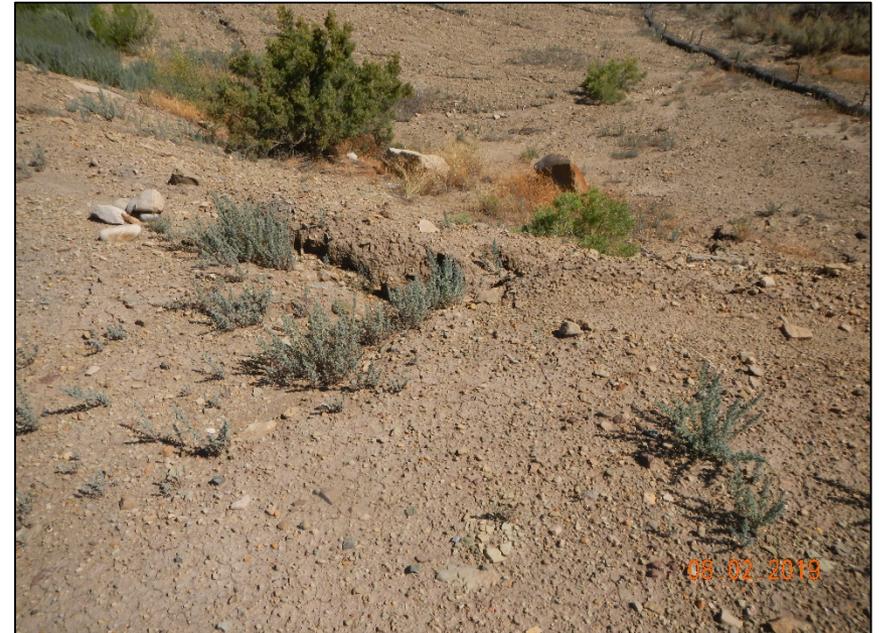
**Photo #9 Erosion sediment moving off North side location
and down Un-stabilized slope**
