Maralex Resources Inc.
API # 077-08594
Inspection # 696600434

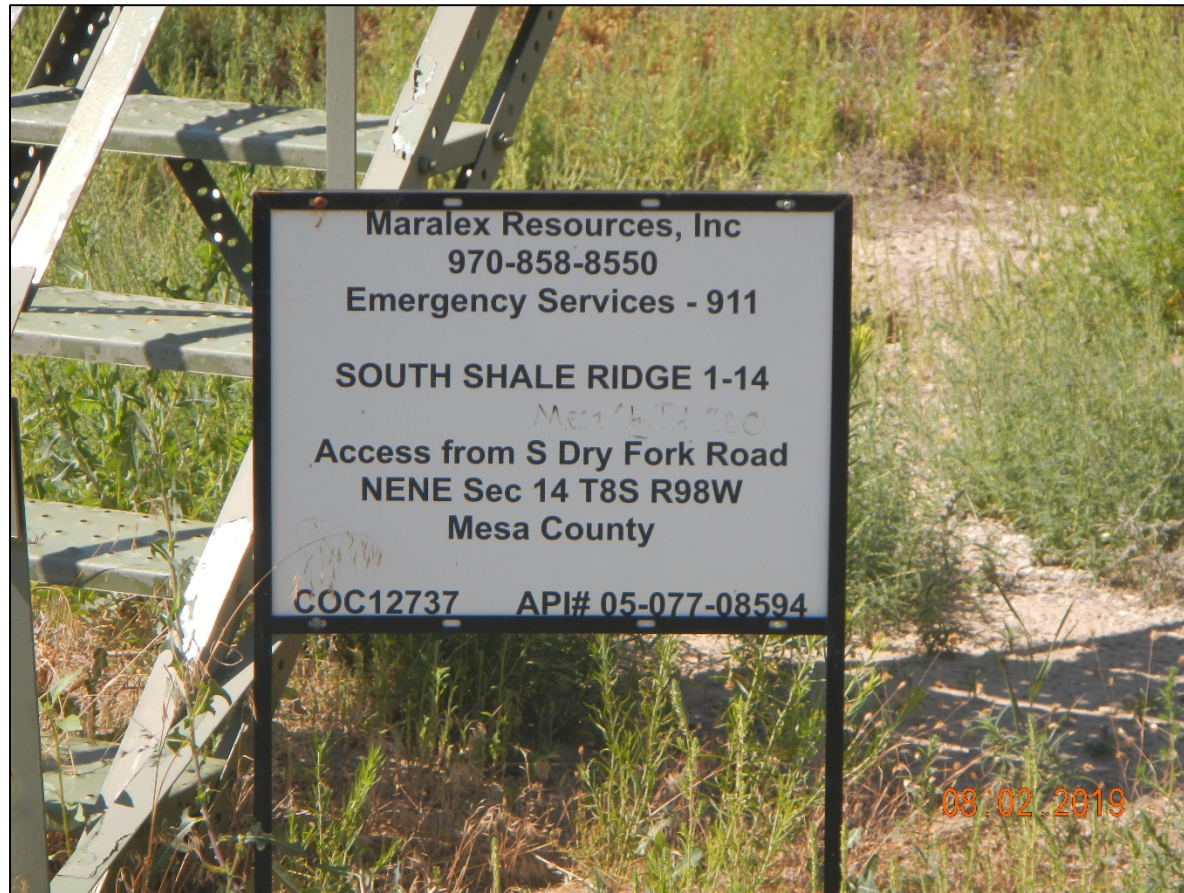
Photo #1 Sign is at the tank battery

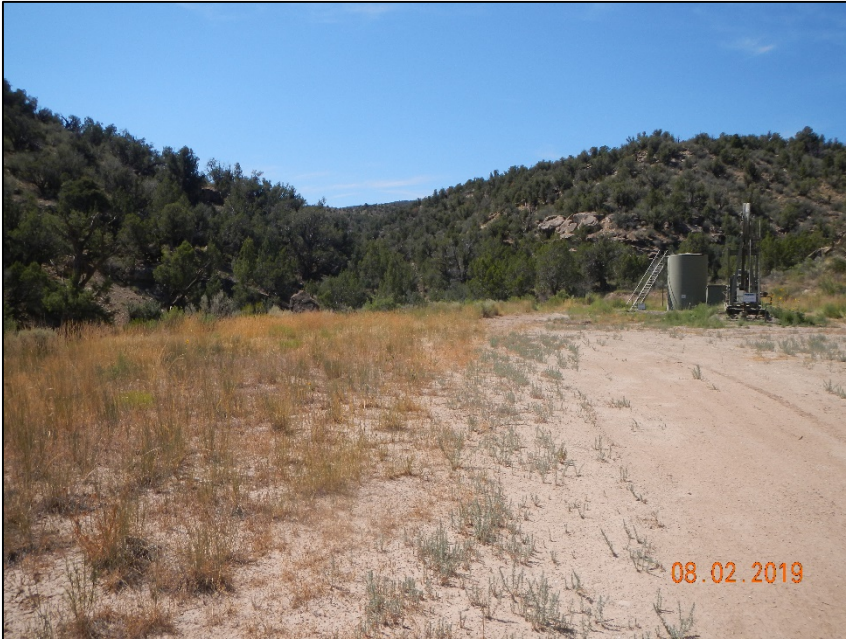
Photo #2 Photo at entrance of location.

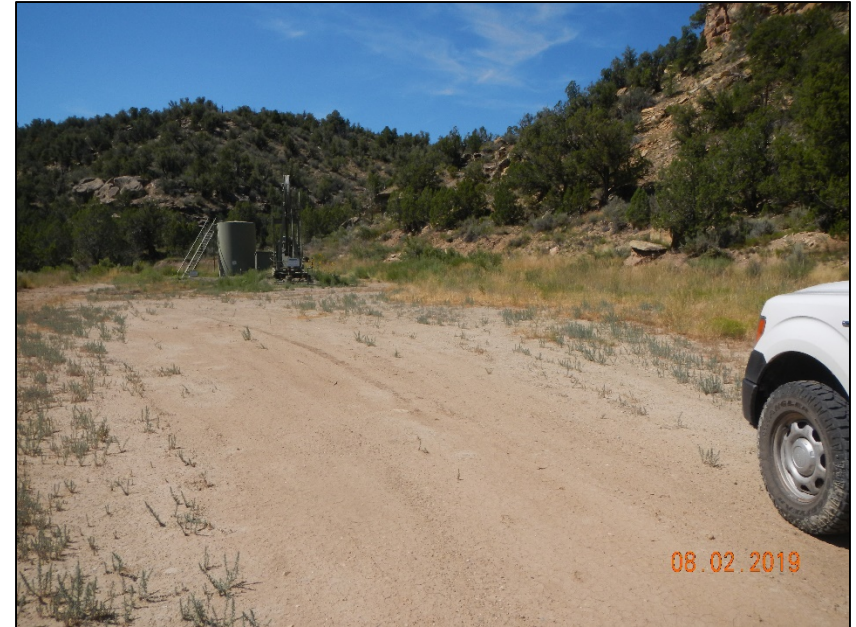
**Photo #3 Photo at entrance of location.
containment**

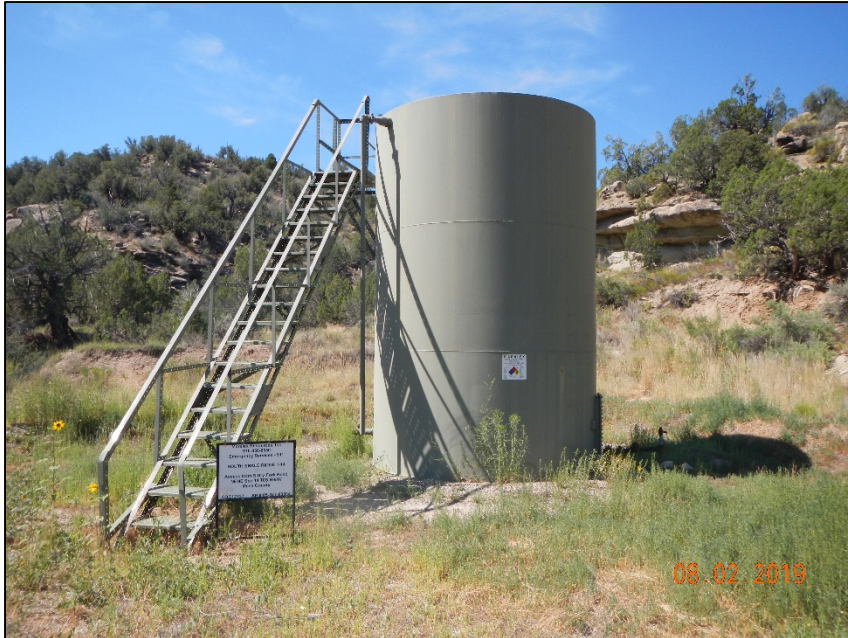
Photo #4 Photo of tank battery. Weeds inside of tank containment.

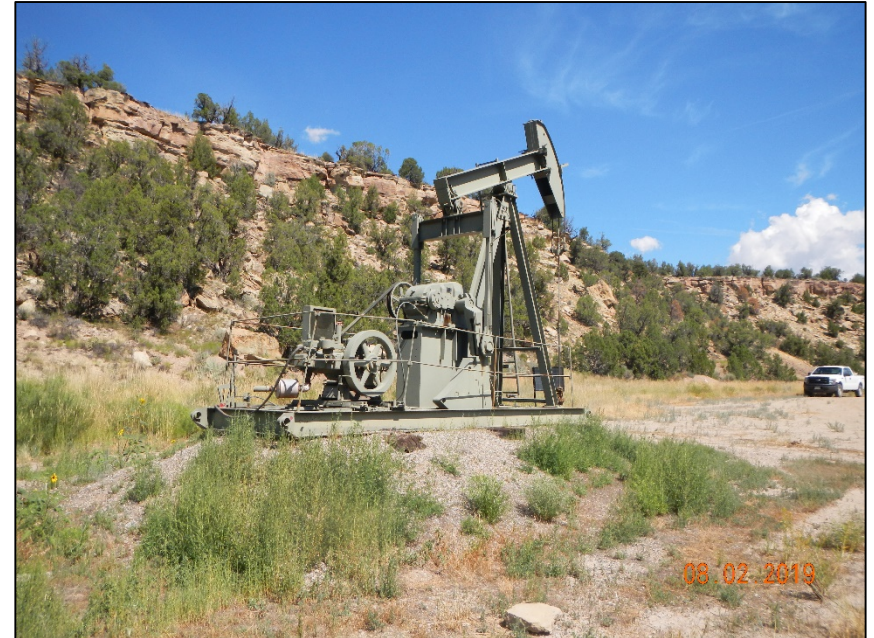
Photo #5. Photo of wellhead and pump jack. Weeds are present.

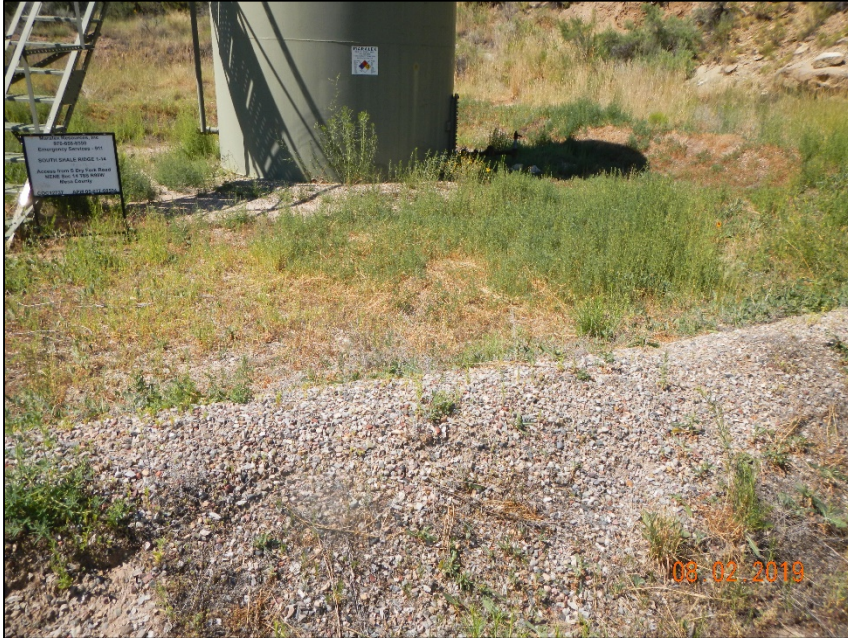
Photo #6 Weeds inside of tank containment.

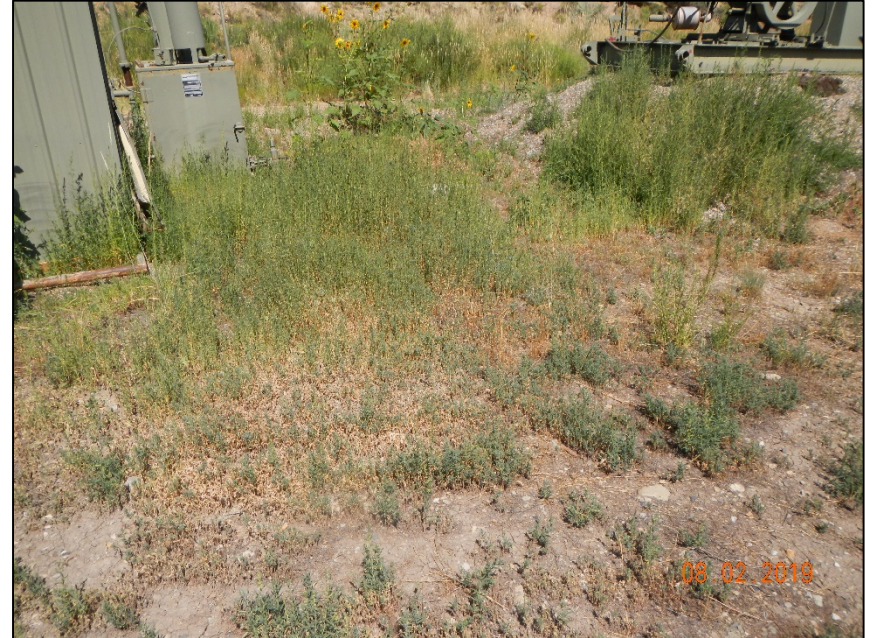
Photo #7 Weeds on and around location

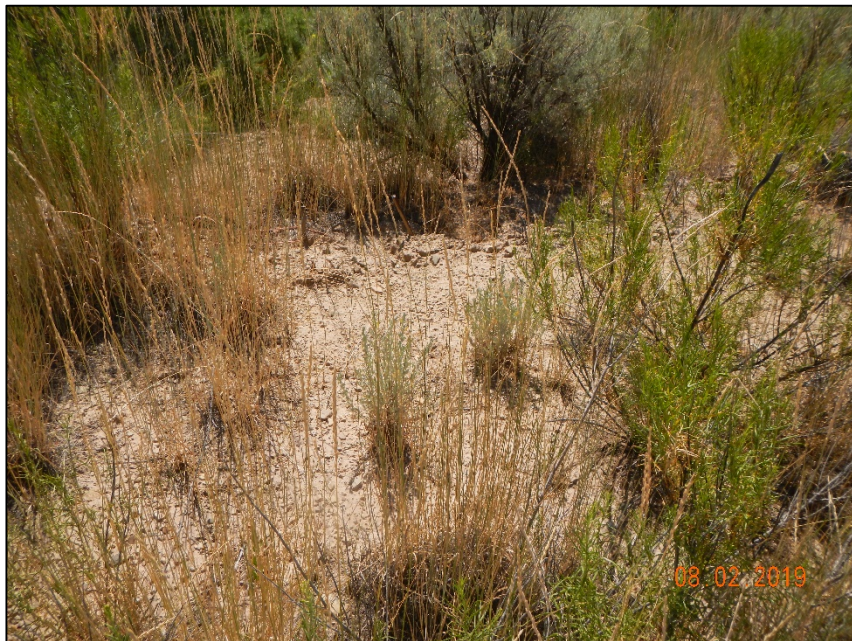
Photo #8 Erosion sediment moving off on east side of location. Waddles or BMP need maintenance.

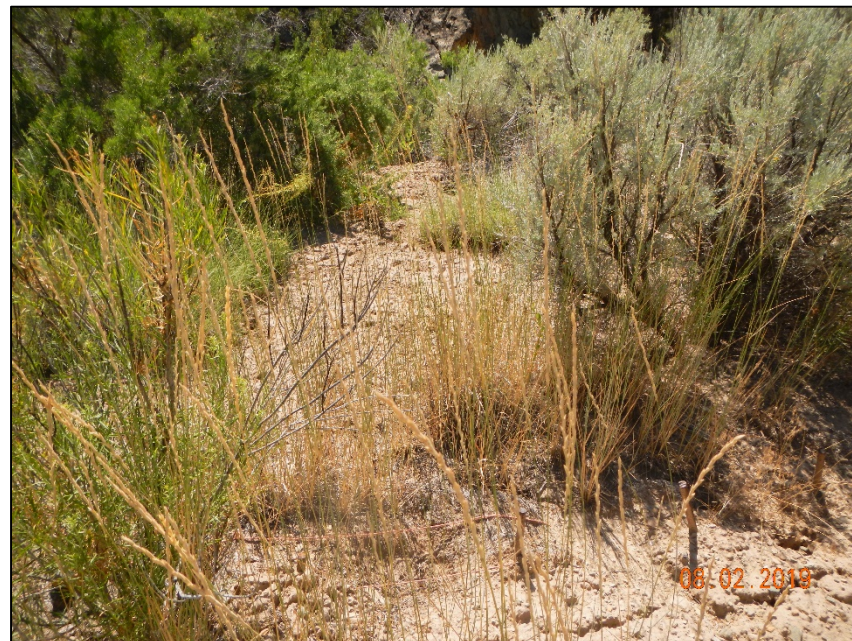
Photo #9 Erosion sediment moving off on east side of location. Waddles or BMP need maintenance. Vegetation is being choked out by sediment.

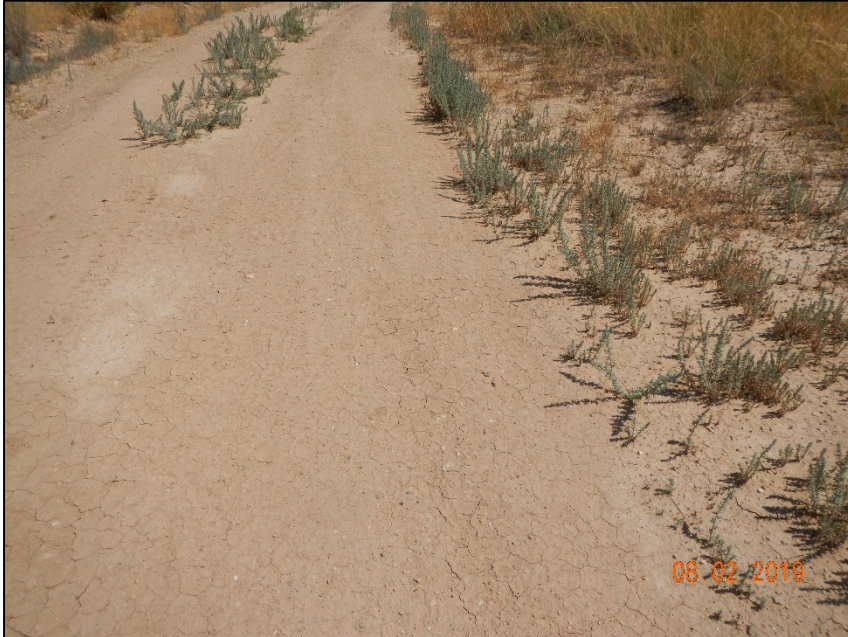
Photo # 10 Erosion sediment moving off location and down Access road

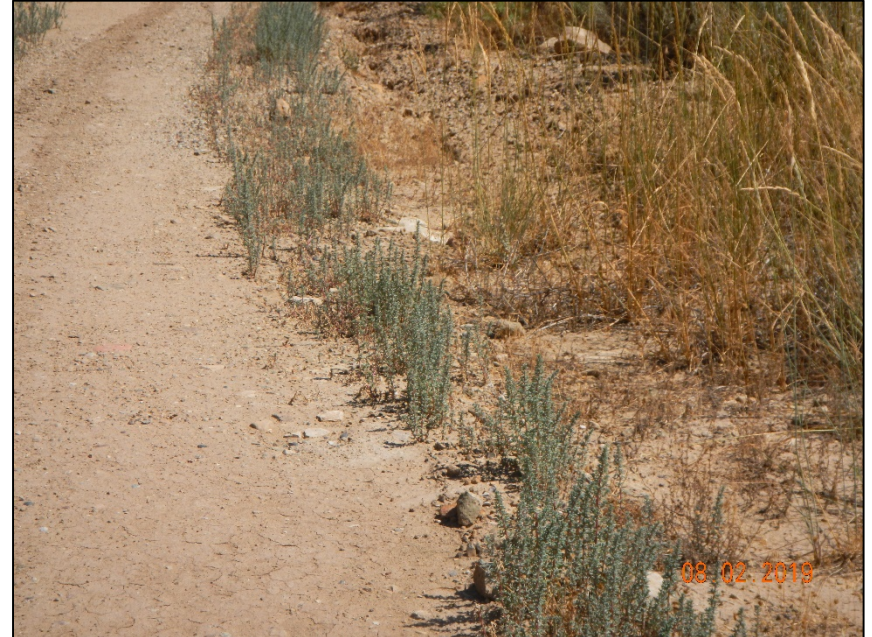
Photo # 11 Erosion sediment moving off location and down Access road
