Inspection Photos

API: 05-055-06017

Operator: OXY USA INC

Inspection Date: 8/1/2019

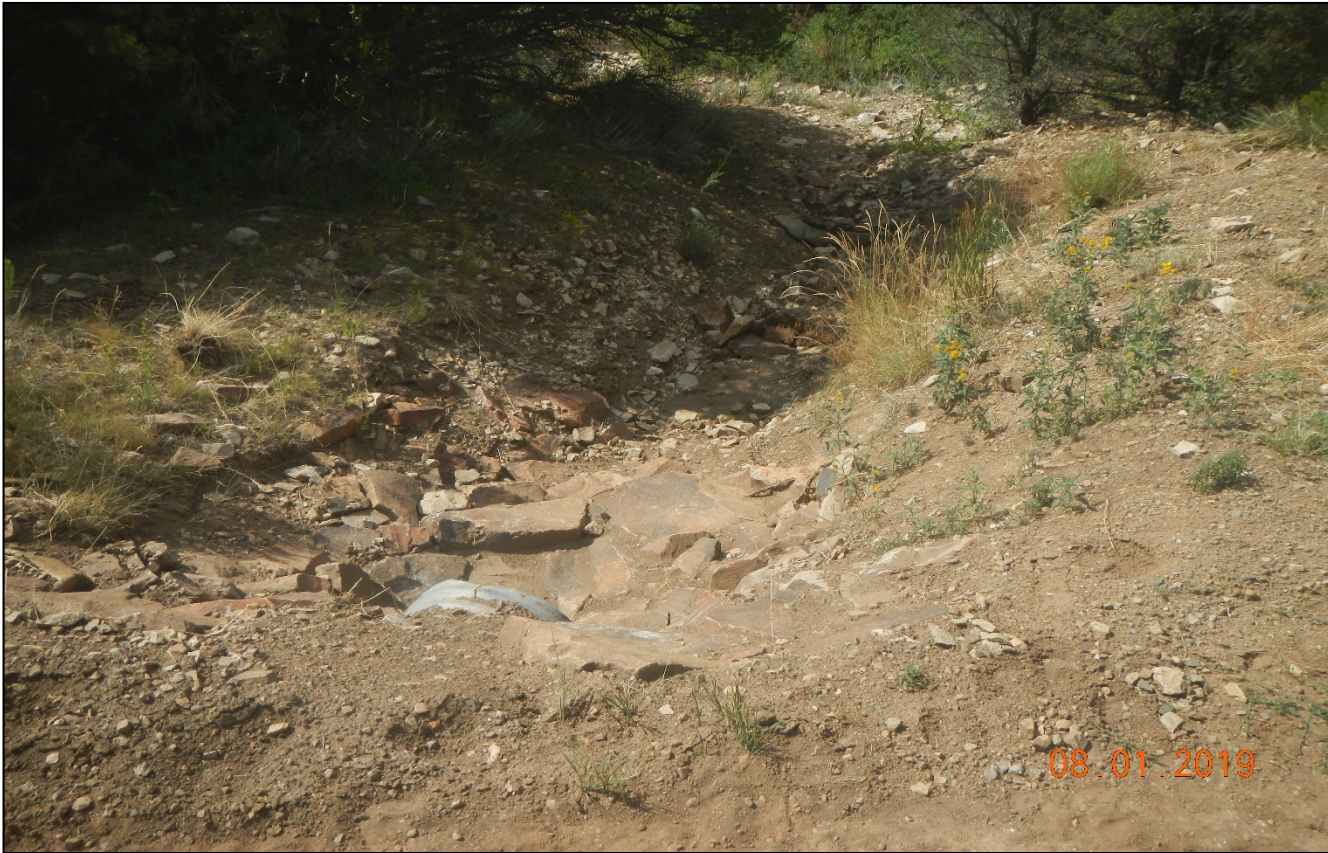
Photo 1. Rock rip/rap and check dams have been installed at the culvert outlet.
Lat/Long:37.69957,-105.22668

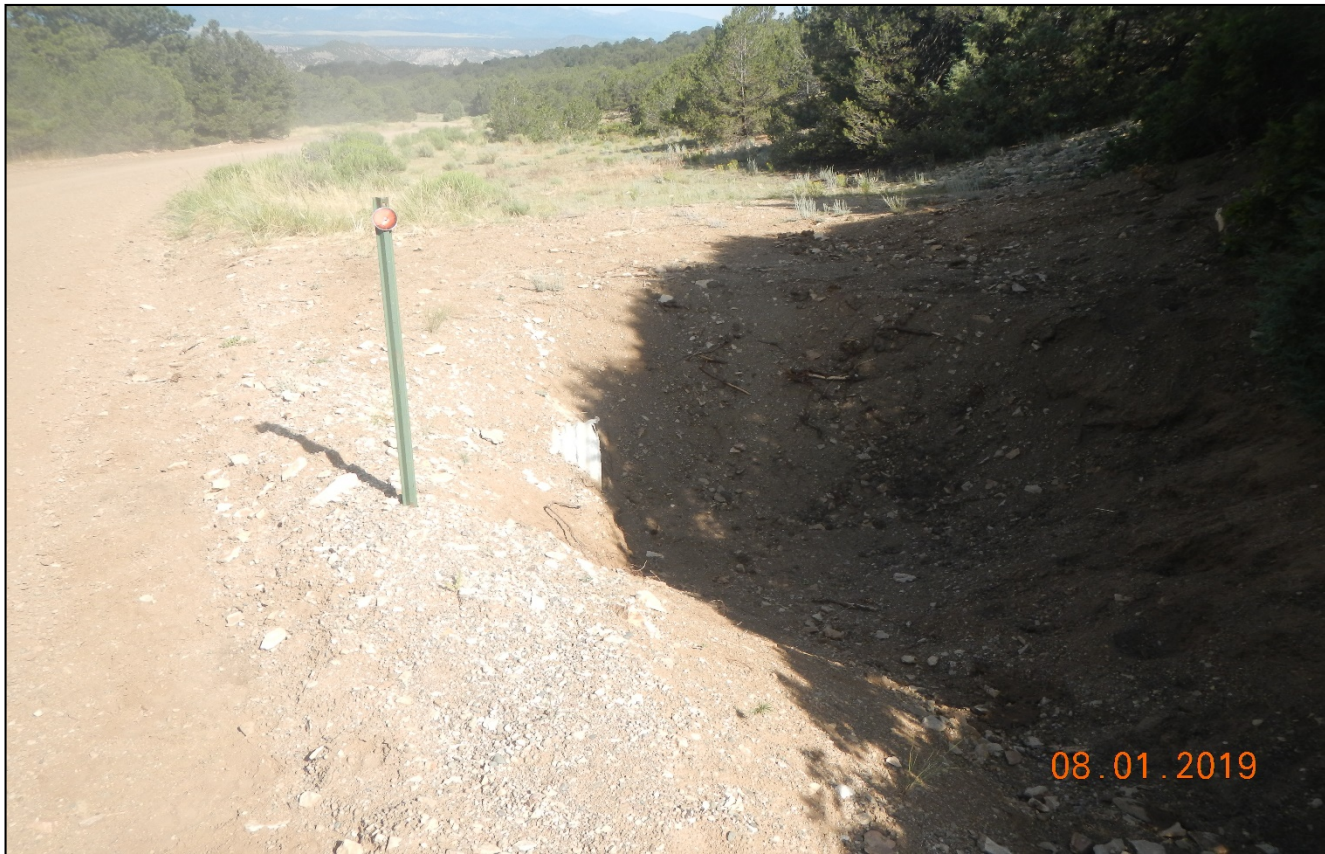
Lat/Long:37.69845,-105.22215

Photo 2. Sediment at culvert inlet has been removed.

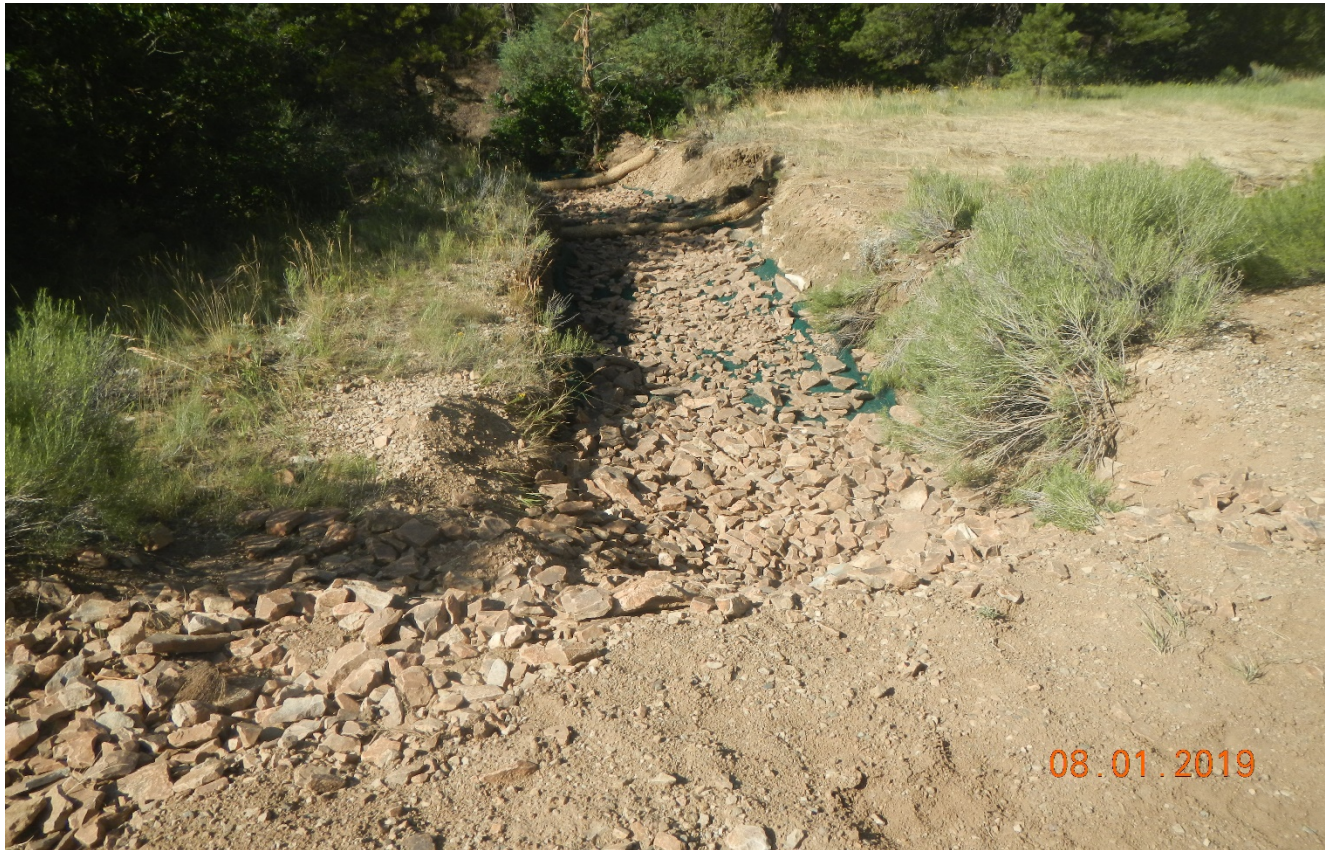
Lat/Long:37.69829,-105.21889

Photo 3. Erosion channel has been repaired at the culvert outlet. Rock rip/rap, wattles, and erosion matting was placed in channel. It is uncertain if rip/rap is large enough to handle high water flow in heavy rain events.

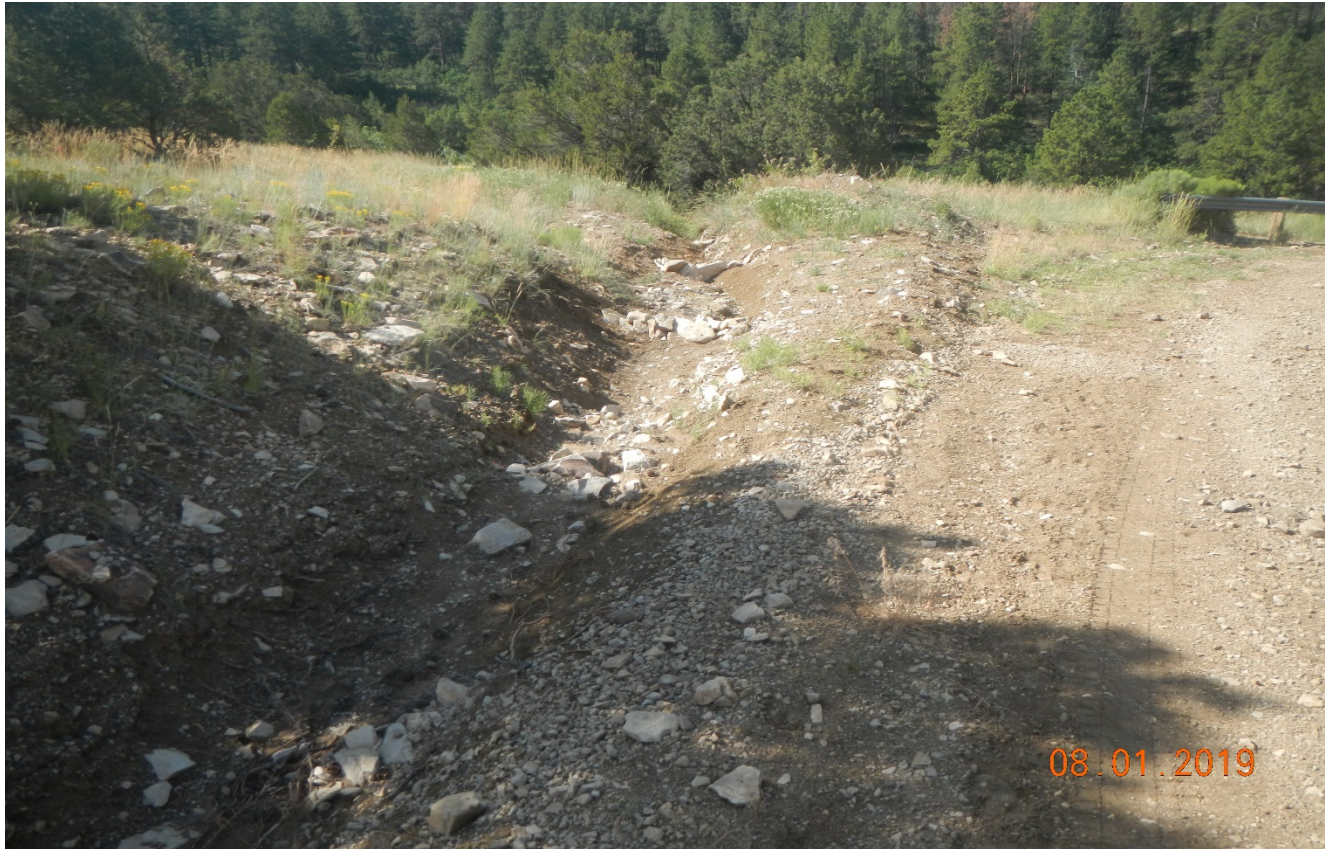
Photo 4. Rock check dams have been installed along the diversion ditch. These check dams are small and will likely fill in with sediment and will need ongoing maintenance. Lat/Long:37.69860,-105.21673

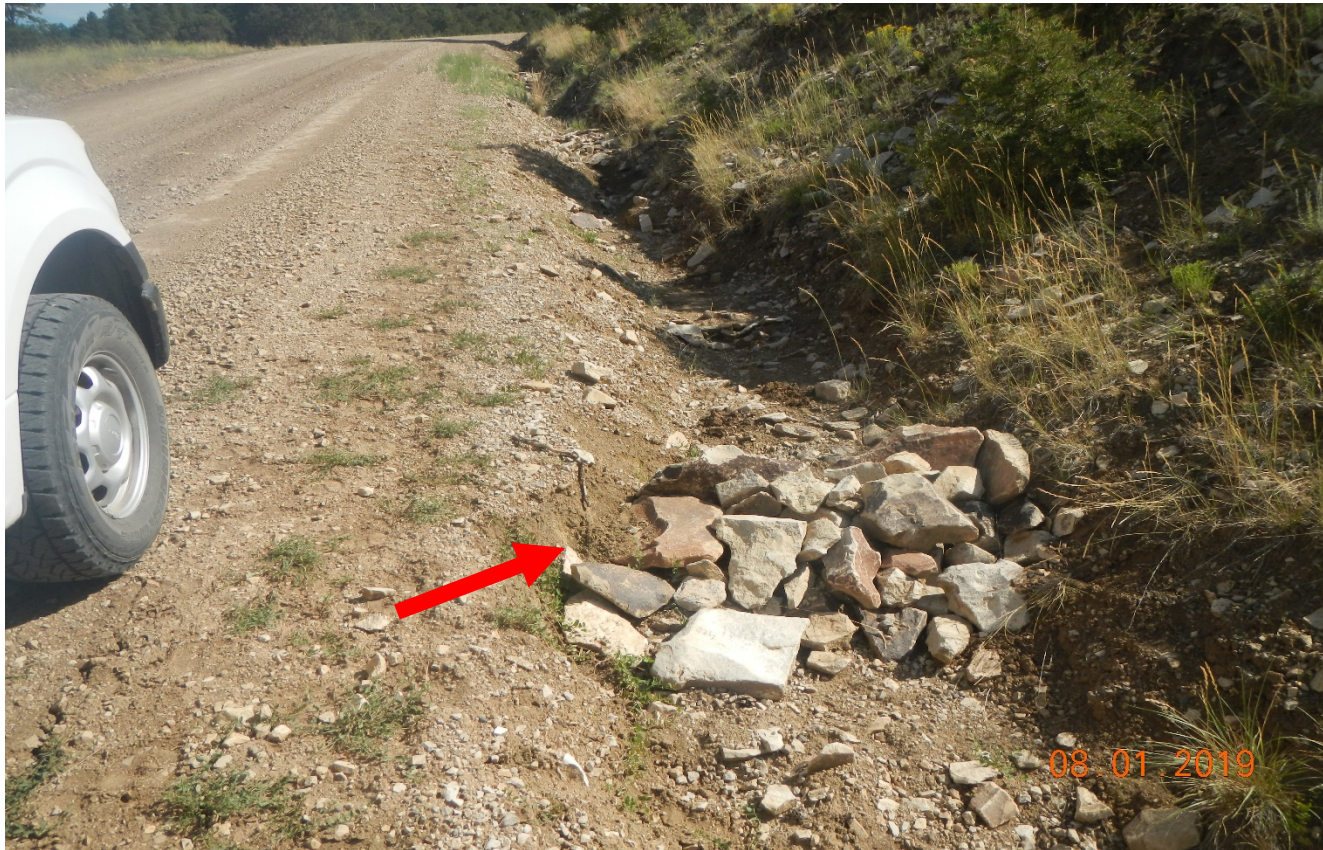
Photo 5. Rock check dams have been installed along the side of the road. The low point of the check dams should be in the center and on this one it is on the side shown by arrow. Stormwater will flow toward the side and will erode the into road.
Lat/Long:37.69860,-105.21673

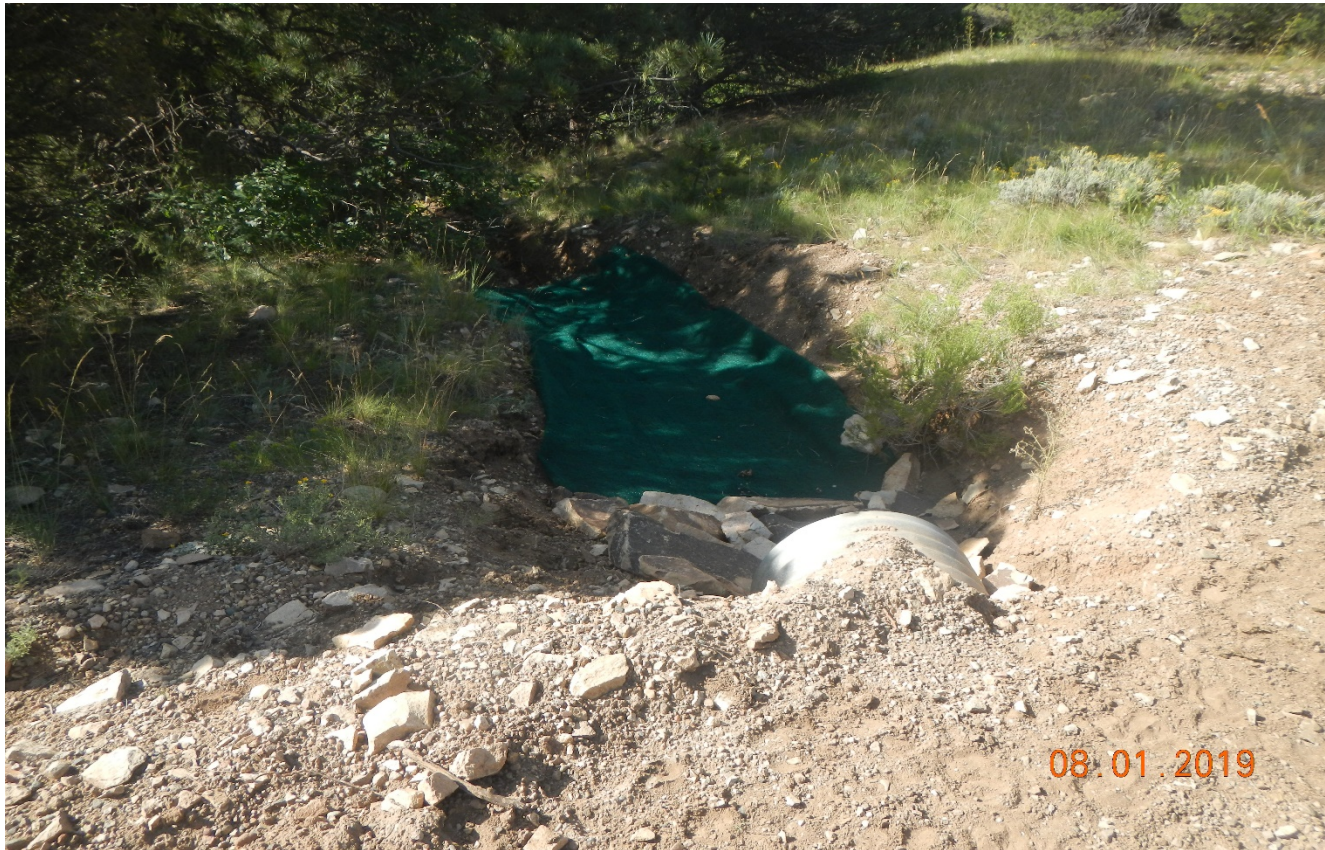
Lat/Long:37.70004,-105.21143

Photo 6. Erosion channel has been repaired at the culvert outlet. Rock rip/rap and erosion matting was placed in channel. The matting is not trenched in on the side and could become displaced.

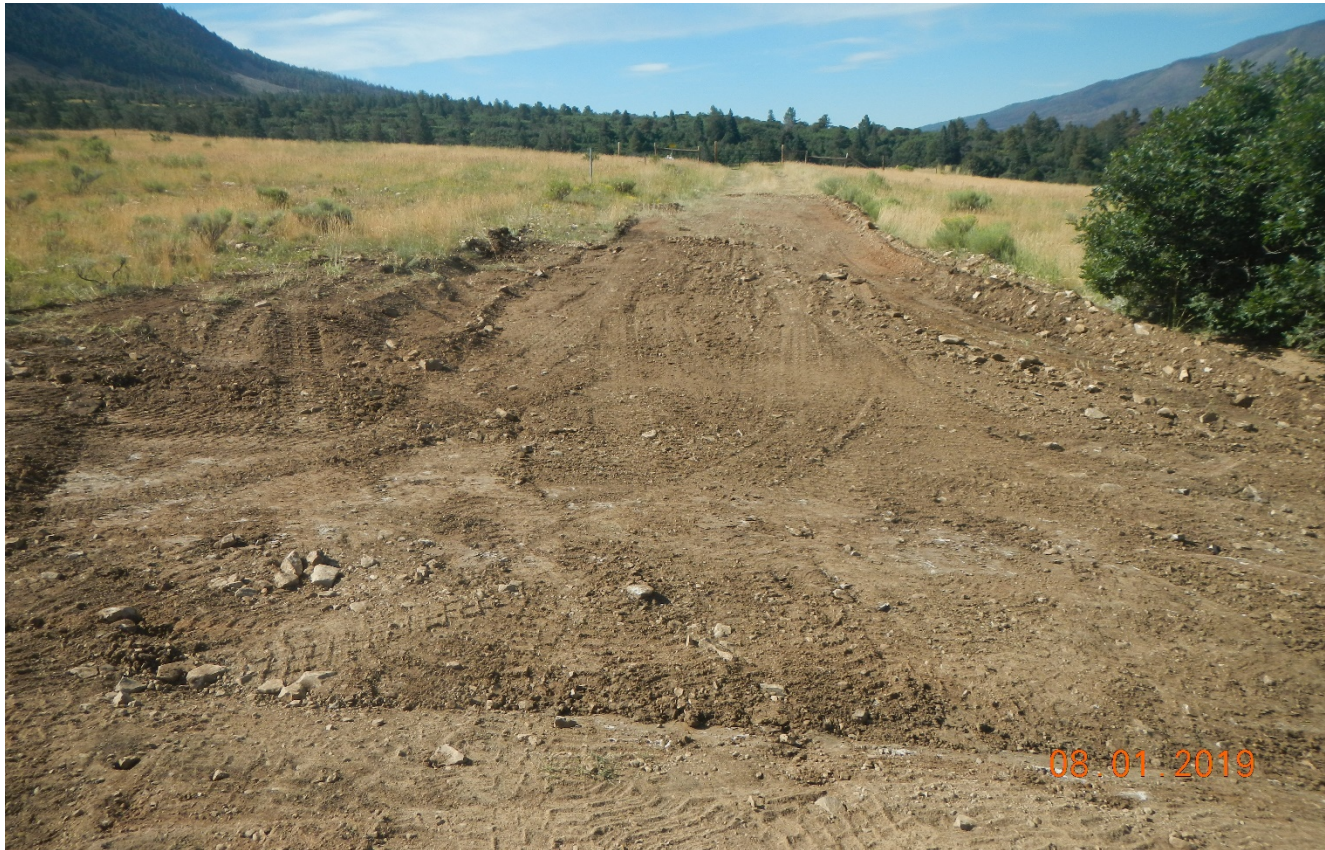
Photo 7. Facing south toward the access road. Which was graded. This area needs to be stabilized.

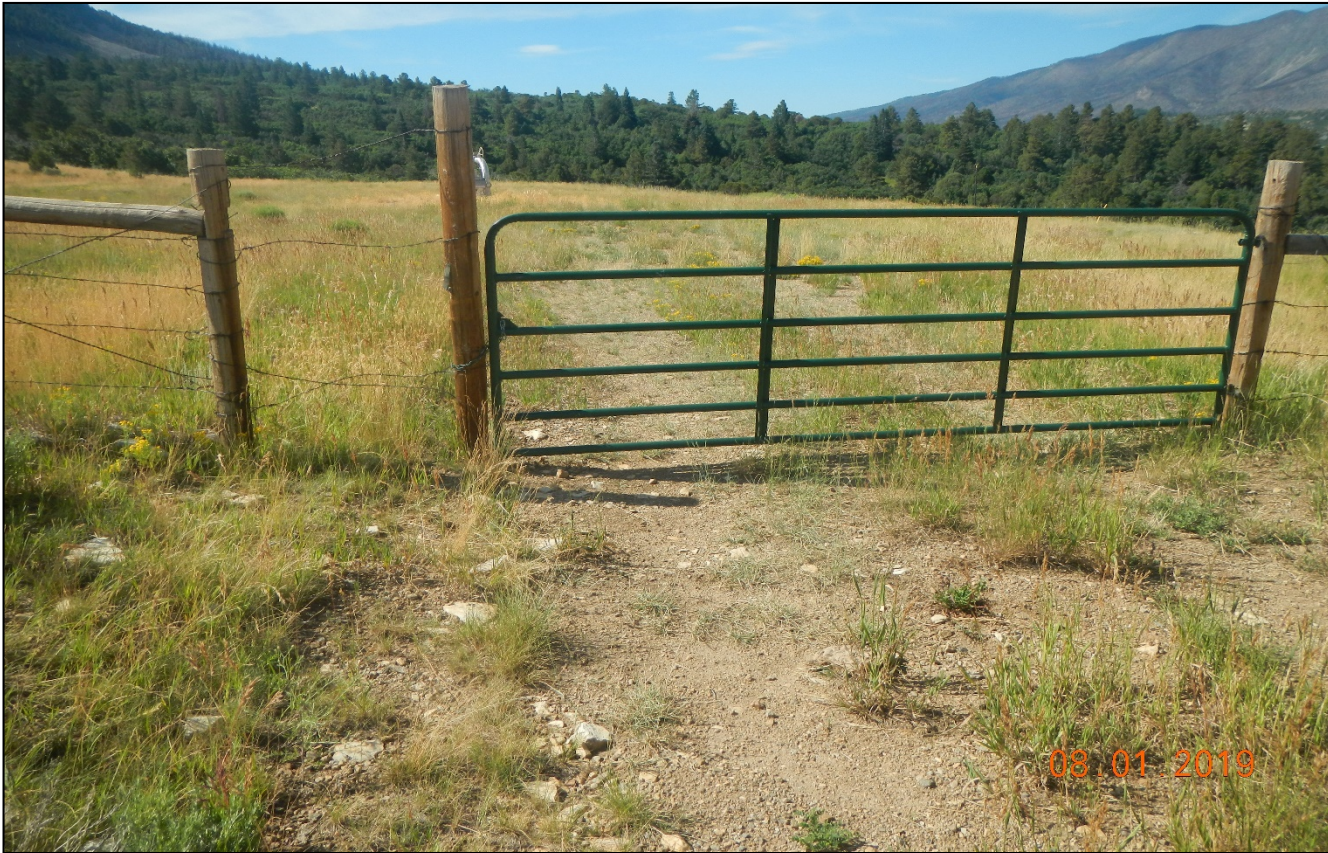
Photo 8. The gate at the location has been repaired.

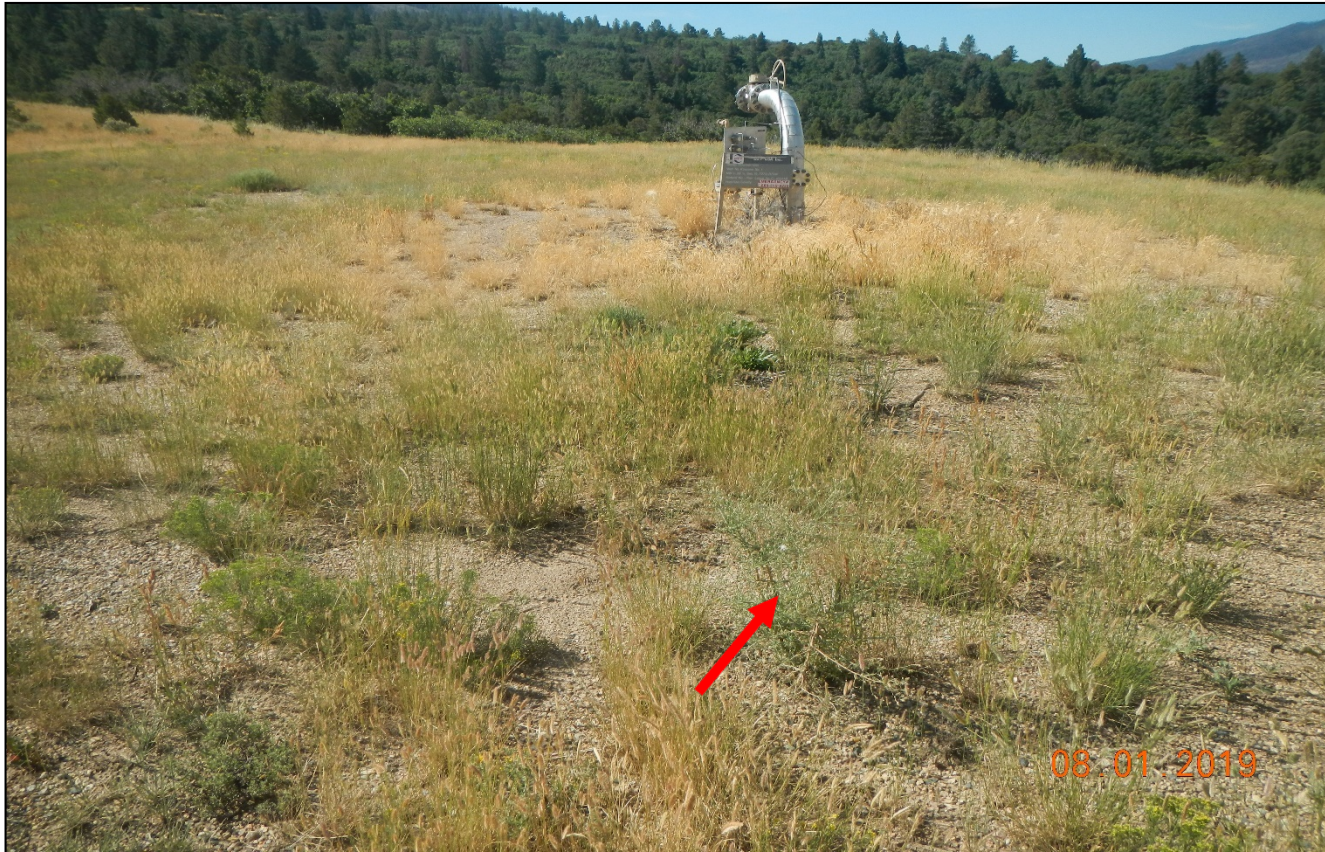
Photo 9. Facing south toward the location. There are numerous noxious weeds (Diffuse knapweed) in this area that were not treated.

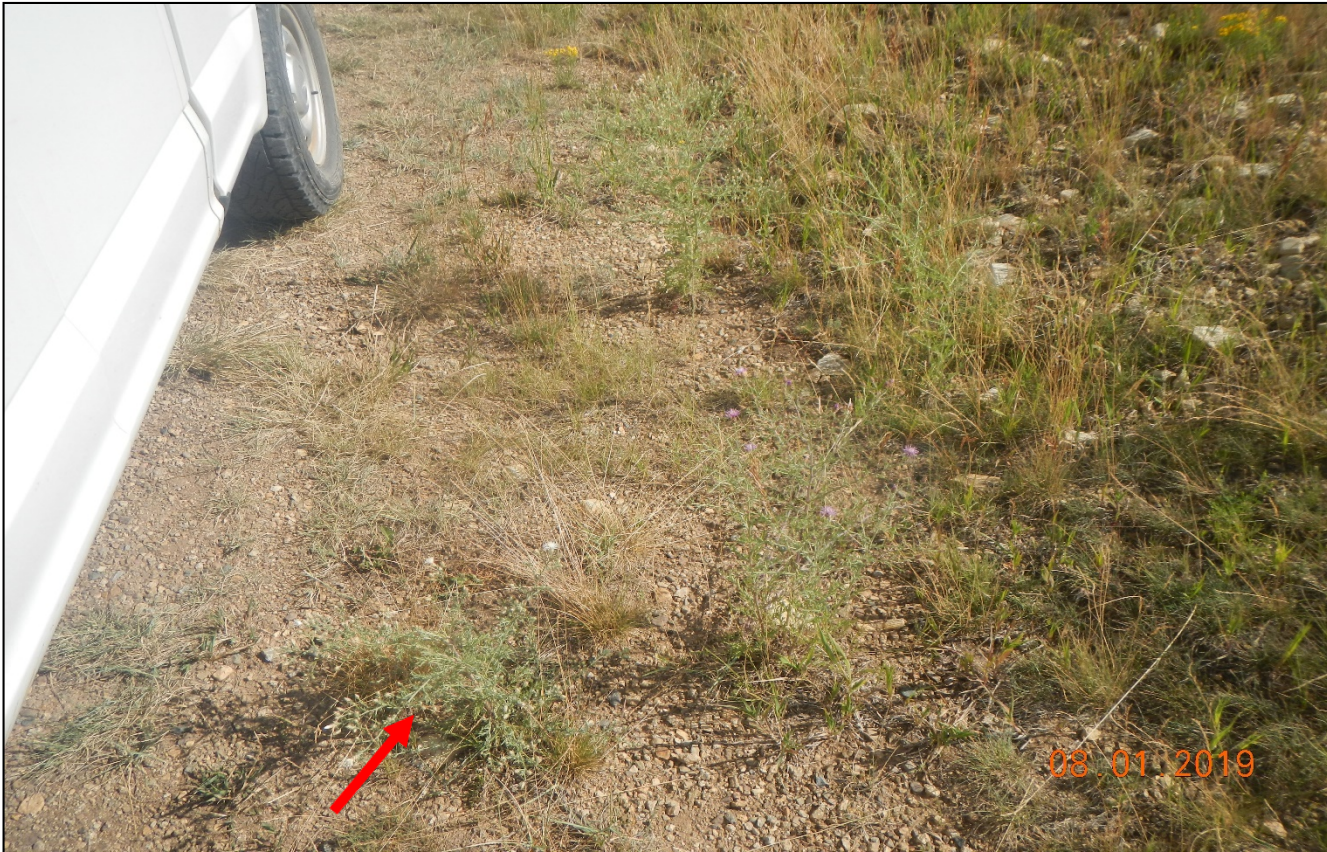
Photo 10. Facing along the access road. There are numerous noxious weeds (Diffuse knapweed) in this area that were not treated.
