# Inspection Photos

API: 05-055-06314

Operator: OXY USA INC

Inspection Date: 8/1/2019

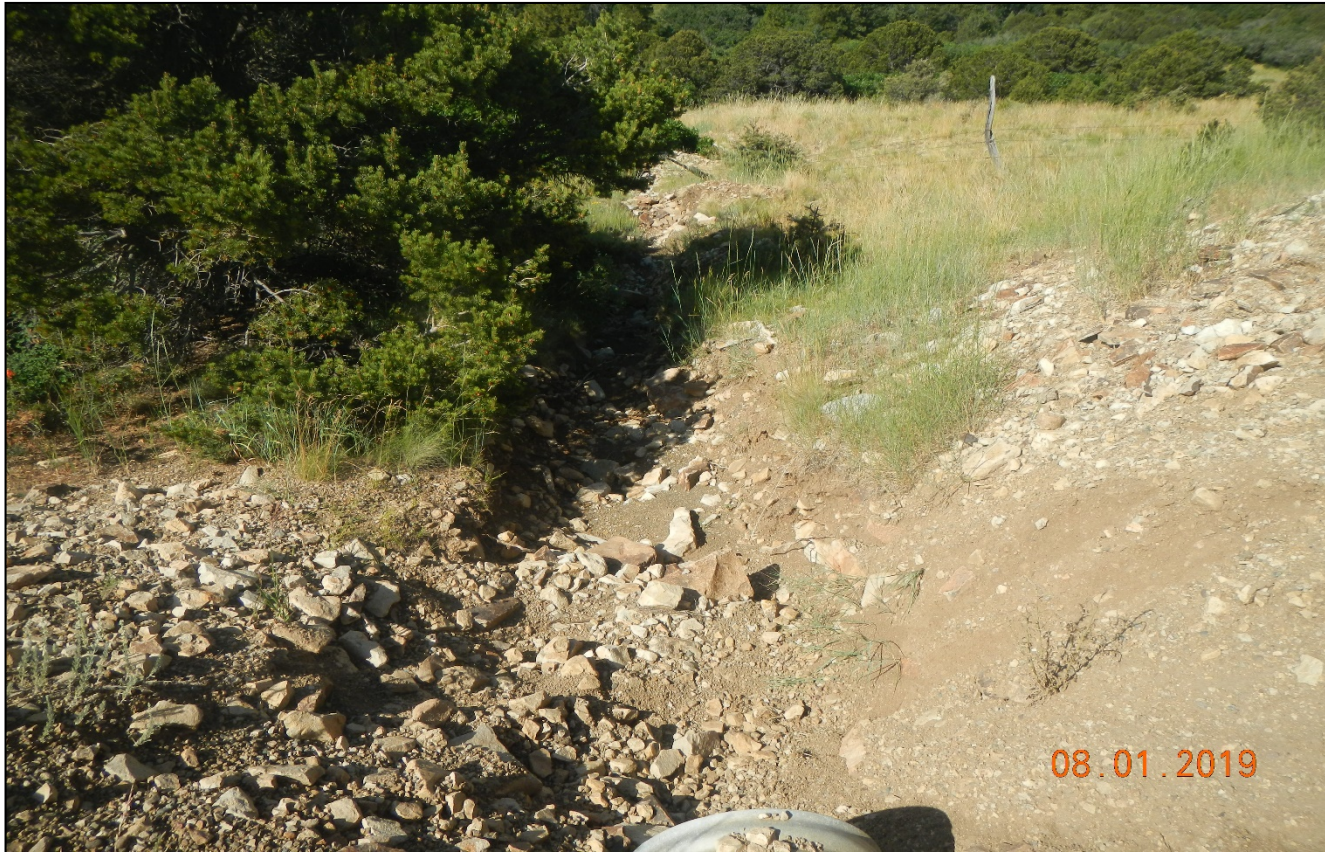
**Photo 1.** There is erosion occurring at the culvert with no outlet protection.  
No outlet protection has been installed at this culvert identified by previous inspection.  
Lat/Long:37.69799,-105.20237

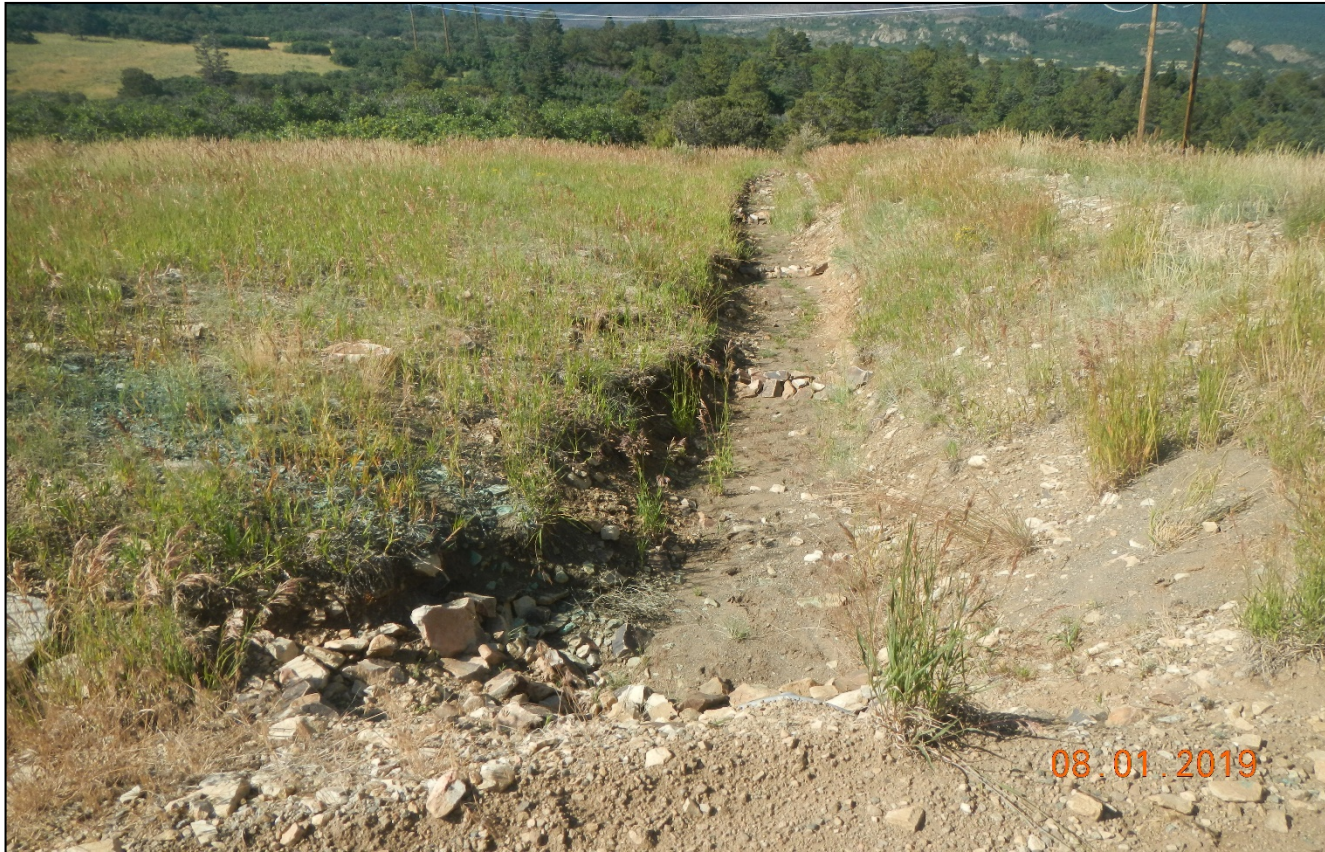
**Photo 2.** Rock check dams have been installed along the diversion ditch. These check dams are small and will likely fill in with sediment and will need ongoing maintenance. Lat/Long:37.69759,-105.201516

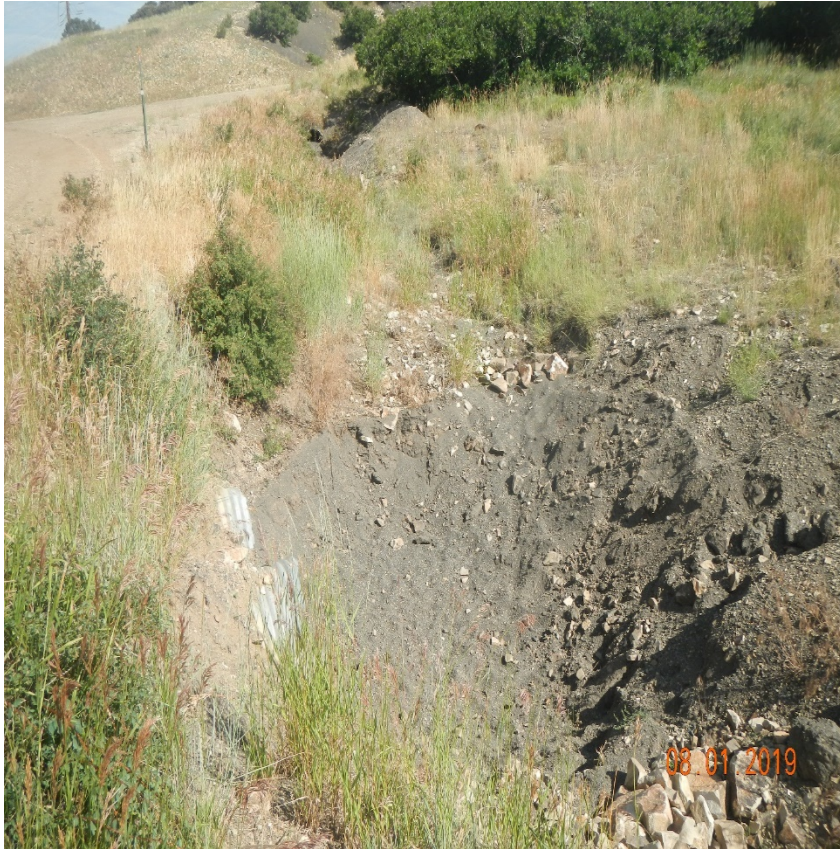
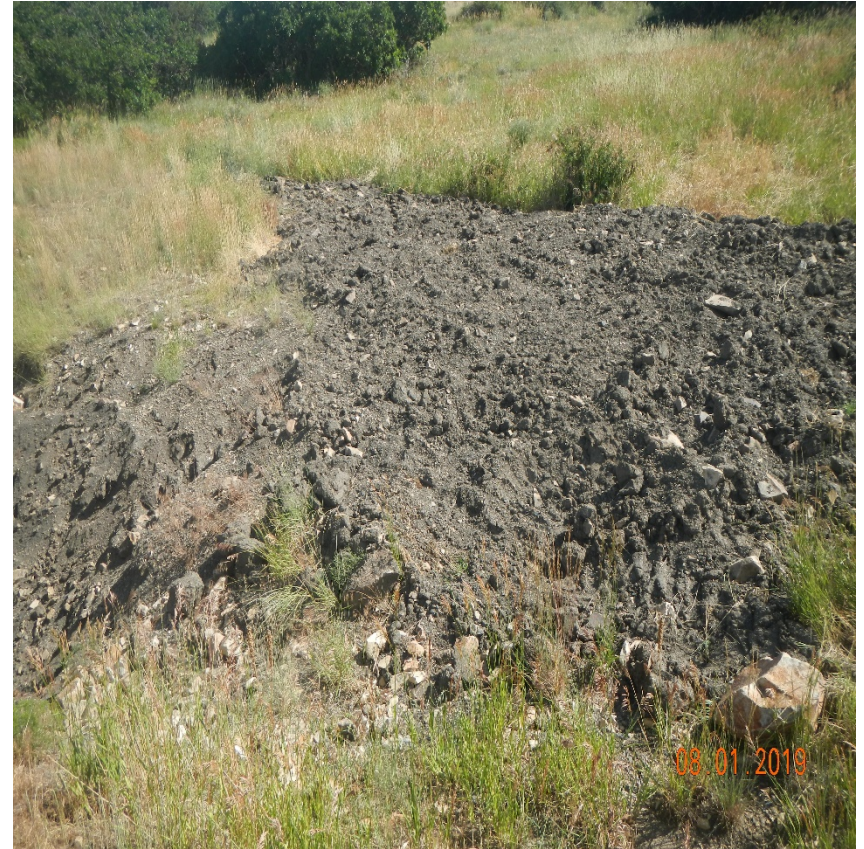
**Photo 3.** Sediment has been cleaned out of the culverts inlet (left photo). Material was placed off to the side (right photo) and must be seeded and stabilized.

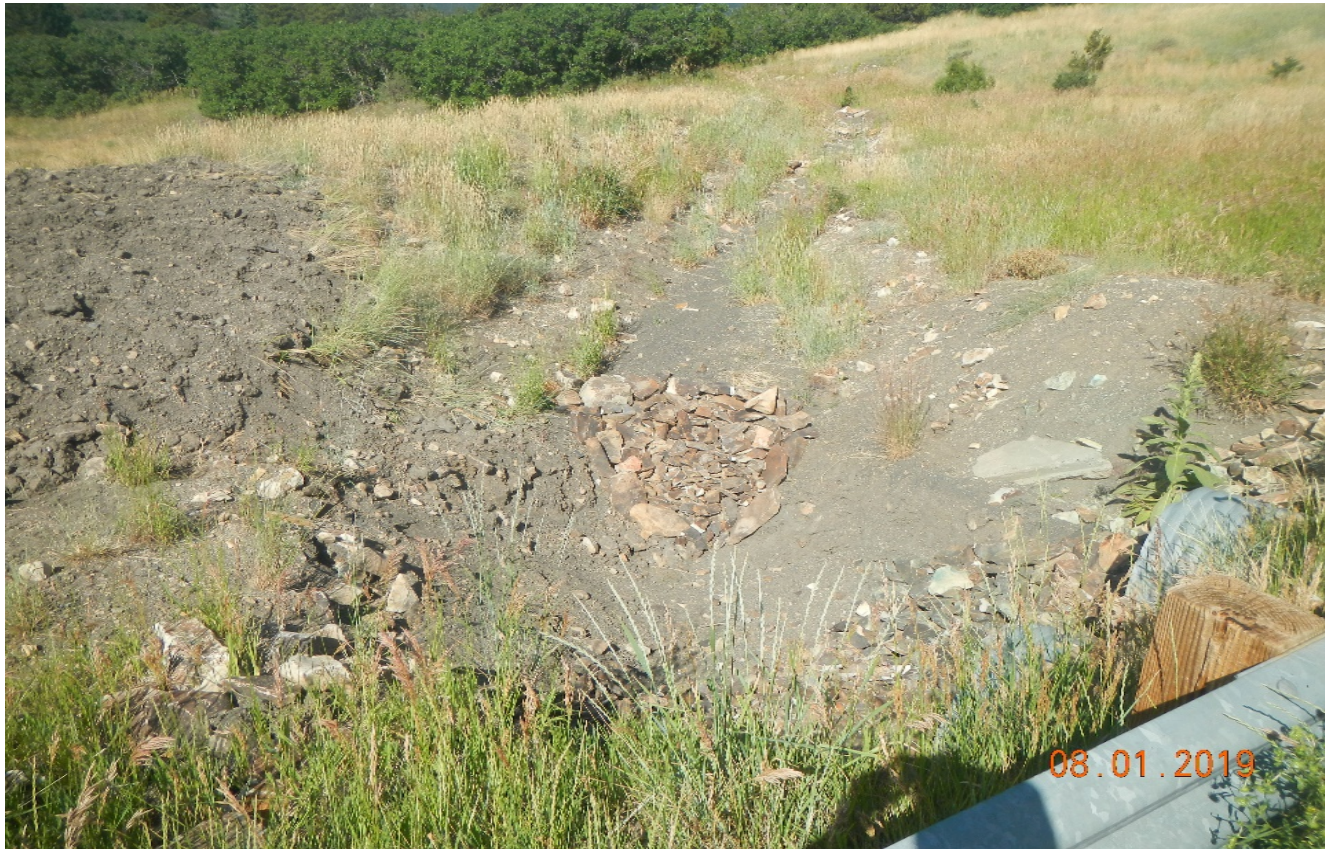
**Photo 4.** Sediment has been cleaned out of the culverts outlet. Material was placed off to the side which must be seeded and stabilized.

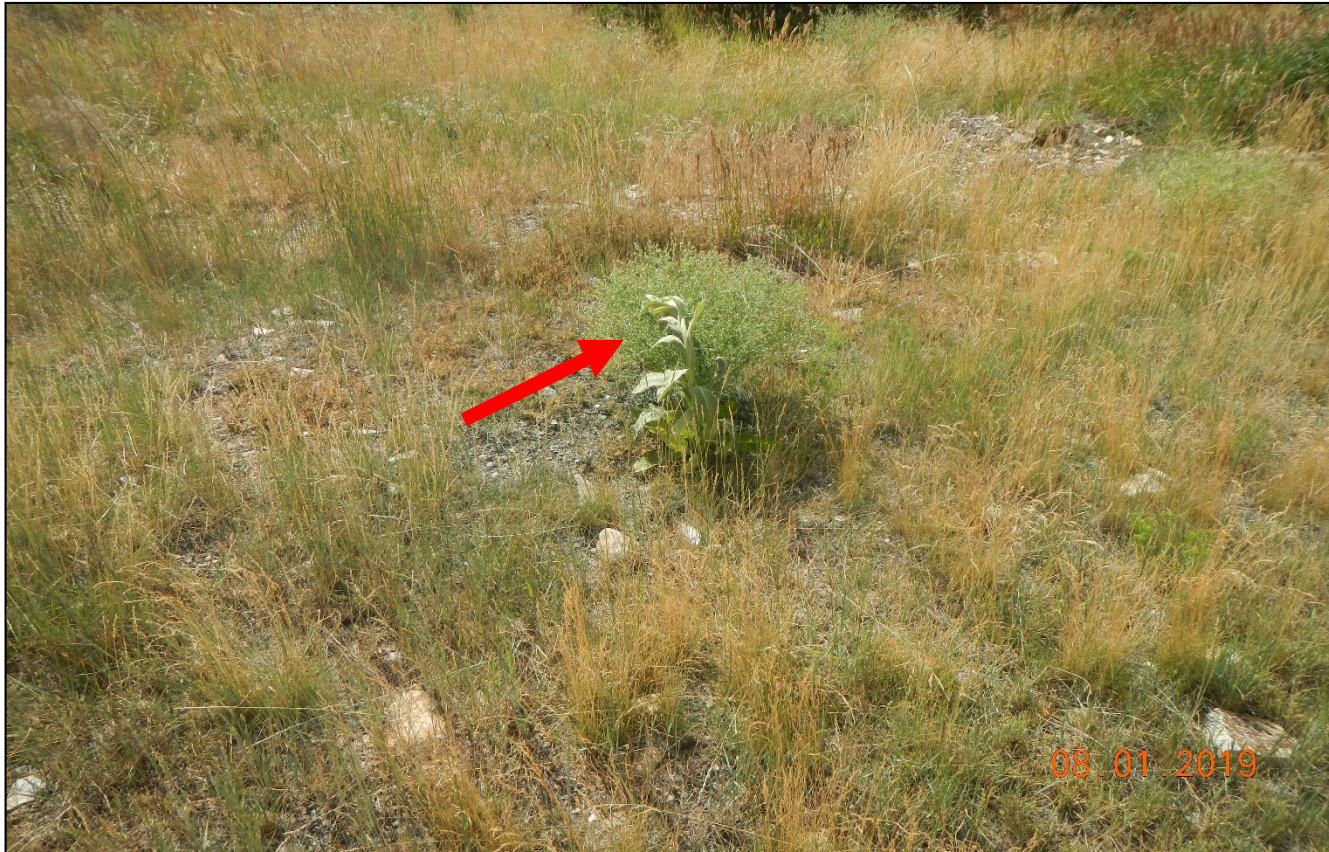
**Photo 5.** There were some noxious weeds along the pipeline that were wilted and others that were not treated.

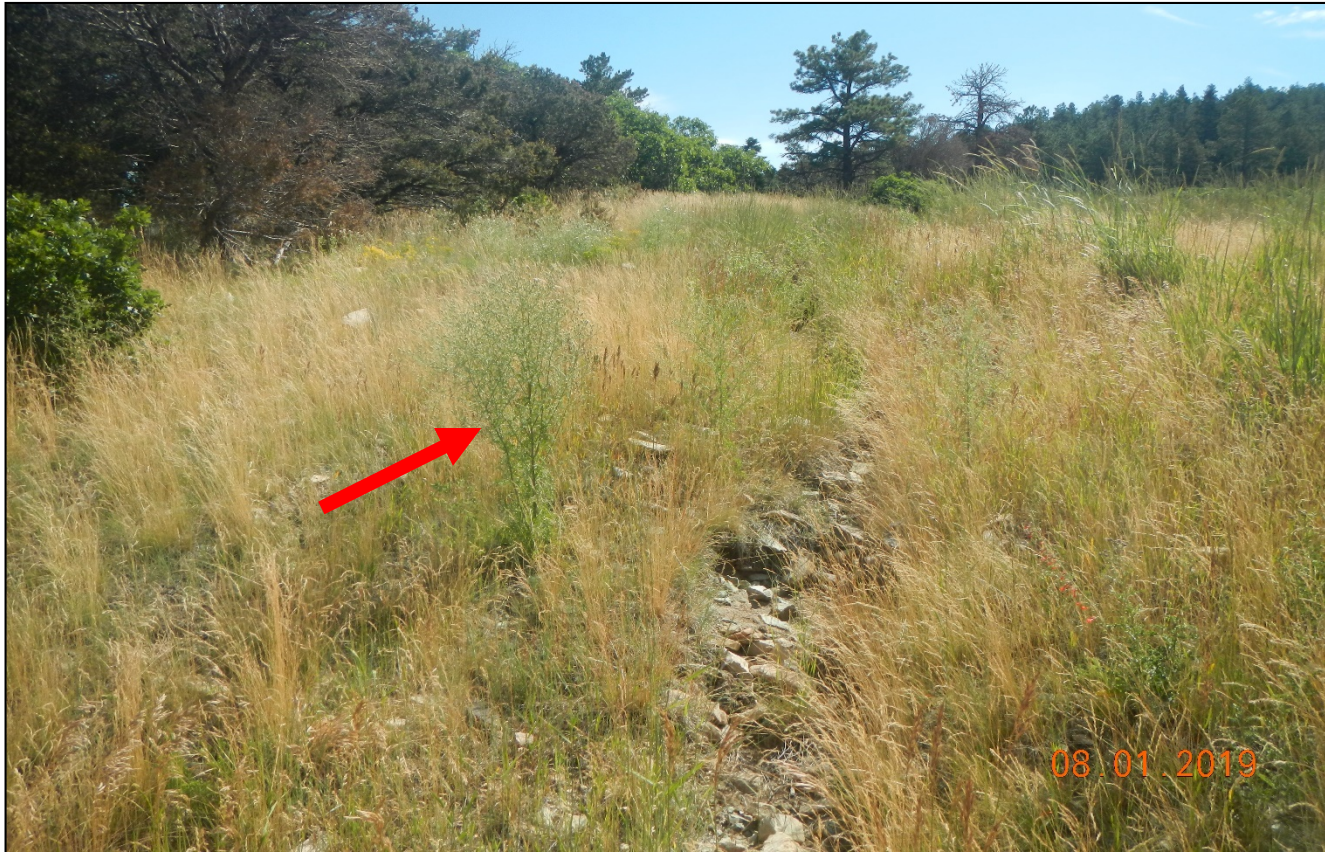
**Photo 6.** There were noxious weeds (Diffuse knapweed) behind the has compressor that were not treated.

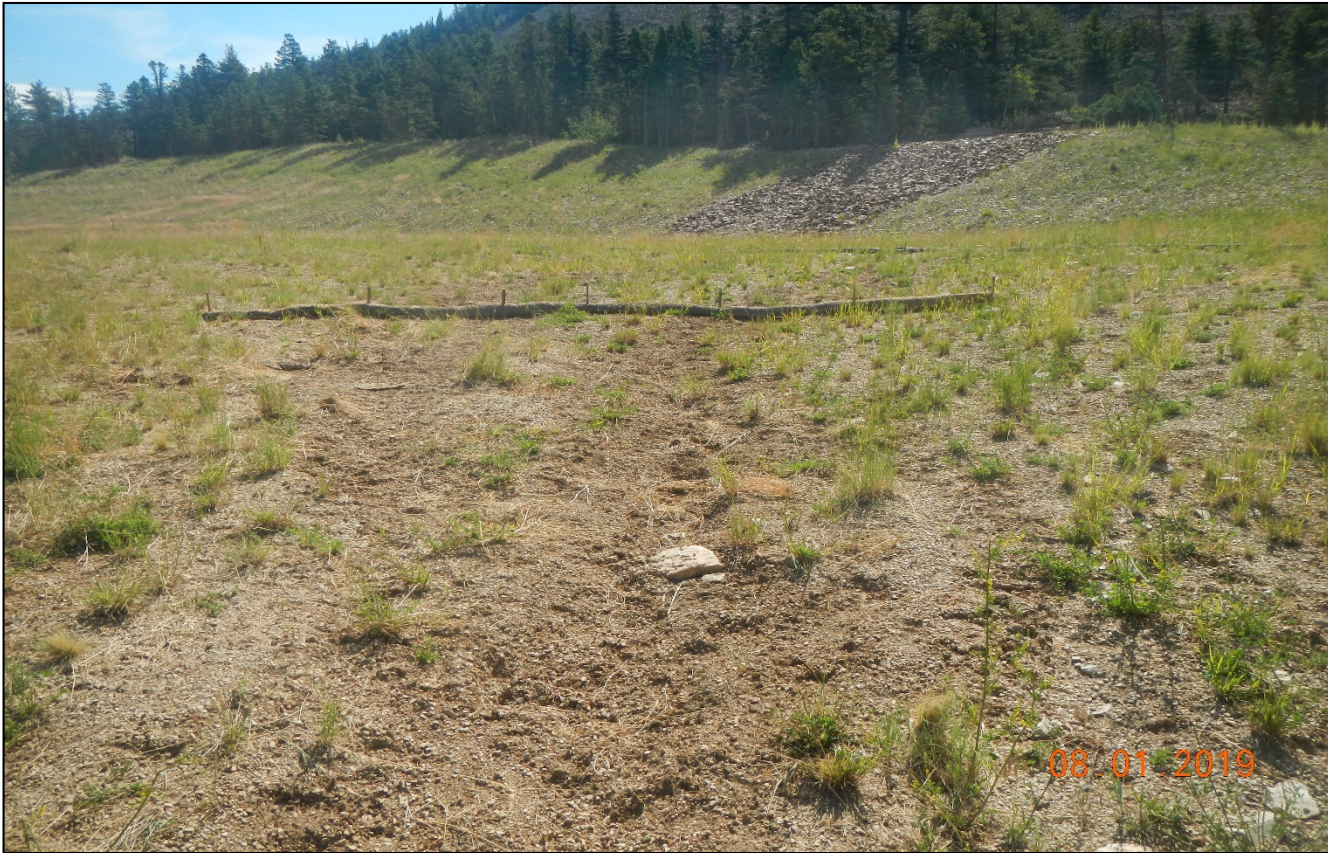
**Photo 8.** The erosion and BMP's have been repaired. There are bare areas that need to be seed and revegetated.

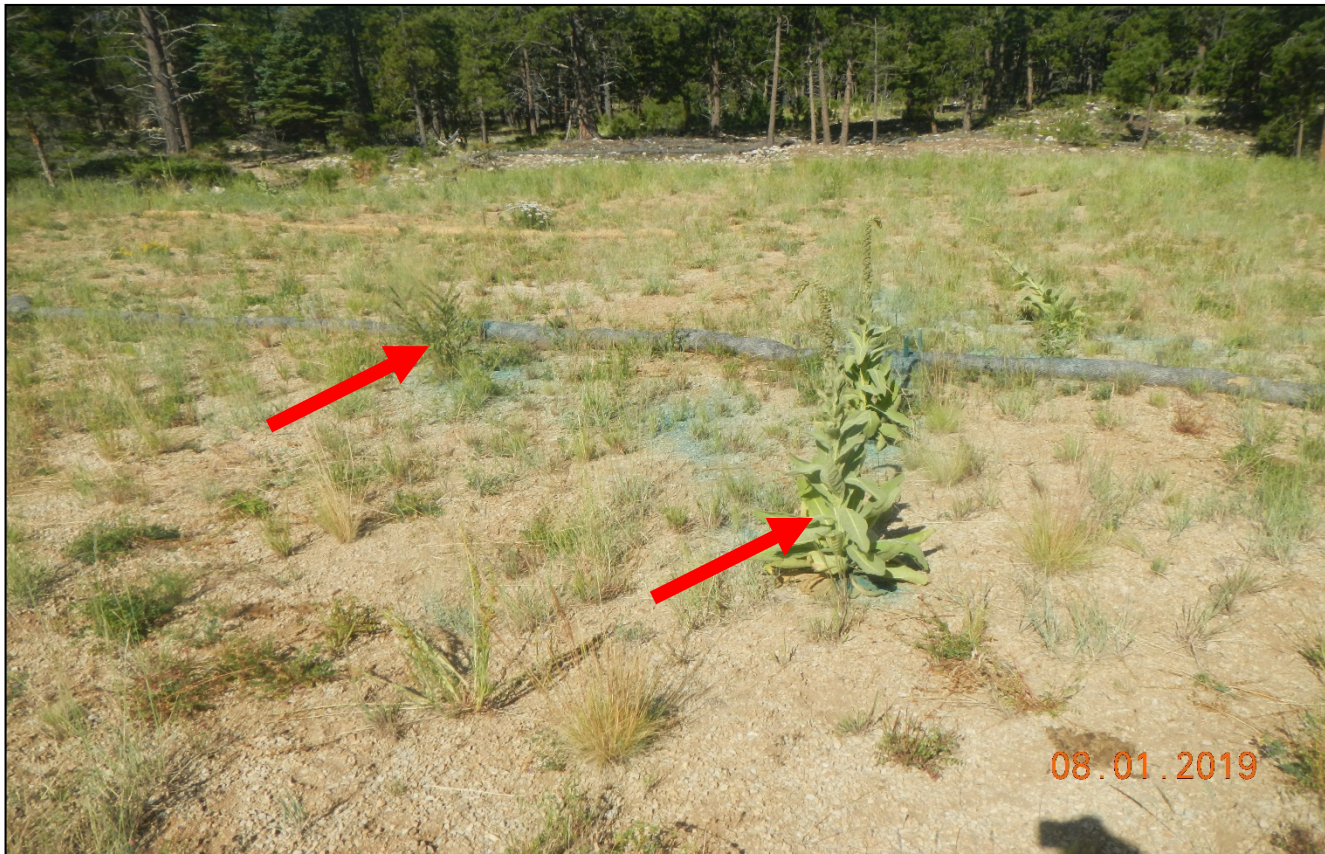
**Photo 9.** The noxious weed in this are appear to have been sprayed. The Mullein and Houndstongue are biennials which will die at the end of season anyway during second year of growth. To control these weeds, seed heads should be collected and disposed of.

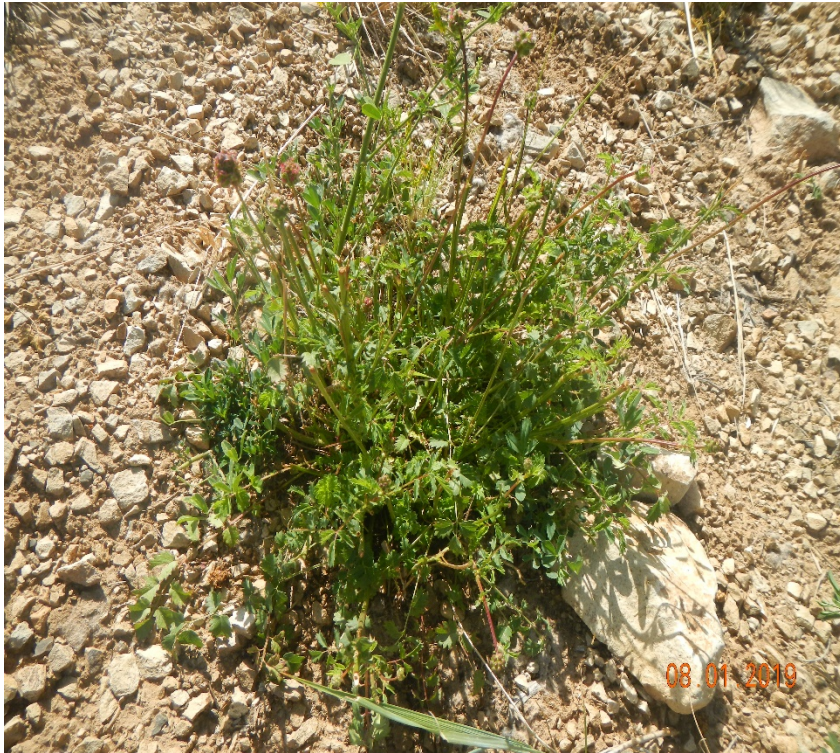
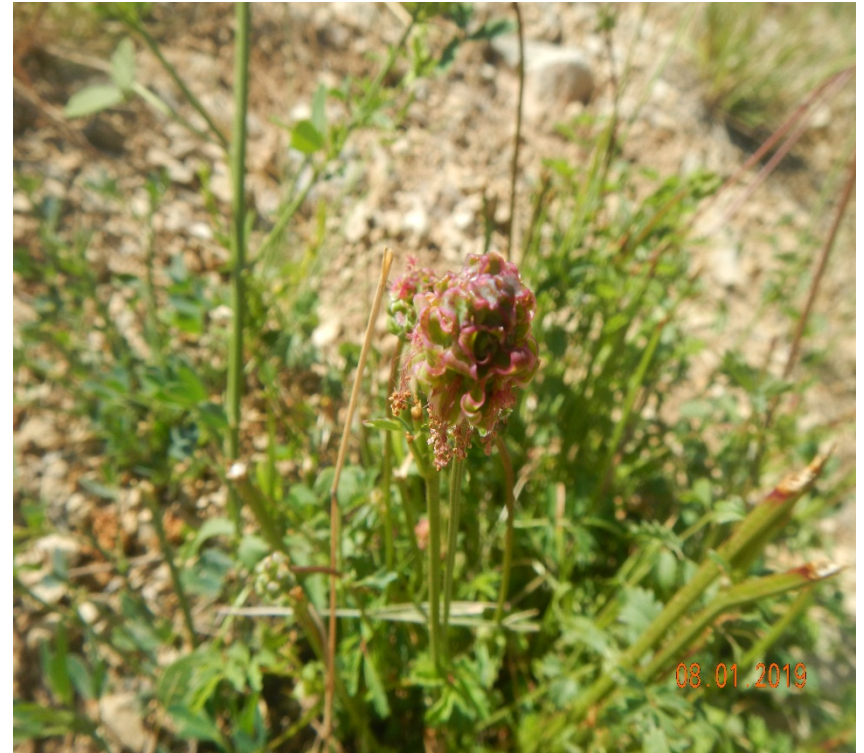
**Photo 10.** There are numerous non native Small burnet (*Sanguisorba minor*) plants growing in the interim reclamation area. The plants are not reflective of reference area vegetation.

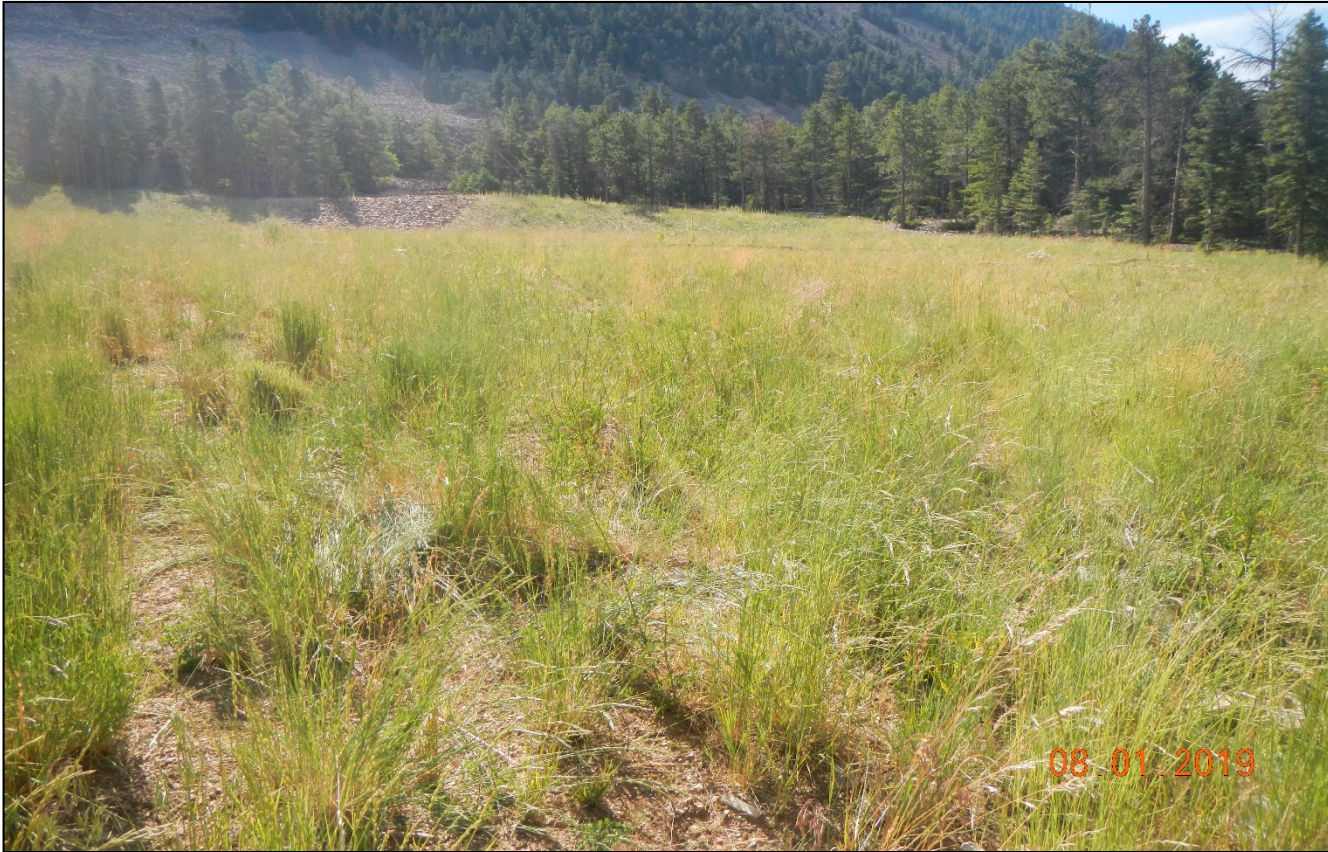
**Photo 11.** The vegetation is establishing well in the interim reclamation area at the fill slope.

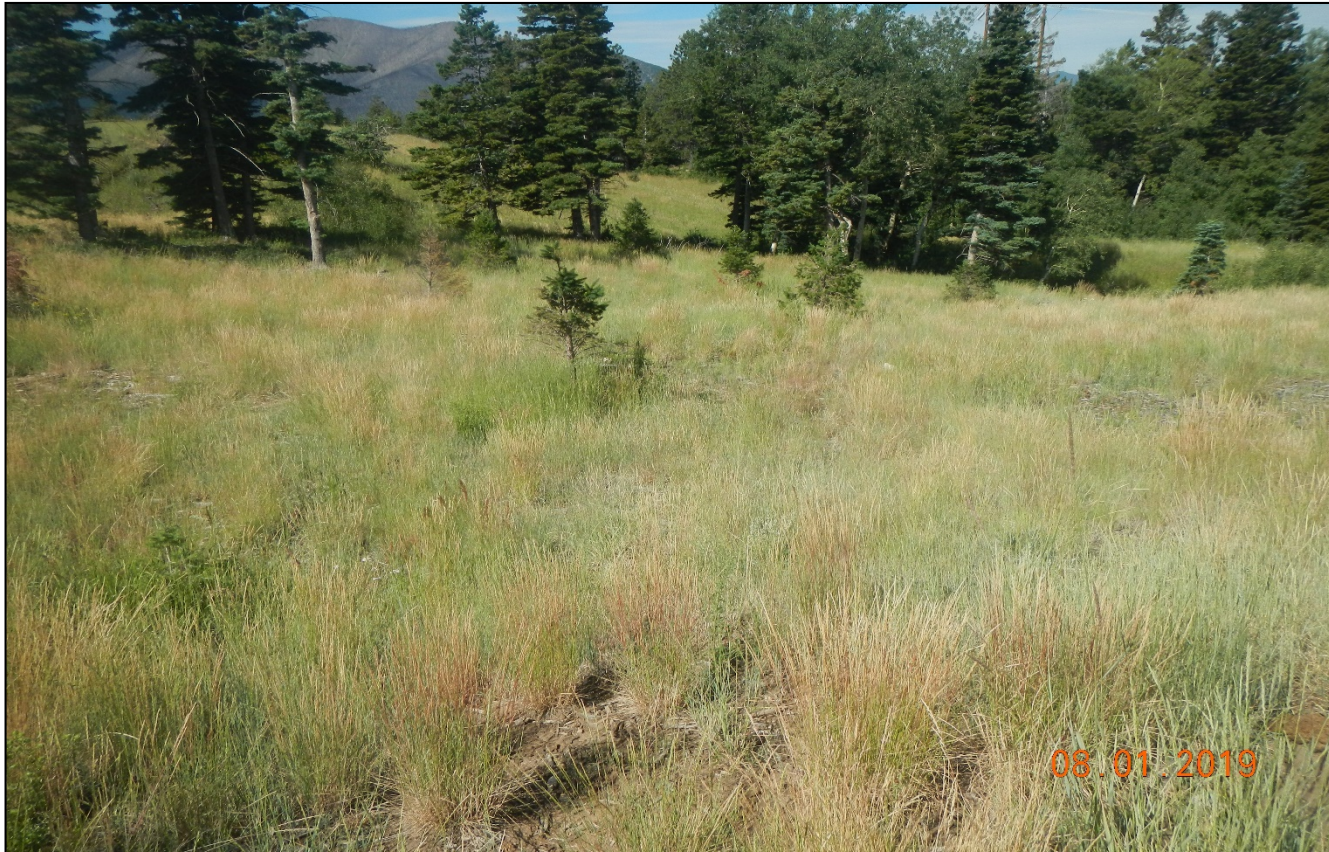
**Photo 12.** Northwest side of the location. Vegetation is well established in this area. The electric fence remains have been removed since previous inspection.
