Inspection Photos

API: 05-055-06102

Operator: OXY USA INC

Inspection Date: 8/1/2019

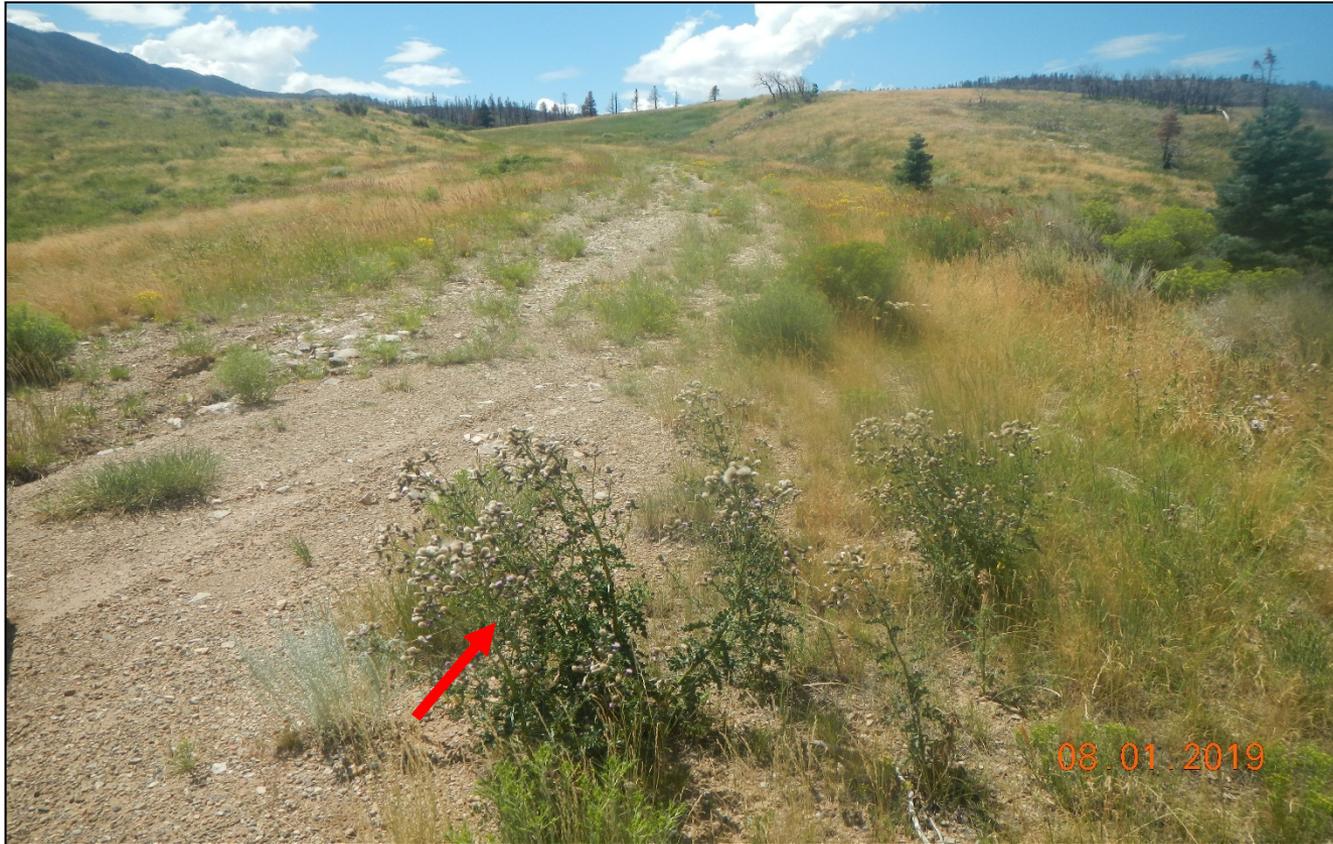
Photo 2. Facing south along the access road toward the wellsite. There are numerous noxious weeds (Canada thistle) in this area that have not been controlled since previous inspection.

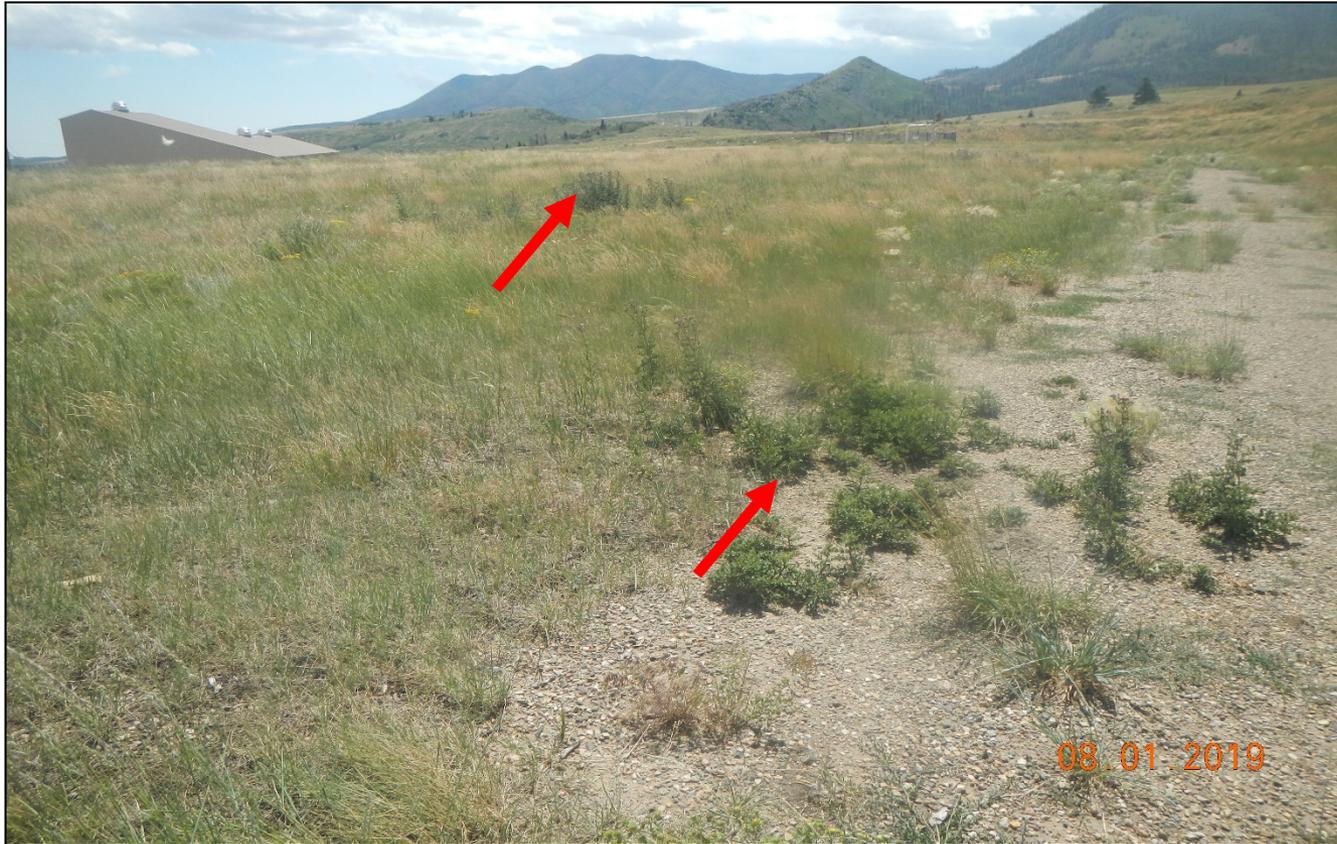
Photo 3. Facing east at the wellsite. There are numerous noxious weeds (Canada thistle) in this area that have not been controlled since previous inspection.

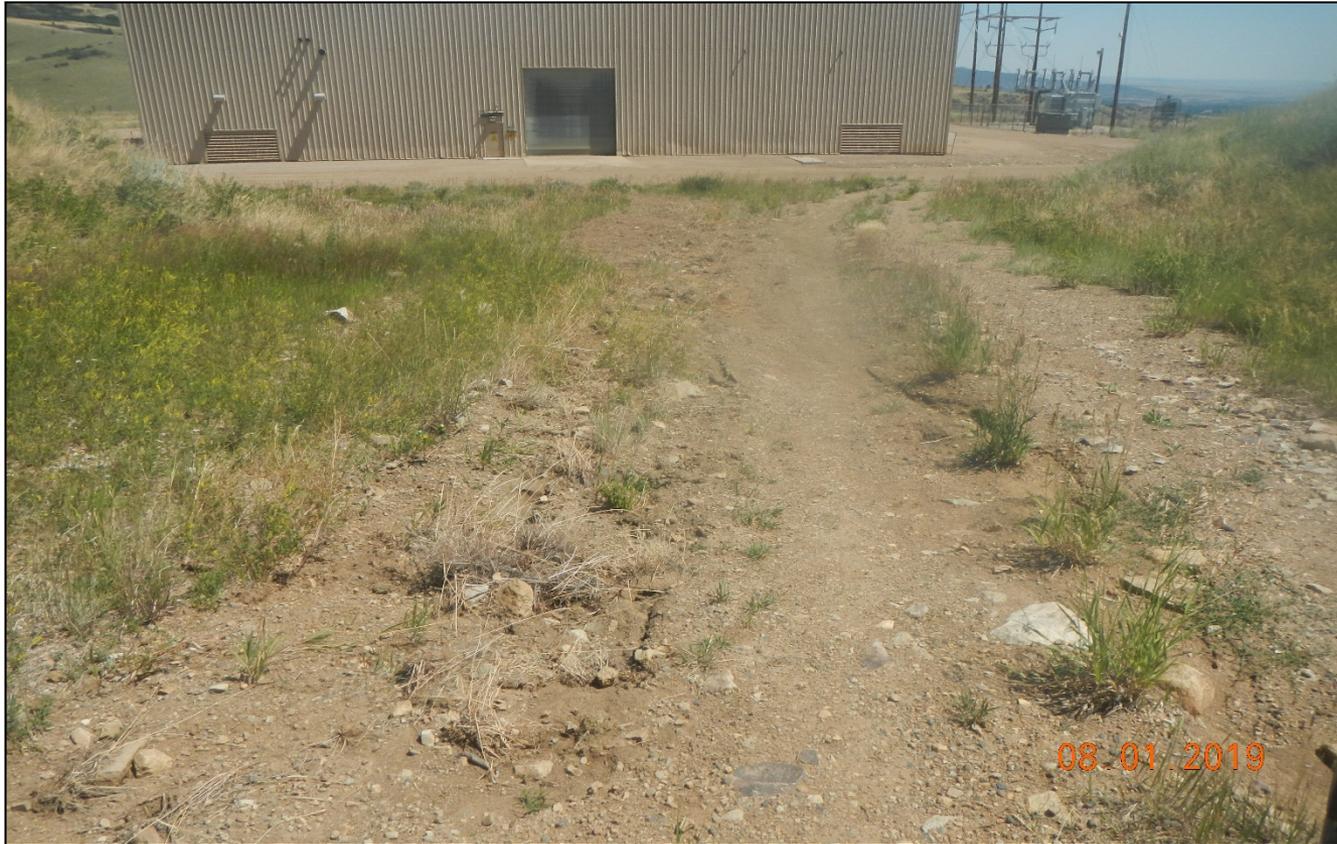
Photo 4. The area of erosion along the access road has been repaired. It is unclear if this area was reseeded for stabilization.
