Inspection Photos

Location Name: 596-29C-65S96W 29NESW Pad

Location ID: #335943

Inspection Date: July 29, 2019

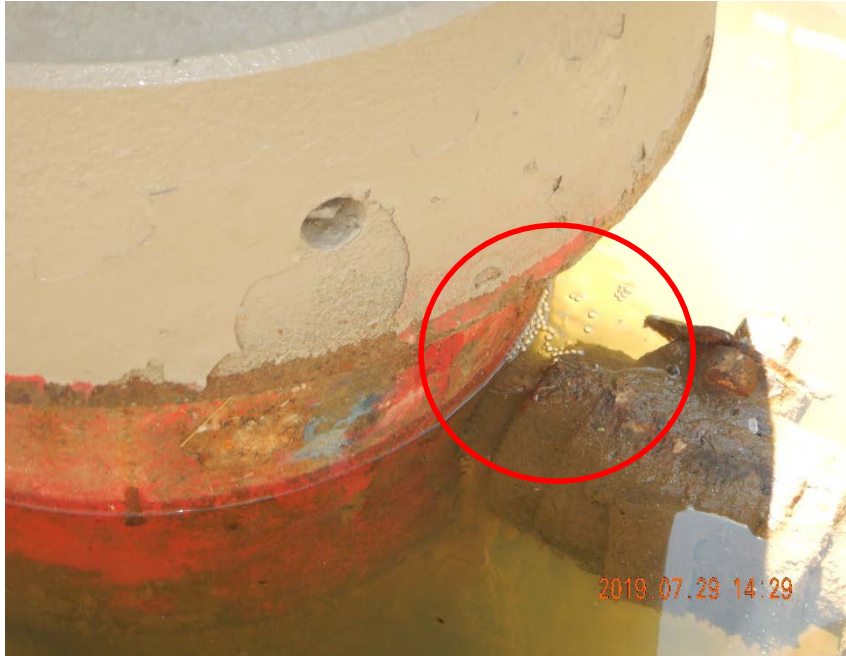
Photo #3 – Gas bubbling was observed from Marathon 596-29C-14 wellhead during inspection. Video is attached to this inspection report. Operator was notified via phone on inspection date.

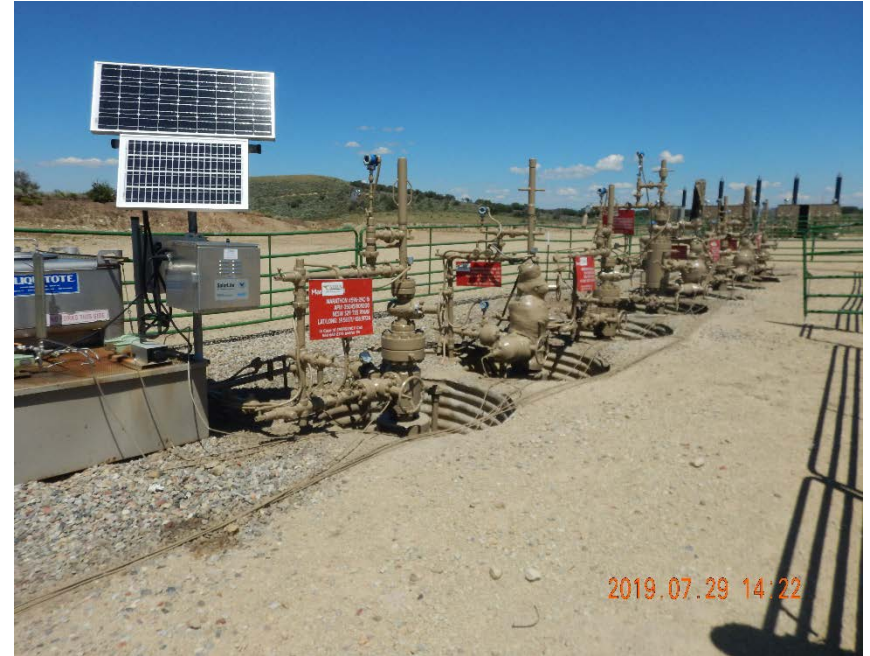
Photo #4 – View of wellheads, looking east. Note well cellars are uncovered.

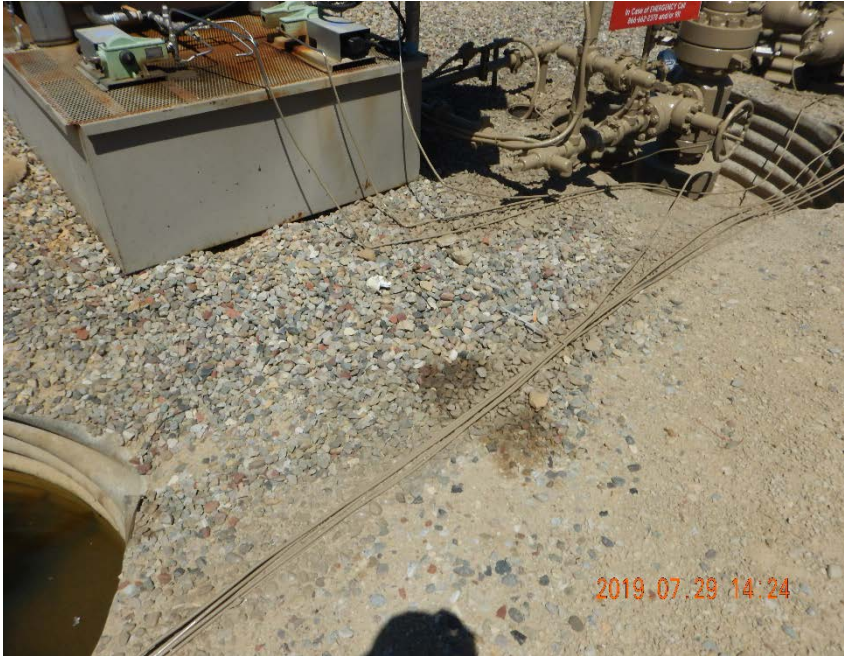
Photo #5 – Localized accumulation of oil-stained soil located between wells #14 and #16.

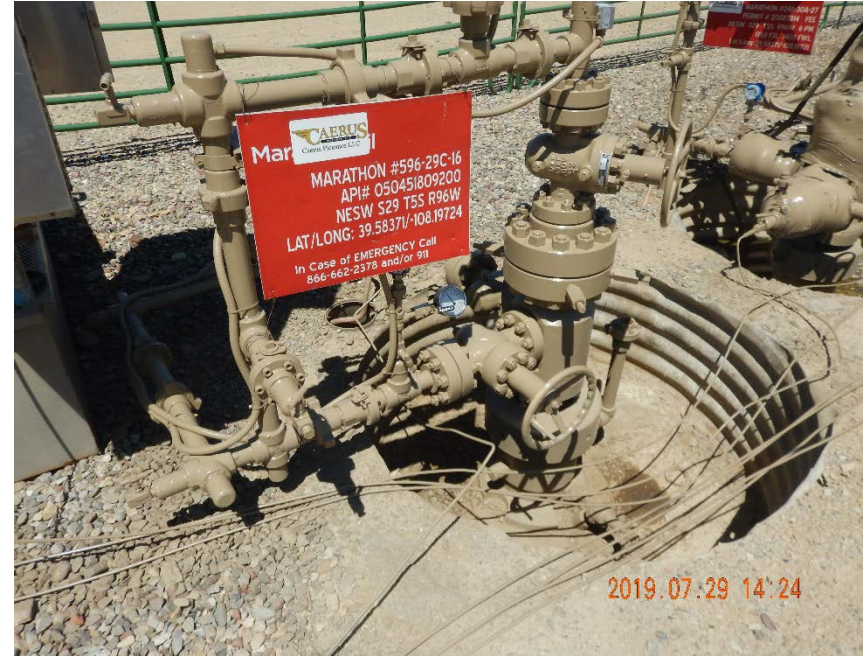
Photo #6 – Localized accumulation of oil-stained soil inside of Marathon 596-29C-16 cellar.

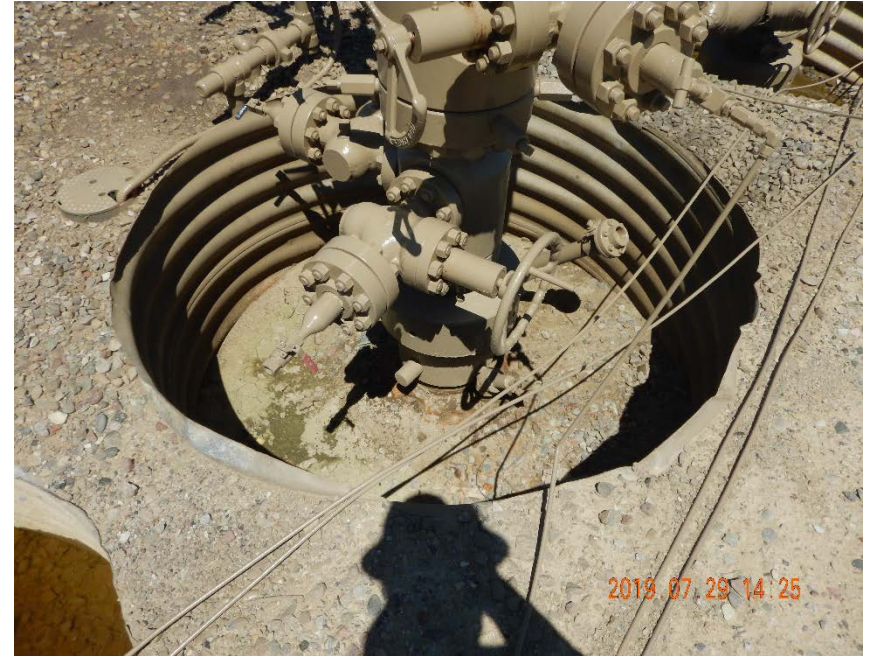
Photo #8 - Localized accumulation of oil-stained soil inside of Marathon 596-29C-12 cellar.

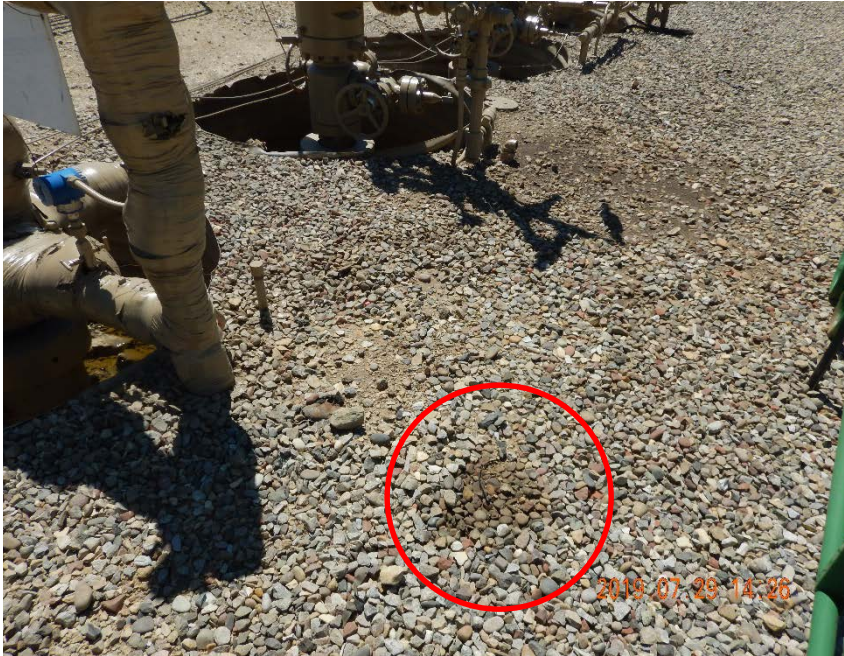
Photo #9 - Localized accumulation of oil-stained soil on north side of the Marathon 596-29C-25 wellhead.

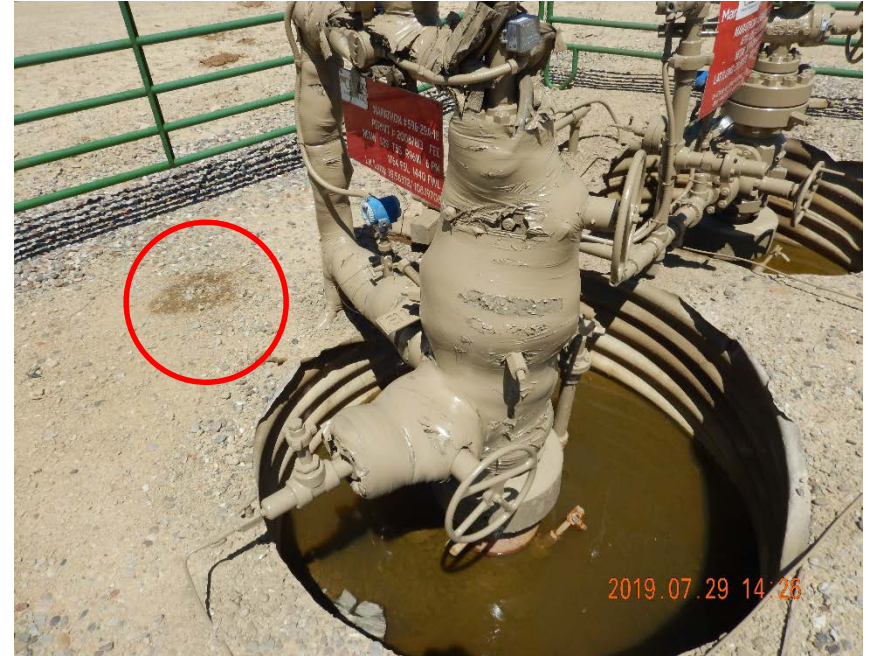
Photo #10 - Localized accumulation of oil-stained soil on north side of the Marathon 596-29C-18 wellhead.

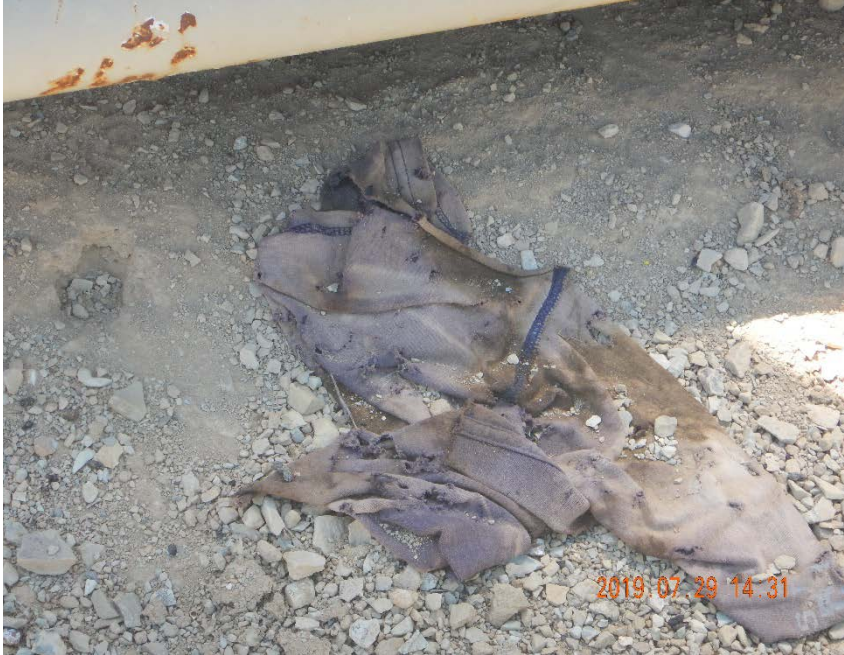
Photo #11 – Oily rag located on east side of separators.

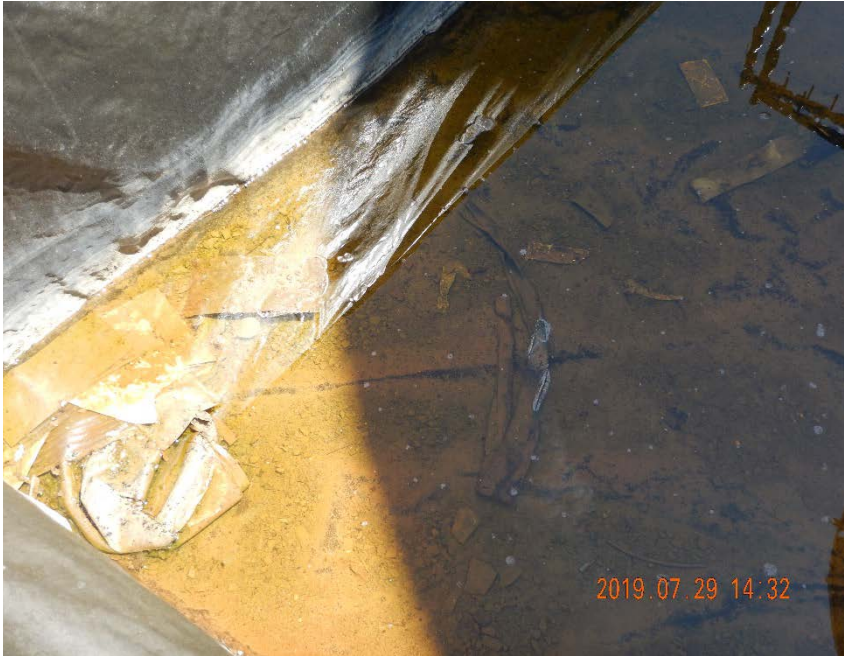
Photo #13 – Trash and fluid inside of tank battery secondary containment. No hydrocarbon sheens or odors were observed on fluids. No holes or tears were observed in visible portion of liner.

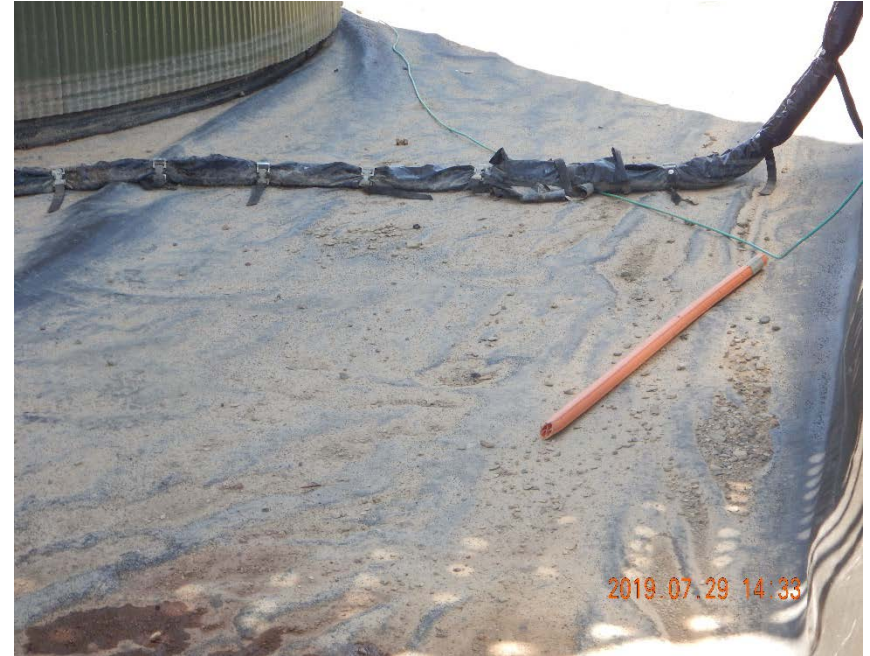
Photo #14 – Trash inside of tank battery secondary containment.

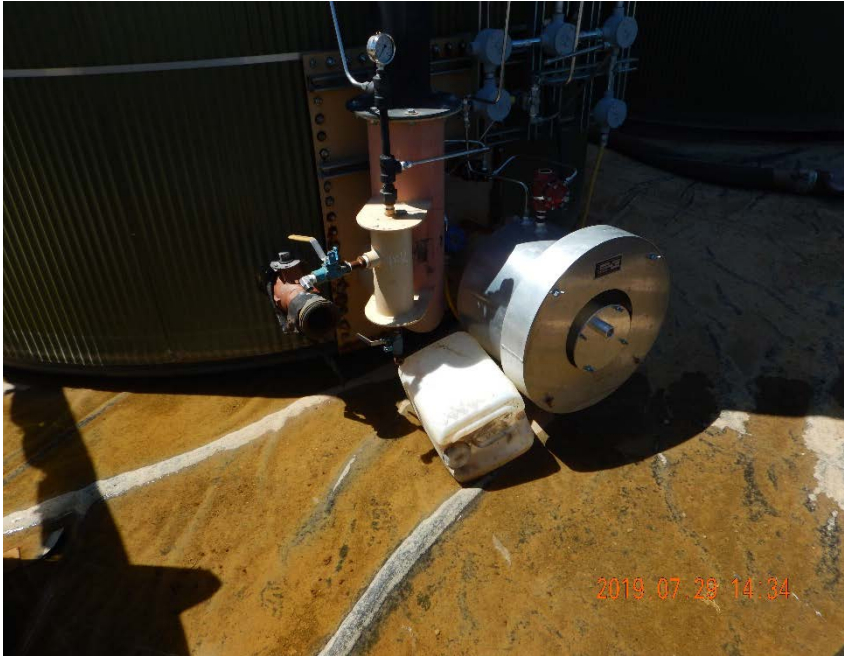
Photo #15 – Trash inside of tank battery secondary containment.

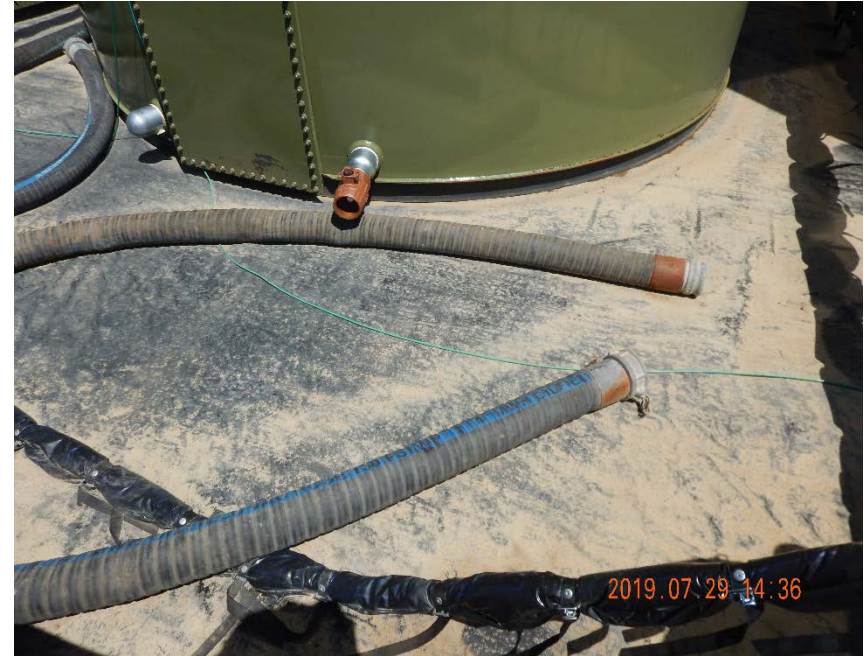
Photo #16 – Hoses stored inside of tank battery secondary containment with metal fittings in contact with liner.

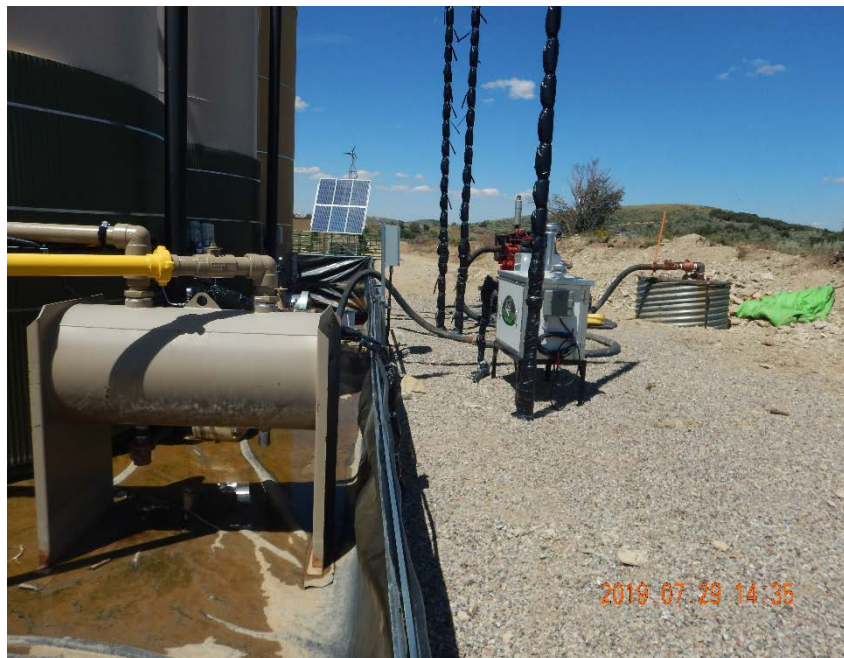
Photo #17 – View of east side of tank battery. Hydrocarbon odors were detected in this area during inspection.
