Laramie Energy LLC
API # 077-10542
Inspection # 696600438

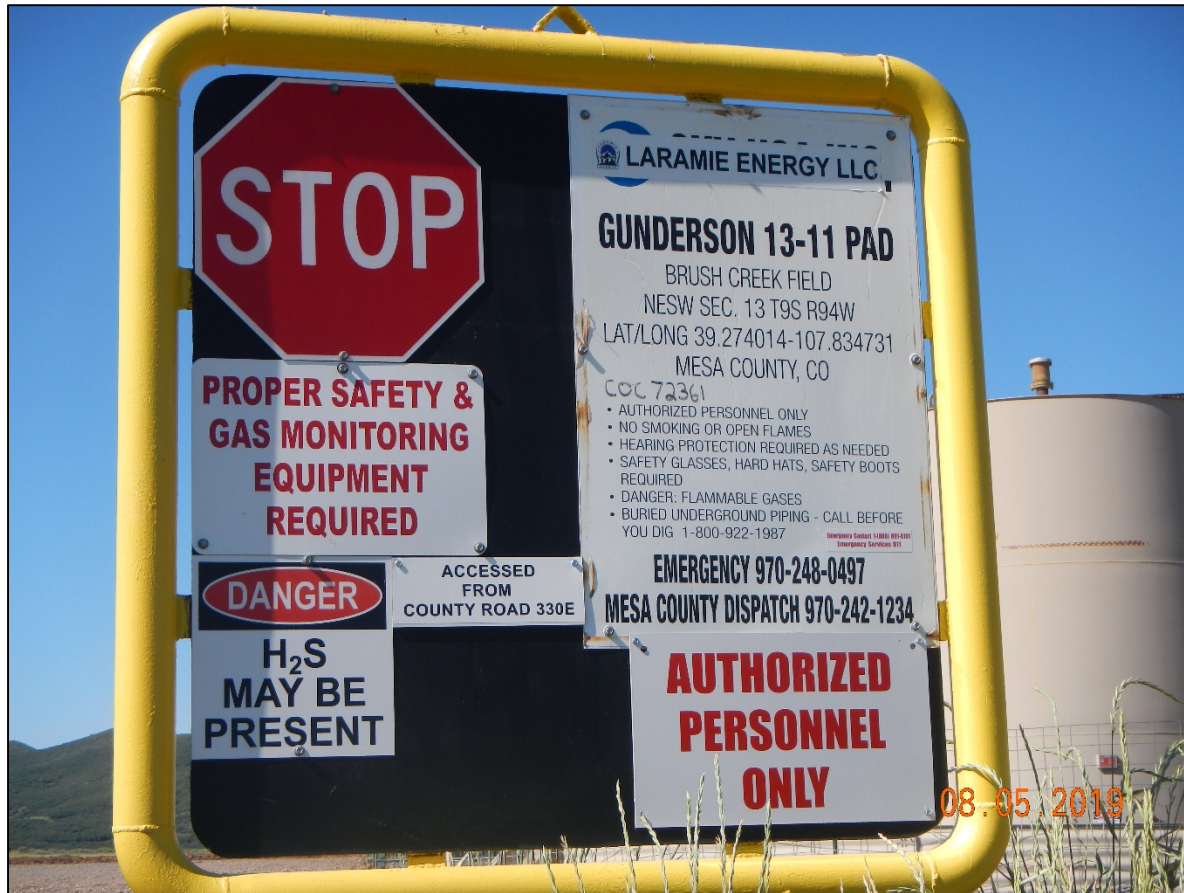
Photo #1 Sign is posted the entrance to location

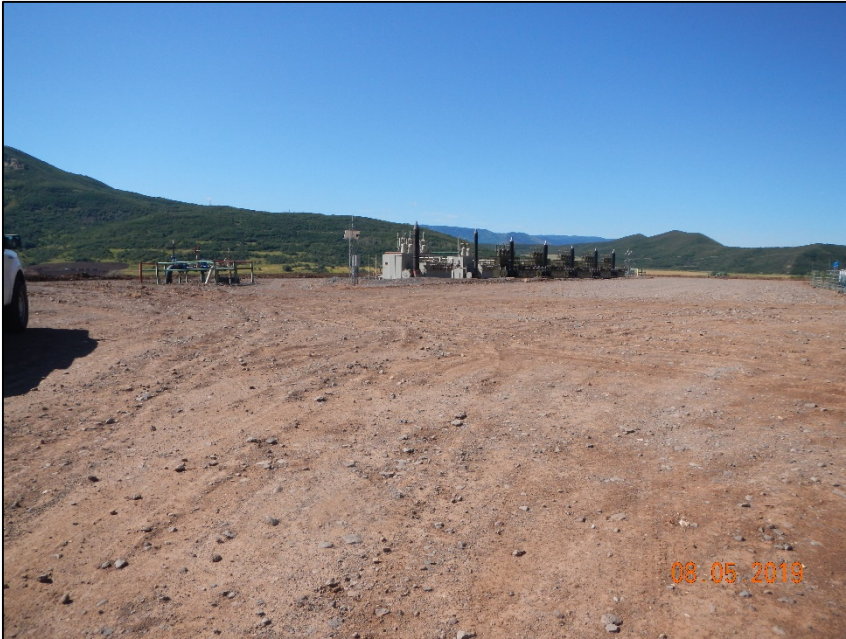
Photo #2 Photo at entrance of location.

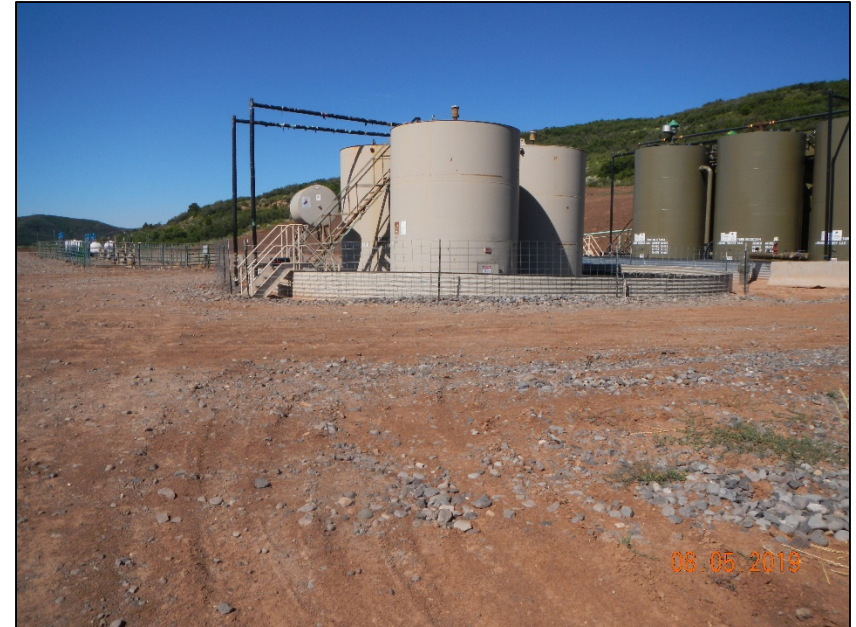
Photo #3 Photo at entrance of location.

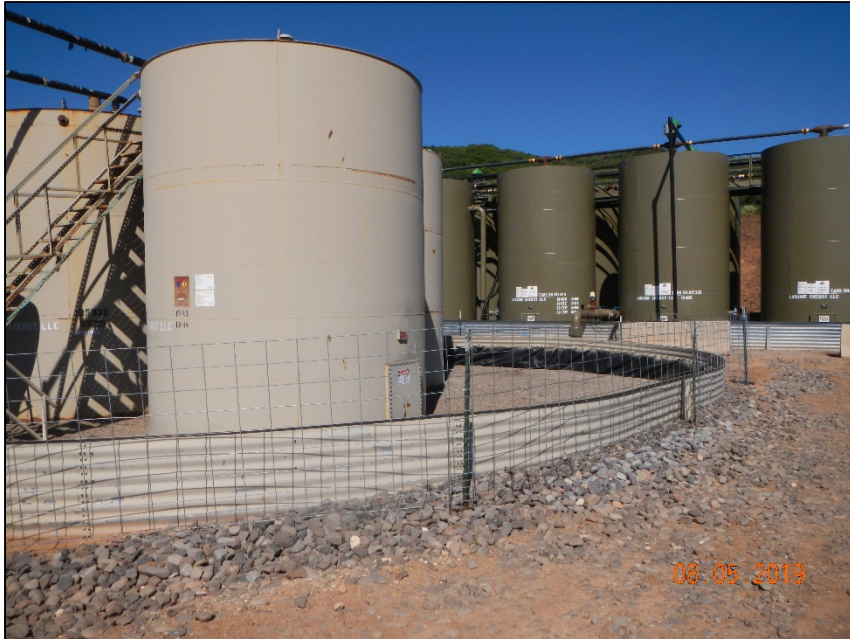
Photo #4 Photo of tank battery.

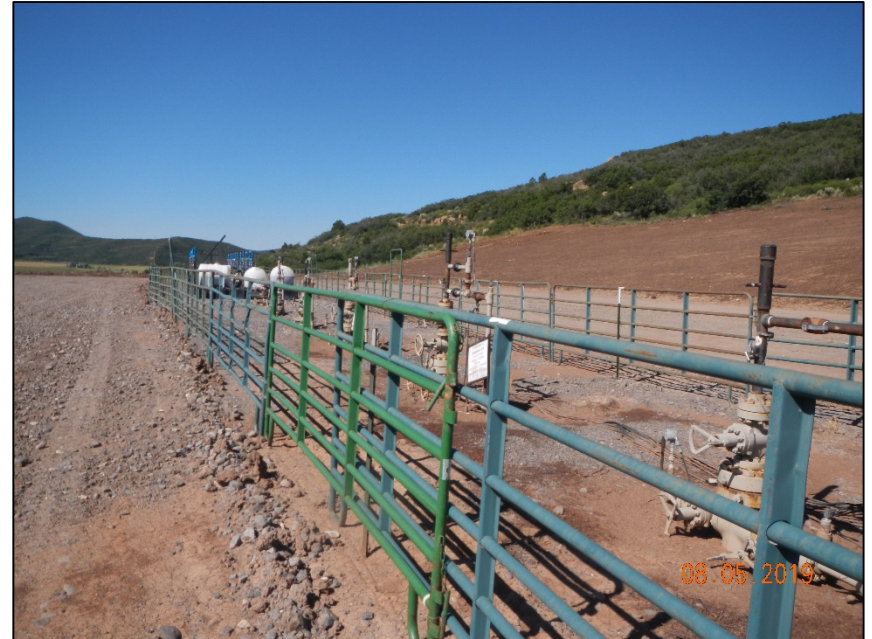
Photo #5. Photo of wellheads

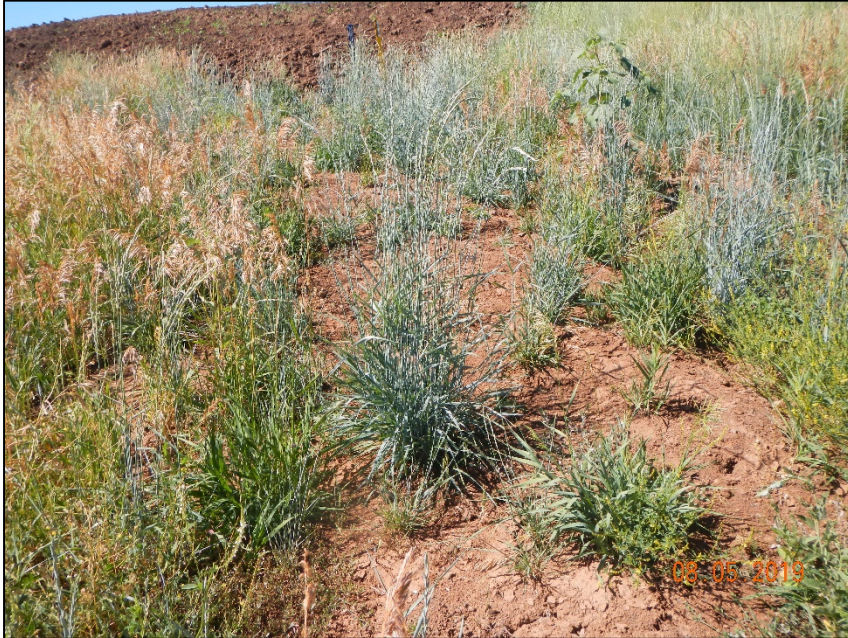
Photo #6 Erosion is evident below the un-stabilized slope on the North/East side of location by the entrance. Sediment is moving and choking out vegetation.

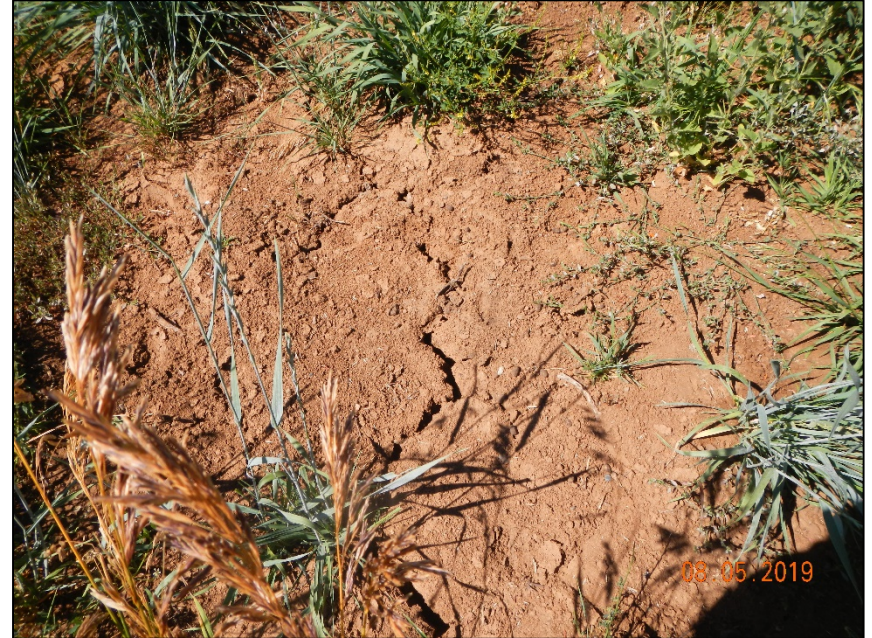
Photo #7 Erosion is evident below the un-stabilized slope on the North/East side of location by the entrance. Sediment is moving and choking out vegetation.

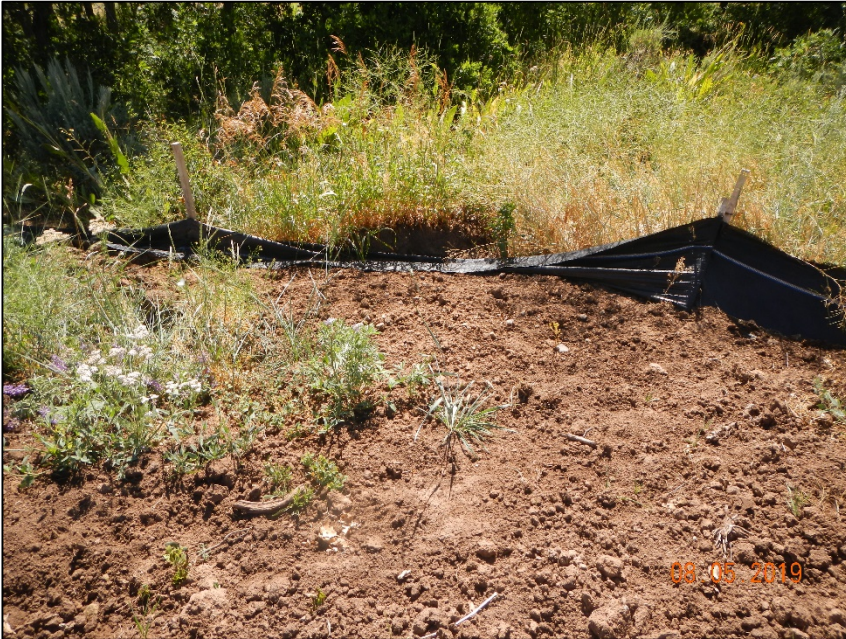
Photo #8 Silt Fence needs maintenance on the South and West sides of location.

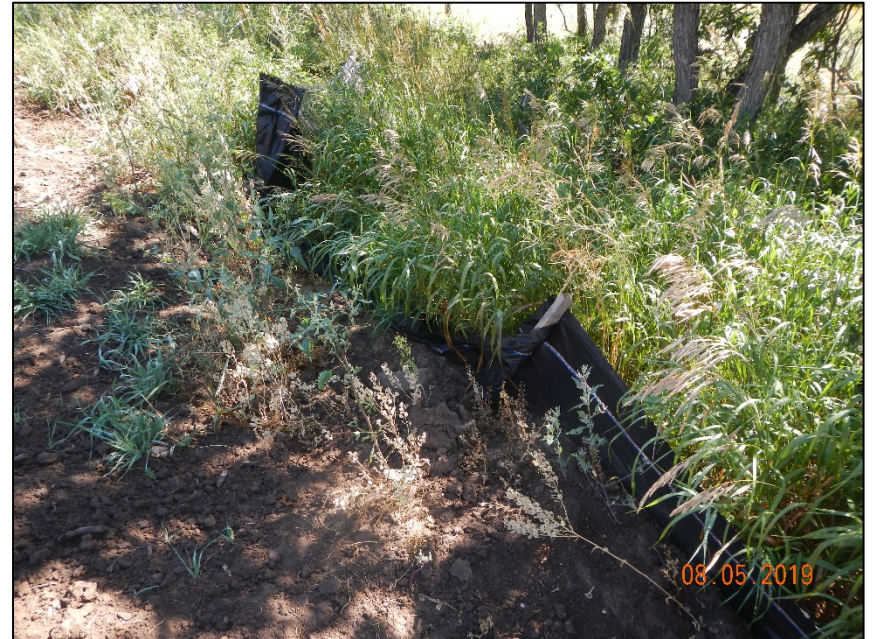
Photo #9 Silt Fence needs maintenance on the South and West sides of location.
