Inspection Photos
Location Name: Starkey 14-28-969
Facility ID: 454686
Inspection Date: August 2, 2019

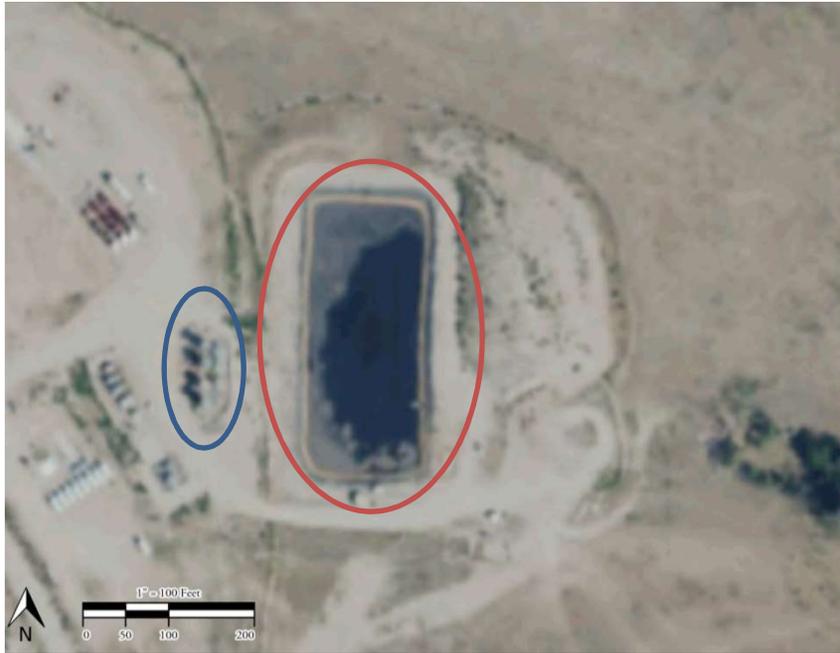
Photo #1 - Aerial view of the location. The blue oval is around the tank battery and the red oval is around the pit (GISOnline Maps).

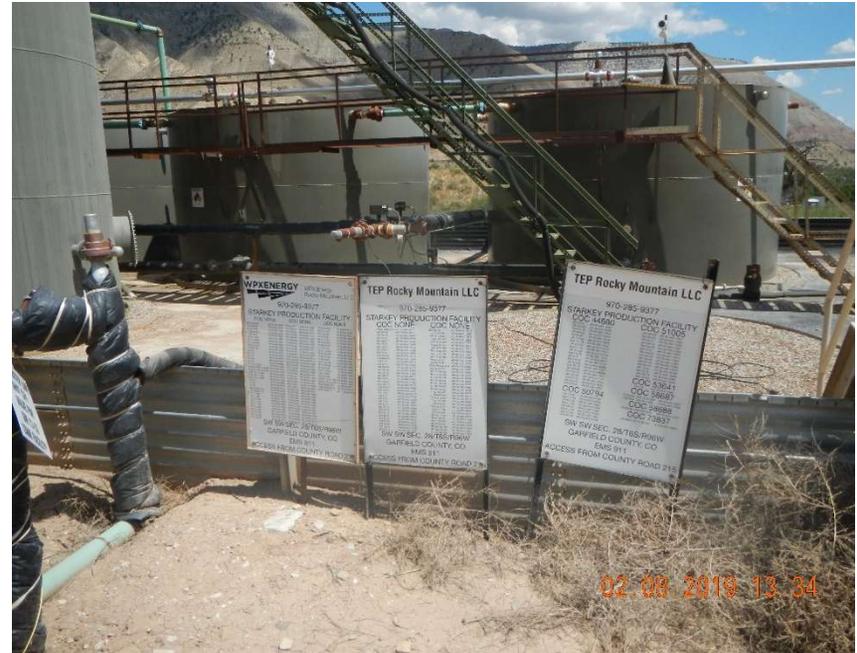
Photo #2 – Tank battery sign.

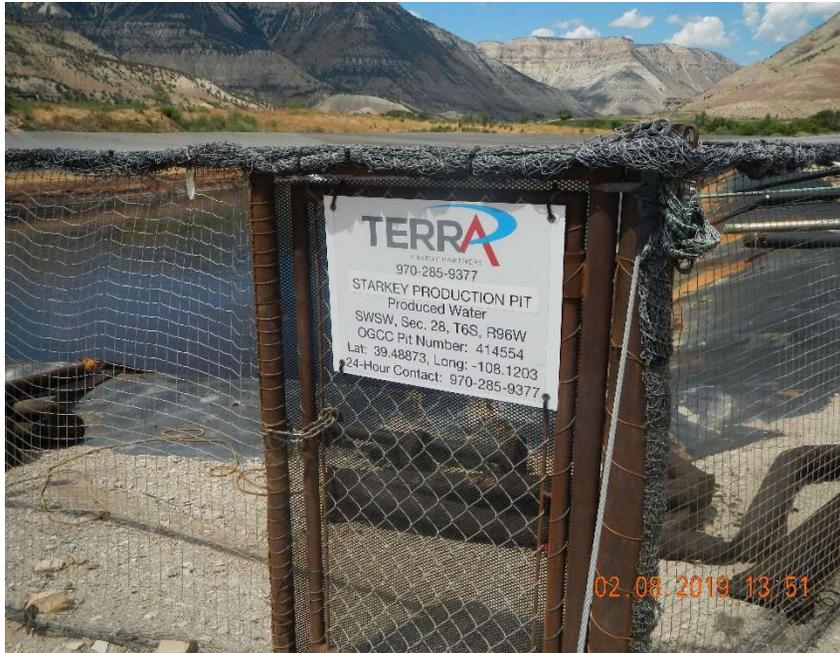
Photo #3 – Pit sign.

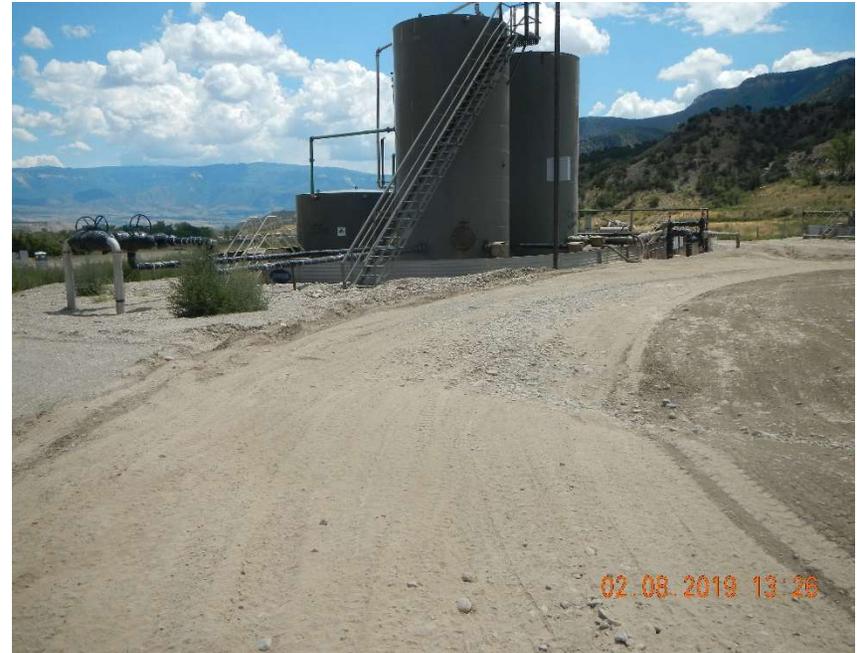
Photo #4 – Unlabeled 500 bbl ASTs. Ruts and erosions can also be seen.

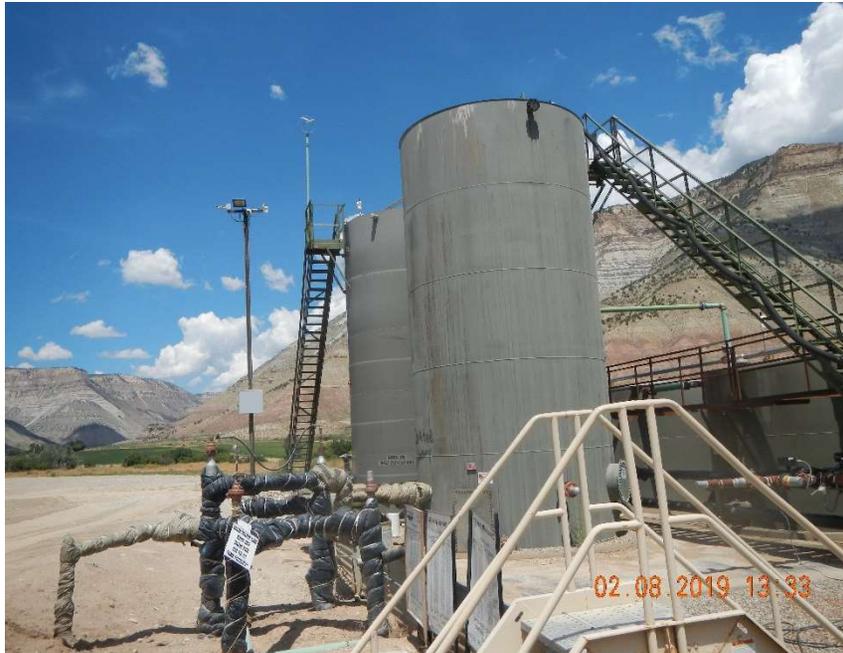
Photo #5 - Missing windsock.

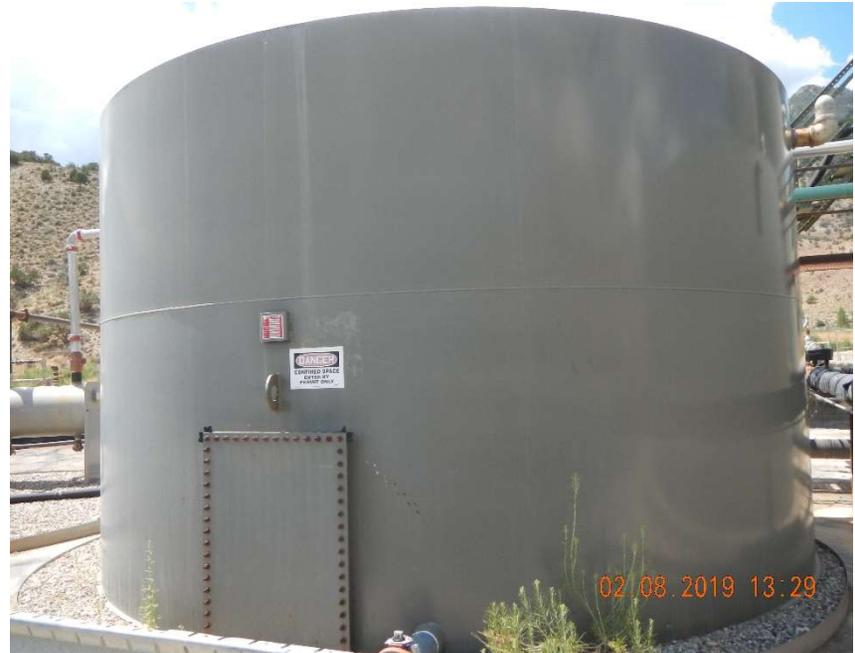
Photo #6 - Unlabeled 200 bbl AST.

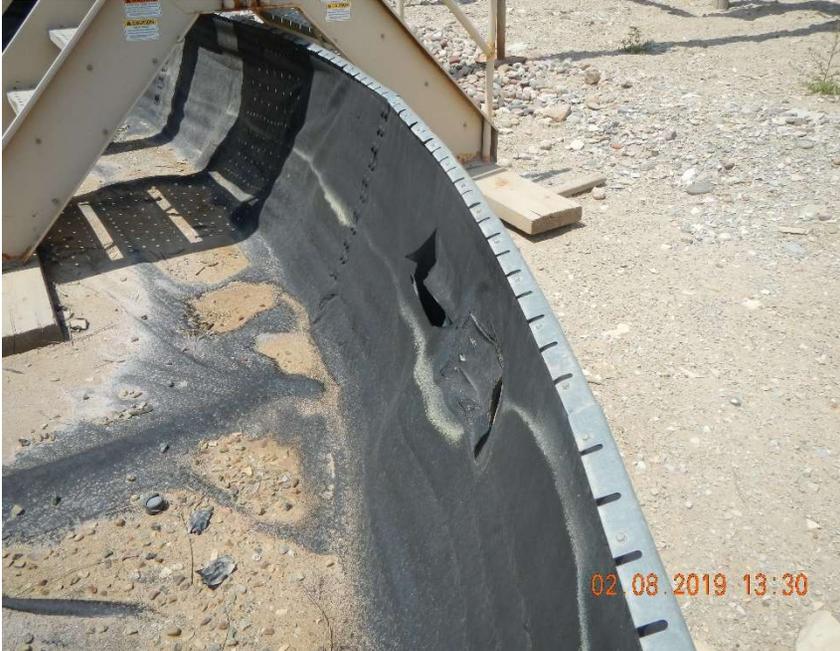
Photo #7 – Hole in liner.

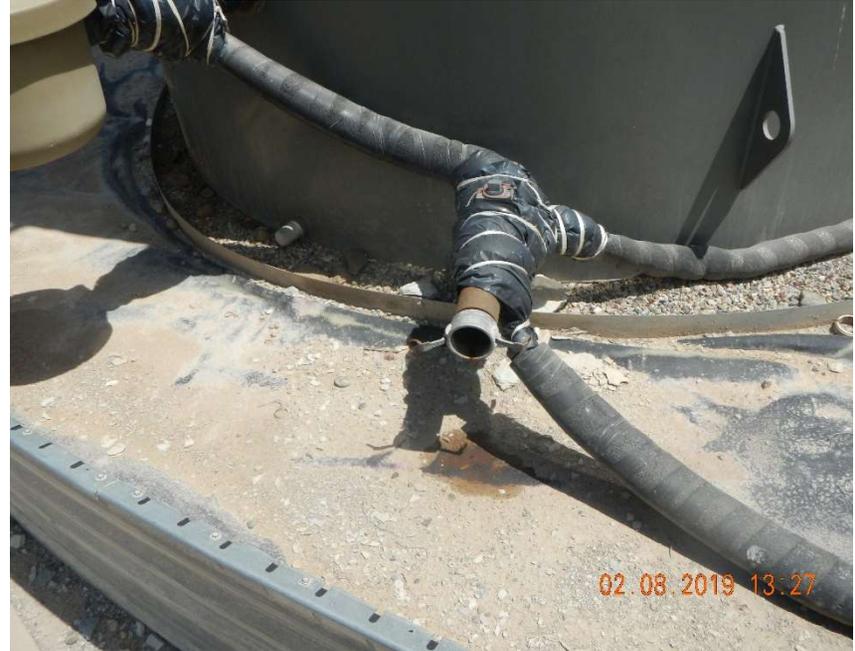
Photo #8 – Oil stained soil from 500 AST load out valve.

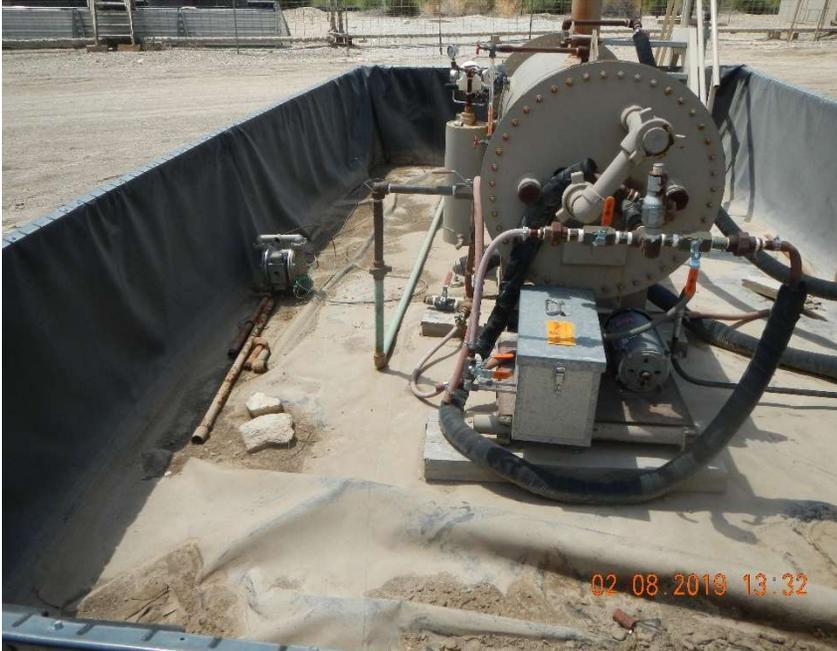
Photo #9 - Storage of equipment in separator secondary containment.

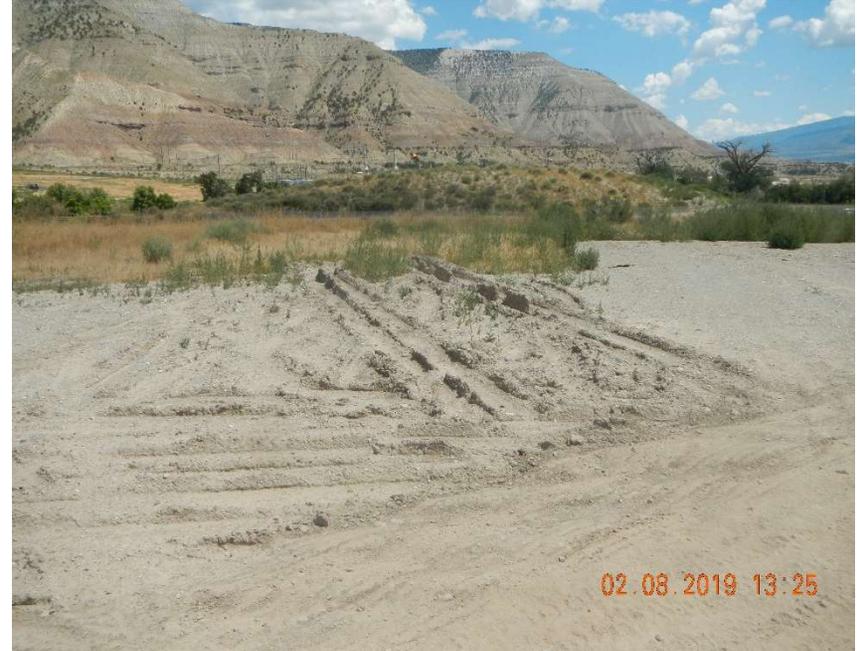
Photo #10 – Ruts and erosion north of tank battery.

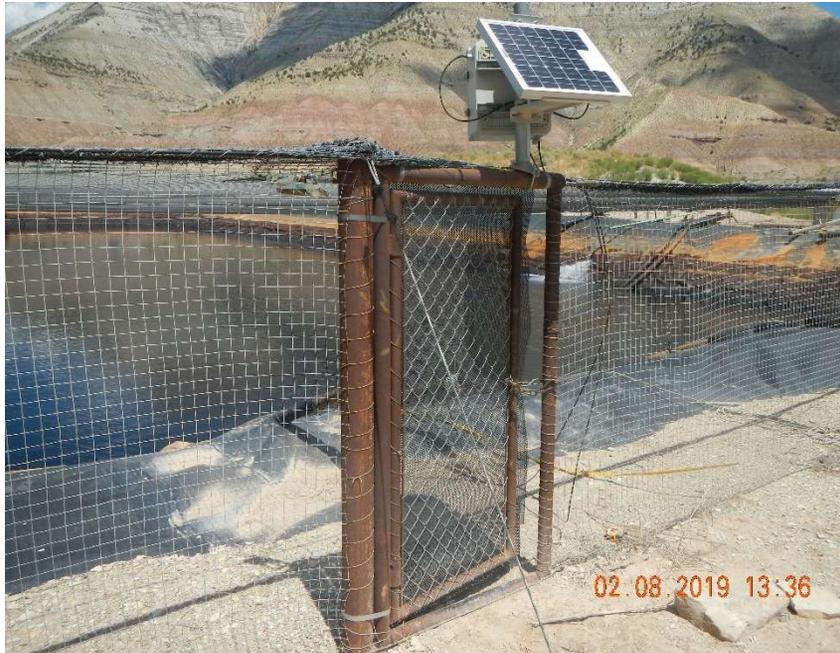
Photo #11 – Open gap in access gate located on the south side of the pit.

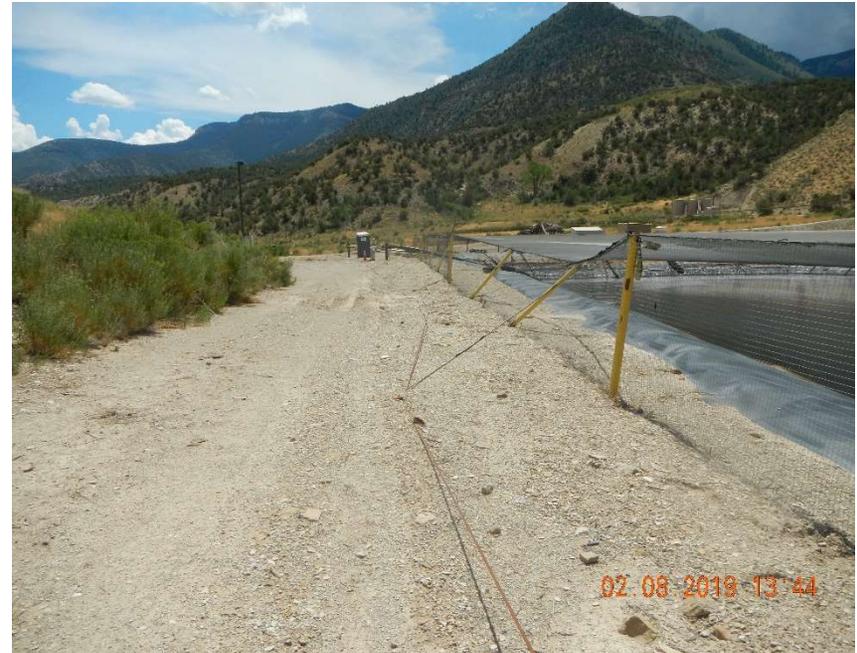
Photo #12 – Ballards on east side of the pit leaning to the west.

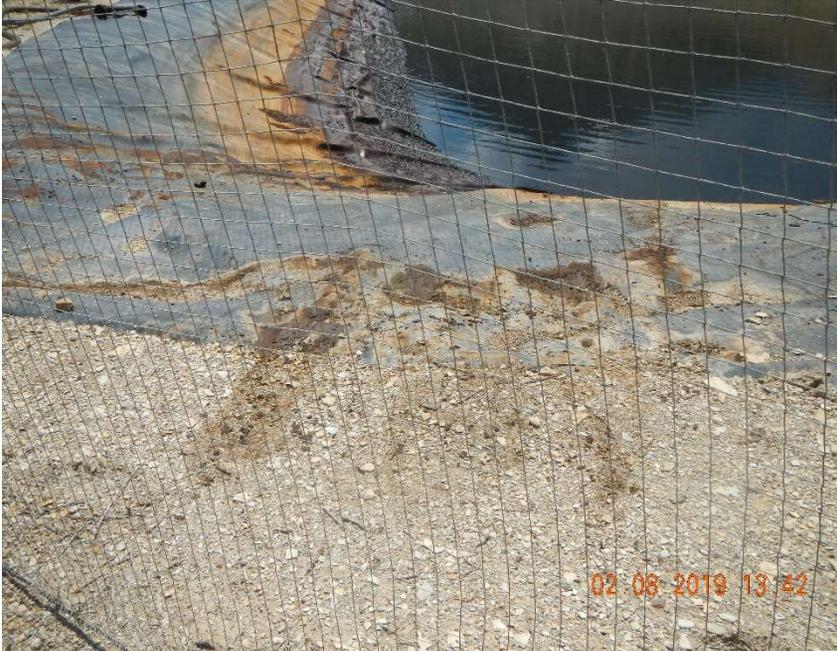
Photo #13 – Oil stained soil located at the northeast corner of the pit.

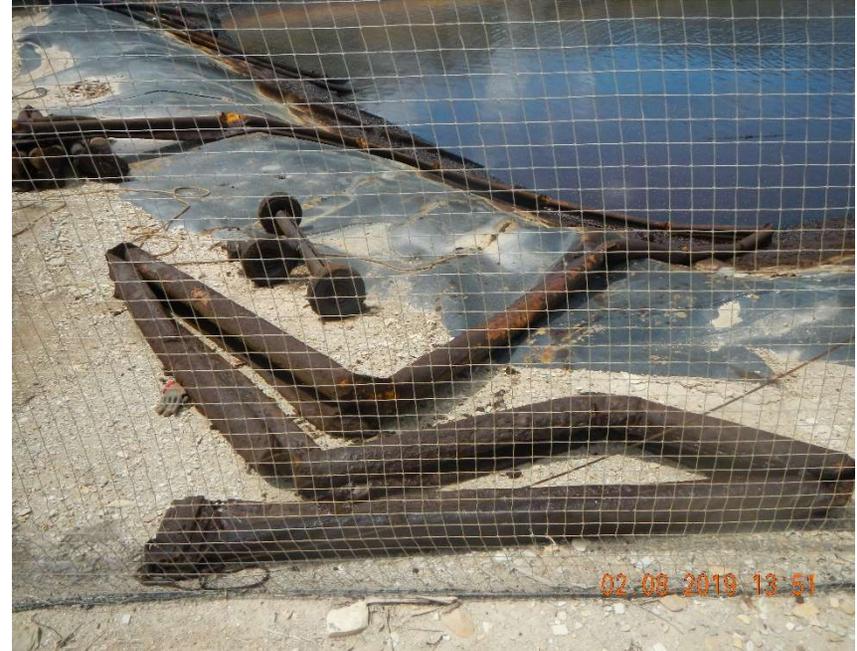
Photo #14 – Oil stained booms / soil located at the southeast corner of the pit.

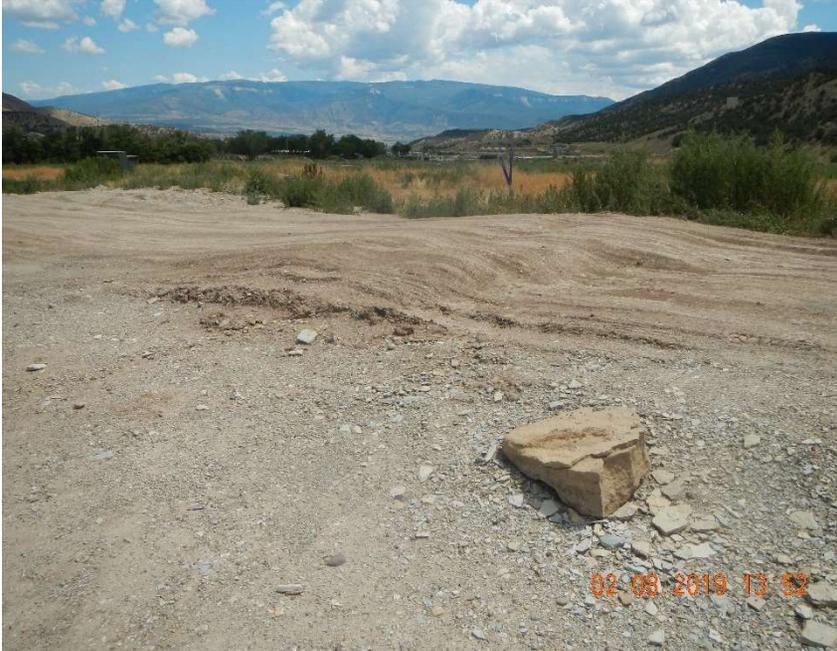
Photo #15 – Ruts and erosion on the south side of the pit.

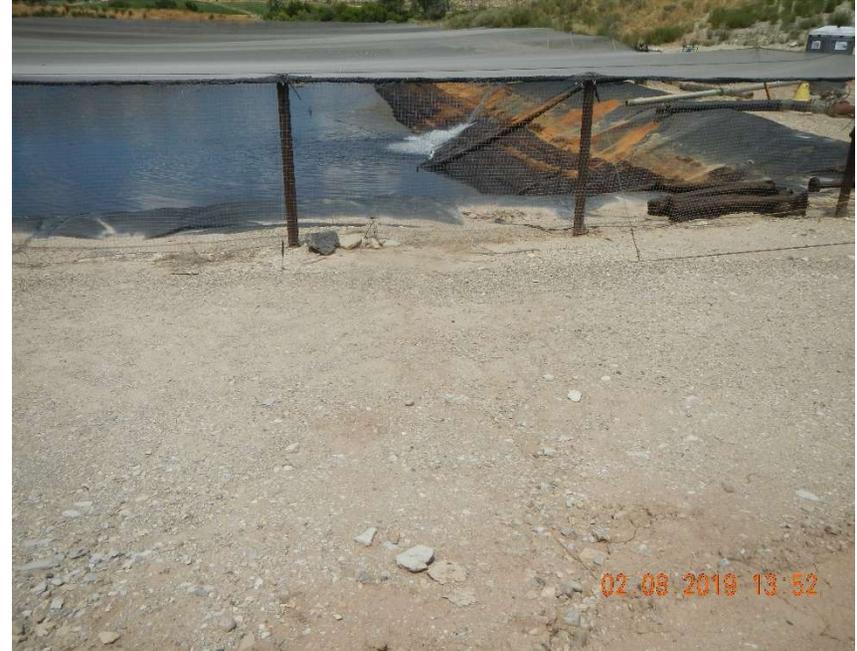
Photo #16 – Erosion leading into the south side of the pit.
