Inspection Photos

Loc#441601

Operator: XTO

Inspection Number: 692401244

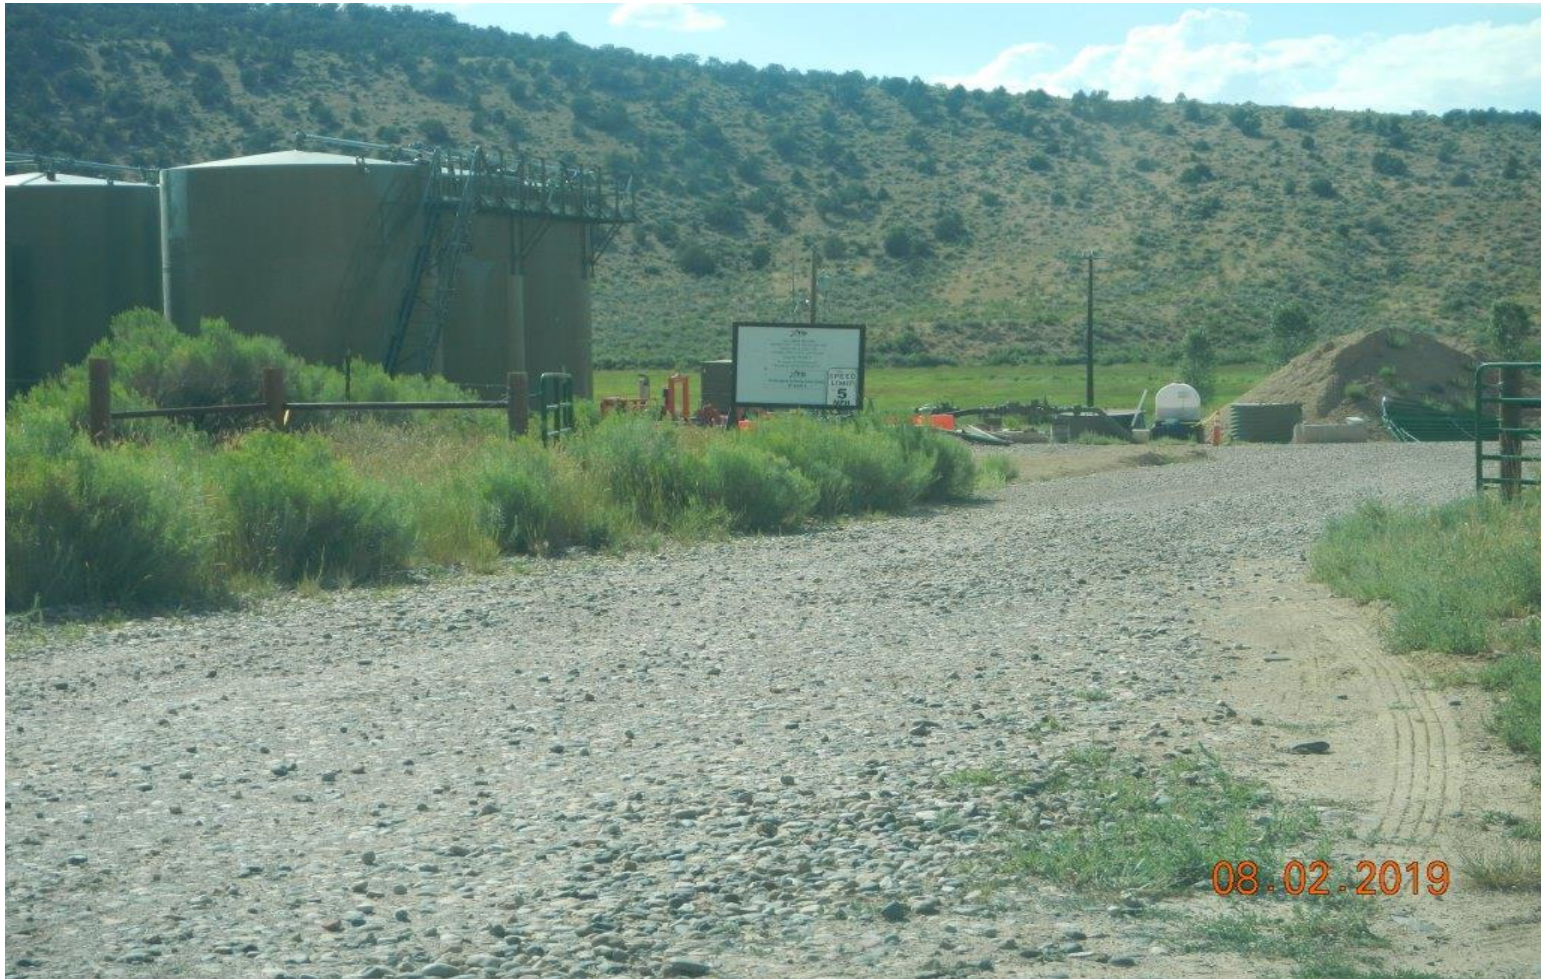
Photo#1:
Overview of Location to Southeast.

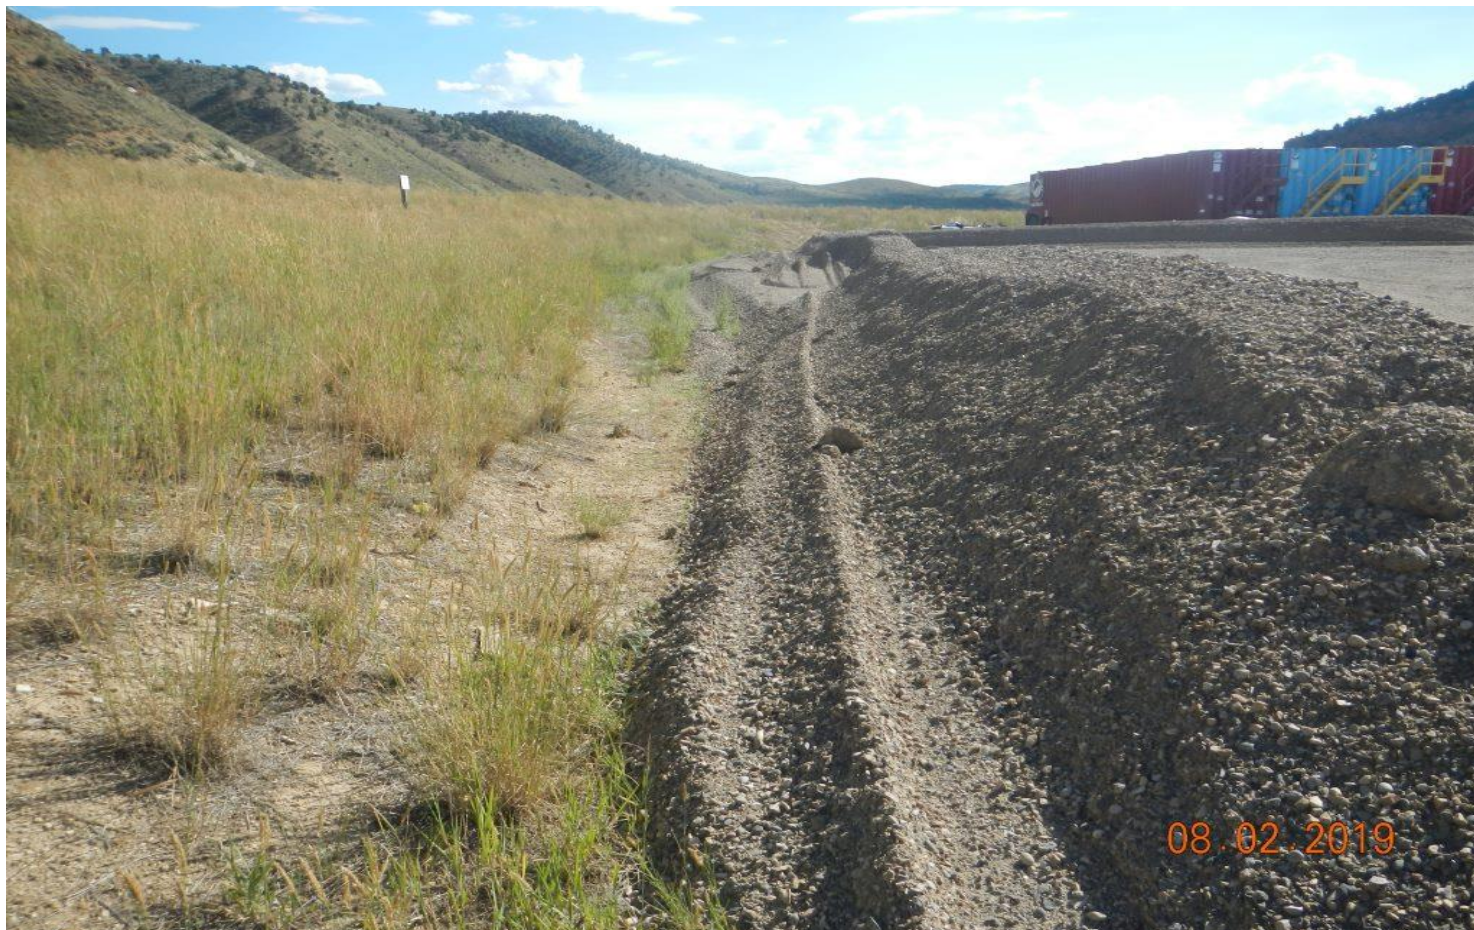
Photo#2:
Berms constructed on East side of Pad.

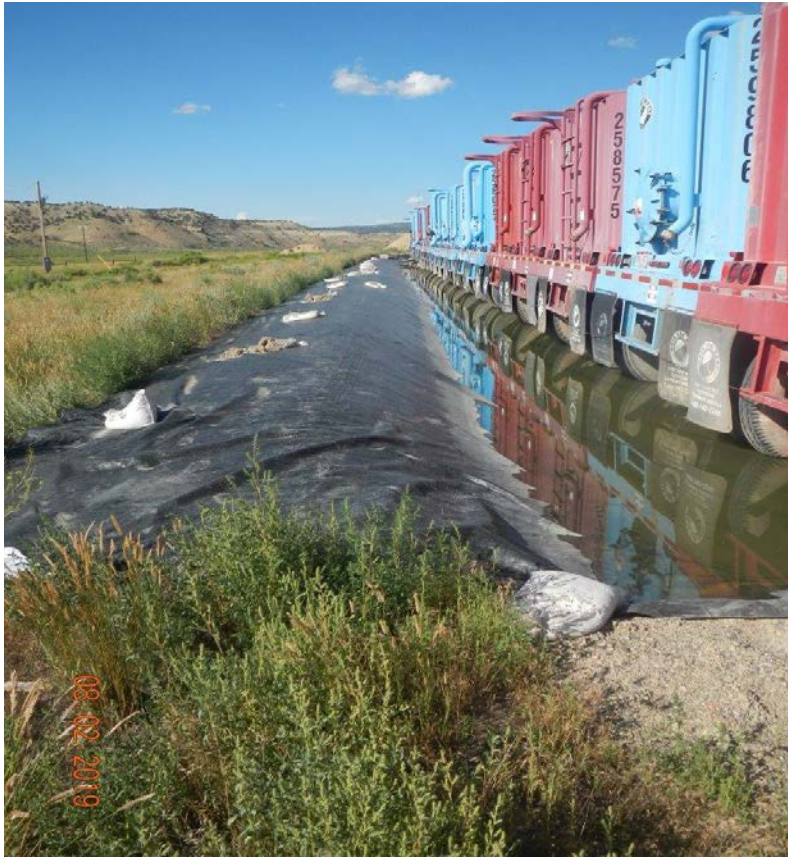
Photo#3:
Containment around Frac tanks at SW corner has only 4" of freeboard.

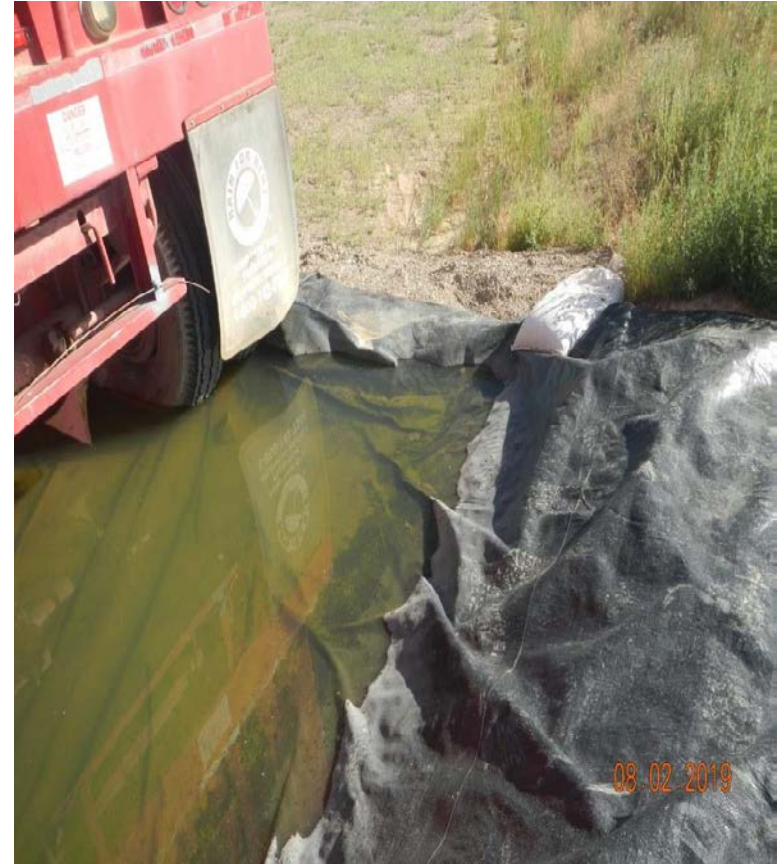
Photo#4:
Containment around Frac tanks at SW corner has only 4" of freeboard.

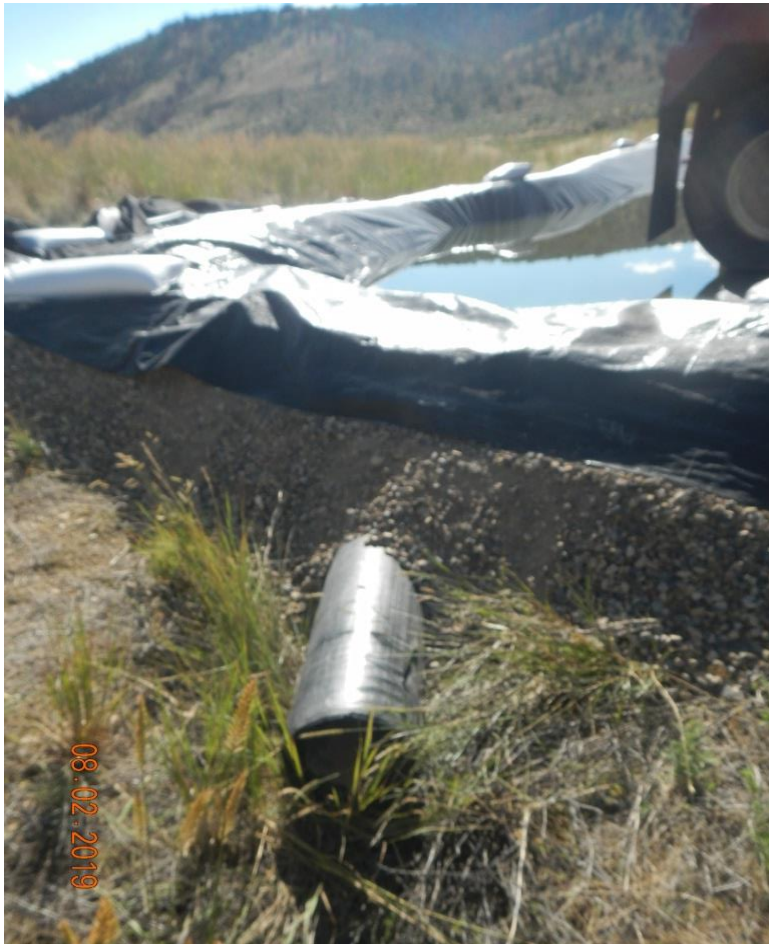
Photo#5:
Pipe installed to convey stormwater under Frac
tank containment at SE corner of pad.

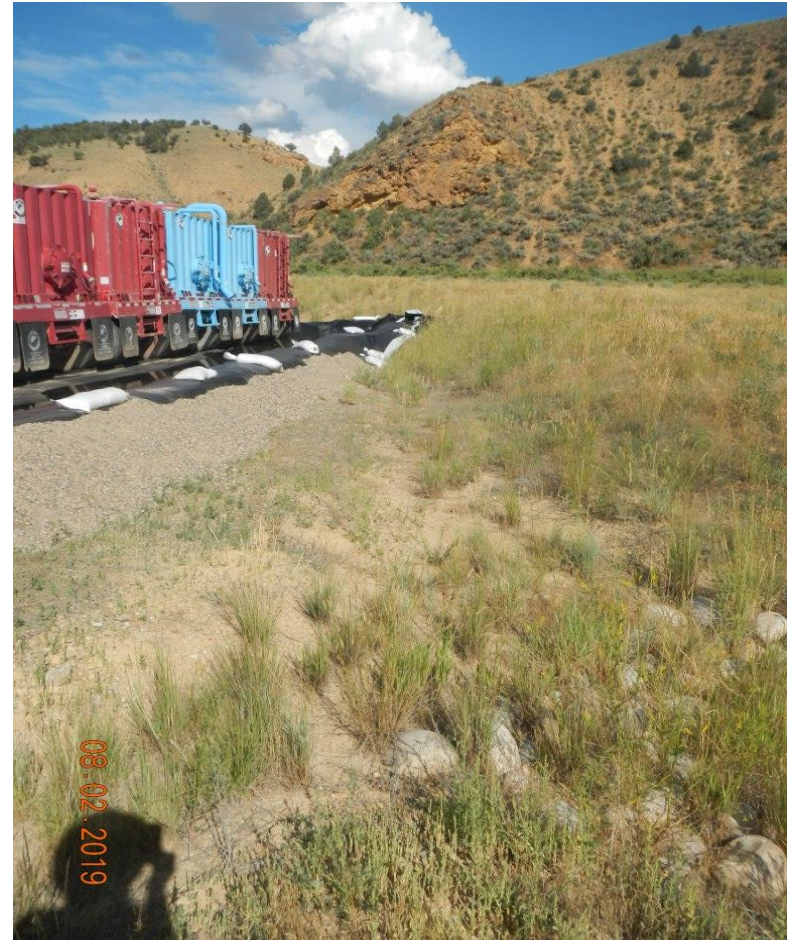
Photo#6:
Not able to confirm conveyance path of
pipe in Photo #5.

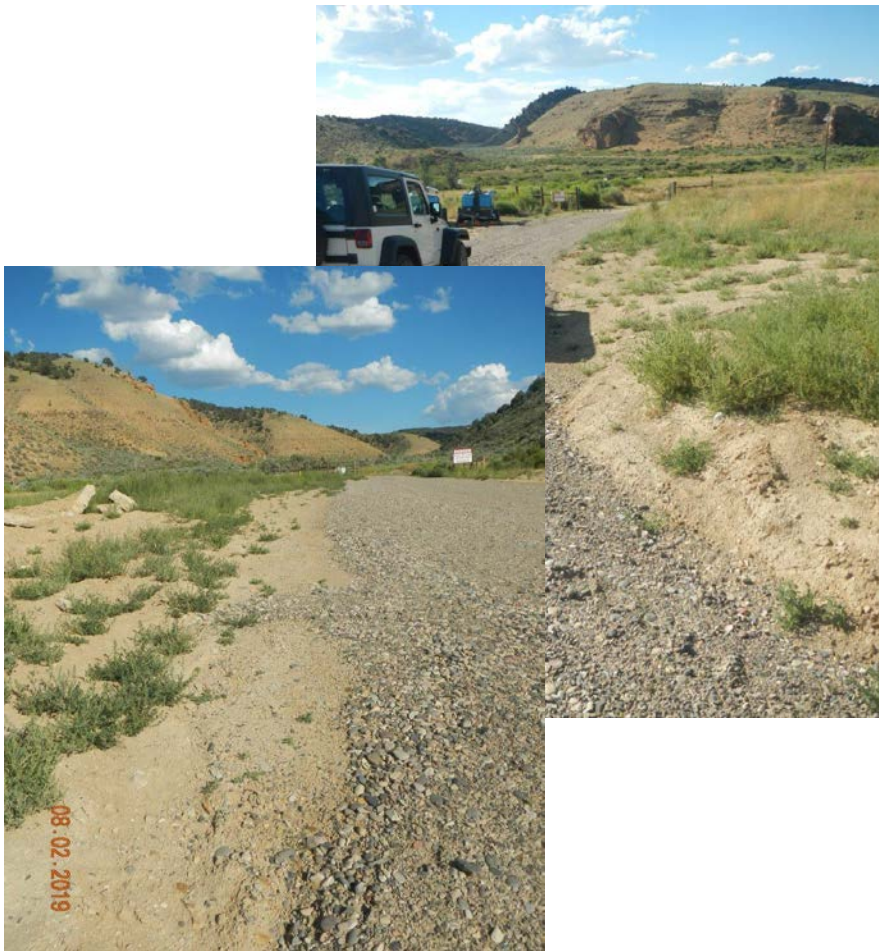
Photo#7:
Entry area of Access Road.

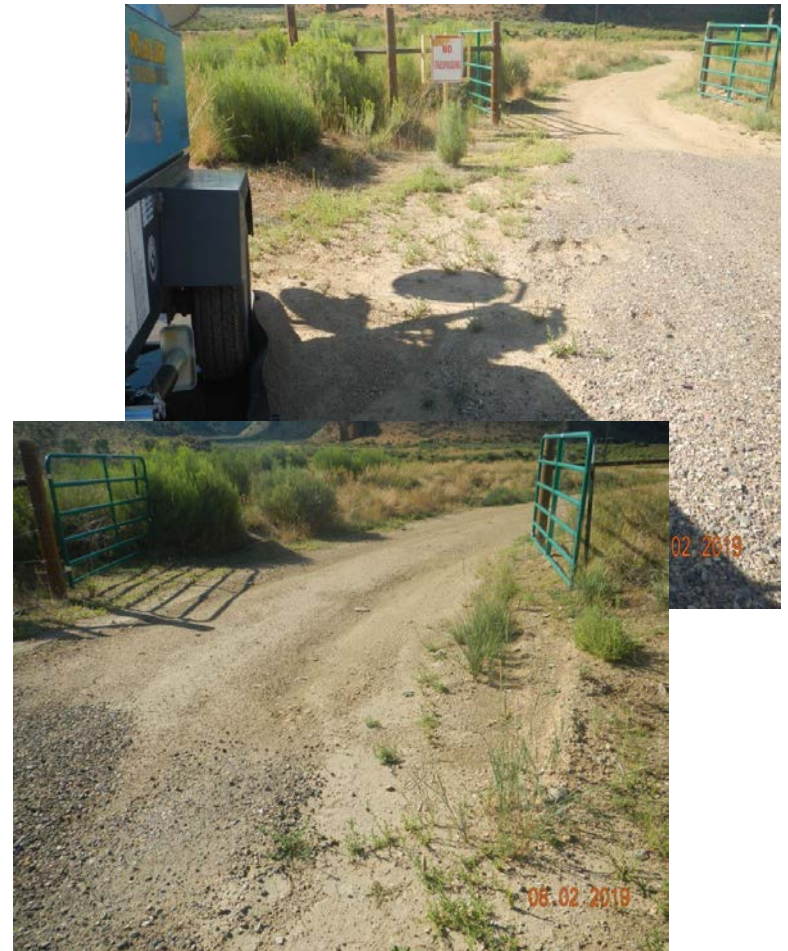
Photo#8:
Exit area of Access Road.

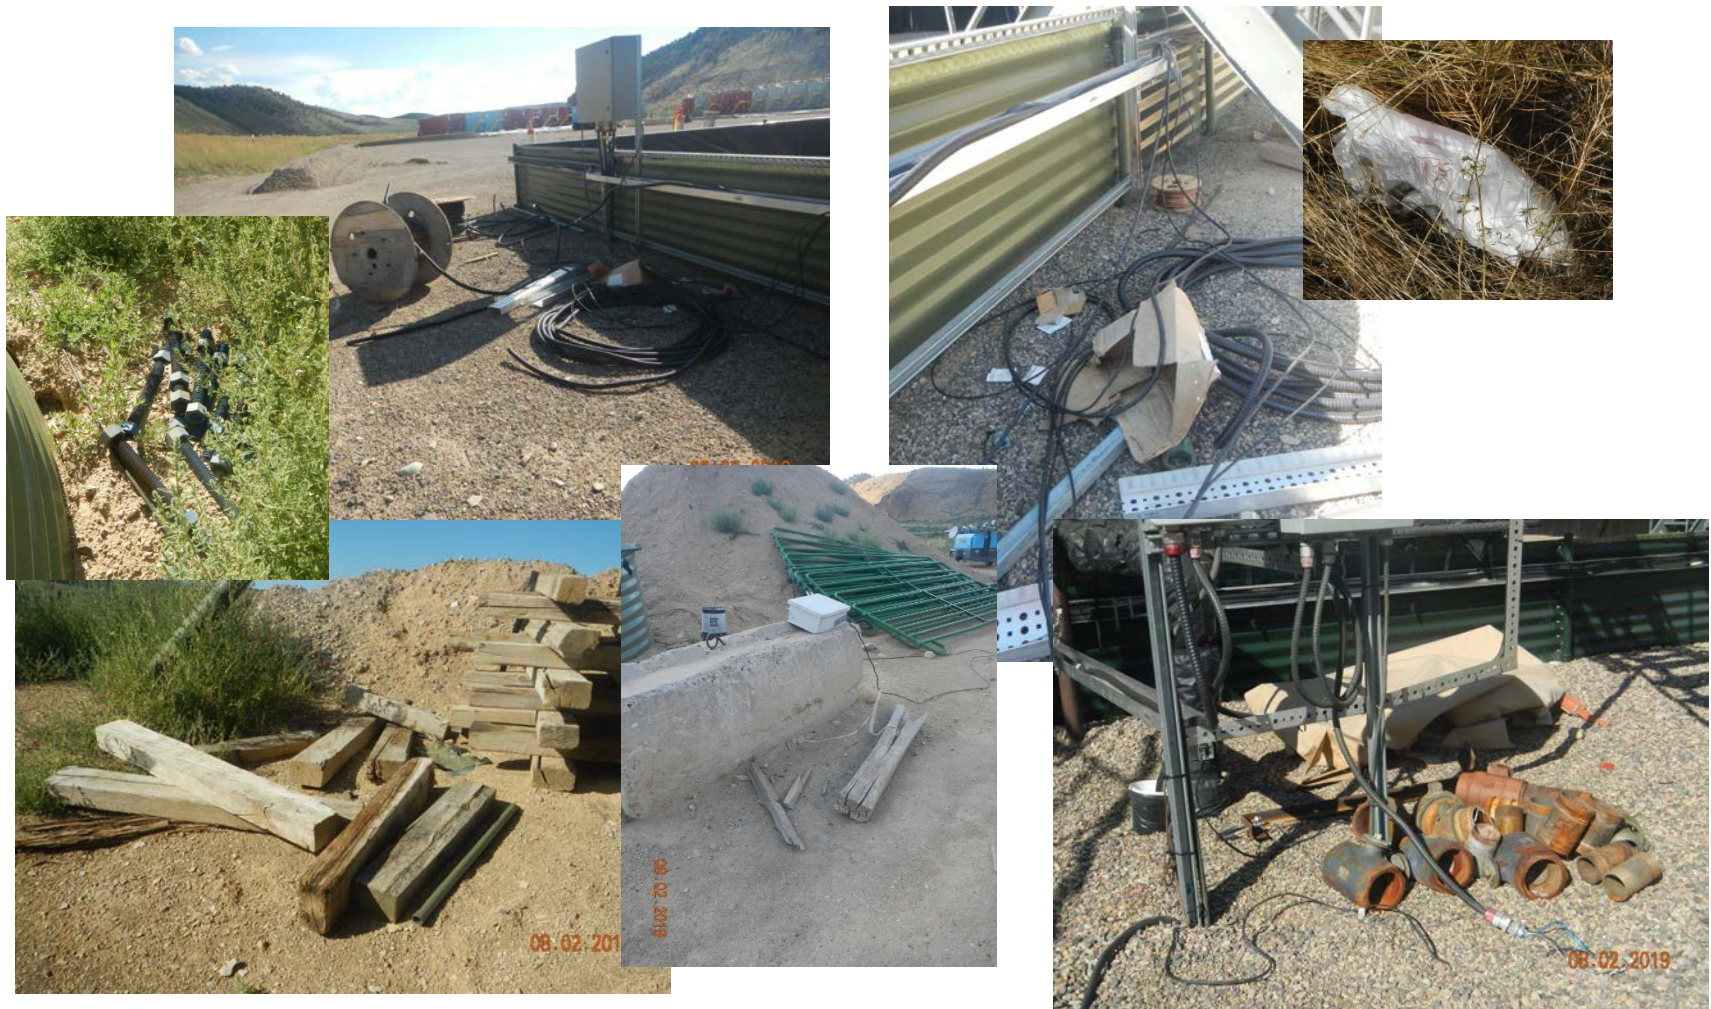
Photo#9 montage:
Debris scattered across site; supplies not stored in a workman like manner.
