Laramie Energy LLC
API # 077-08428
Inspection # 696600442

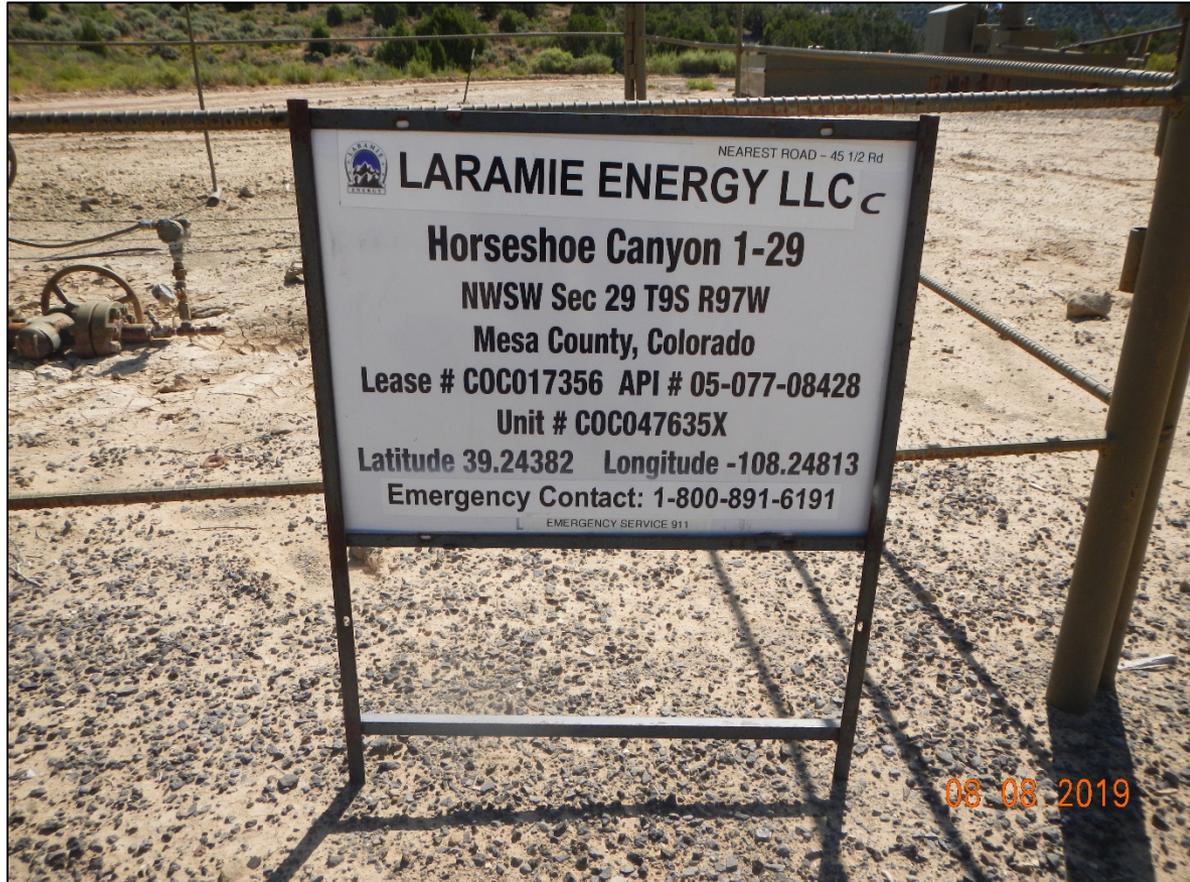
Photo #1 Sign is posted the tank battery on location

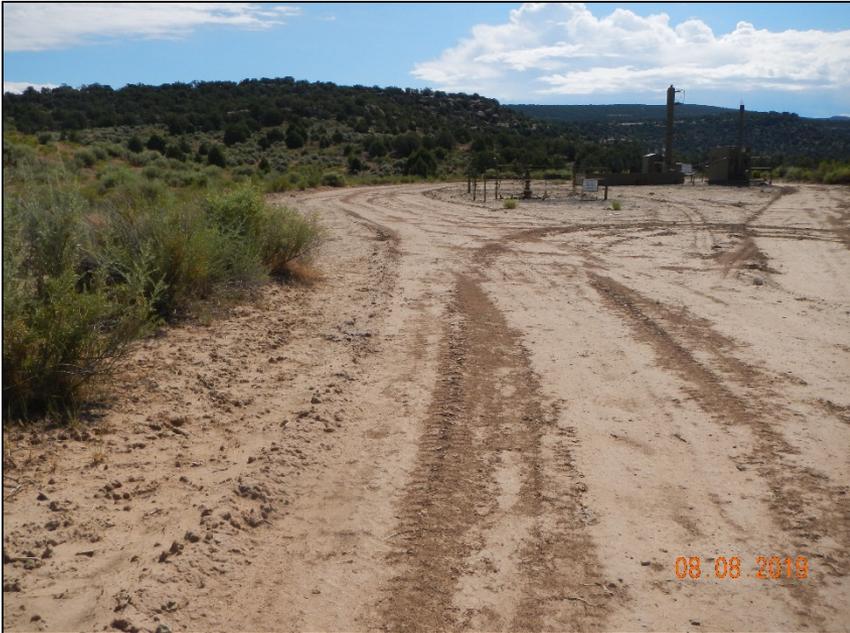
Photo #2 Photo at entrance of location.

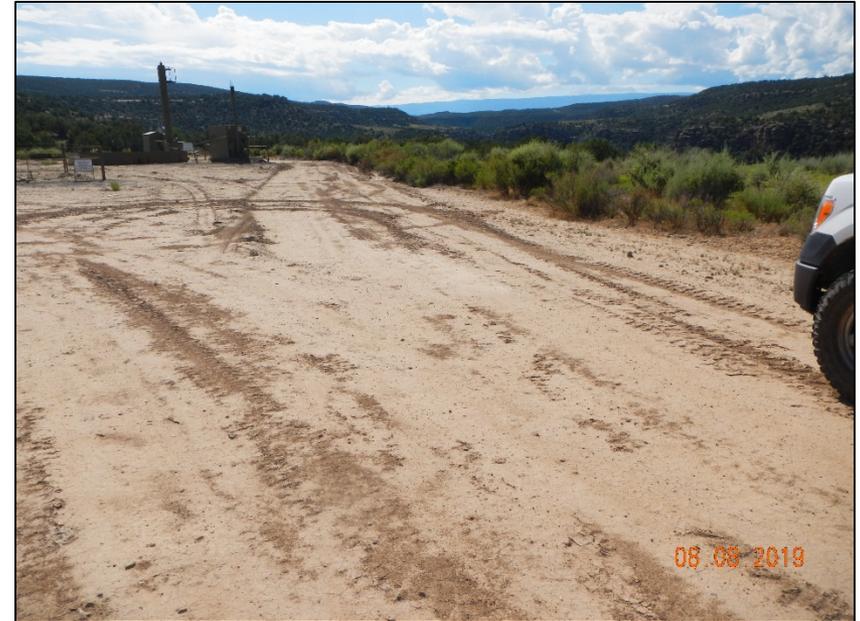
Photo #3 Photo at entrance of location.

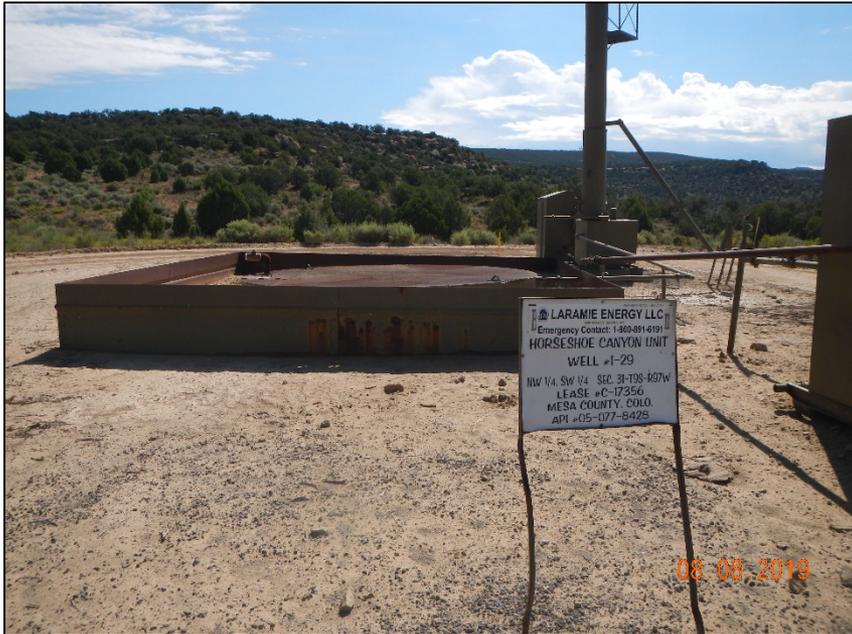
Photo #4 Photo of tank battery.

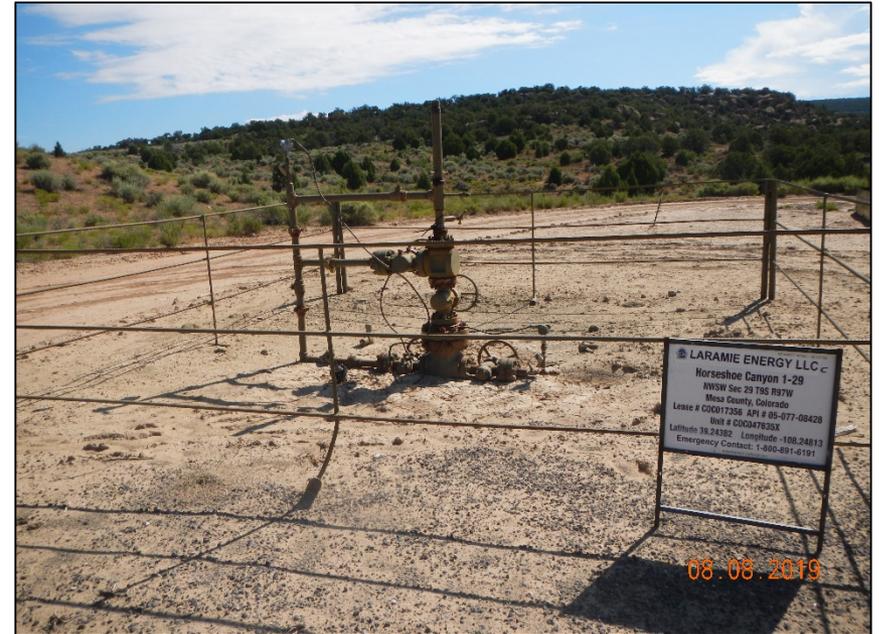
Photo #5. Photo of wellheads

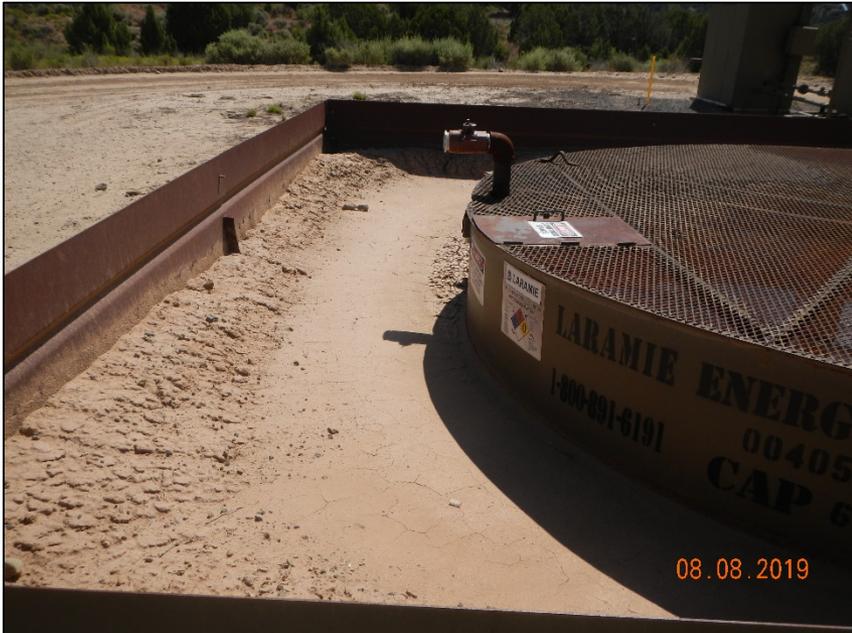
Photo #6 Earth berm has is in need of maintenance. Berms and secondary containment devices and all containment areas shall be sufficiently impervious to contain any spilled or released material.

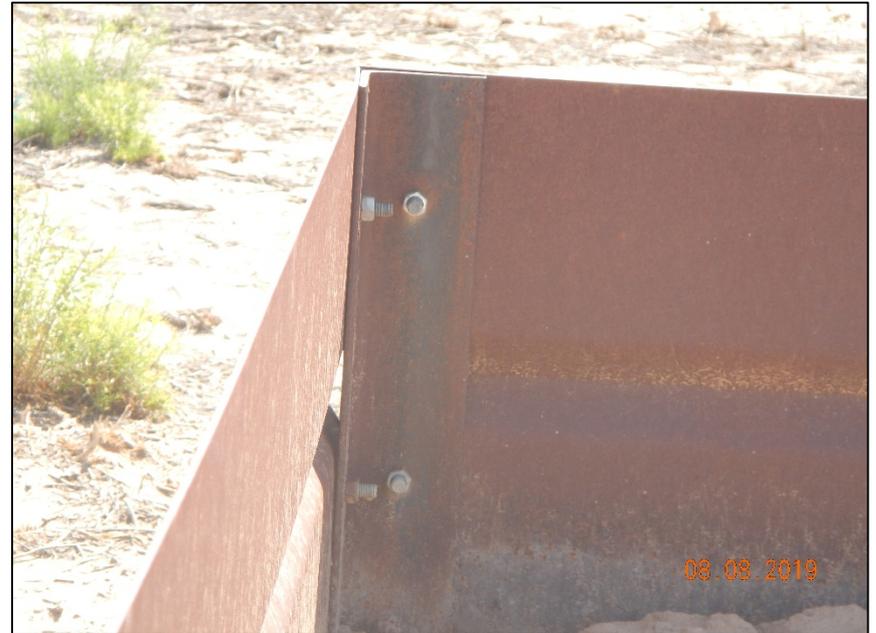
Photo #7 Wall around earth berm will not contain any spilled material. Shown here is a gap in construction of the wall

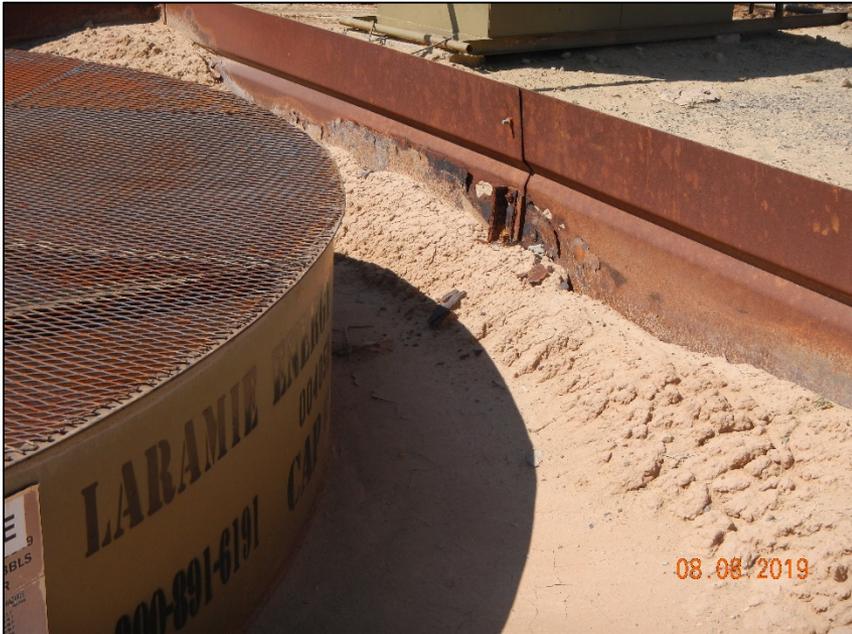
Photo #8 Earth berm is in need of maintenance. Berms and secondary containment devices and all containment areas shall be sufficiently impervious to contain any spilled or released material.

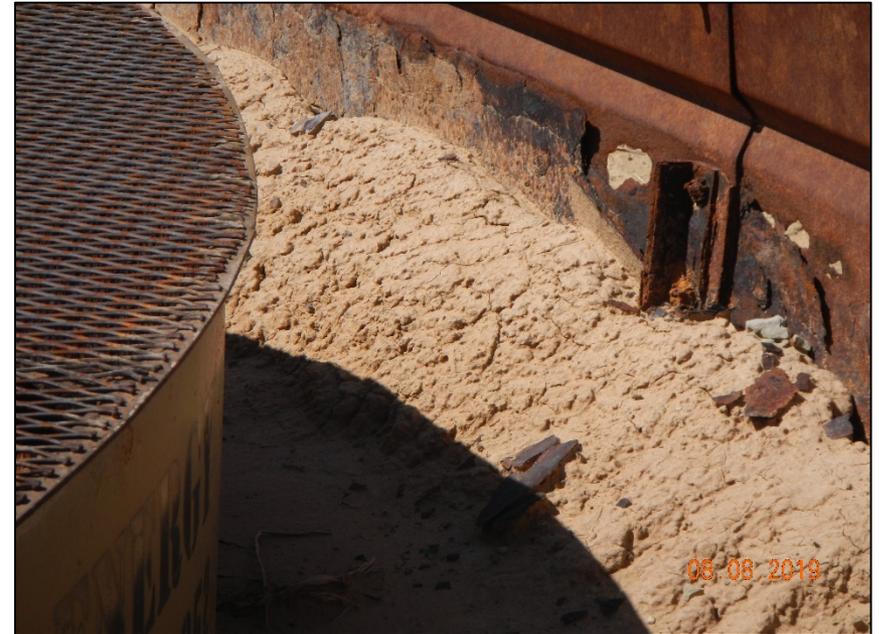
Photo #9 Walls around earth berm will not contain any spilled material. Shown here is holes in containment metal wall

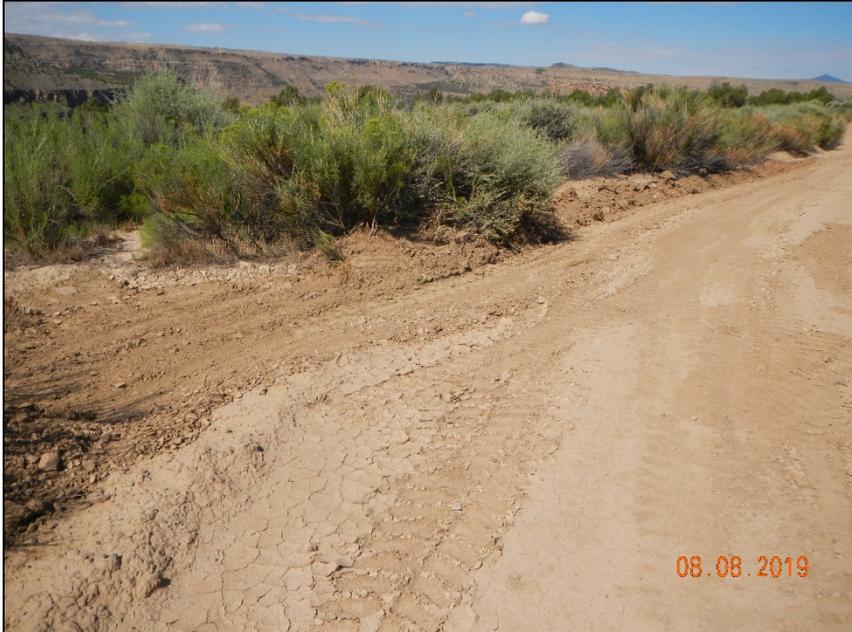
Photo #10 Erosion ditch moving down hill from south side of access road onto the south side onto location, into a gathering area, but no BMP in place to catch sediment or slow storm water erosion

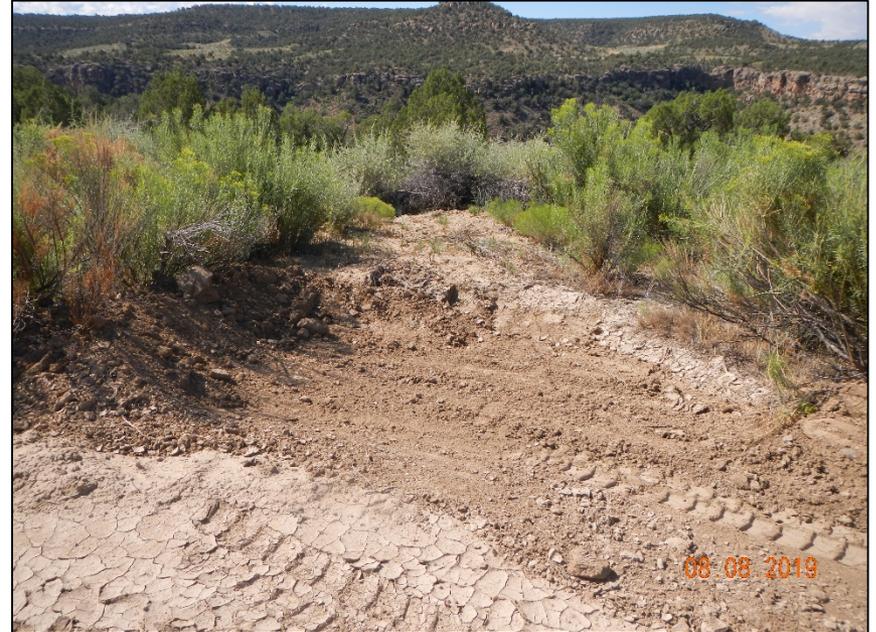
Photo #11 Ditch up stream and downstream gather here, on the south side of location, there is no BMP in place to catch sediment or slow flow of stormwater.

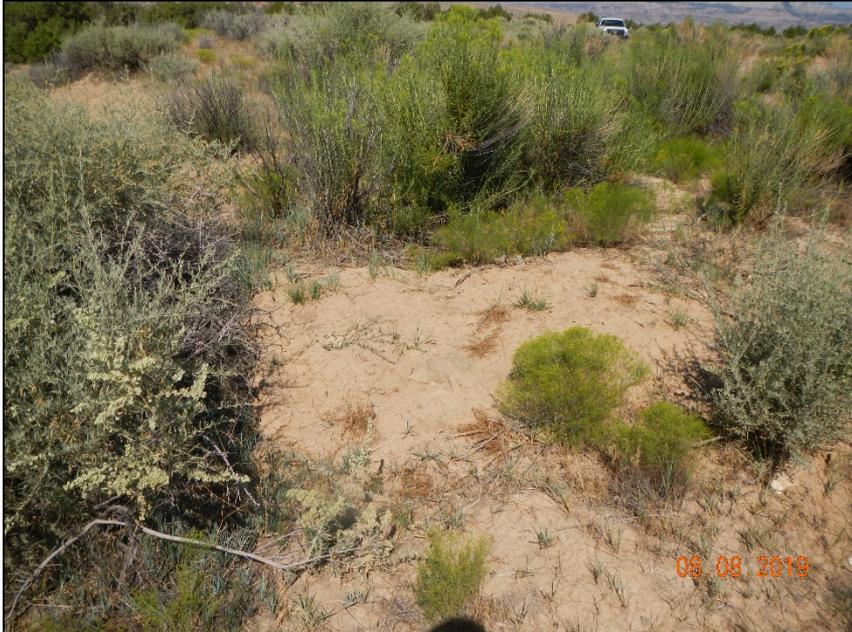
Photo #12 Vegetation is being choked from no BMP place to stop sediment from leaving location.

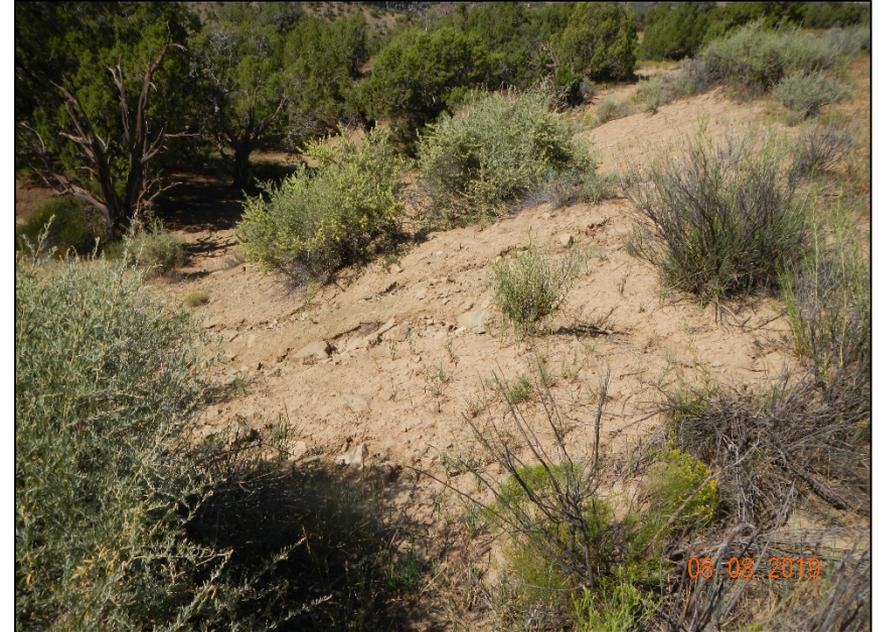
Photo #13 Erosion channels on south side of location.
