Laramie Energy LLC
API # 077-08658
Inspection # 696600444

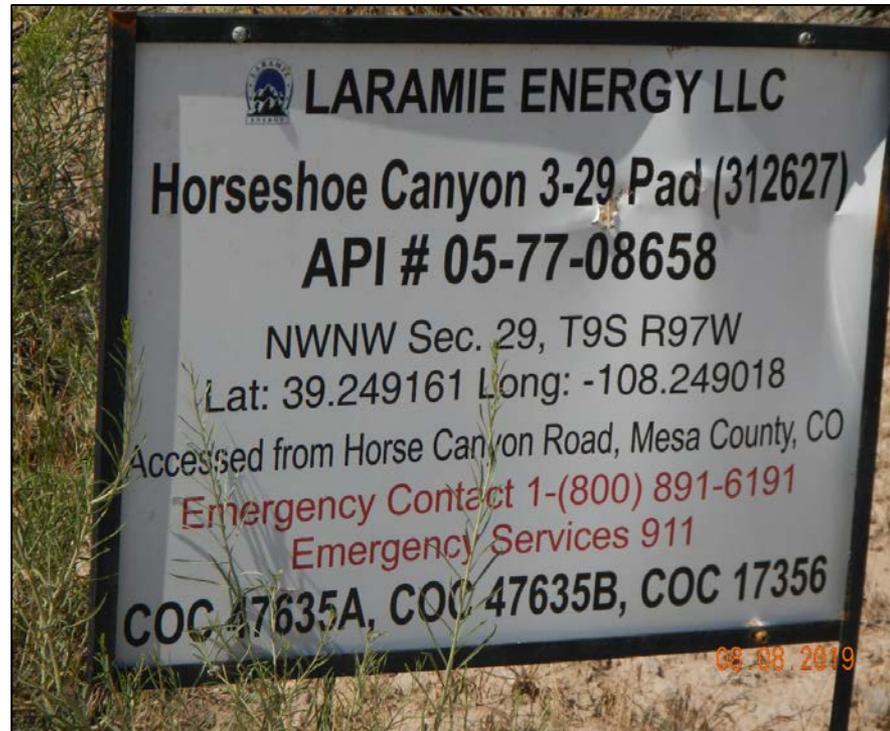
Photo #1 Battery sign is posted the entrance to location

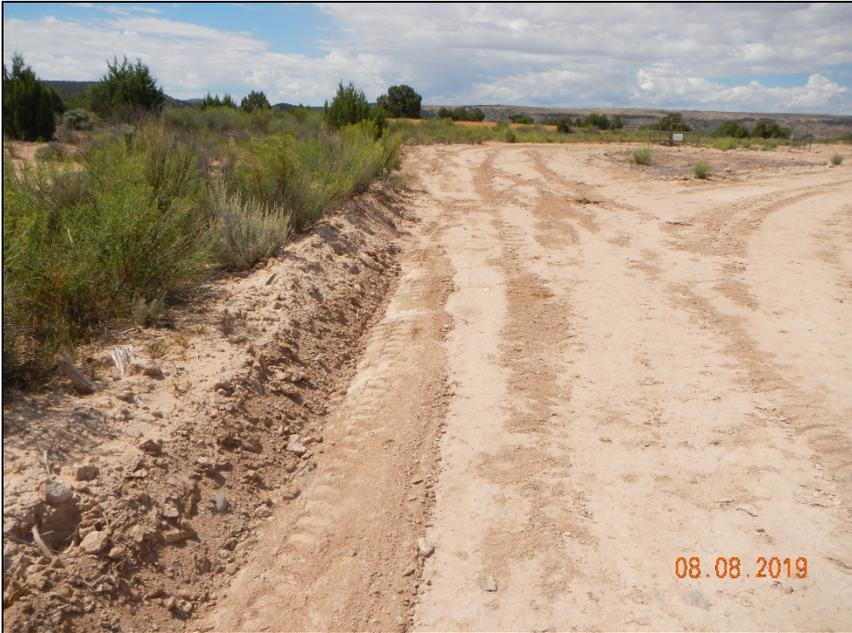
Photo #2 Photo at entrance of location.

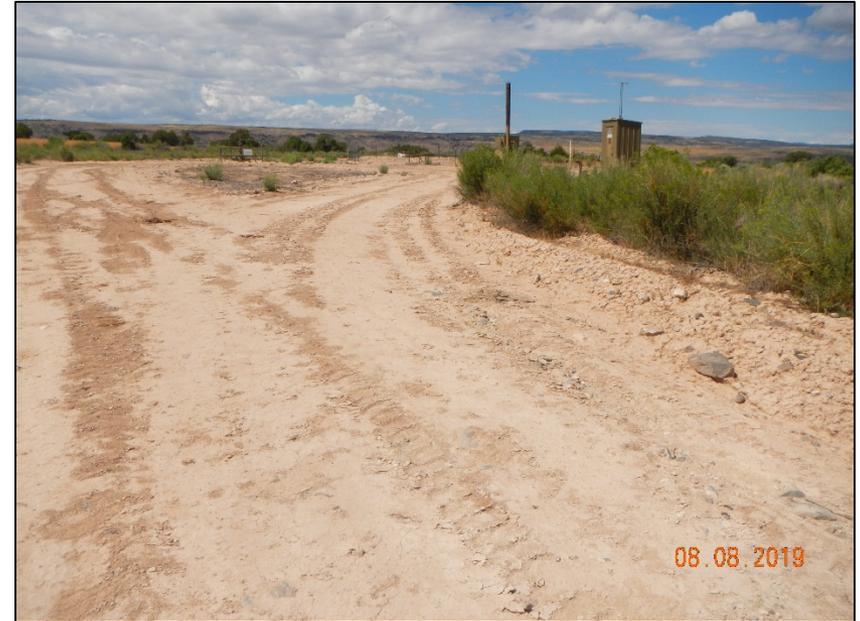
Photo #3 Photo at entrance of location.

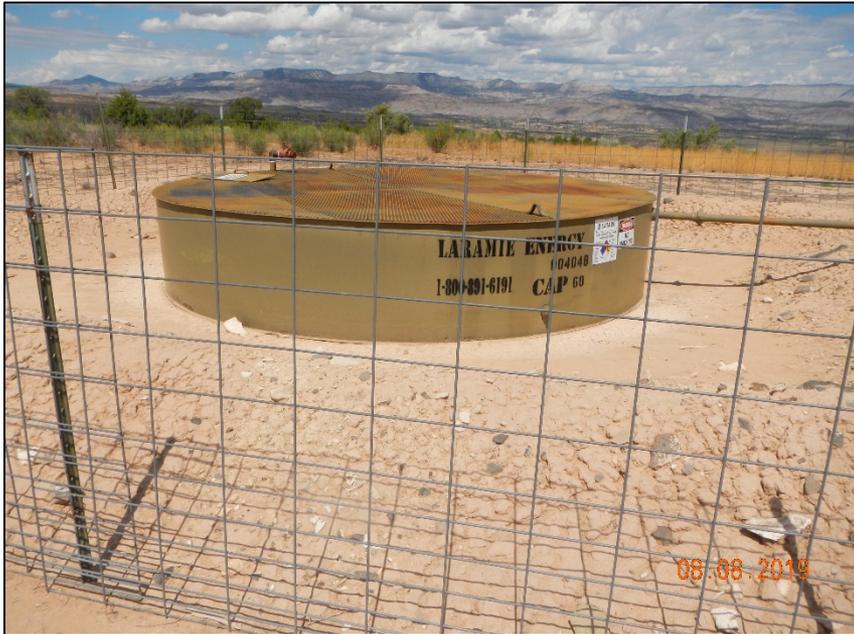
Photo #4 Photo of the tank battery.

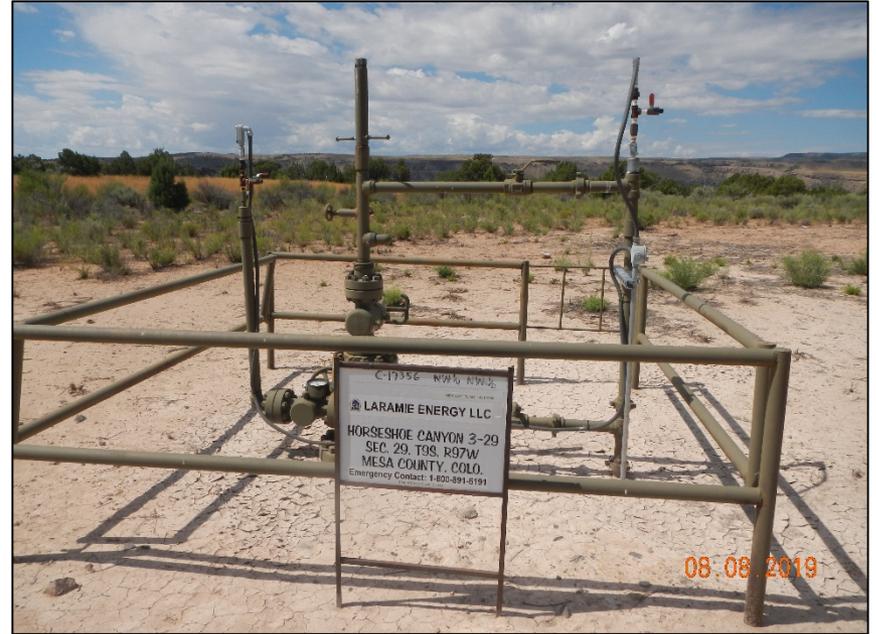
Photo #5. Photo at wellheads

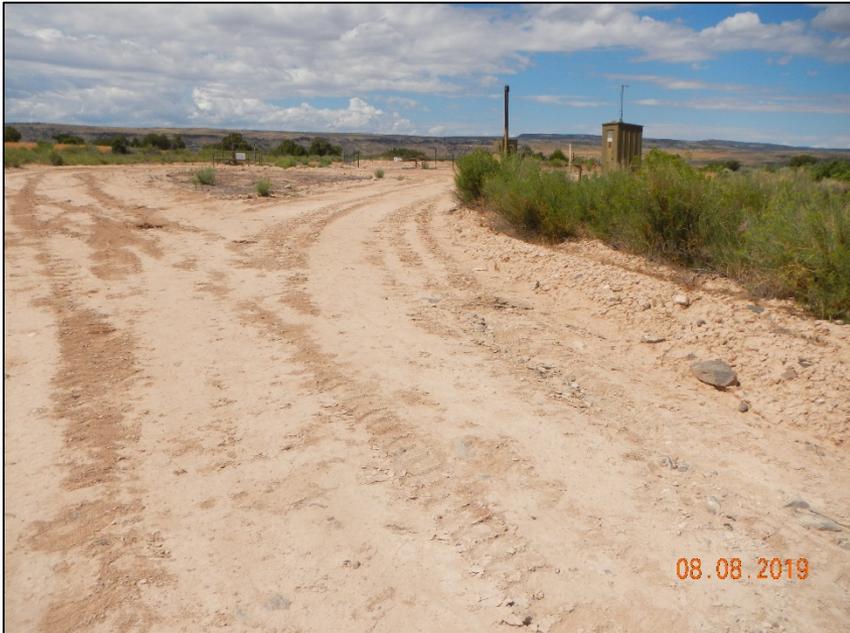
Photo #6. Erosion is moving sediment off location and down access road on both sides of location. No BMP in place to slow storm water or catch sediment.

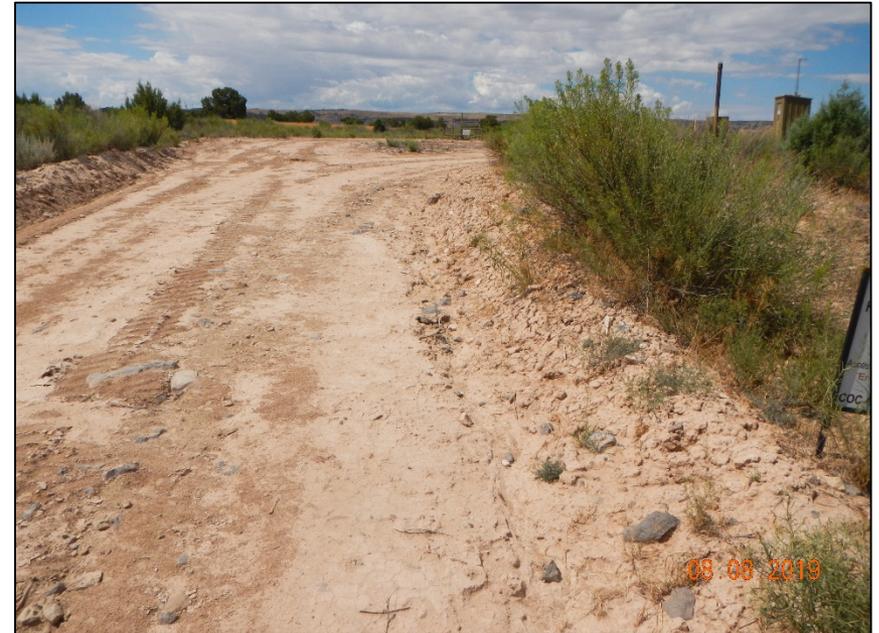
Photo #7 Erosion is moving sediment off location and down access road on both sides of location. No BMP in place to slow storm water or catch sediment.

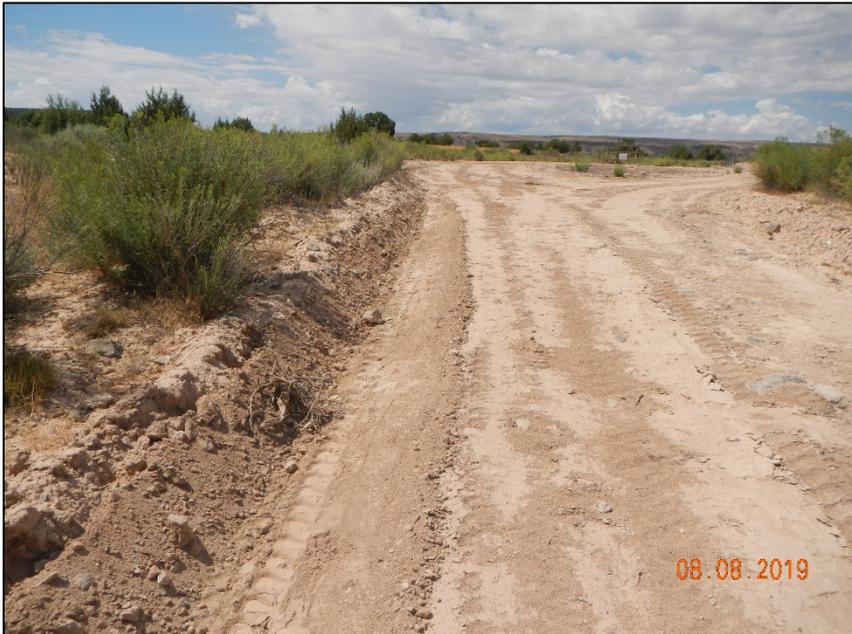
Photo #8 Erosion moving sediment off location and down access road on both sides of location

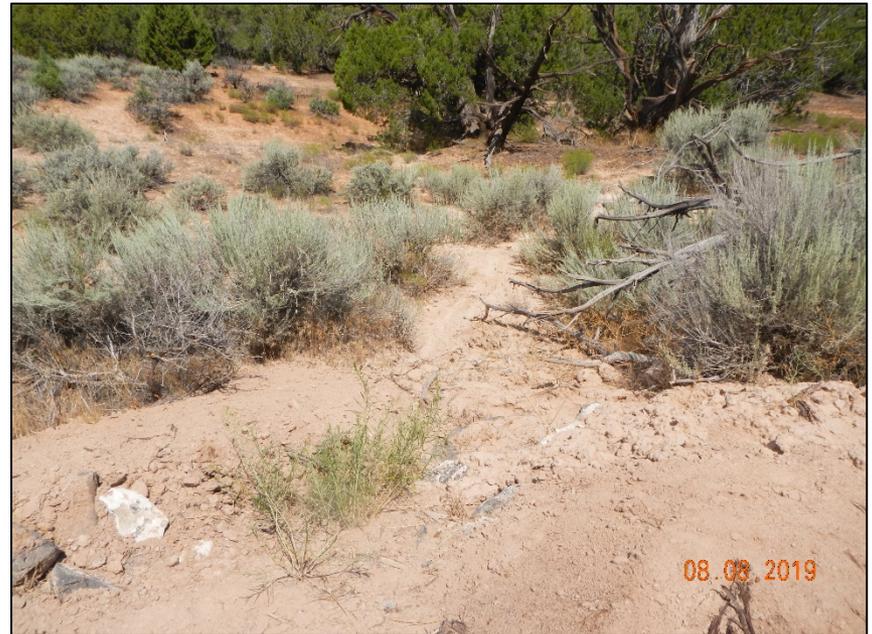
Photo #9 Turn out, made to release stormwater off access road, has no BMP's in place to catch sediment. Erosion moving sediment into ravine and choking out vegetation.

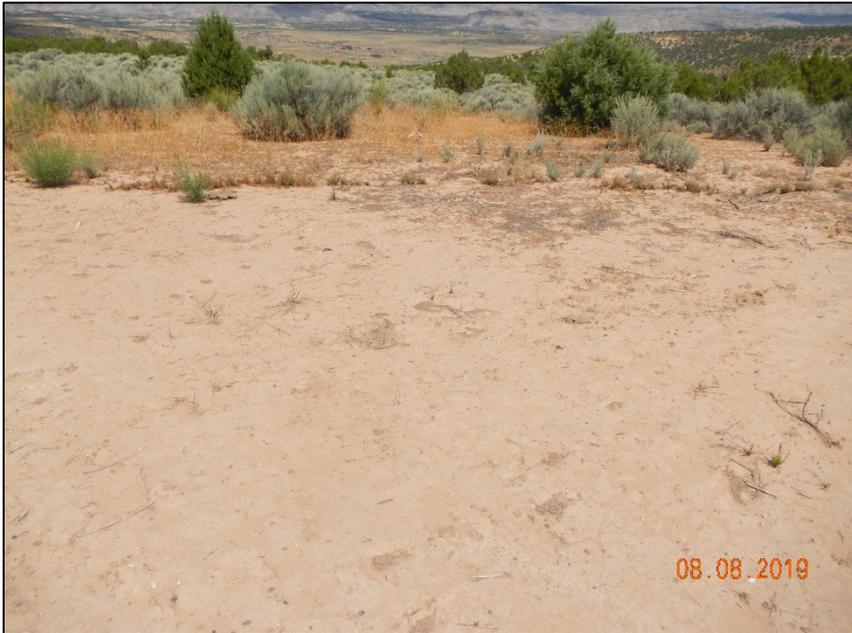
Photo #10 Erosion moving off location, over a un-stabilized slope on the NW side of location. No BMP in place to stop sediment from moving or choking out vegetation.

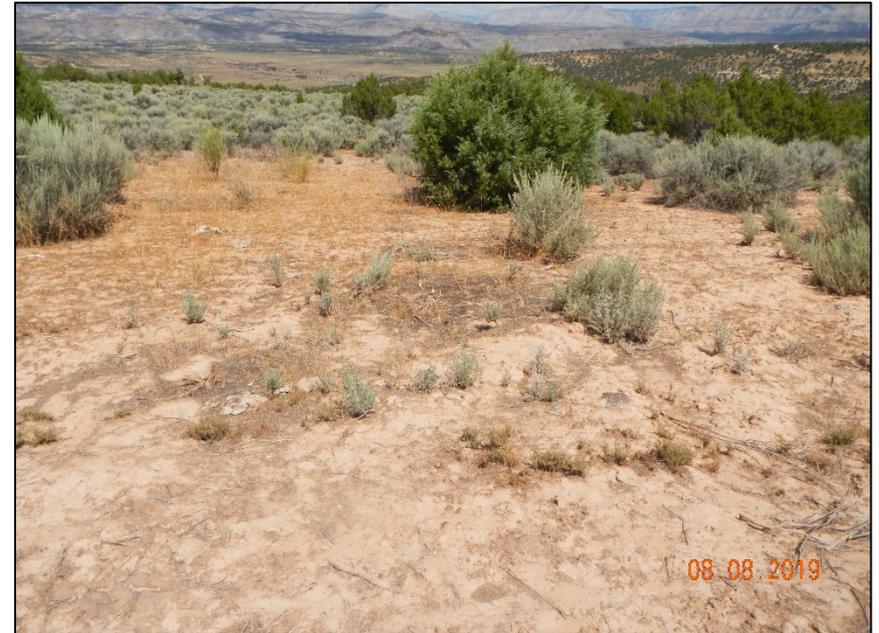
Photo # 11. Erosion moving off location over a un-stabilized slope on the NW side of location. Sediment is choking out vegetation.
