Laramie Energy LLC
API # 077-08663
Inspection # 696600452

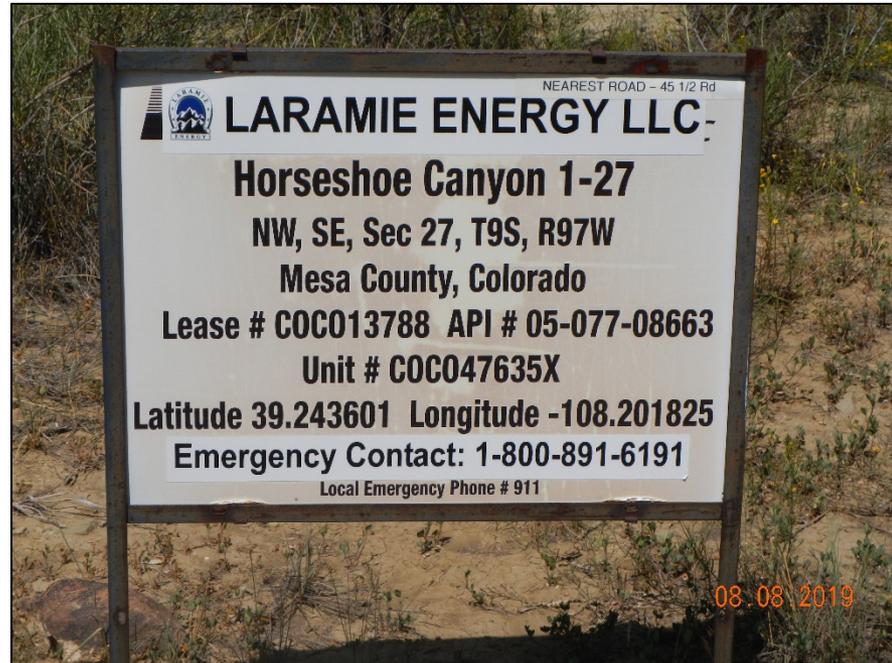
Photo #1 Battery sign is posted the entrance to location

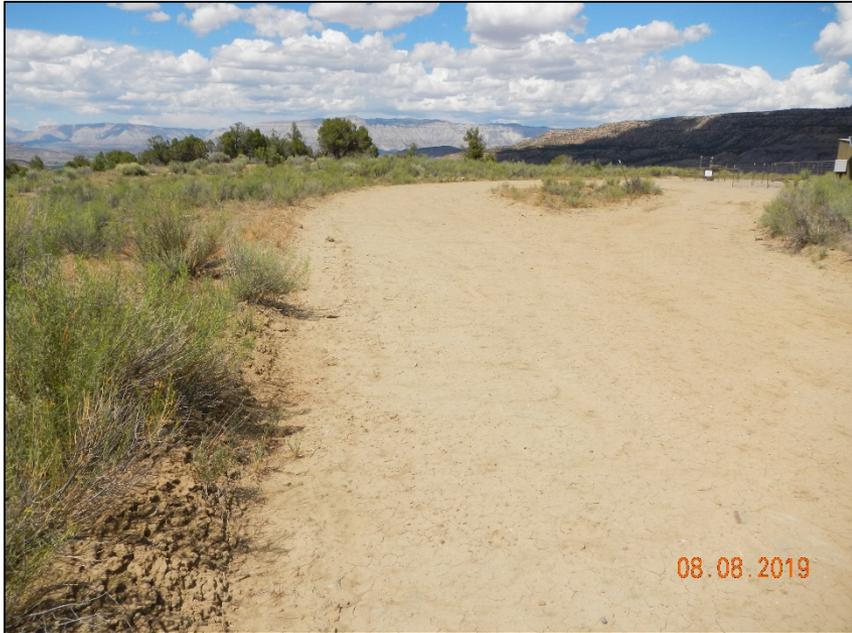
Photo #2 Photo at entrance of location.

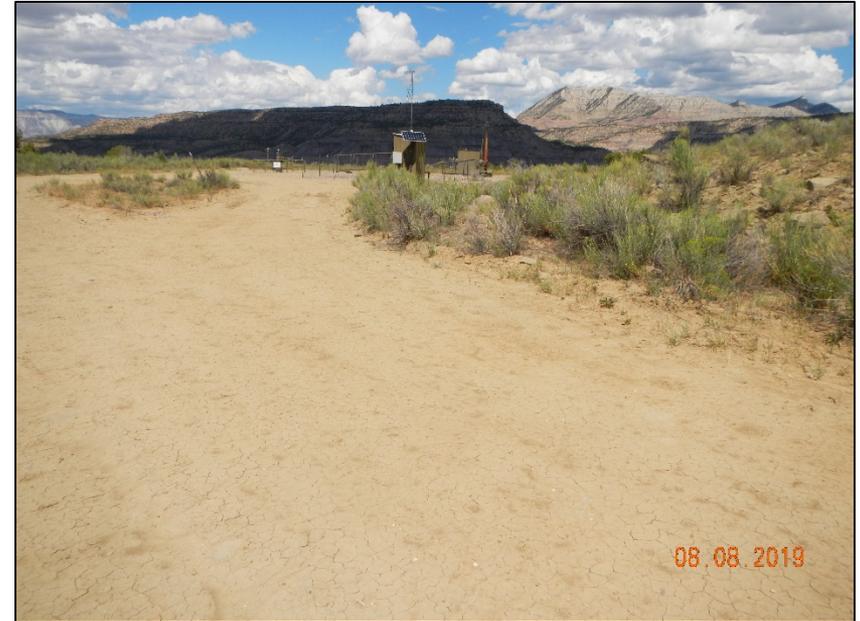
Photo #3 Photo at entrance of location.

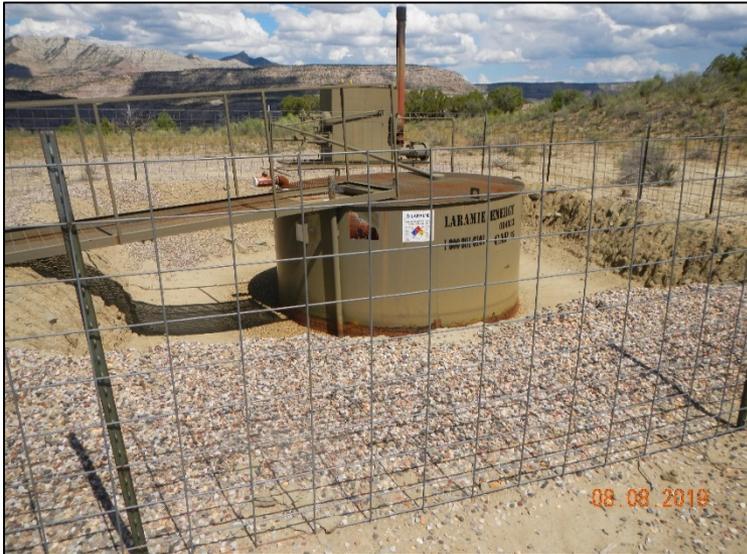
Photo #4 Photo of the tank battery.

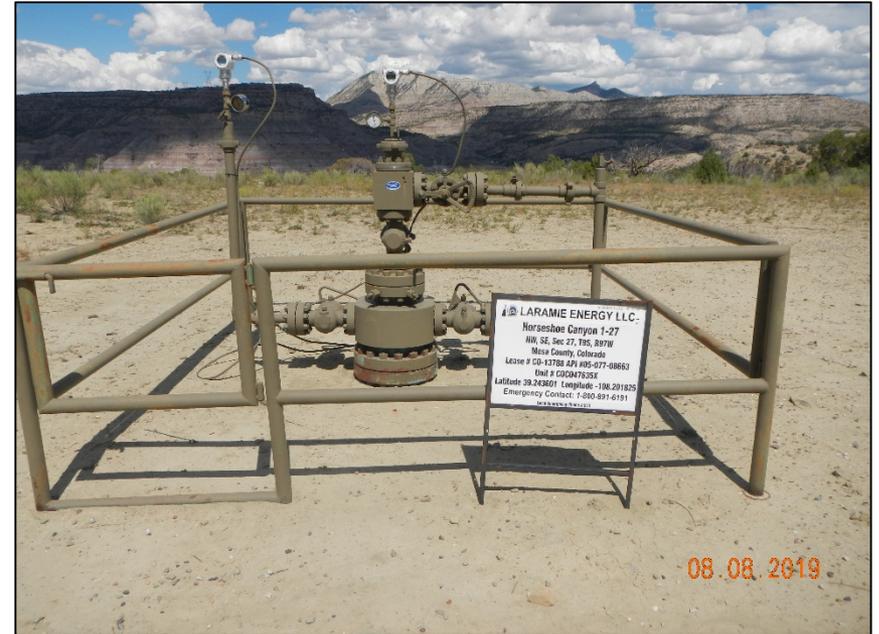
Photo #5. Photo at wellheads

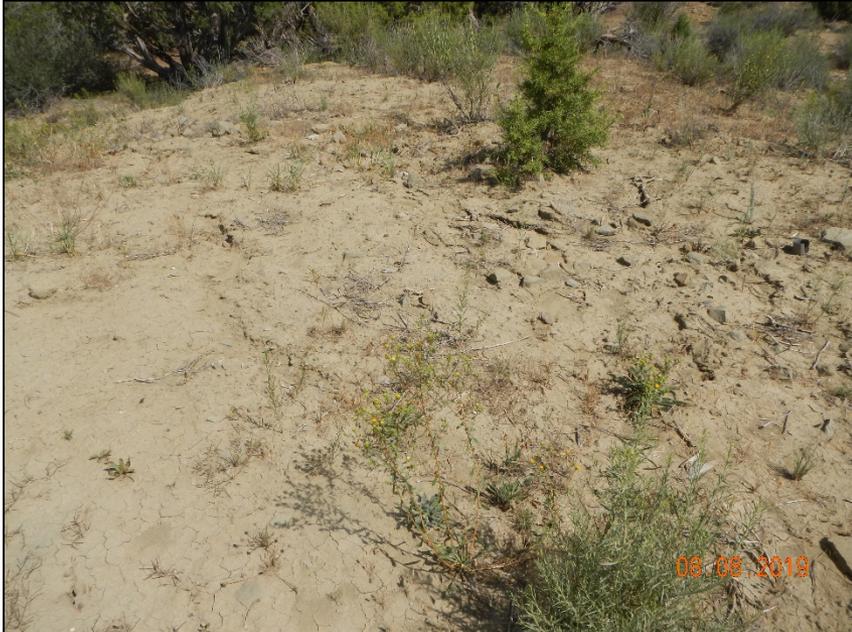
Photo #6 Photo taken on North side of location of heavy channeling and erosion. Vegetation is being choked out by sediment moving off location. No BMP's in place to slow or stop sediment movement

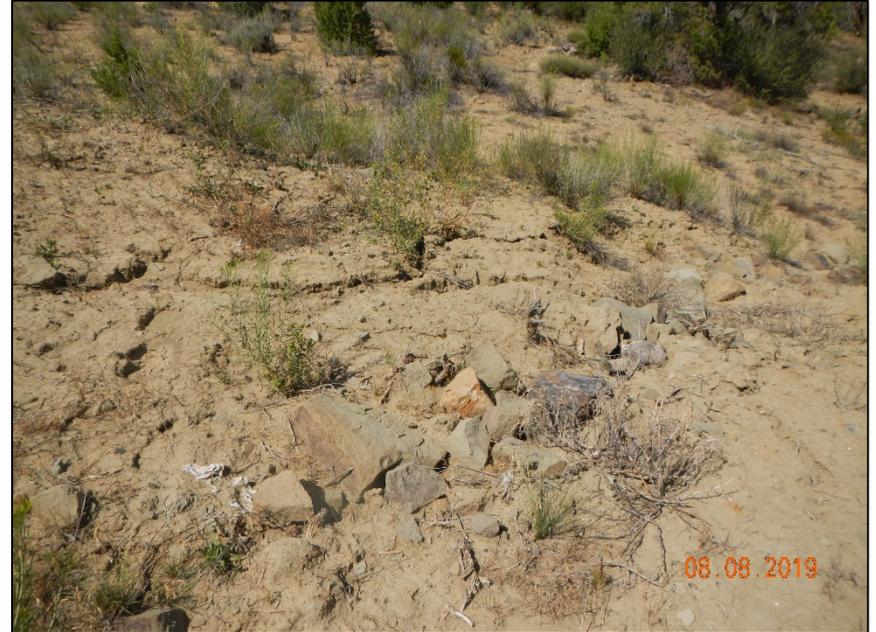
Photo #7 Photo taken on North side of location of heavy channeling and erosion. Vegetation is being choked out by sediment moving off location. No BMP's in place to slow or stop sediment movement

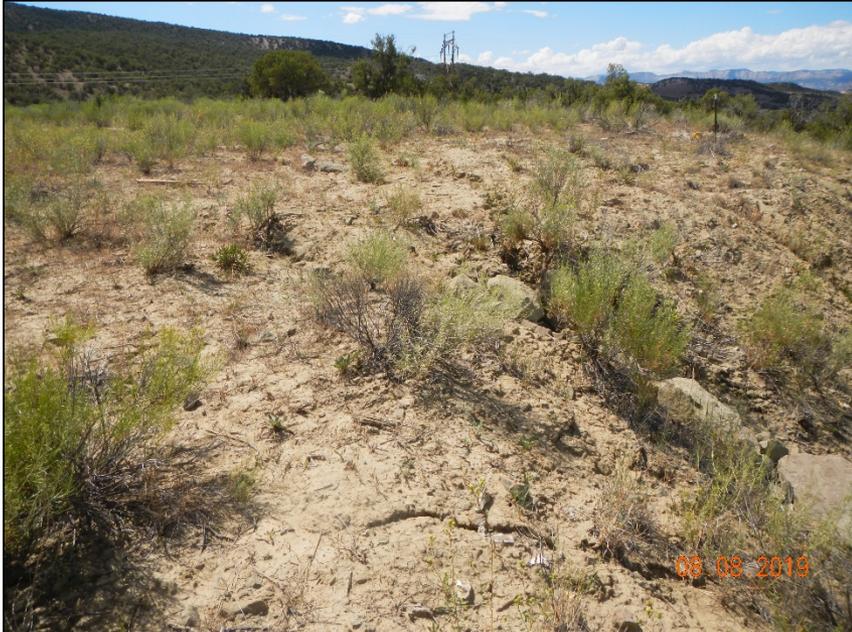
Photo #8 Photo taken on North side of location of heavy channeling and erosion do to no slope stabilization. Vegetation is being choked out by sediment moving off location. No BMP's in place to slow or stop sediment movement

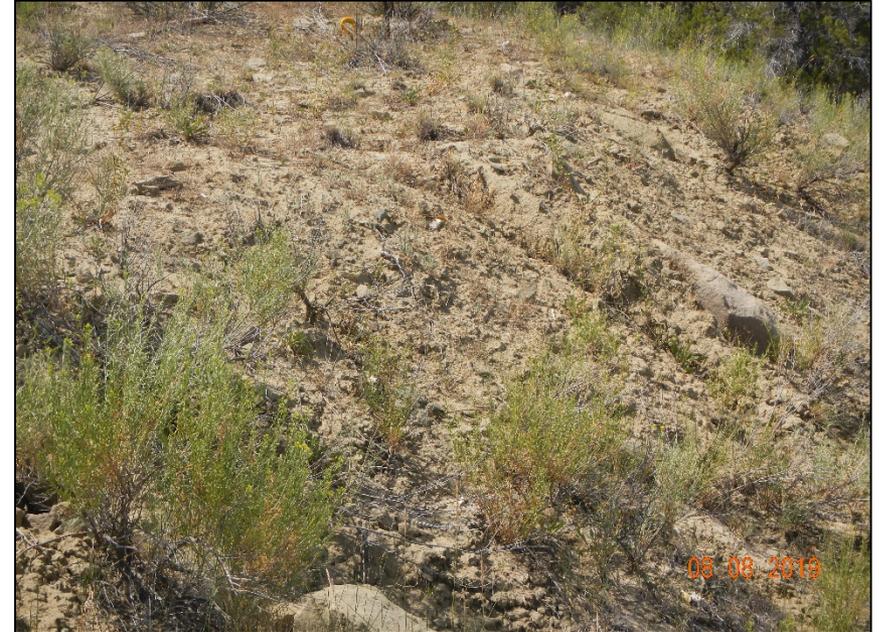
Photo #9 Photo taken on North side of location of heavy channeling and erosion. Vegetation is being choked out by sediment moving off location. No BMP's in place to slow or stop sediment movement

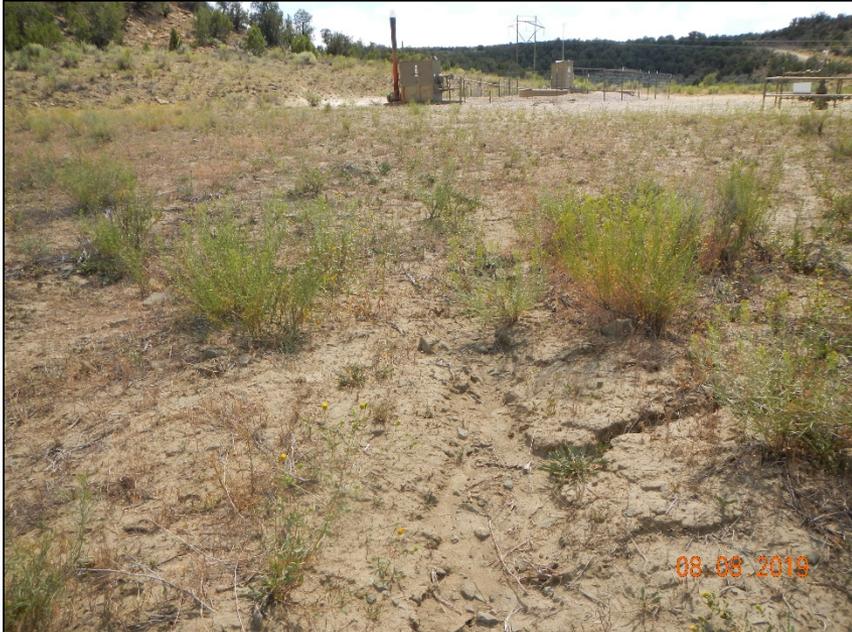
Photo #10 Erosion channel moving sediment off location on the North side of location

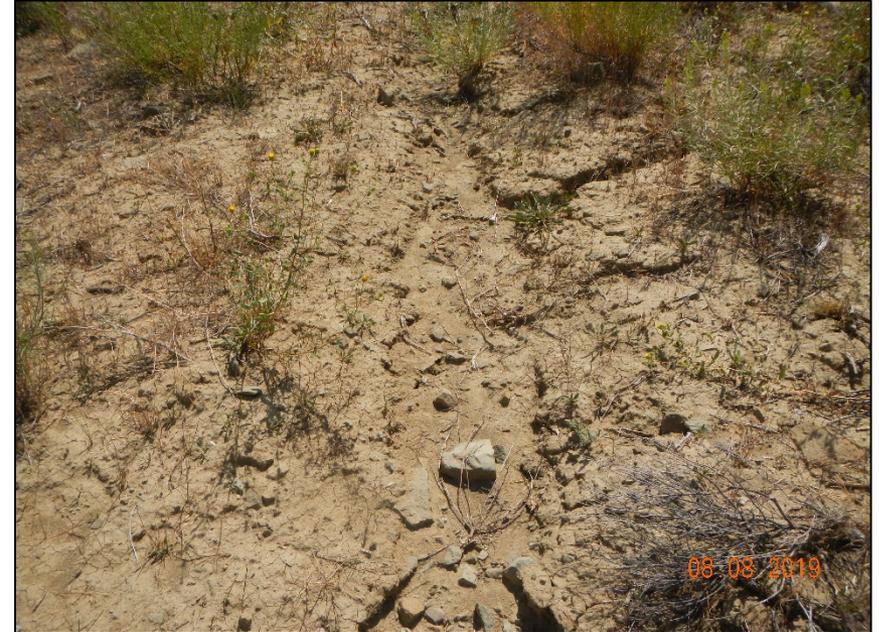
Photo #11 Erosion channel moving sediment off location on the North side of location

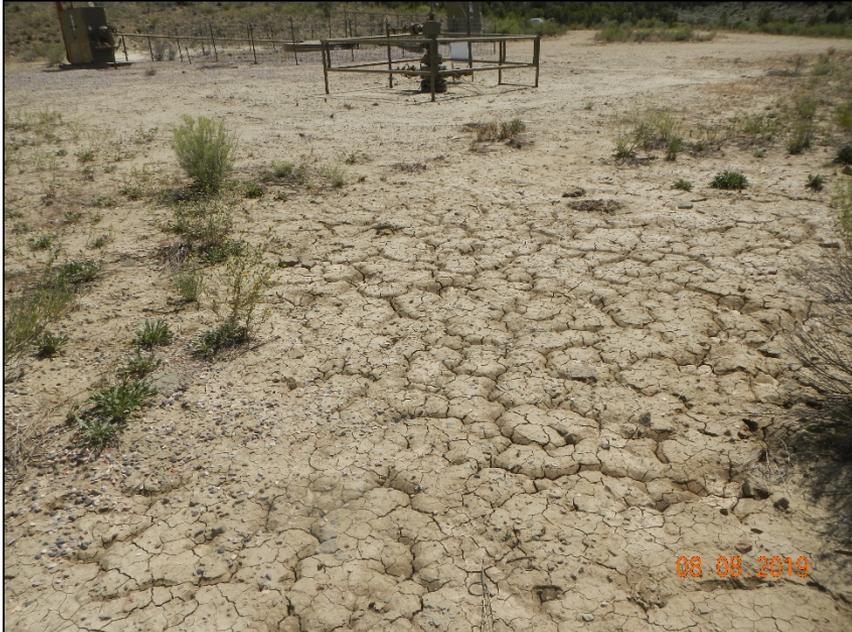
Photo #12 Erosion channel moving sediment off location by wellhead.

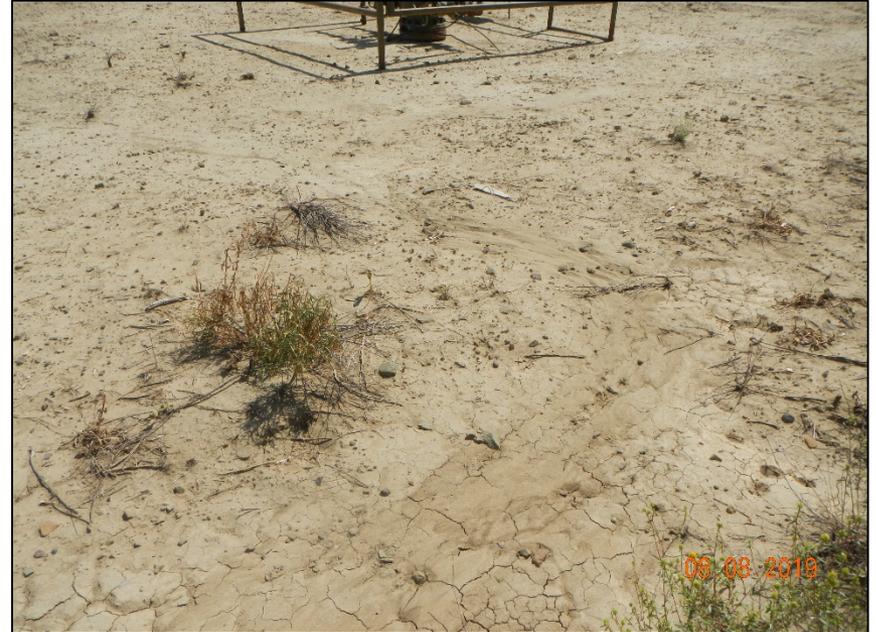
Photo #13 Erosion channel moving sediment off location by wellhead.

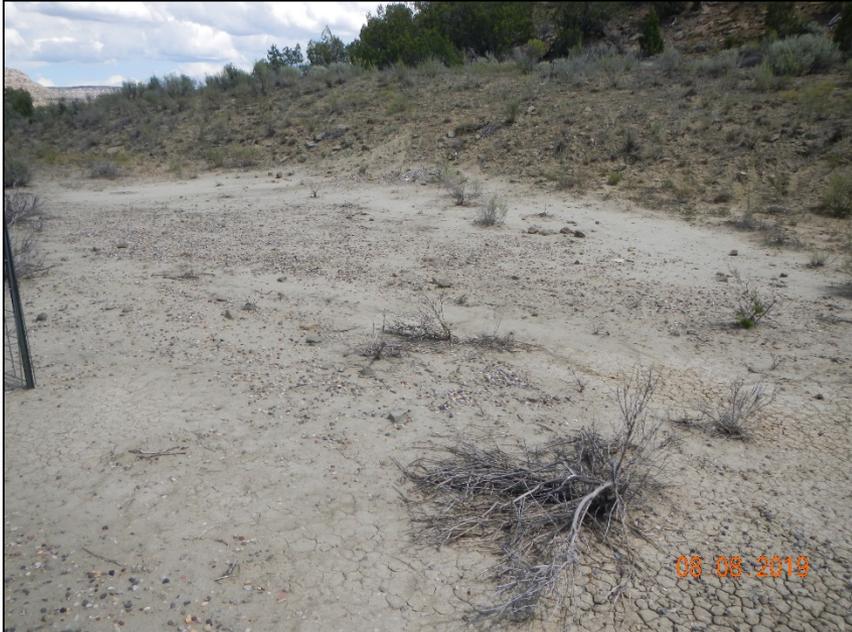
Photo #14. Erosion is evident along un-stabilized slope at the East side of location. Vegetation has been choked out by sediment.

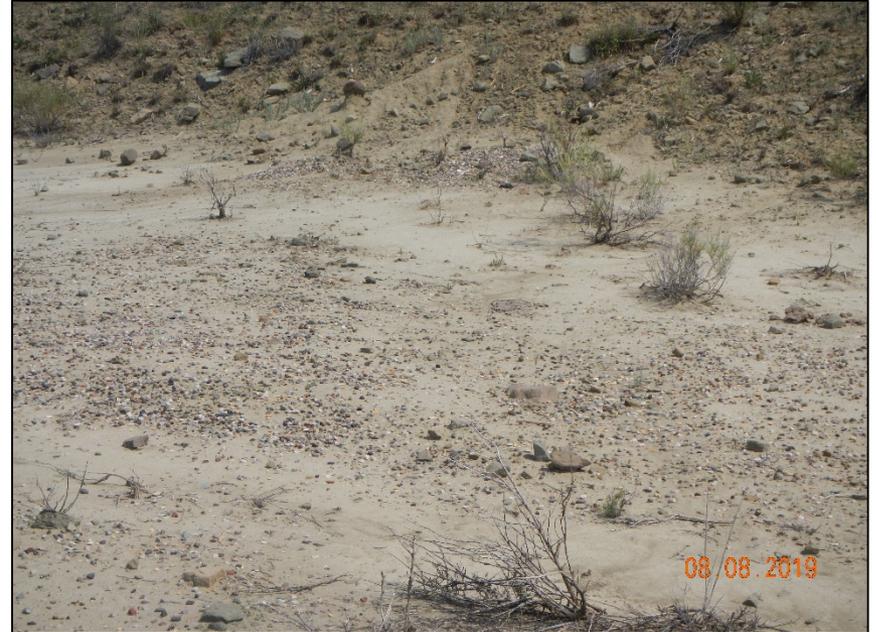
Photo #15 Erosion is evident along un-stabilized slope at the East side of location. Vegetation has been choked out by sediment.

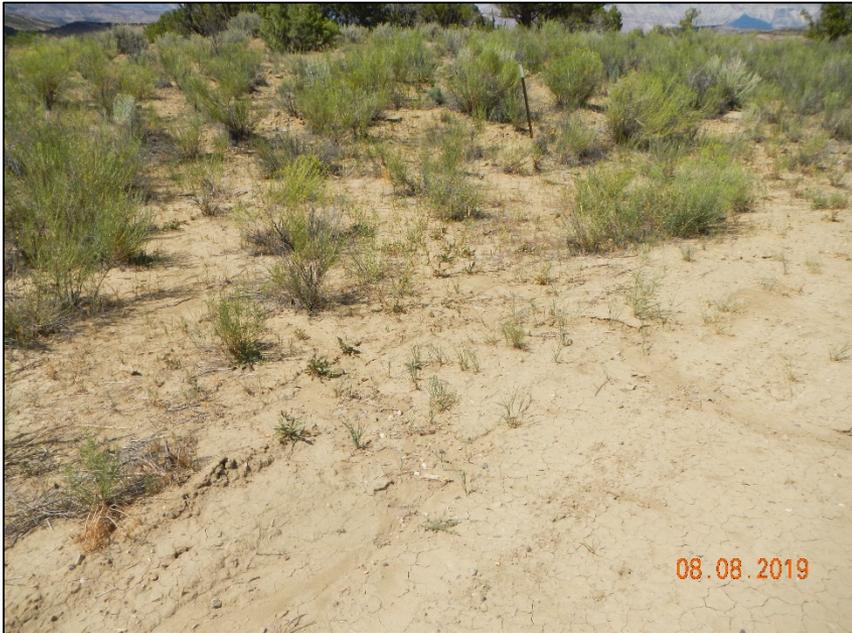
Photo #16. Erosion sediment moving off location on the North/West side of location, choking out vegetation.

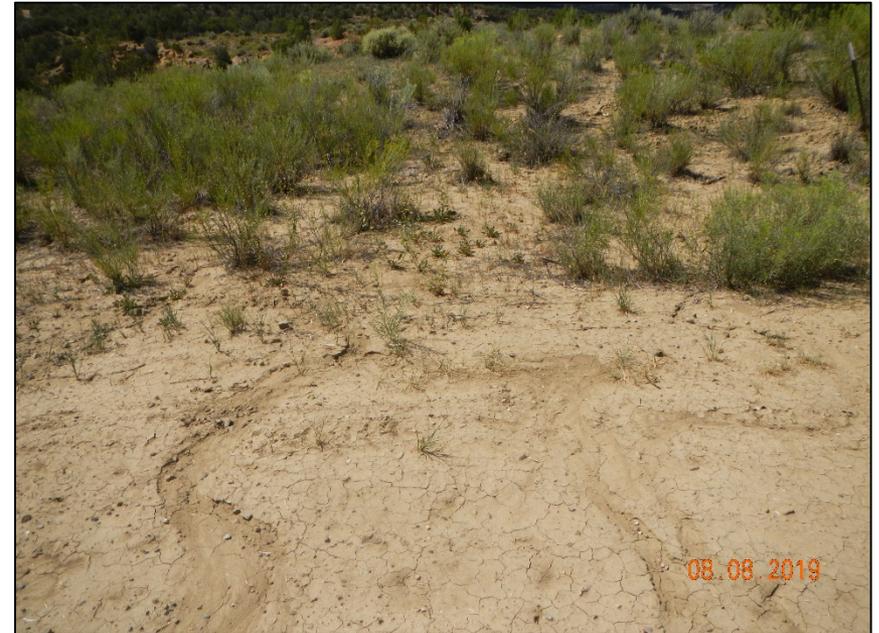
Photo #17. . Erosion sediment moving off location on the North/West side of location, choking out vegetation.

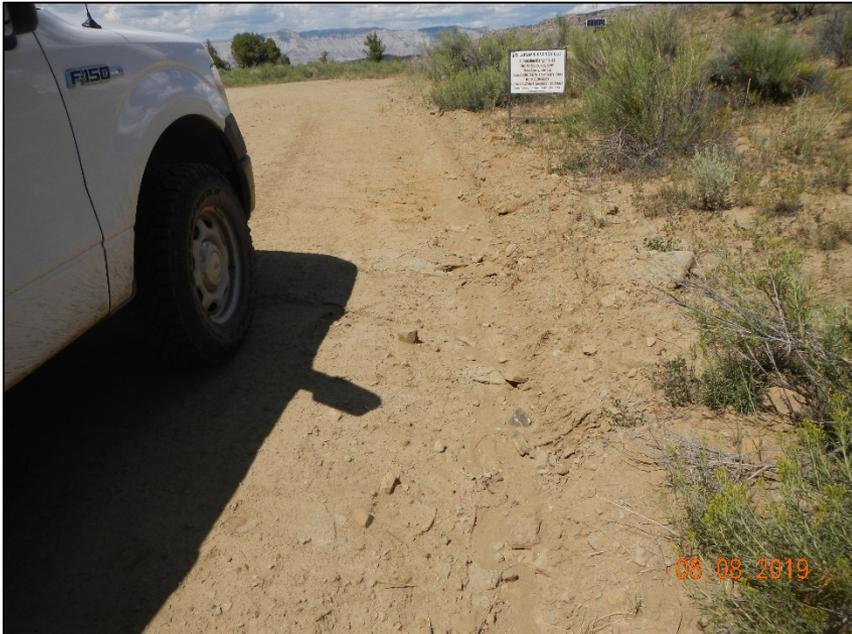
Photo #18 Erosion sediment moving off location and down access road at the entrance to location. BMP needs maintenance or is not in place.

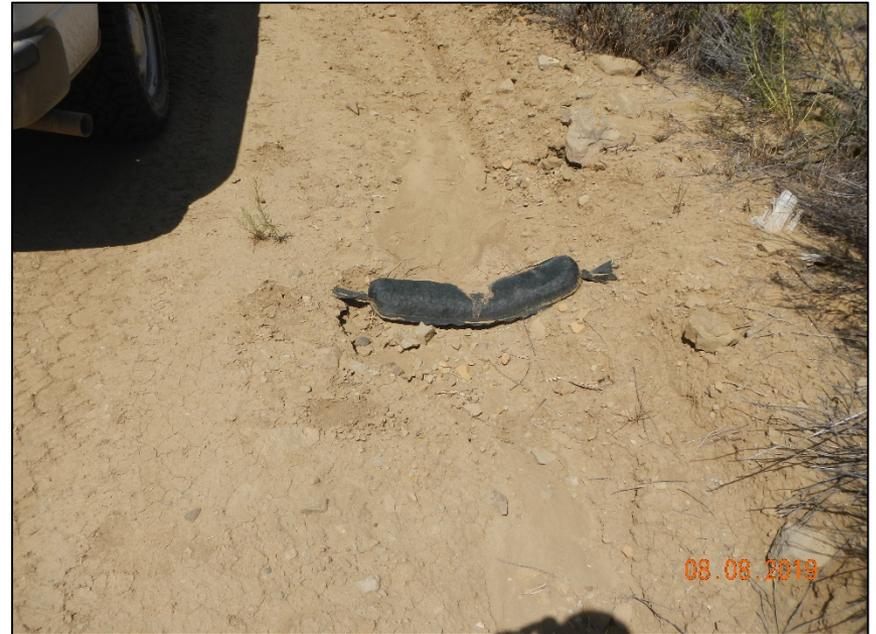
Photo #19. Erosion sediment moving off location and down access road at the entrance to location. BMP needs maintenance.
