Inspection Photos

API: 05-071-06130

Operator: TIMBER CREEK OPERATING LLC

Inspection Date: 8/8/2019

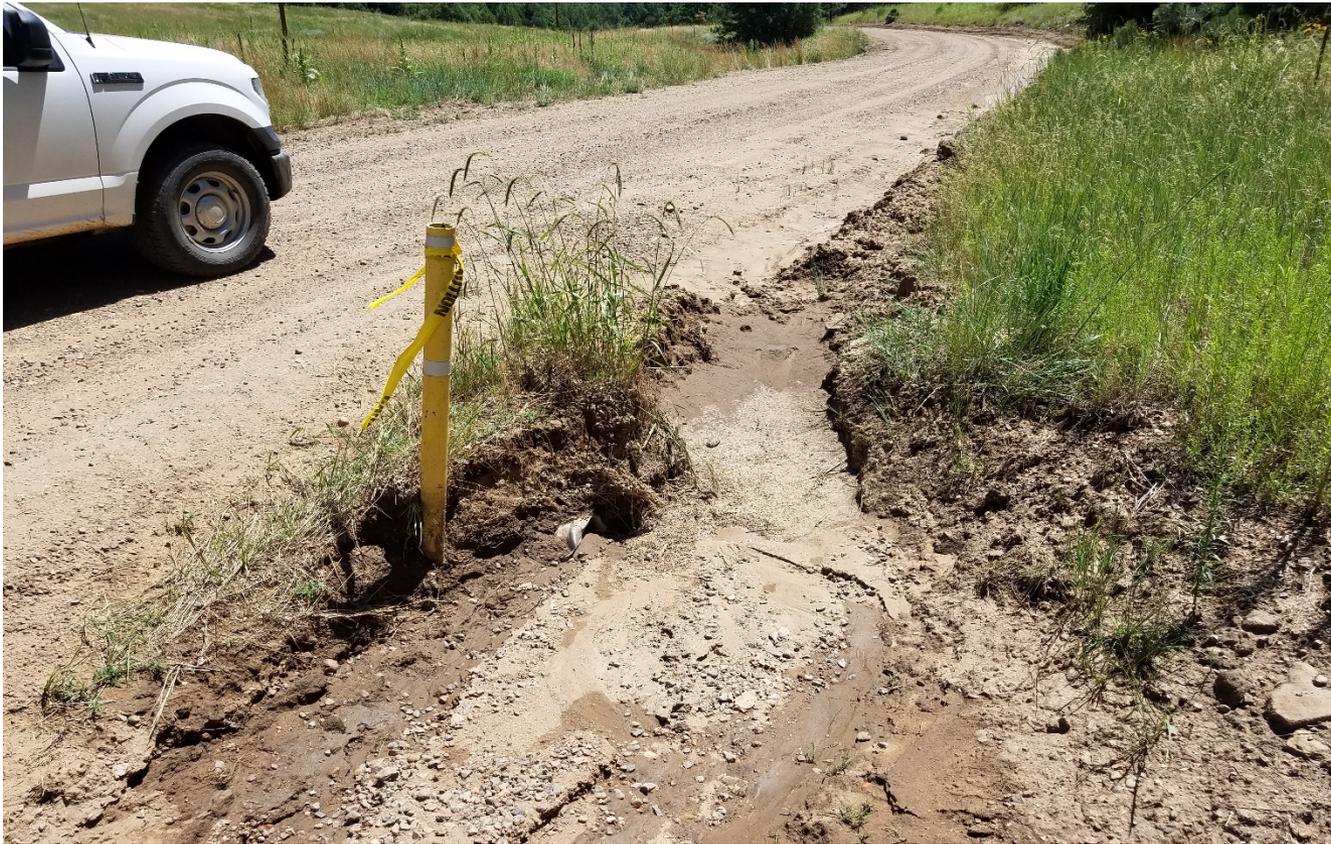
Photo 1. The culvert has filled in with sediment along the main road.

Lat/Long:37.09159/-104.93550

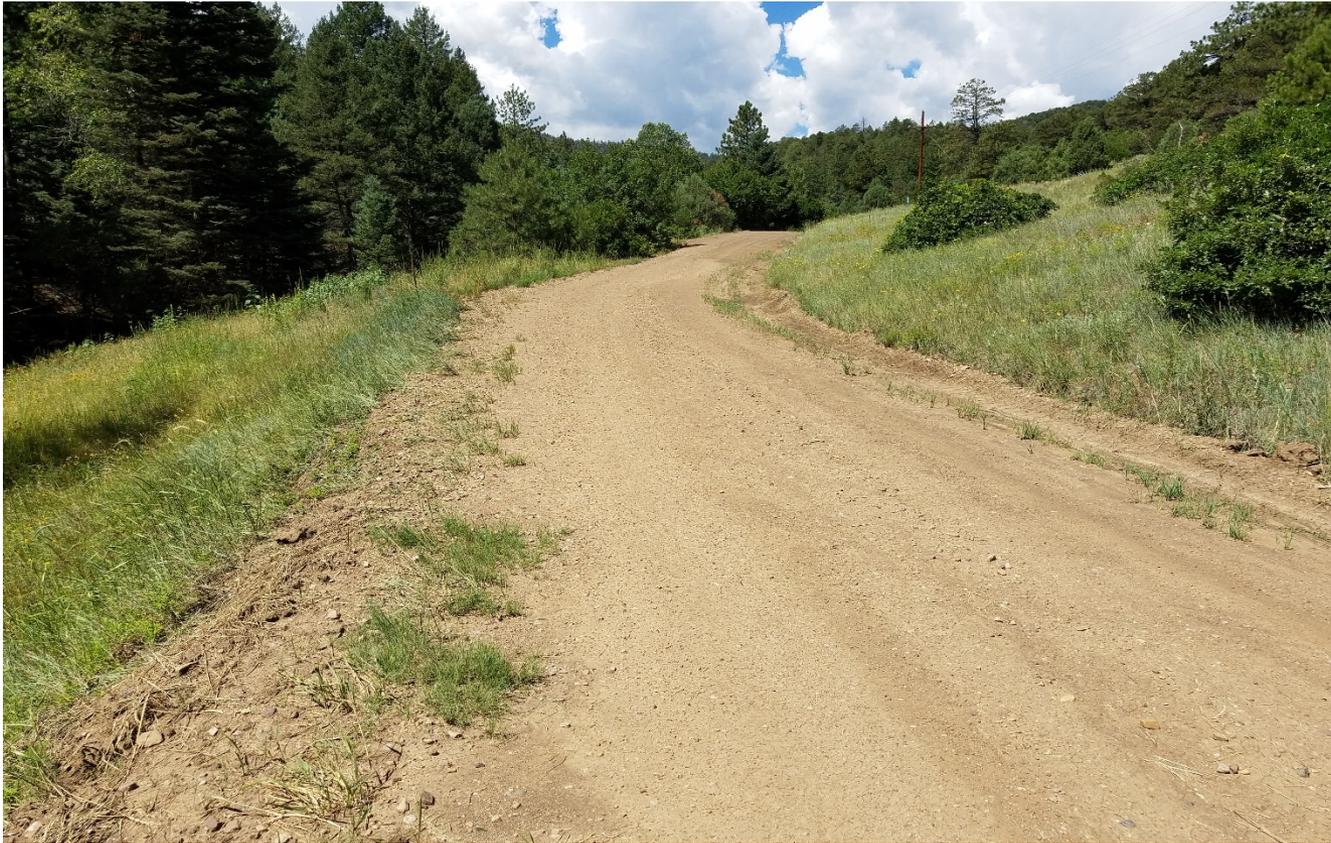
Photo 2. The main road was recently graded.

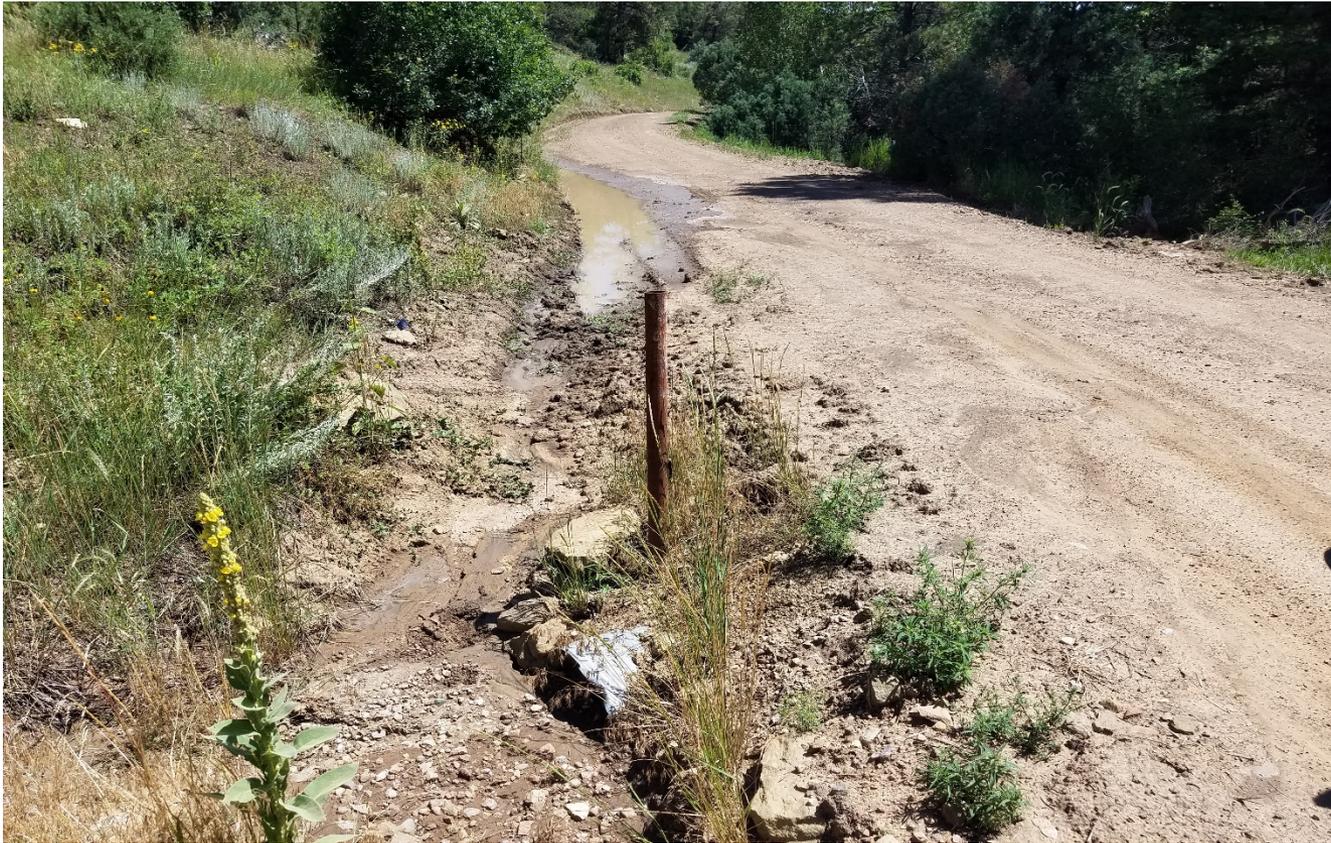
Photo 3. The culvert has filled in with sediment along the main road. Different culvert than previous photo.

Lat/Long:37.09054/-104.94746

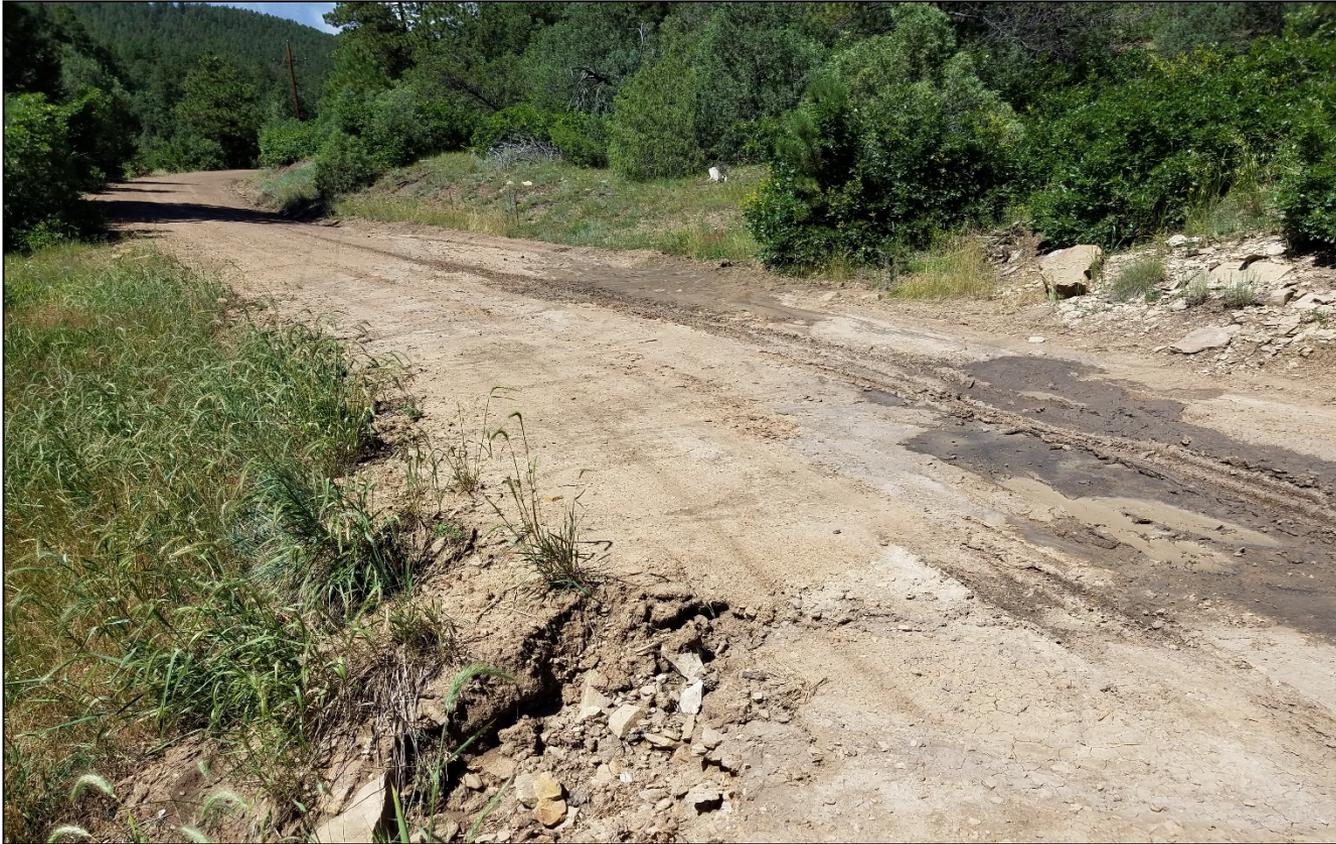
Photo 4. Stormwater is flowing across the road at this point. Culvert is filled in with sediment. Different culvert than previous photo.

Lat/Long:37.09015/-104.94924

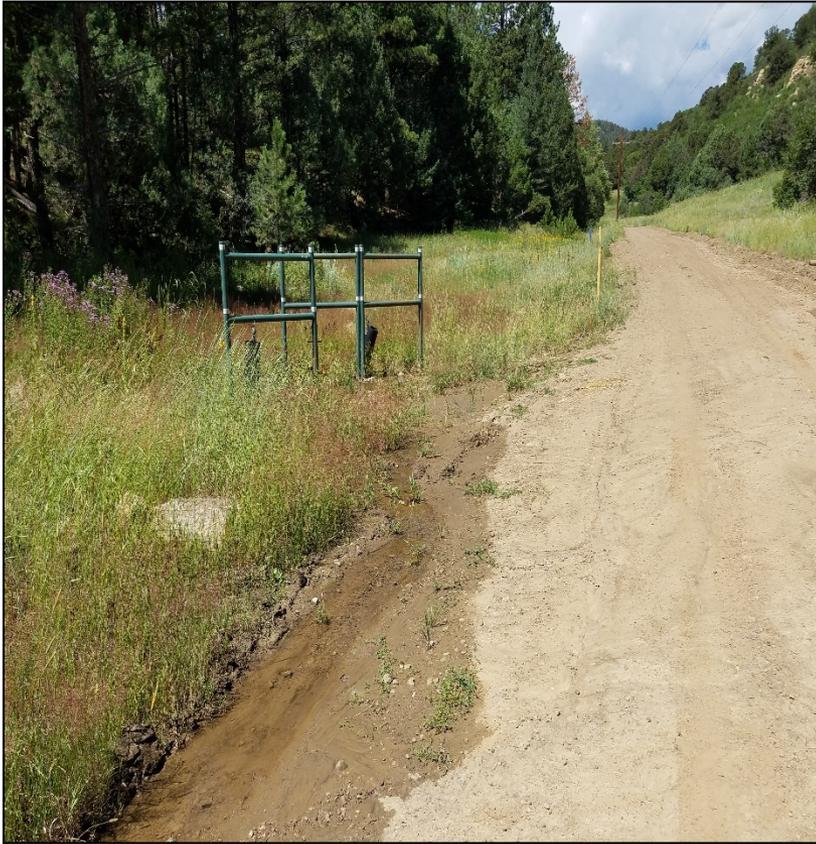
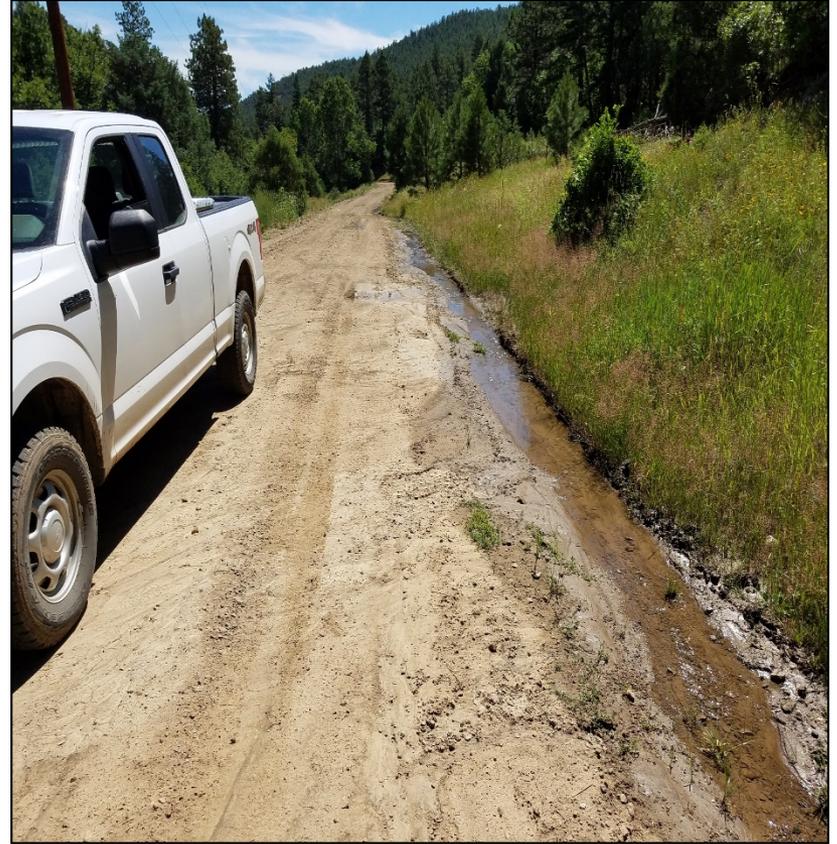
Photo 5. Water from the ephemeral creek is flowing down the side of the road. The culvert is filled in with sediment. Lat/Long: 37.089264/-104.954179

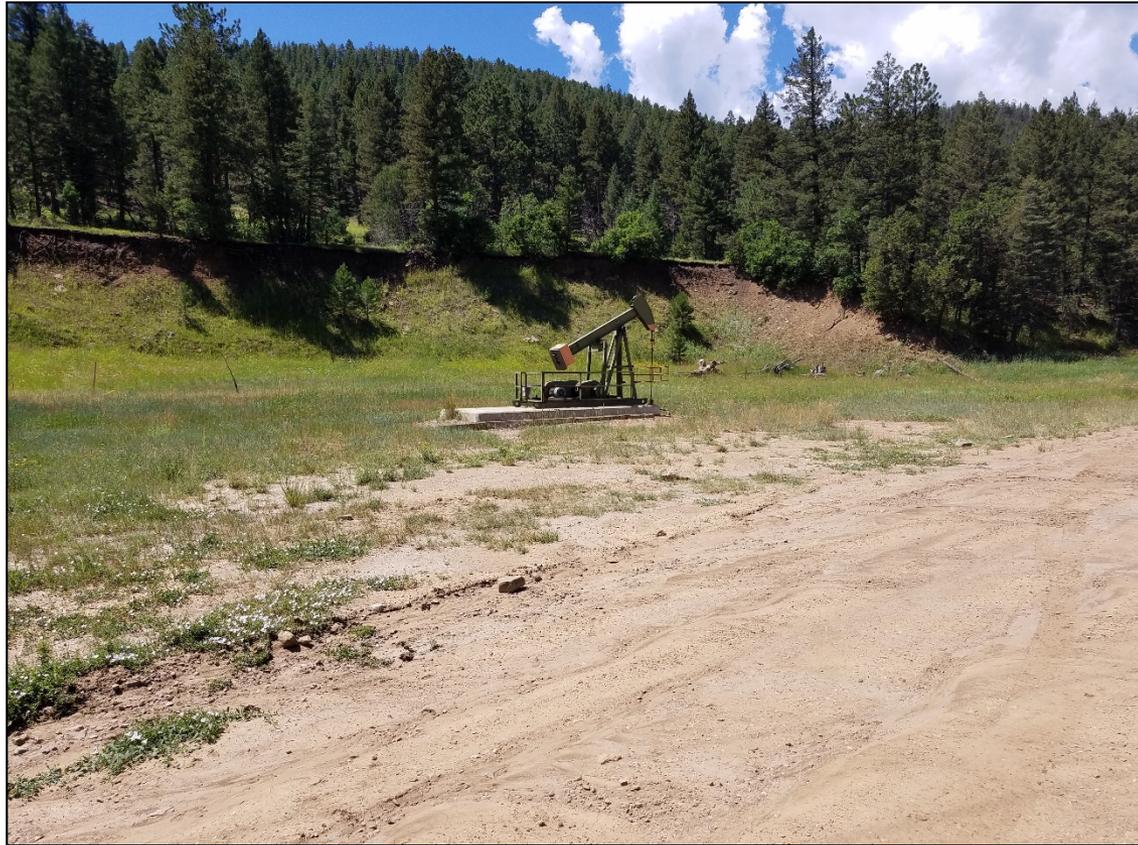
Photo 6. Facing toward the pumjack at the location.
