Construction and Stormwater Inspection

August 5, 2019

Operator: CCRP OPERATING INC- 10665

Inspection Photos
Location Name: True Ranch Fee /27 East
Location ID: 455554

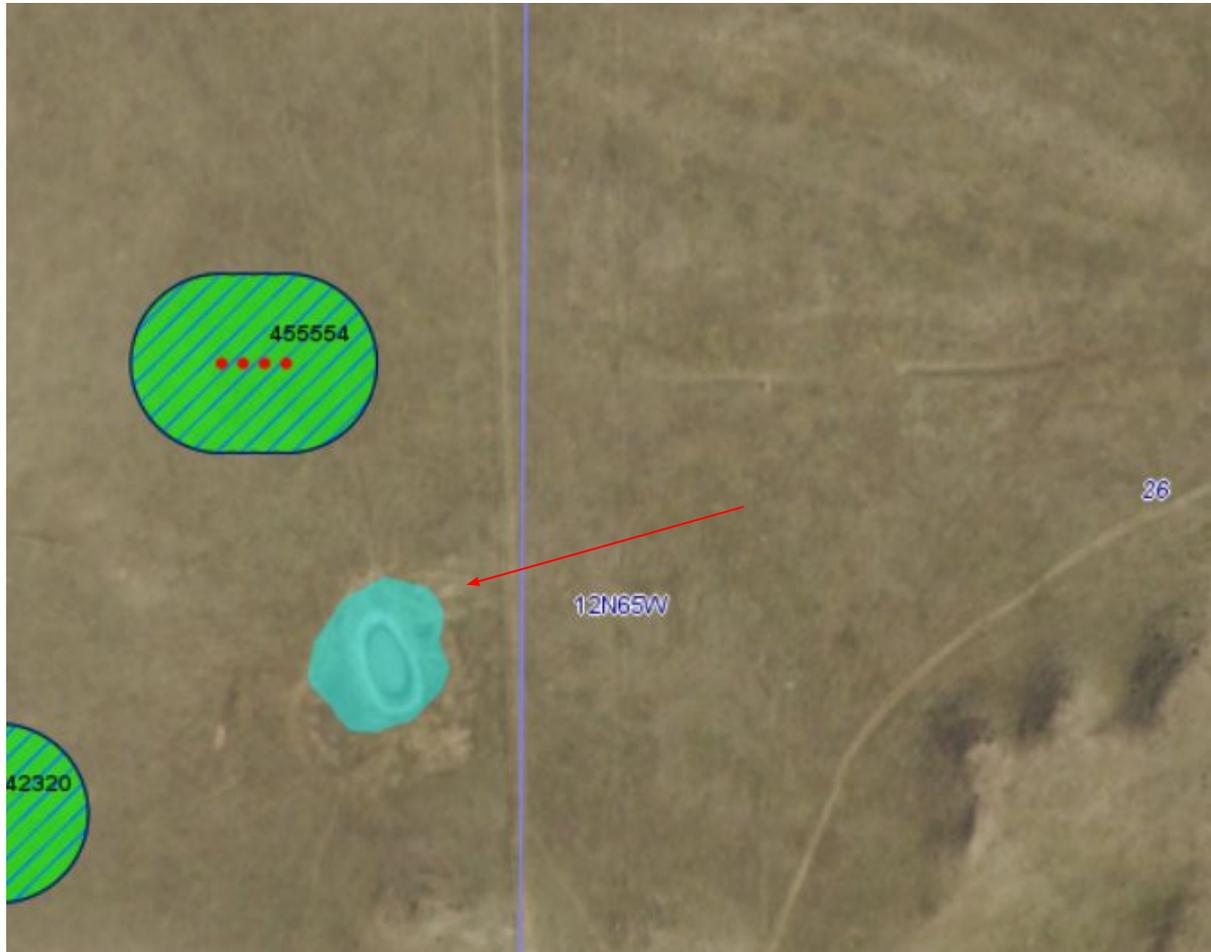
2017 aerial imagery using COGCC GISOnline illustrating the Freshwater Pond habitat classified as a PUSC wetland. Operator has constructed the location right adjacent to the Freshwater Pond.

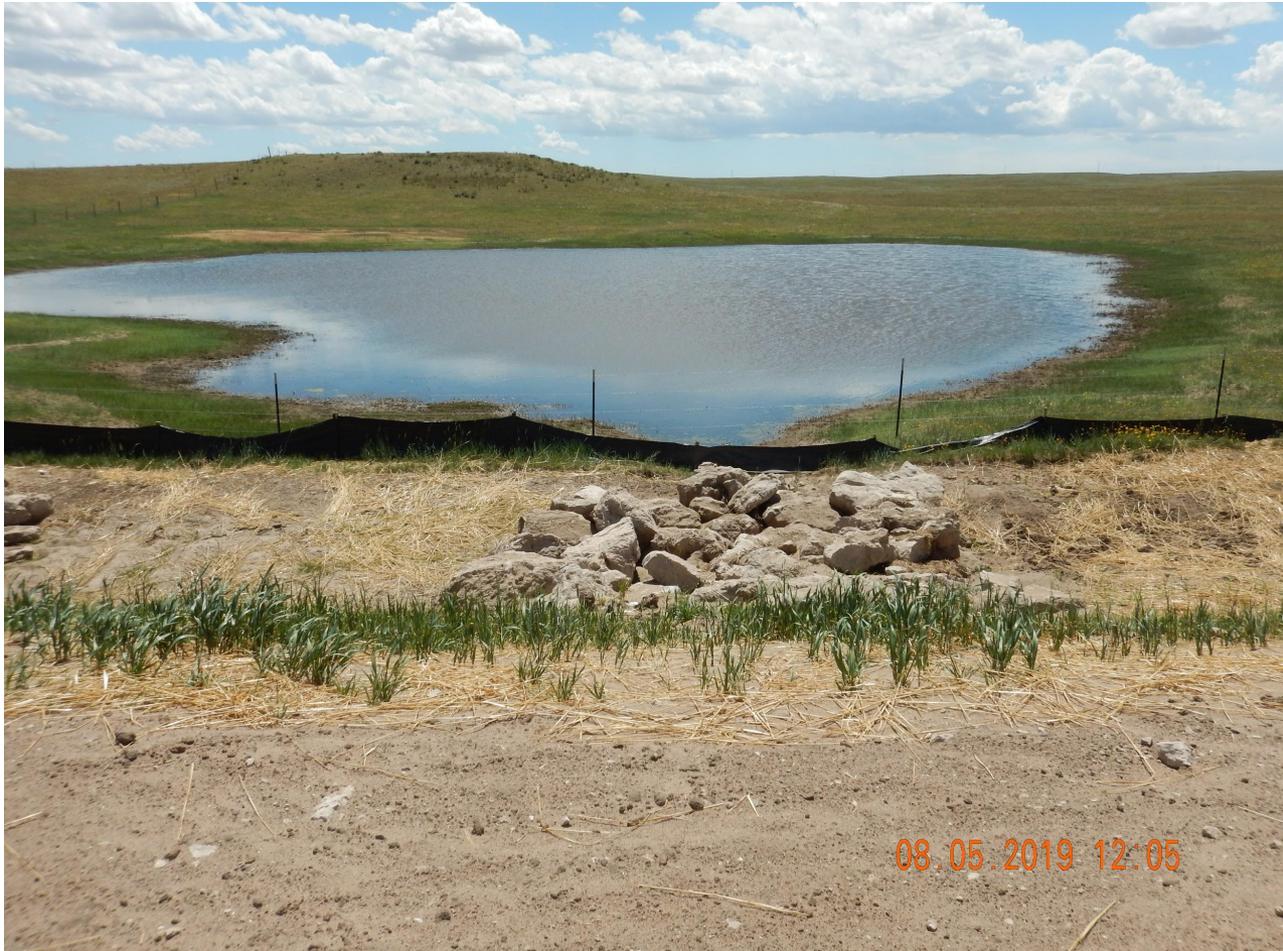
Photo 1. Photo taken from the southern location, facing South. Photo illustrates Operator has constructed the location right adjacent to the Freshwater Pond. The current stormwater BMPs are not sufficient to protect the Freshwater Pond.

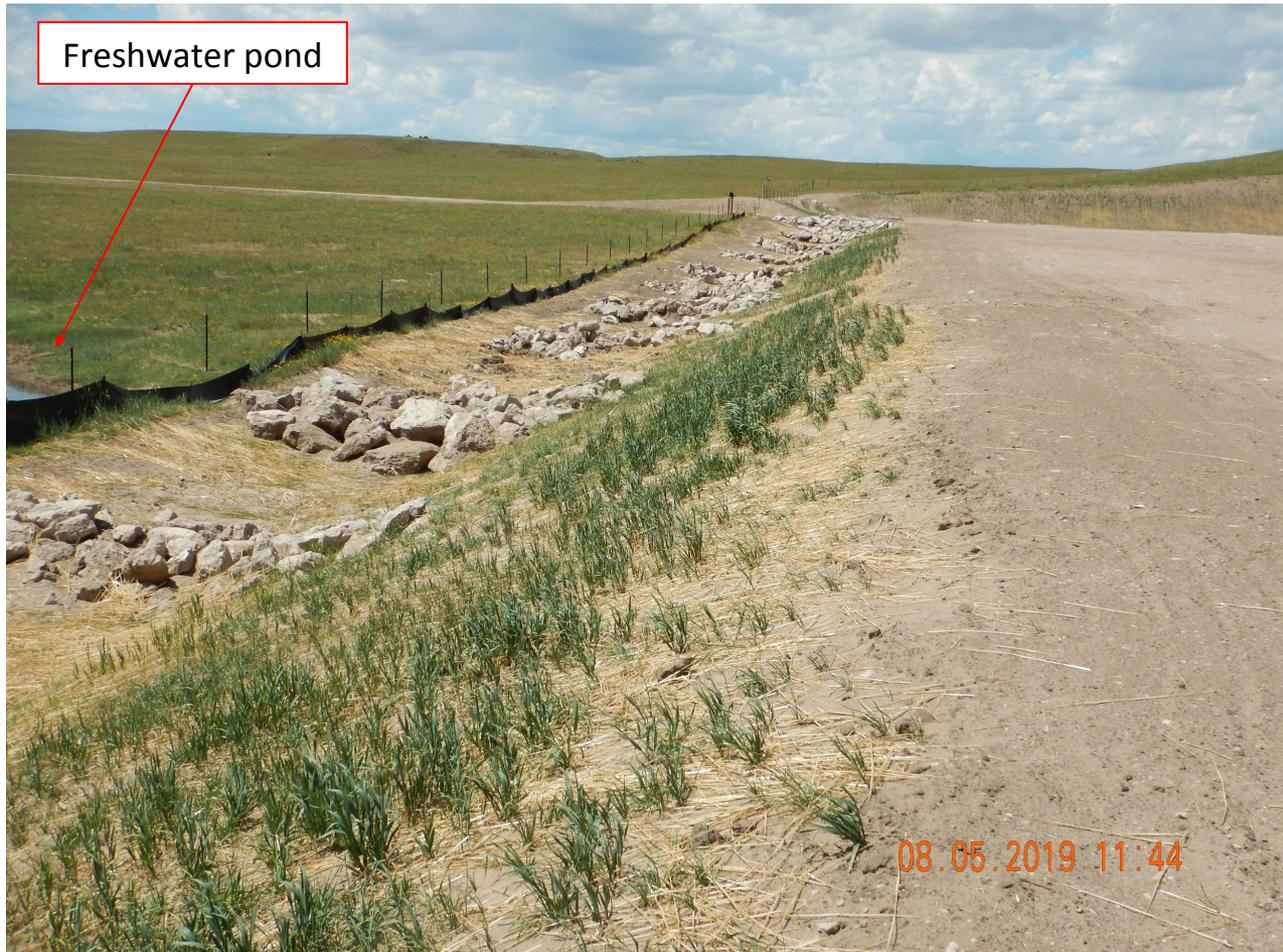
Photo 2. Photo taken from the southern location, facing West. Photo illustrates a ditch BMP installed with check dams and silt fence. Silt fence is in need of repair. The current stormwater BMPs are not sufficient to protect the Freshwater Pond. The observed vegetative growth along the fill slope consists mostly of a cover crop.

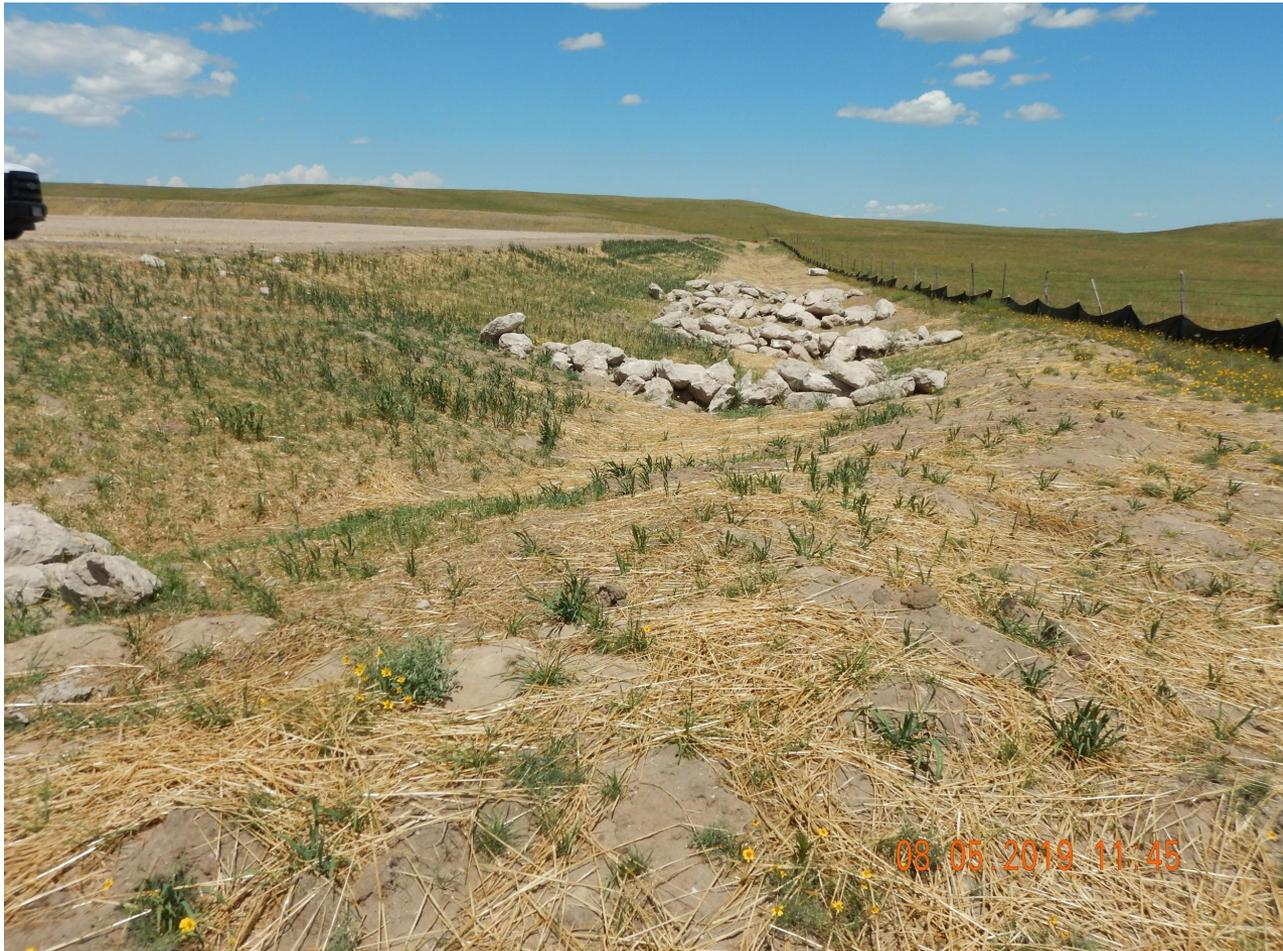
Photo 3. Photo taken from the southeastern location, facing North. Photo illustrates a ditch BMP installed with check dams and silt fence. Silt fence is in need of repair.

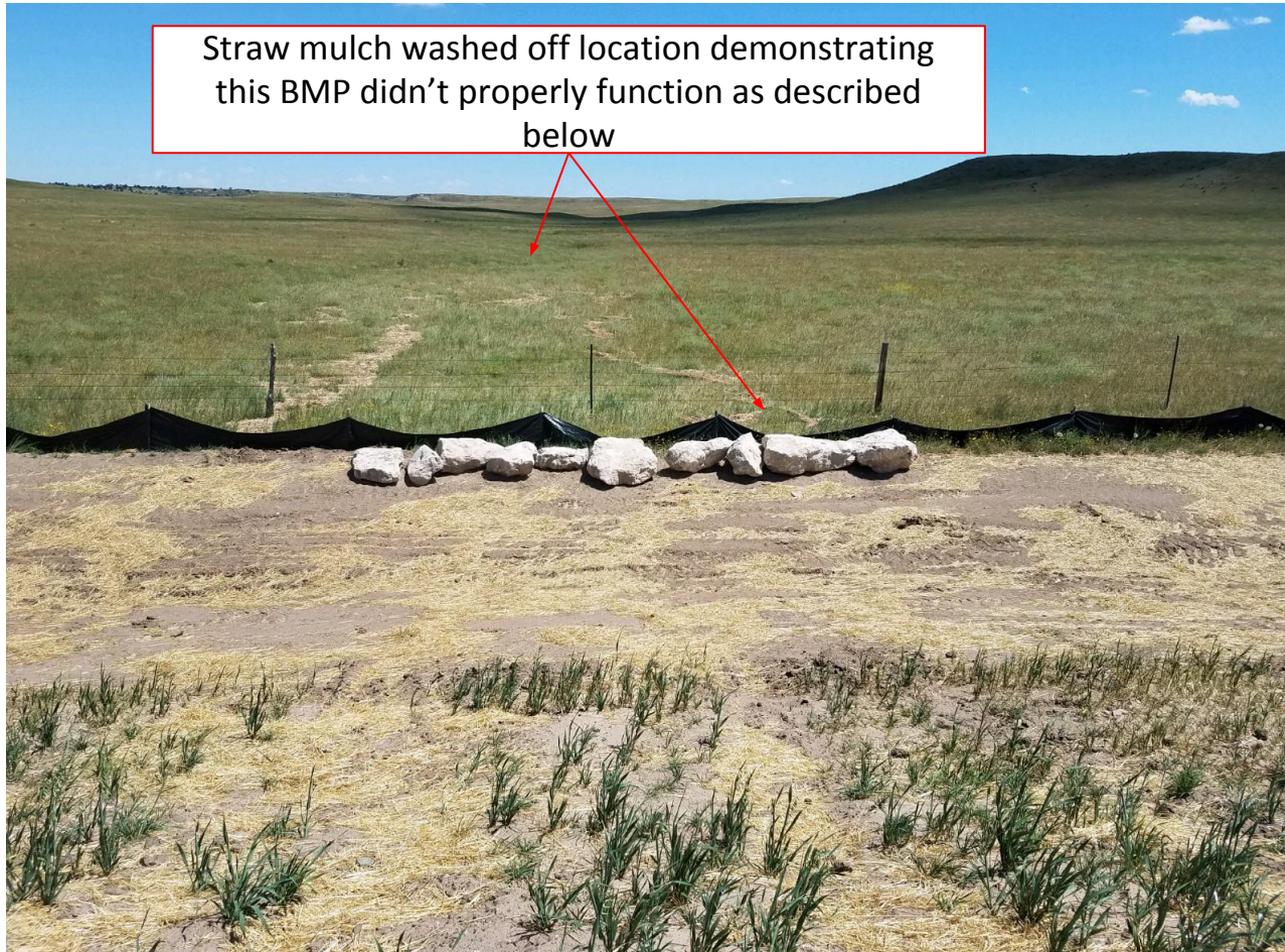
Photo 4. Photo taken from the eastern location, facing East. Photo illustrates the current stormwater BMPs did not have proper retention time to properly function. Also, this would not be considered proper engineering practices for a sediment trap, as a line of rock is not a properly installed outlet.

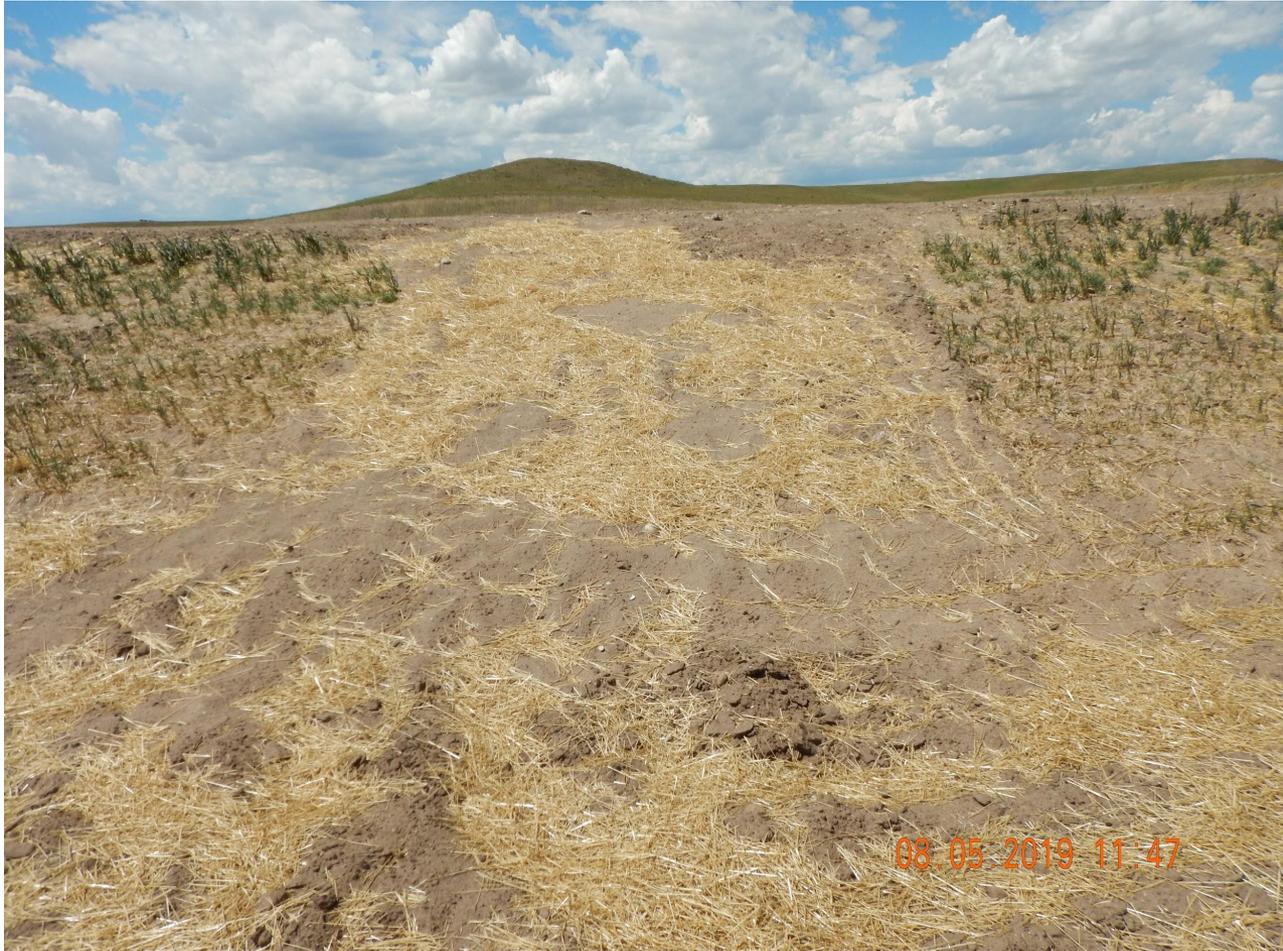
Photo 6. Photo taken from the eastern fill slope of location, facing West. Photo illustrates Operator has repaired erosion due to a recent storm.

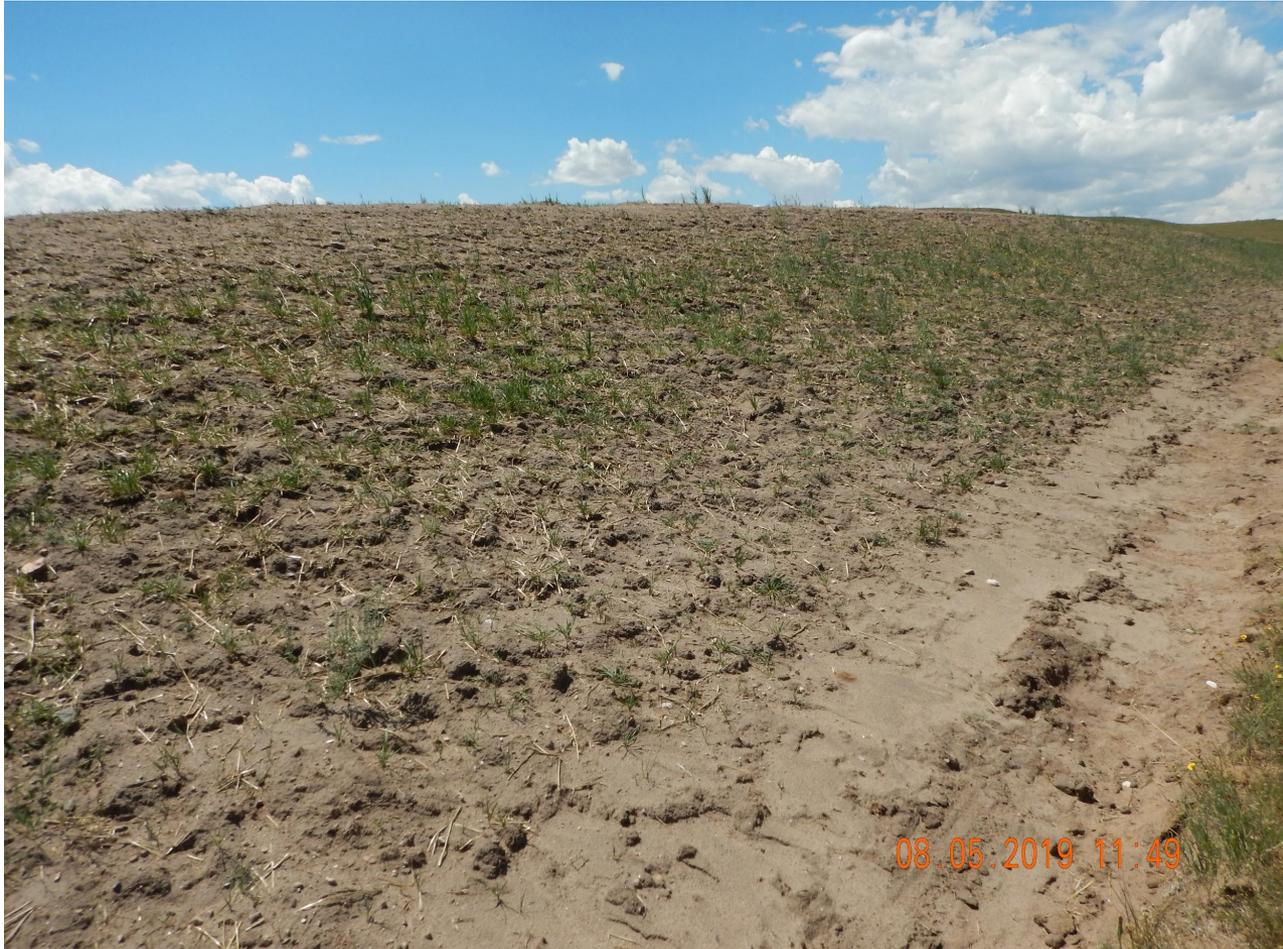
Photo 7. Photo taken from the topsoil stockpile along the northern location, facing North. Photo illustrates Operator has seeded the stockpile which is currently in-process.

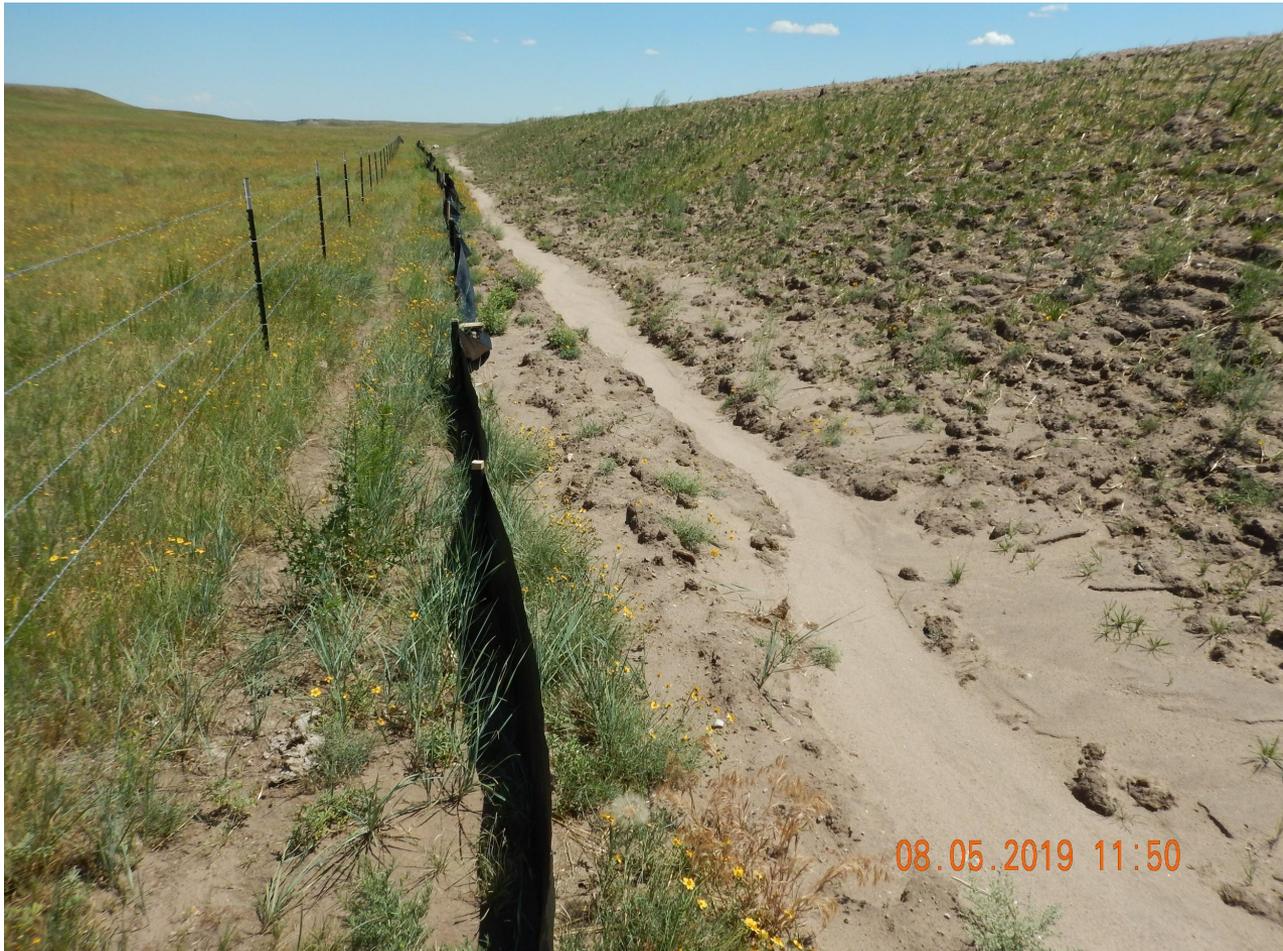
Photo 8. Photo taken from the topsoil stockpile along the northern location, facing East. Photo illustrates stormwater repairs are needed as the ditch BMP is fill in from sediment accumulation from topsoil stockpile erosion.

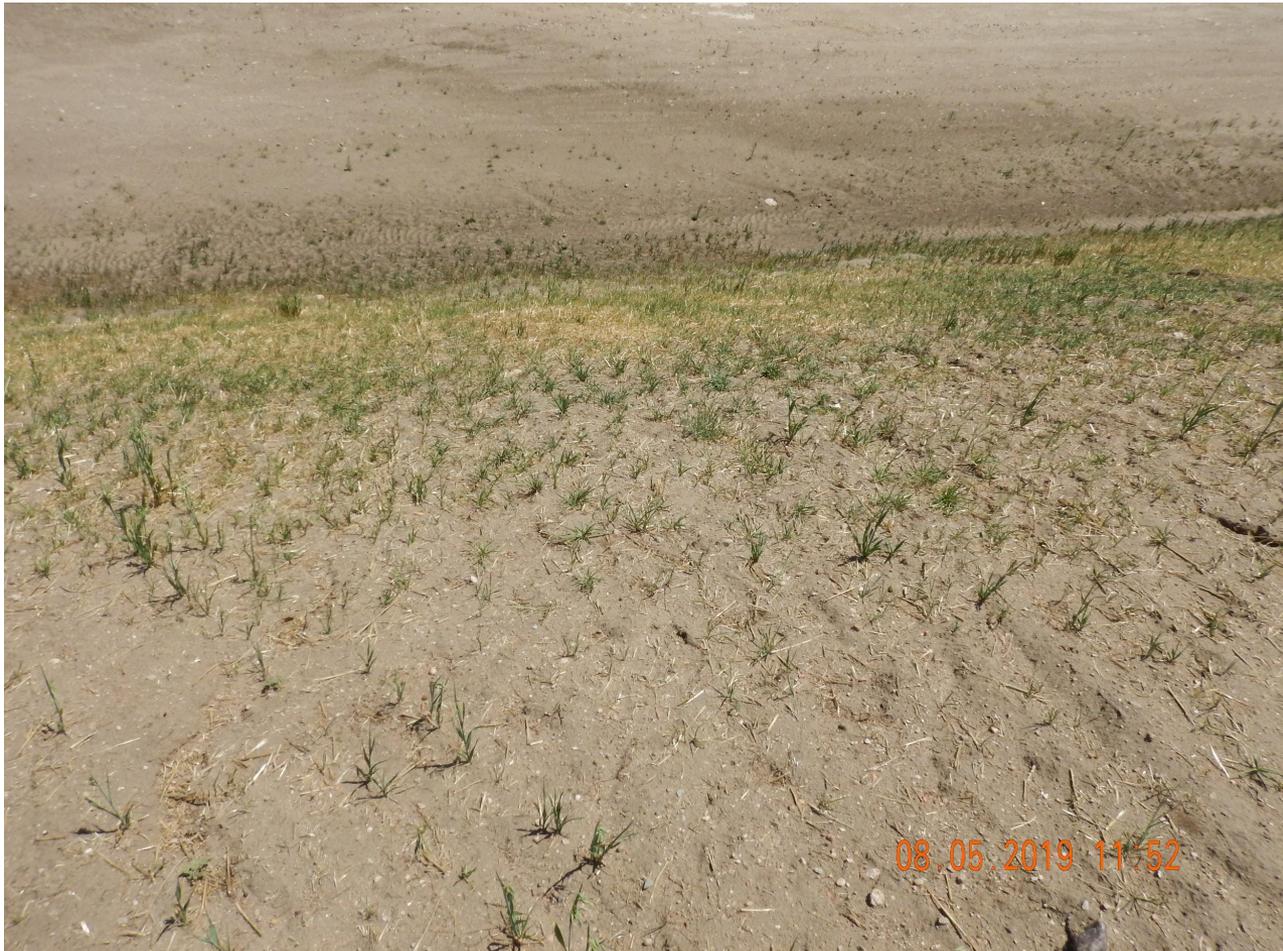
Photo 9. Photo taken from the western location, facing East. Photo illustrates the cut slope has been seeded for long-term stabilization.
