Inspection Photos
Operator: Catamount Energy
Location/API #: 067-09909
Date: 7-29-2019

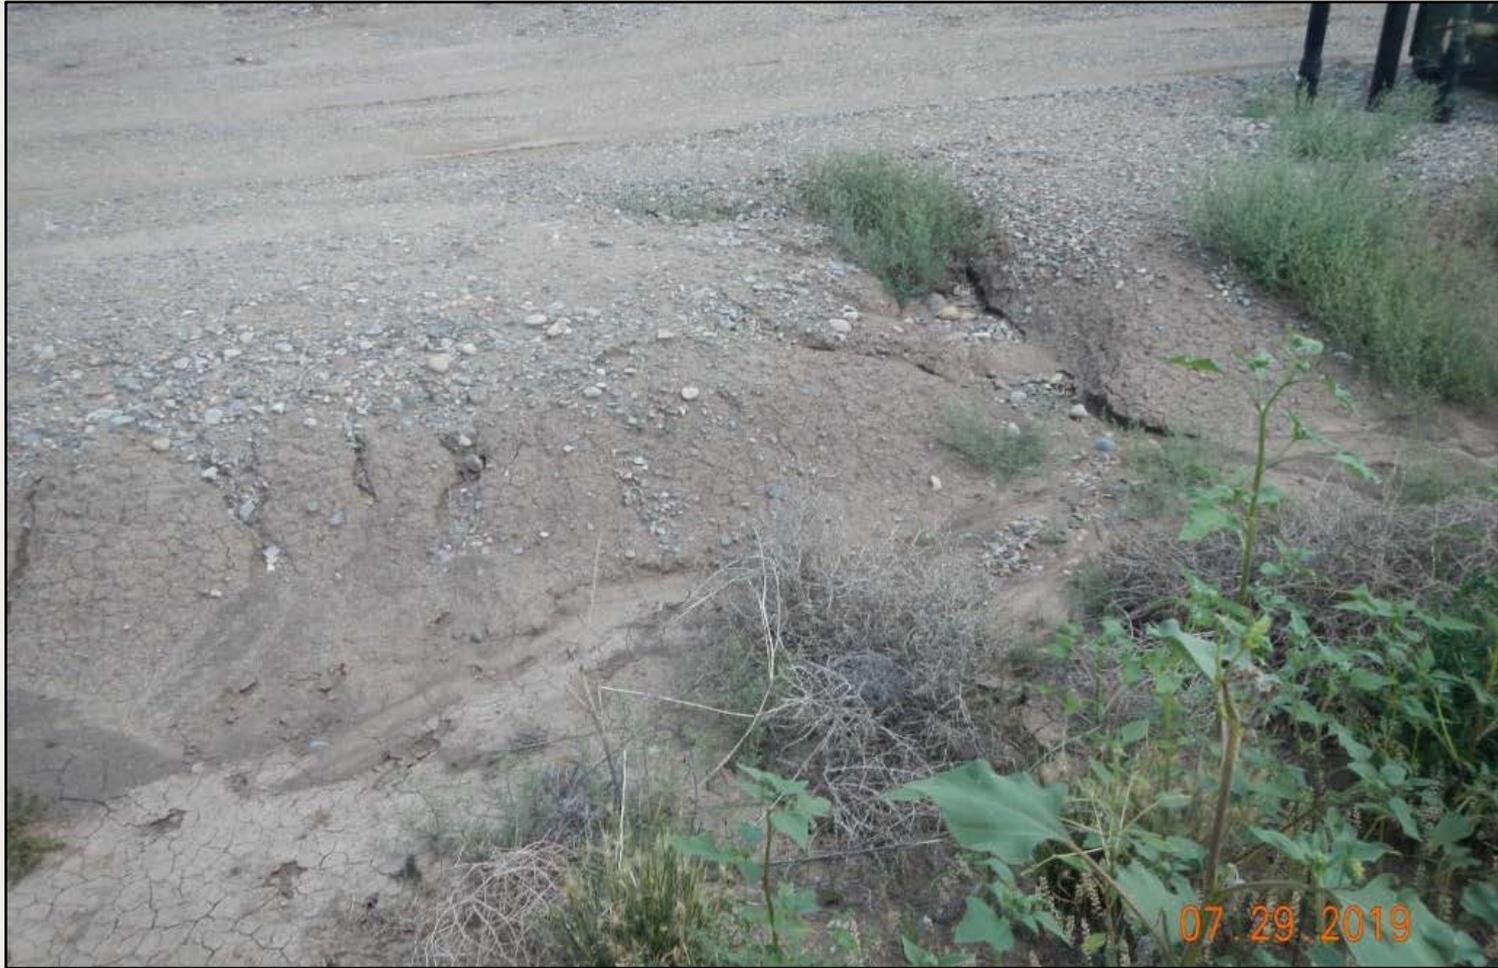
Photo 1. View of erosional channeling and sedimentation along the southern edge of the well pad.

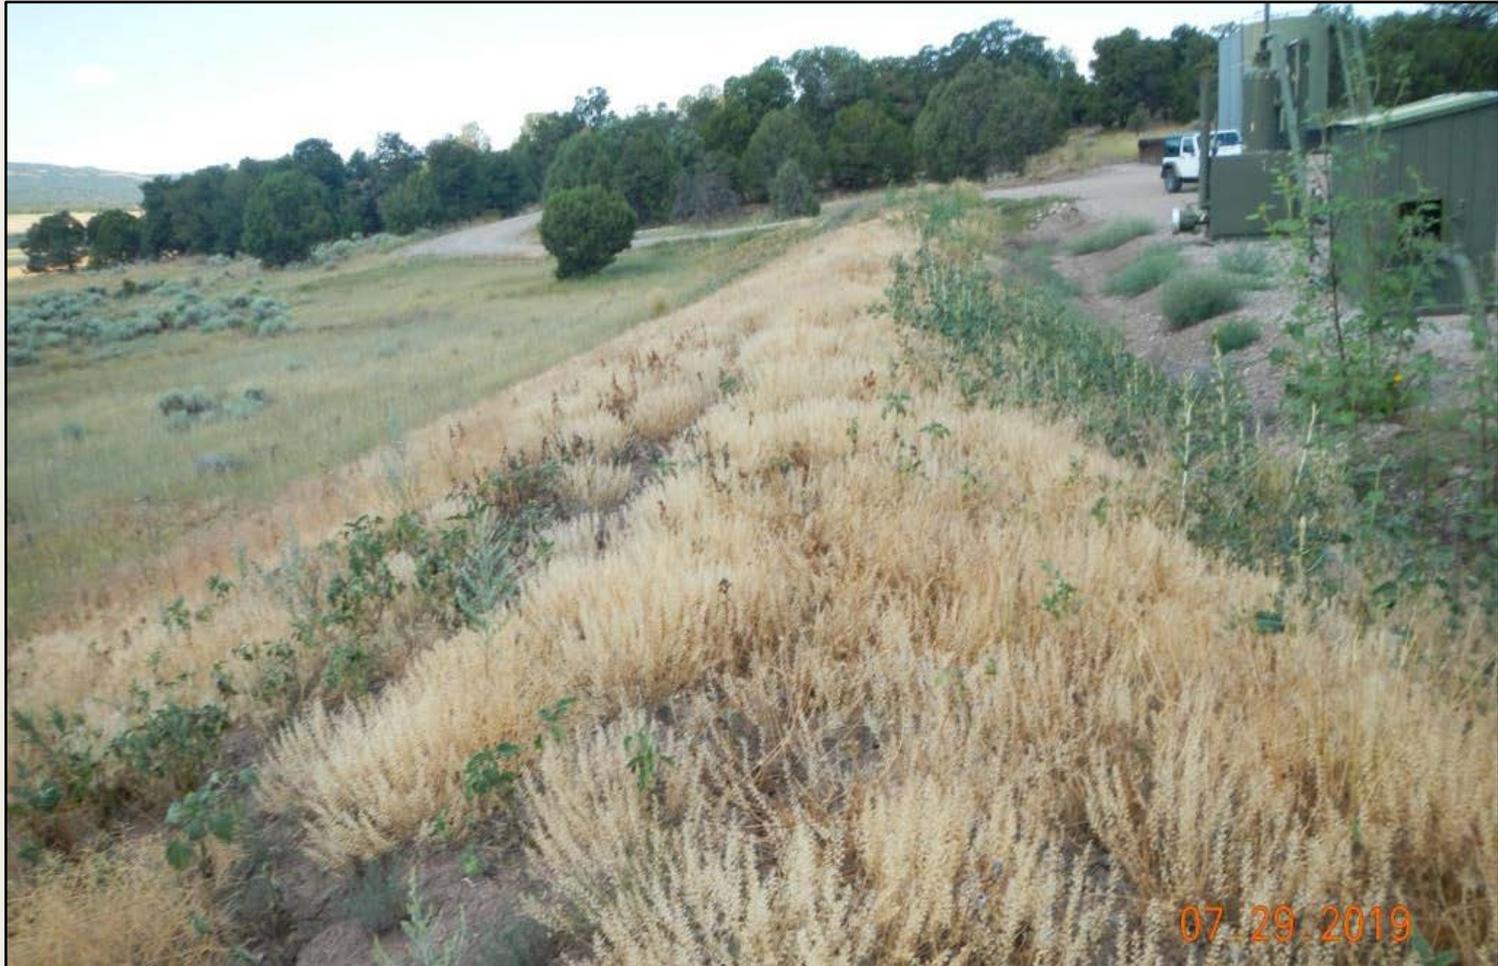
Photo 2. View of the southern project area from the southeastern edge facing westward. Vegetation is largely comprised of annual weeds such as cheatgrass (*Bromus tectorum*), *Alyssum simplex*, field bindweed (*Convolvulus arvensis*).

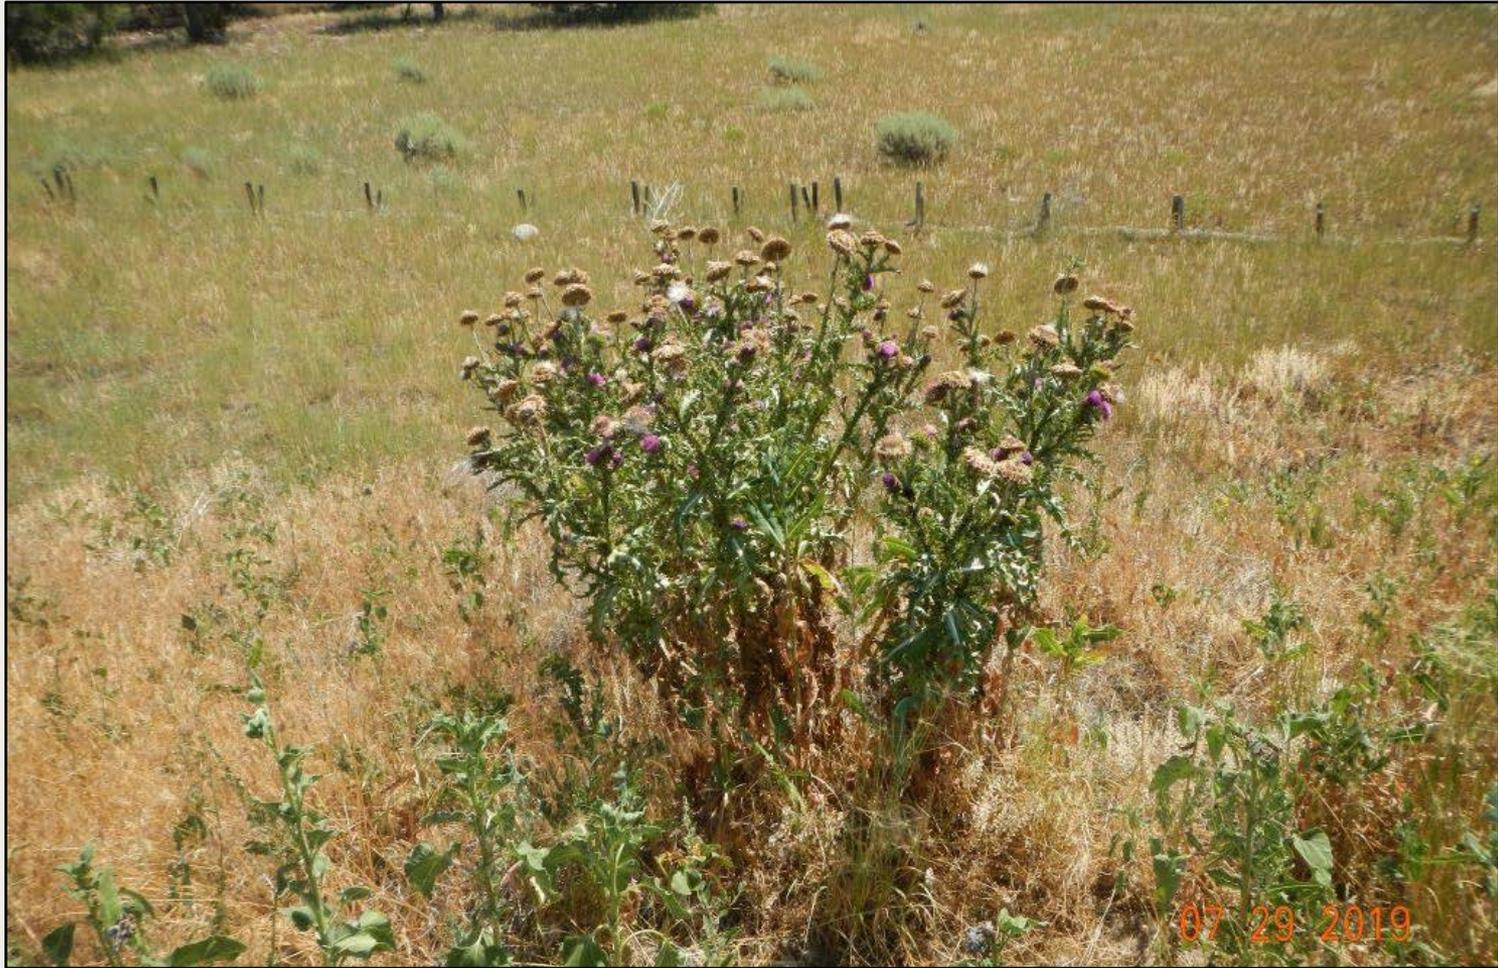
Photo 3. View of flowering musk thistle (*Carduus nutans*) within the eastern project area.

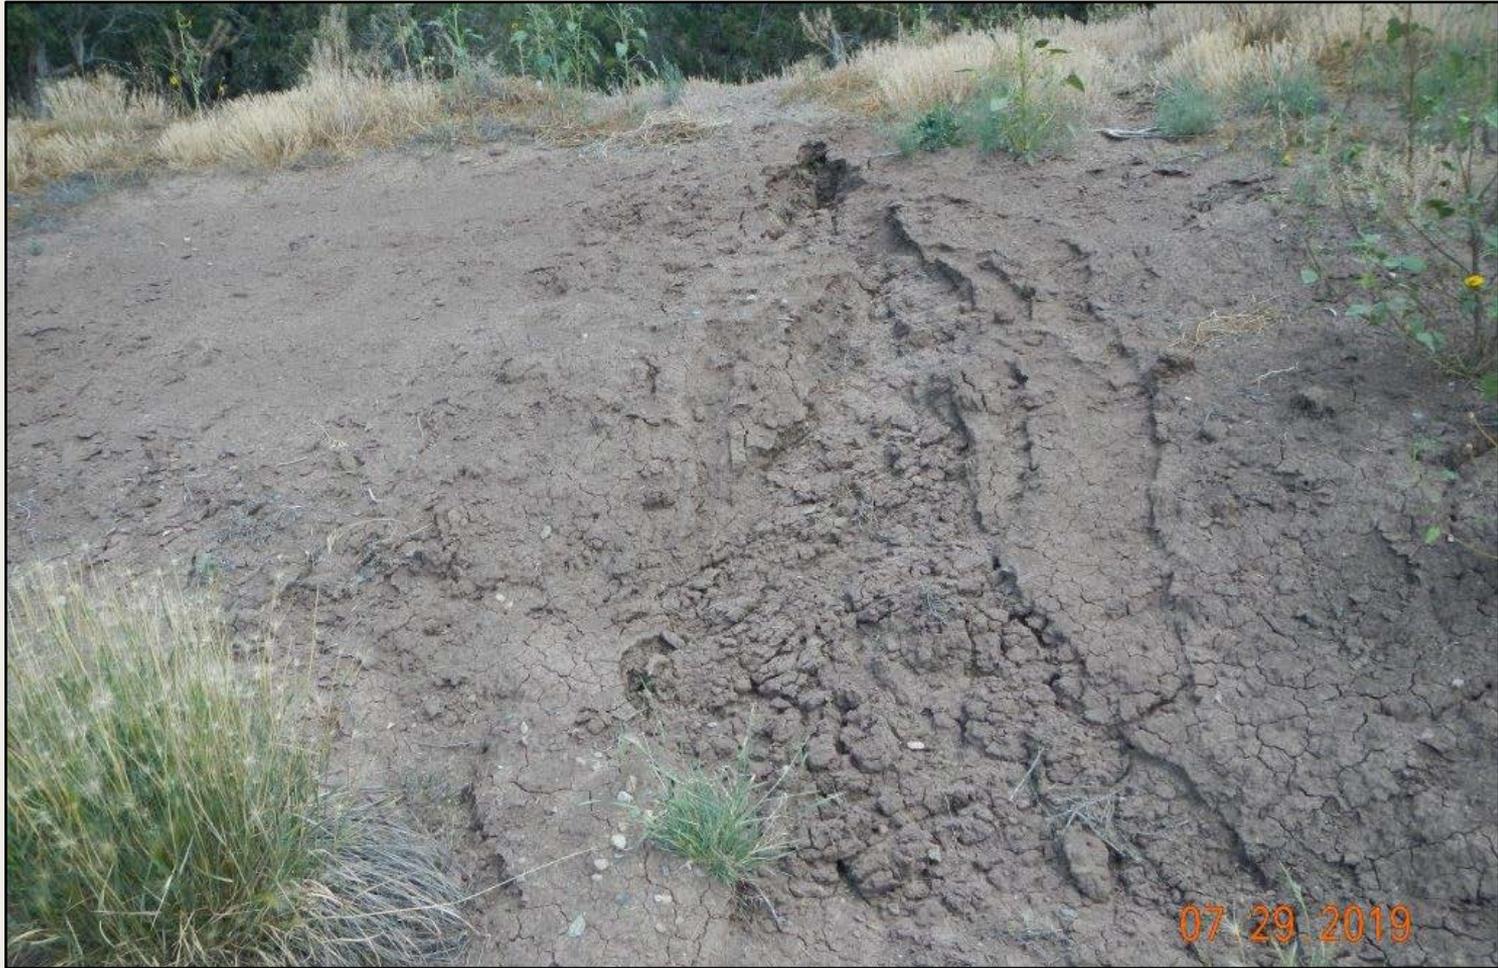
Photo 4. View of erosional channel within the northern cut-slope.

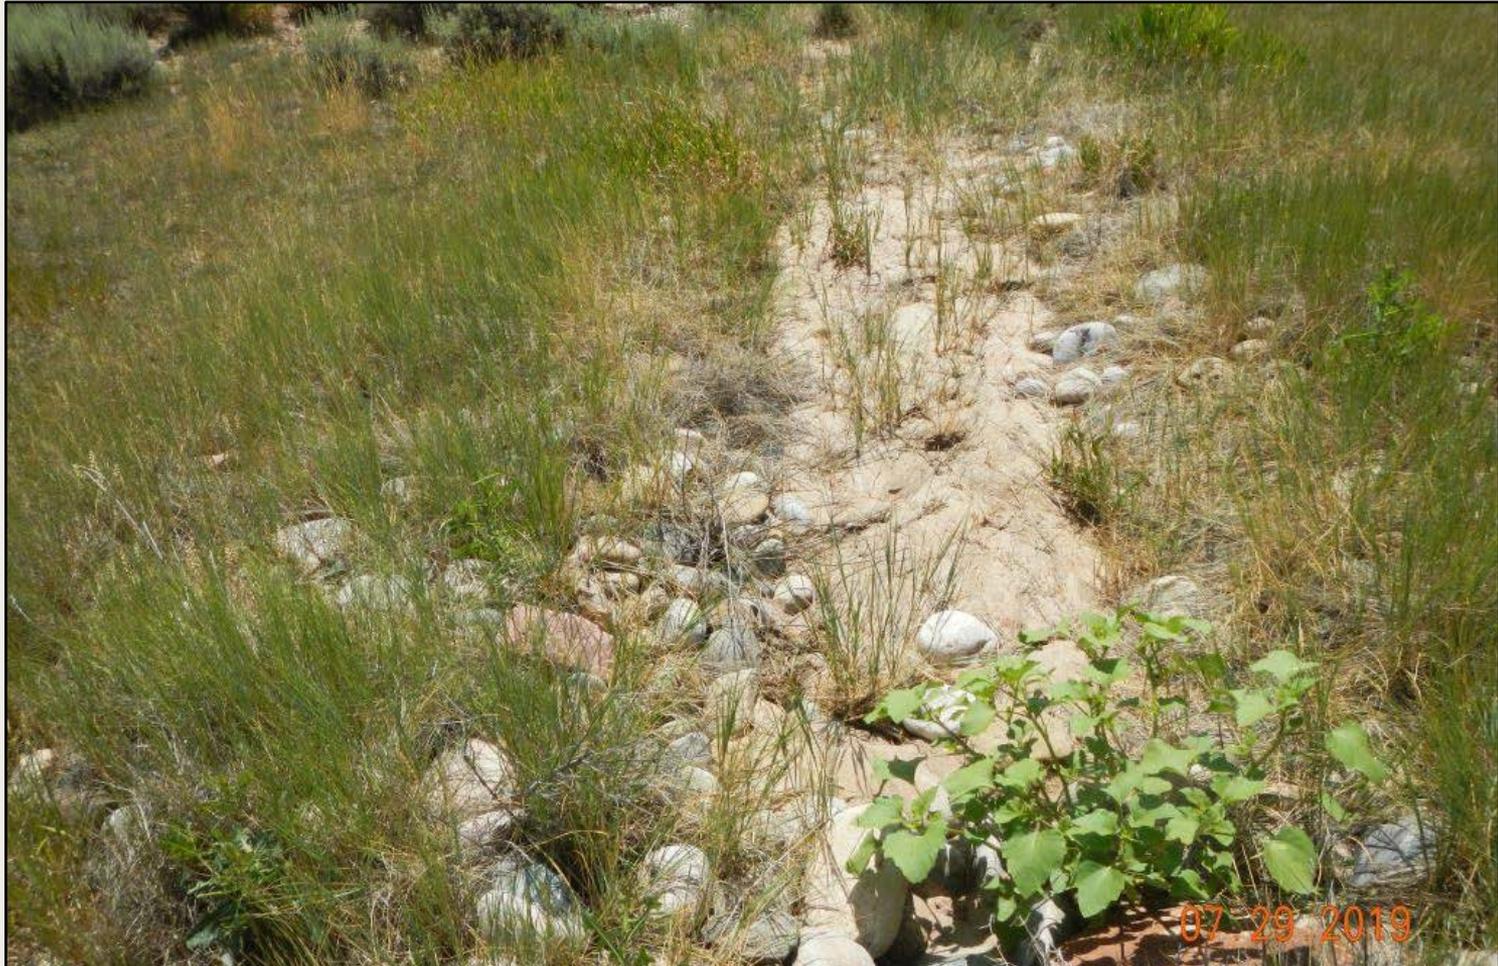
Photo 5. View of sediment-filled channel at culvert outlet along the access road.

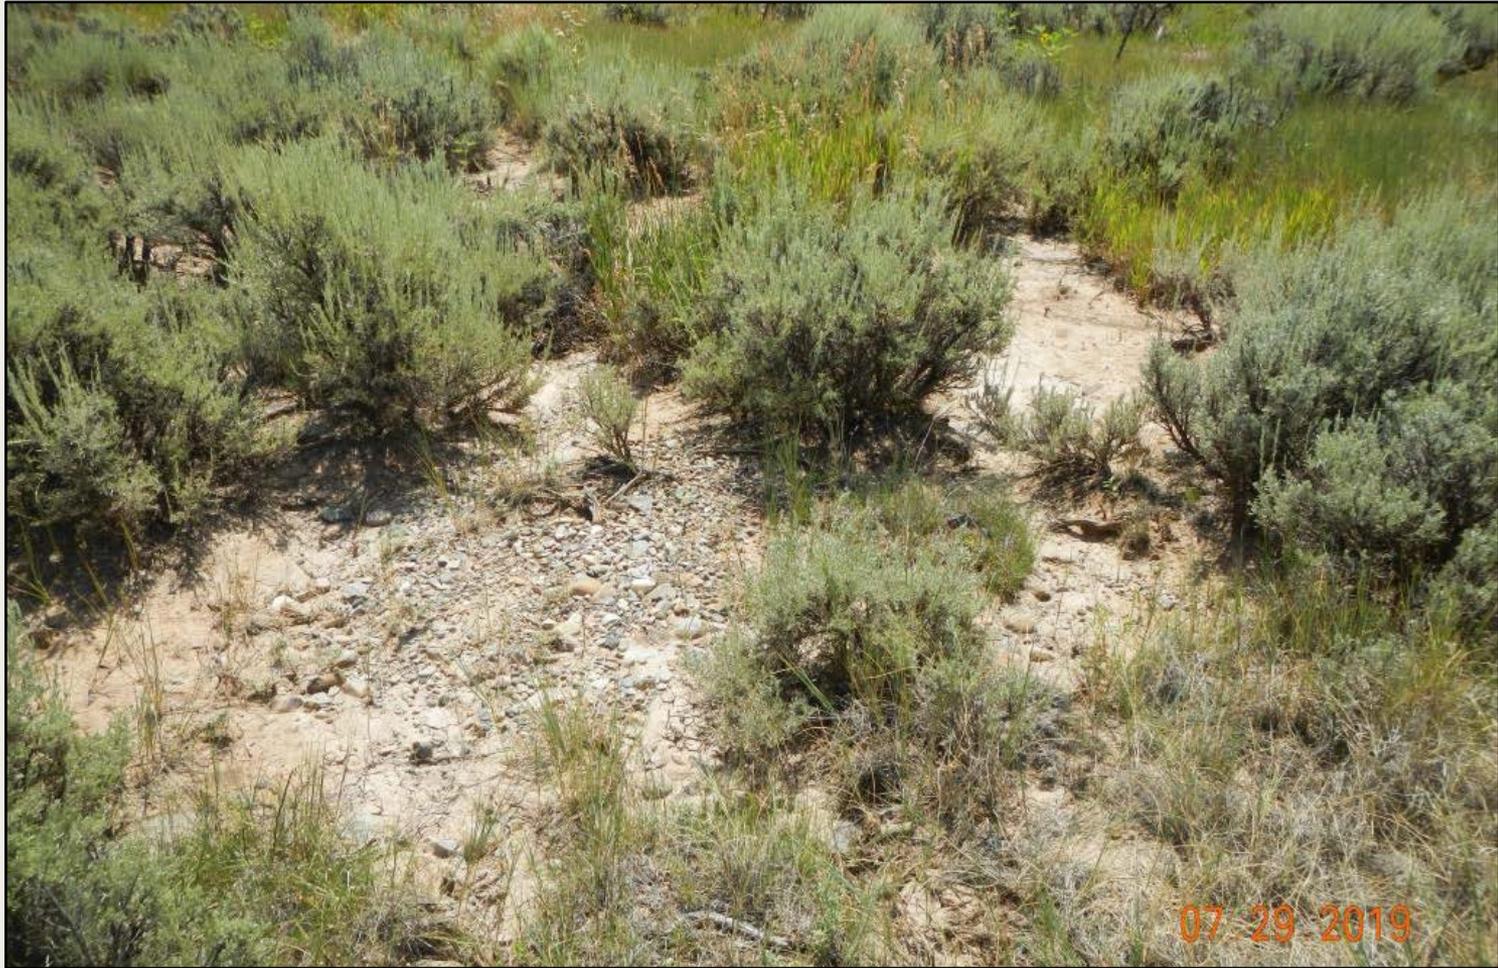
Photo 6. View of sediment and gravel deposition downstream from culvert outlet along access road (downstream from photo 5). Sediment is being discharged from the culvert and discharging off-site where it is damaging vegetation.
