Inspection Photos

08/08/2019

Operator: BISON OIL & GAS II LLC # 10661

Location ID: 454591

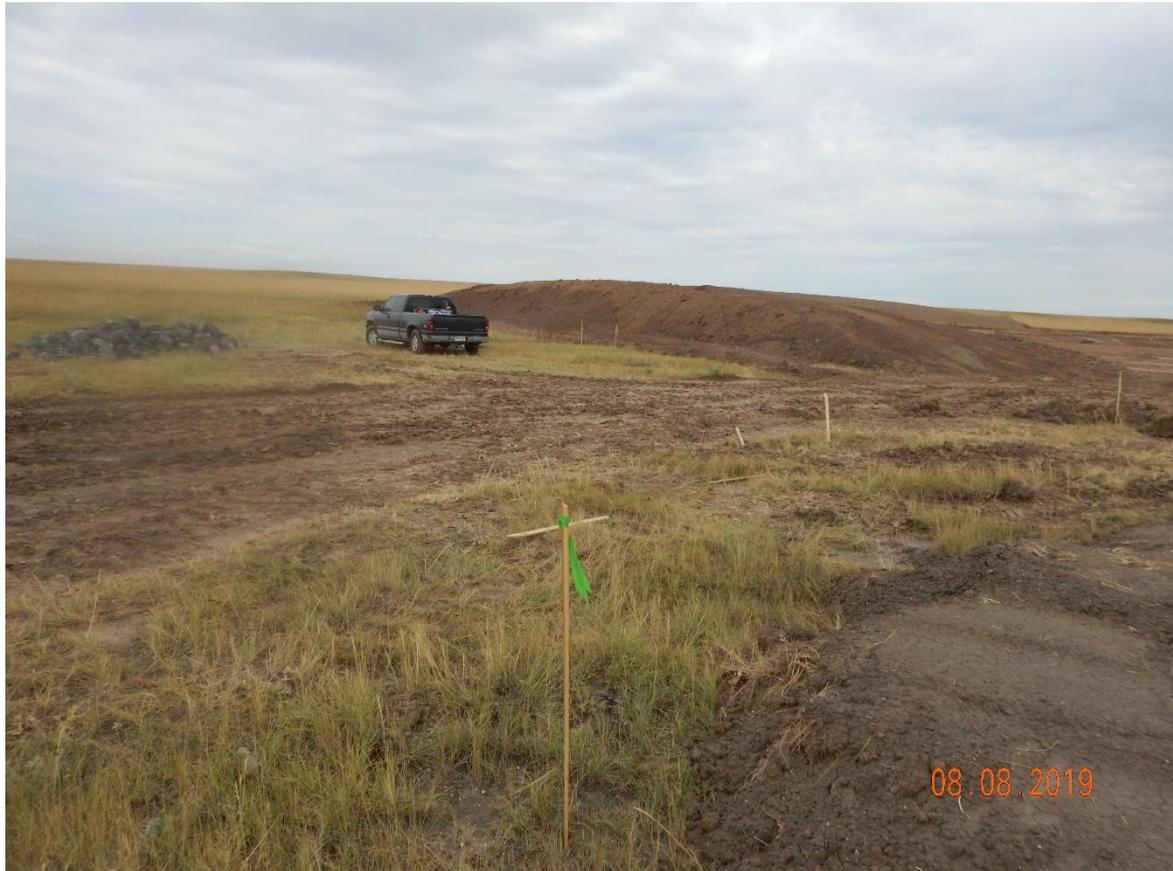
Photo 1: Photo taken from the south end of the location, facing northwest. Photos shows access road immediately at location, as well as topsoil stockpile on the south end of the location.

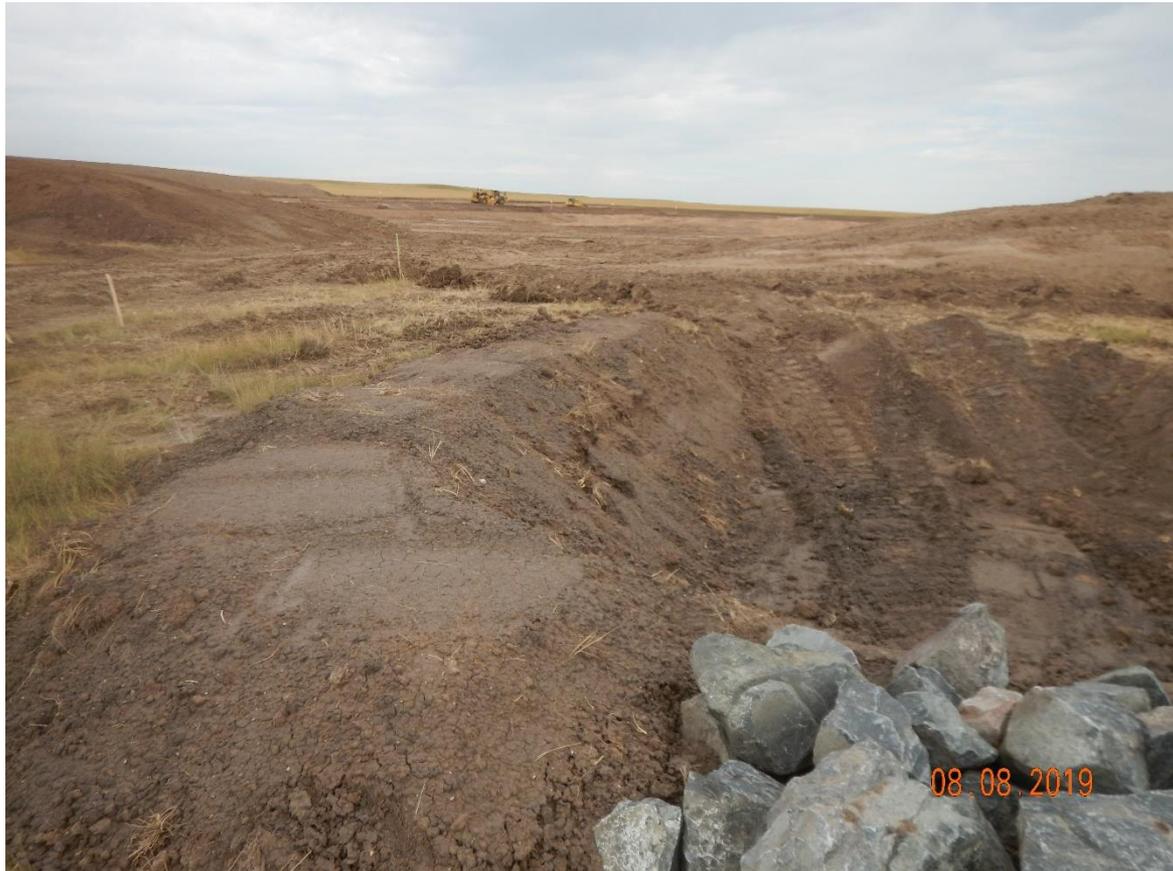
Photo 2: See comments under photo 1. Photo also shows one of the three stormwater sediment traps on the south end of the location. Sediment traps have not been constructed in accordance with good engineering practices; traps do not appear to be sufficient in size to manage runoff from the 10+ acre pad, berms at traps remain unconsolidated. BMPs missing inlet armoring/protection. Rock aggregate used for outlet protection appears too large in size to slow stormwater discharge, trap sediment and sufficiently stabilize outlet.

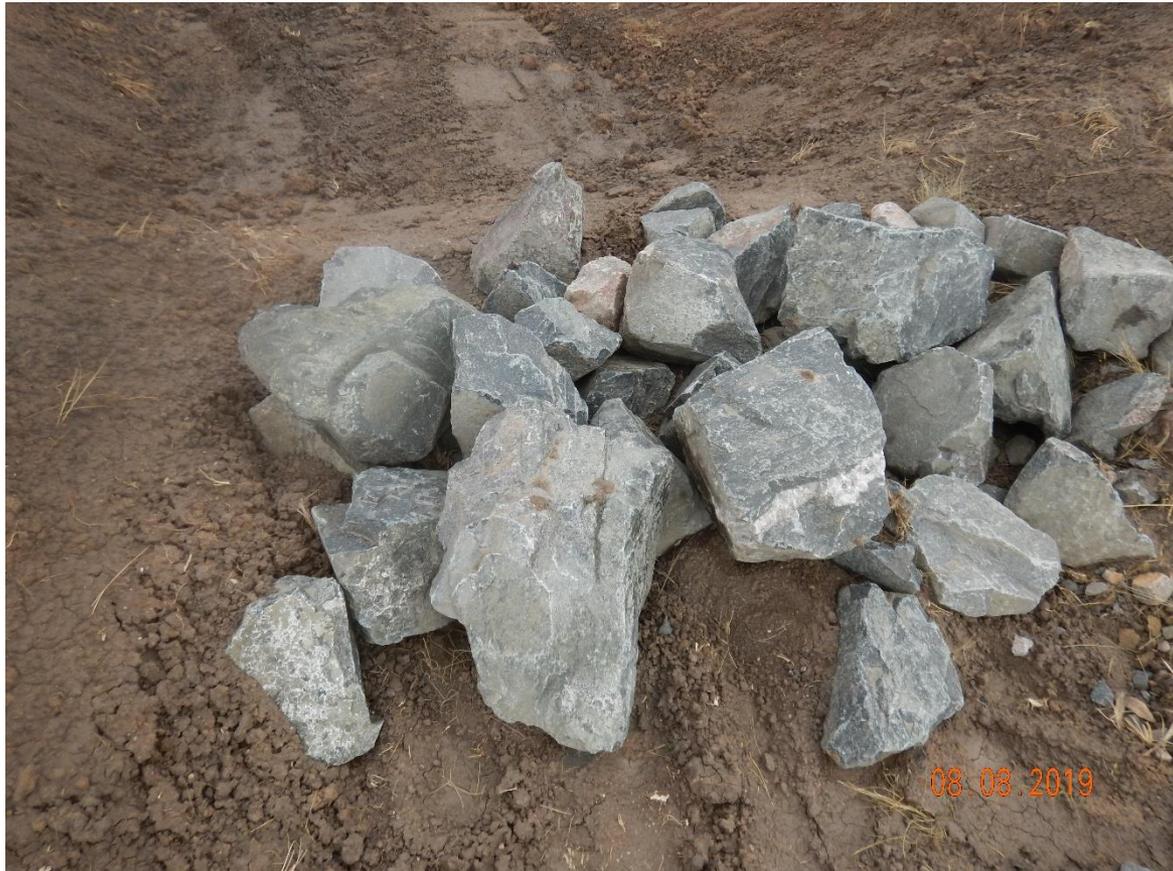
Photo 3: Photo of rock aggregate used at the sediment trap outlet. Rock aggregate used for outlet protection appears too large in size to slow stormwater discharge, trap sediment and sufficiently stabilize outlet.

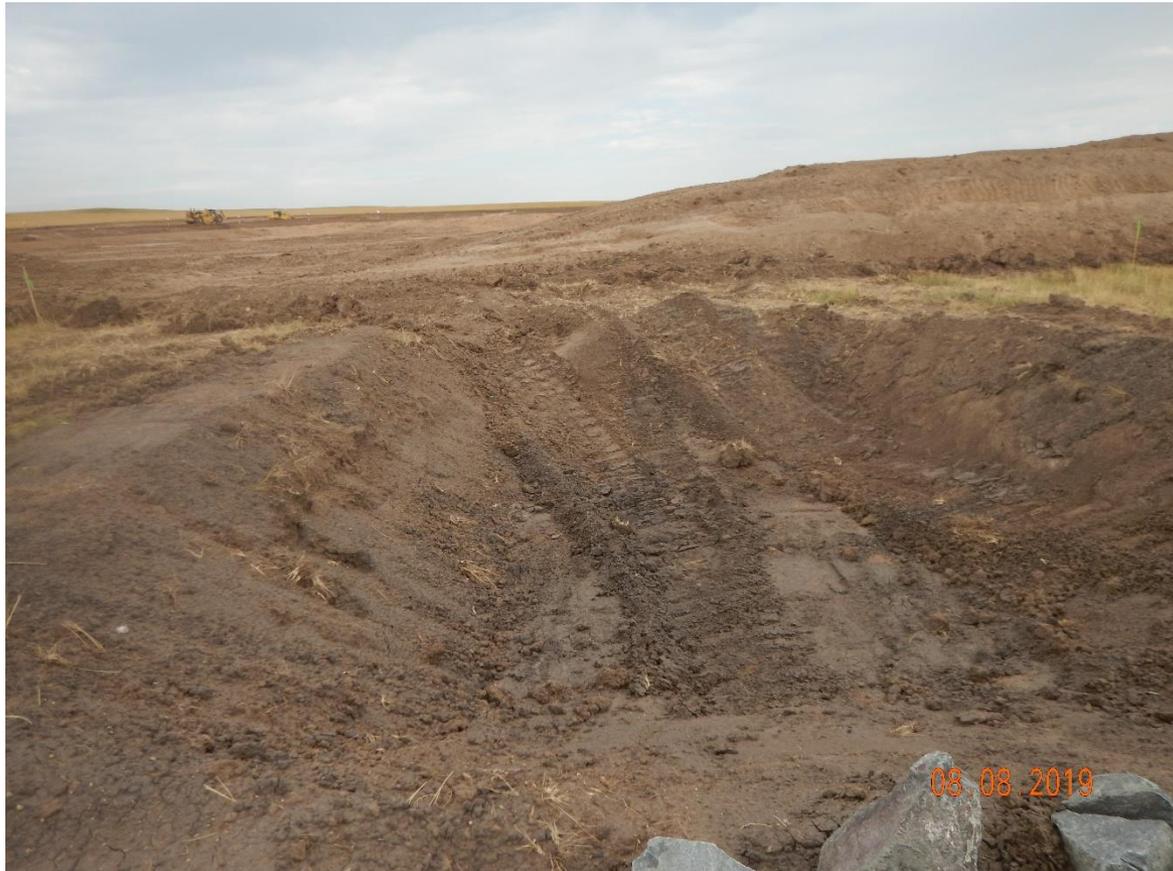
Photo 4: Photo taken of sediment trap. Sediment traps have not been constructed in accordance with good engineering practices; traps do not appear to be sufficient in size to manage runoff from the 10+ acre pad, berms/ slopes of traps remain unconsolidated. BMPs missing inlet armoring/protection. Rock aggregate used for outlet protection appears too large in size to slow stormwater discharge, trap sediment and sufficiently stabilize outlet.

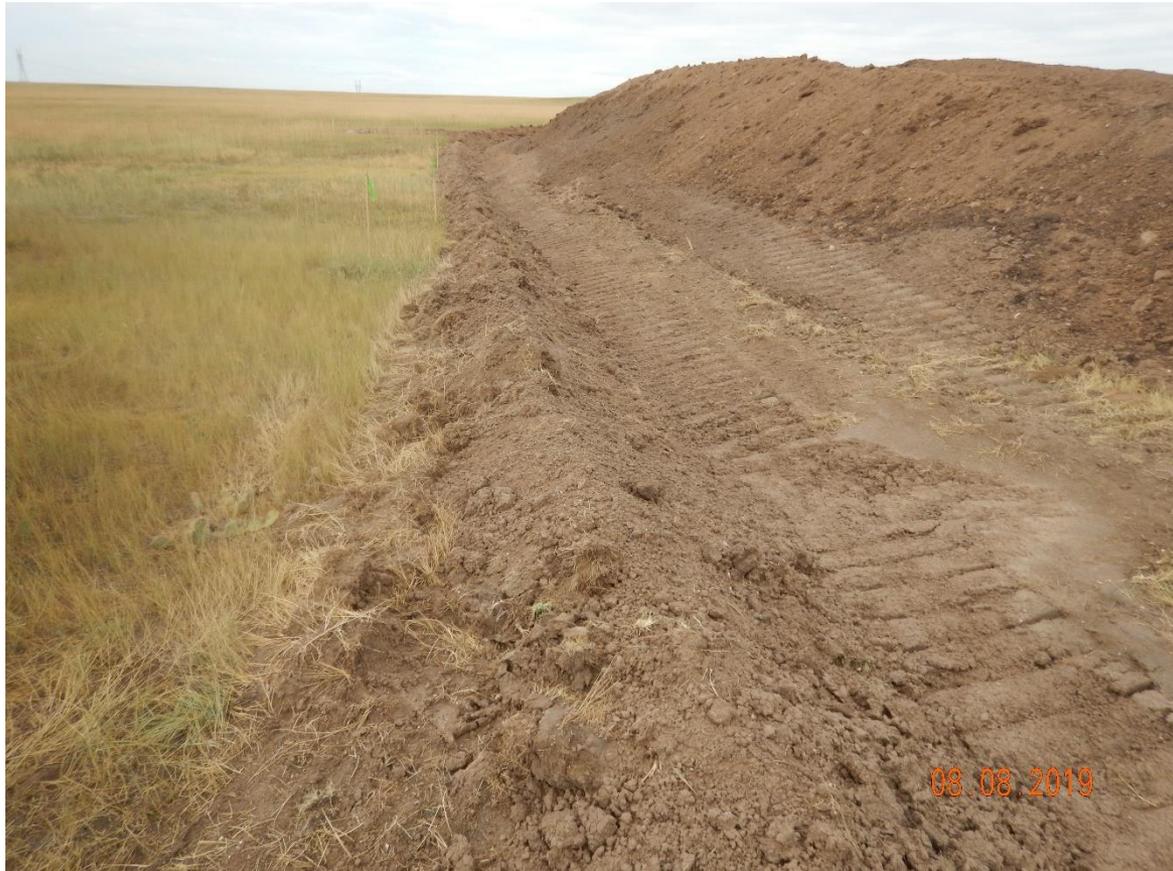
Photo 5: Photo taken from the south end of the location, facing west. Operator has removed surface roughening and installed a stormwater ditch/berm along the perimeter of the pad. Ditch/berm has not been installed in accordance with good engineering practices; Ditch/berm remains loose, unconsolidated material. Ditch appears to have been cut with a single pass of a blade, and has been left with a steep grade on one side that can result in stormwater incision within the ditch.

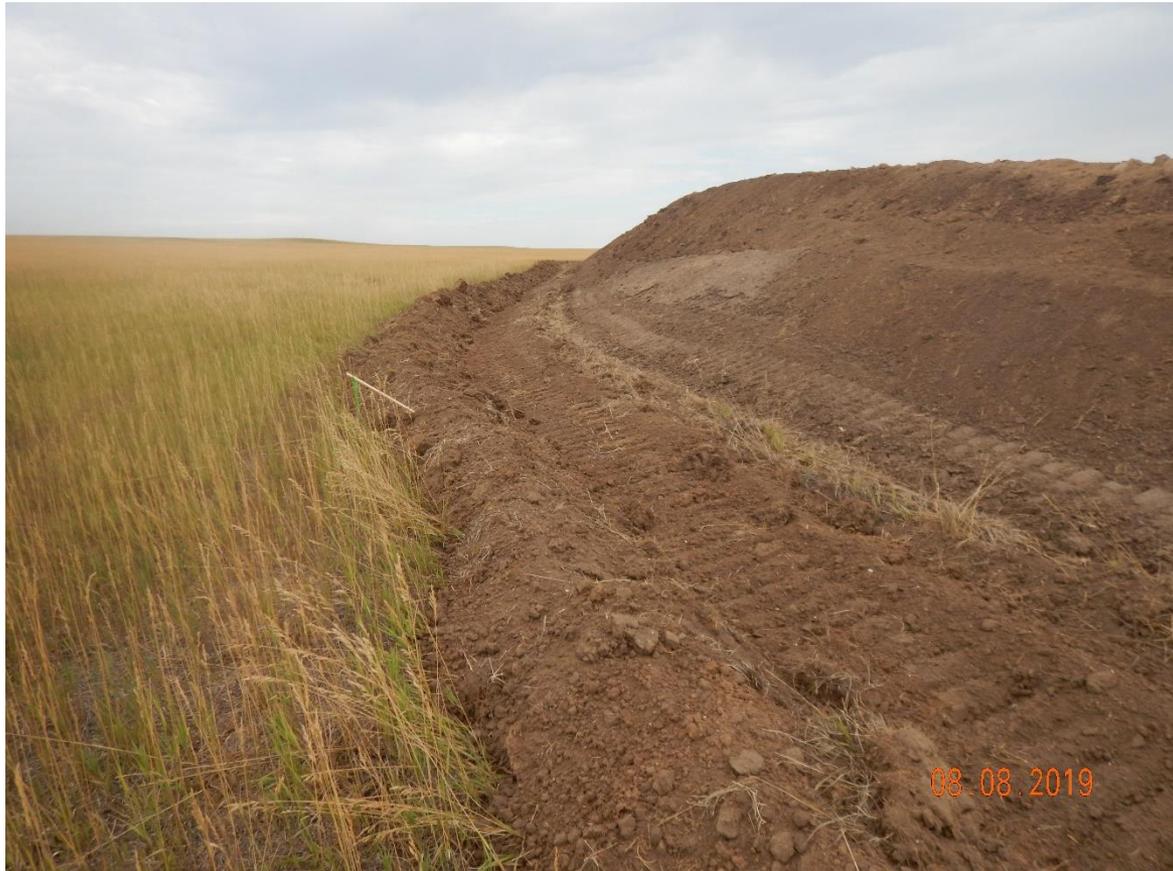
Photo 6: Photo taken from the southwest end of the location, facing north. See comments under photo 5.

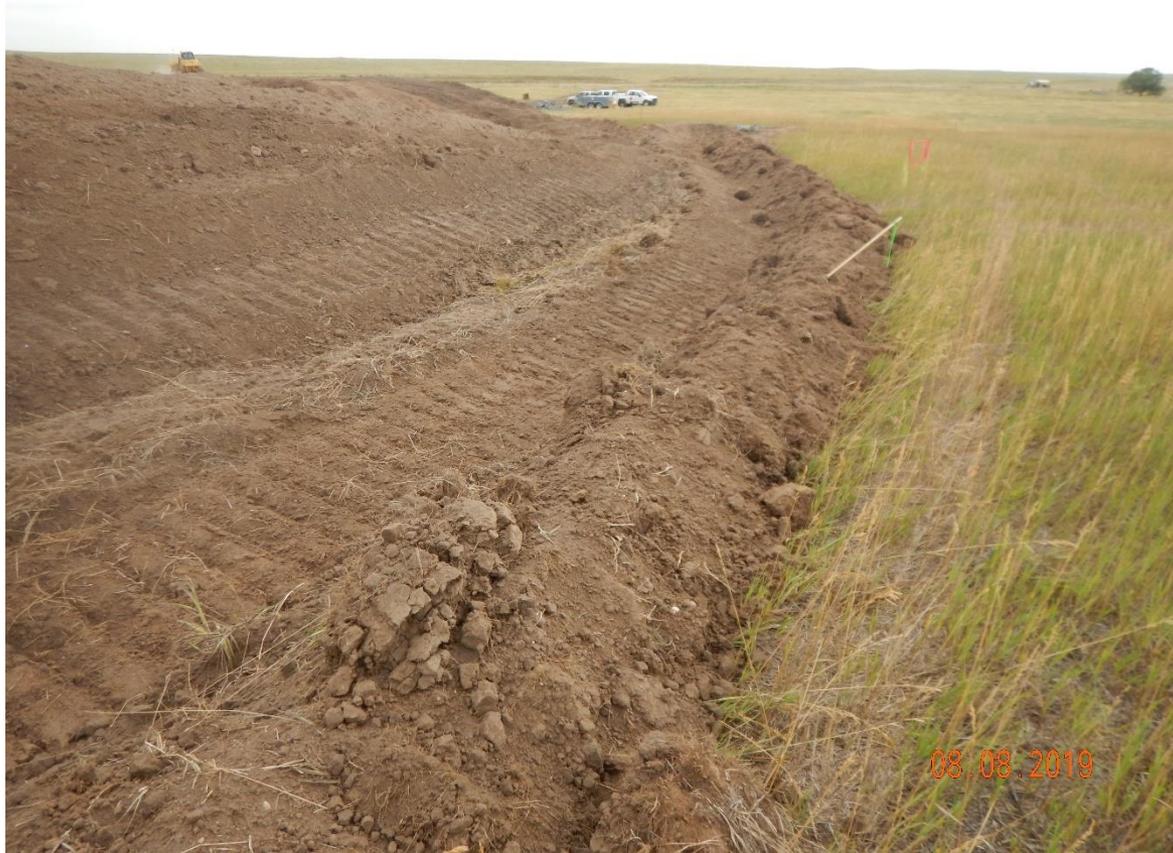
Photo 7: Photo taken from the southwest end of the location, facing southeast. See comments under photo 5.

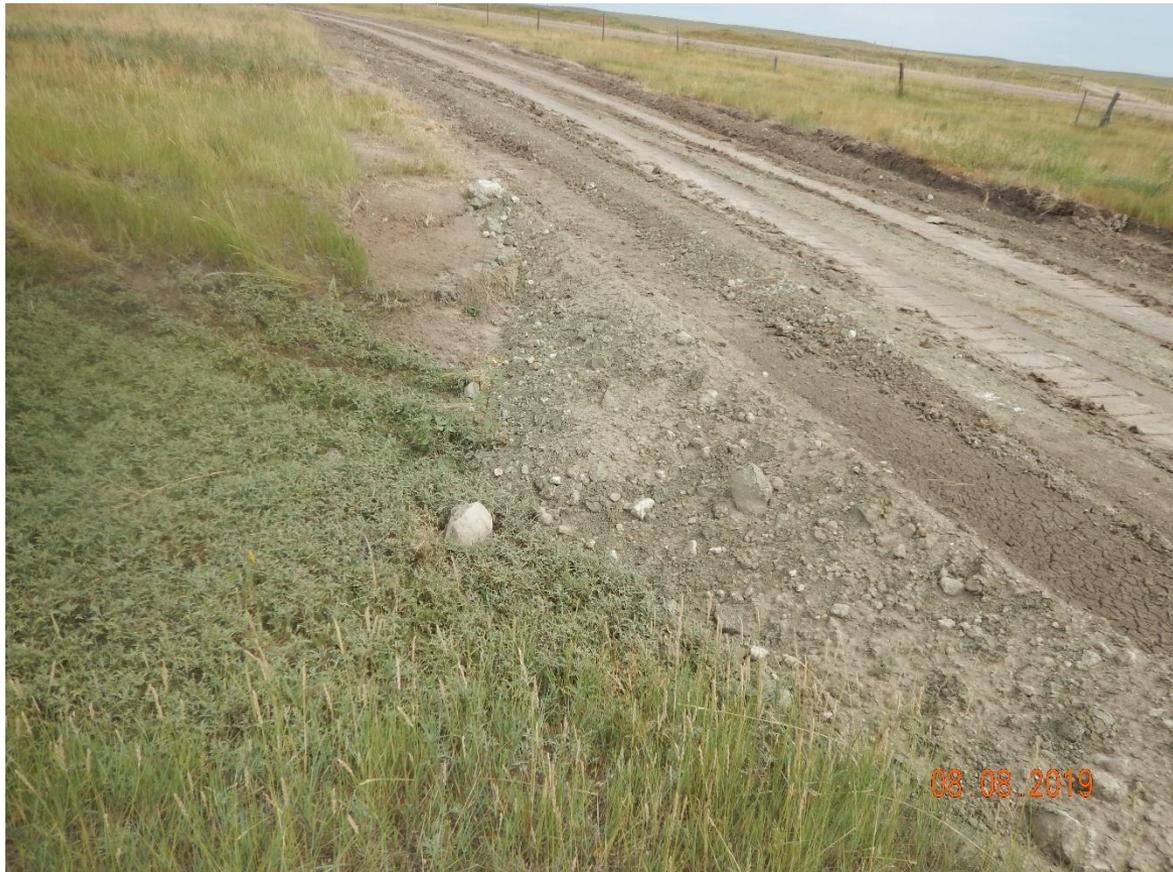
Photo 8: Photo taken from the access road, facing north. Photo shows area of access road that was constructed across a drainage. No BMPs have been installed to prevent ponding and allow for water movement under access road. Additionally no tracking BMPs have been installed to mitigate sediment transport off location.

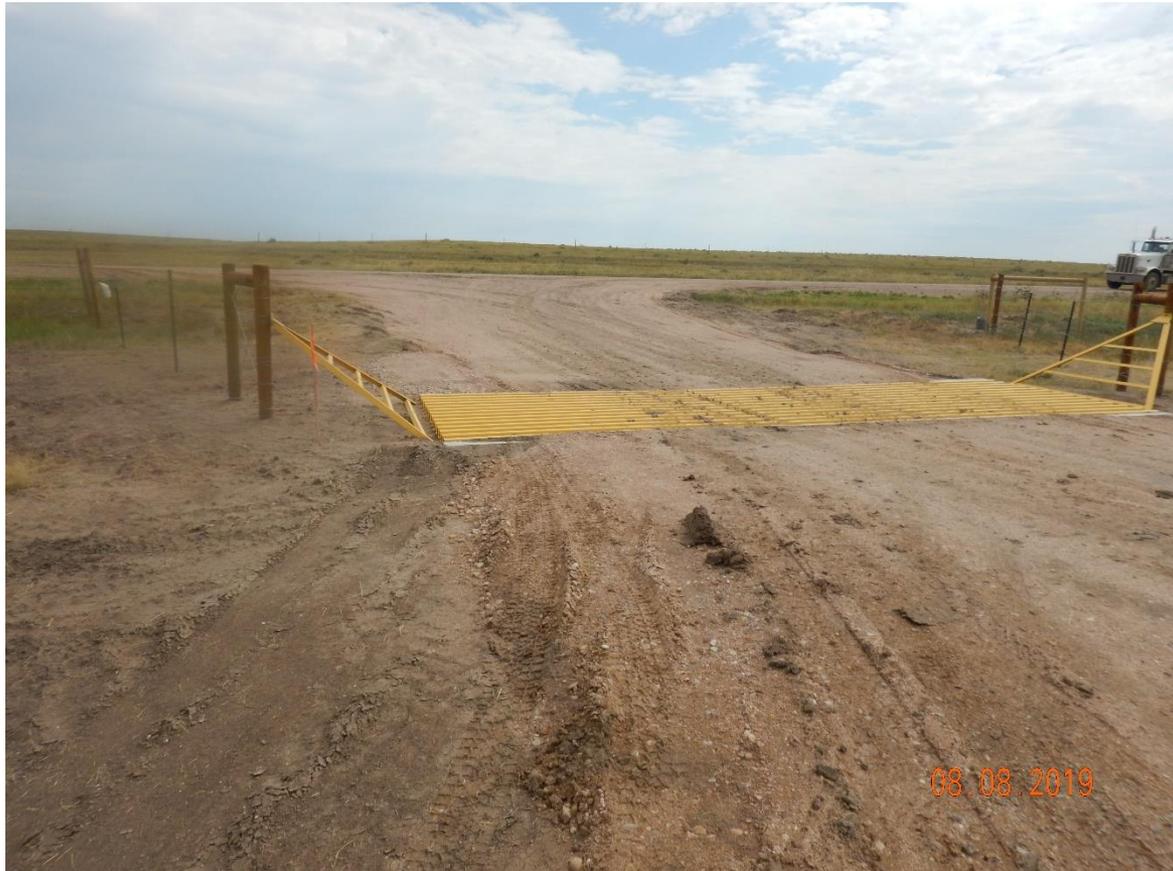
Photo 9: Photo taken from the access road entrance, facing east. Photo shows no tracking BMPs have been installed to mitigate sediment transport off location.
