Wiley 23-3-97 H1  
API: 05-103-11954  
Inspection: 679705029

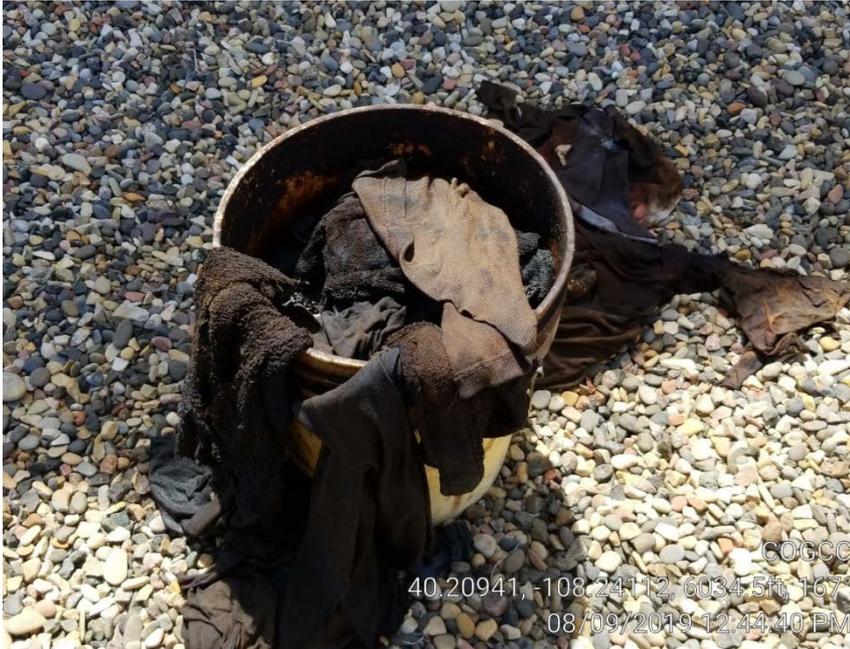
**Photo 2. Oily soaked rags in bucket located within tank containment.**

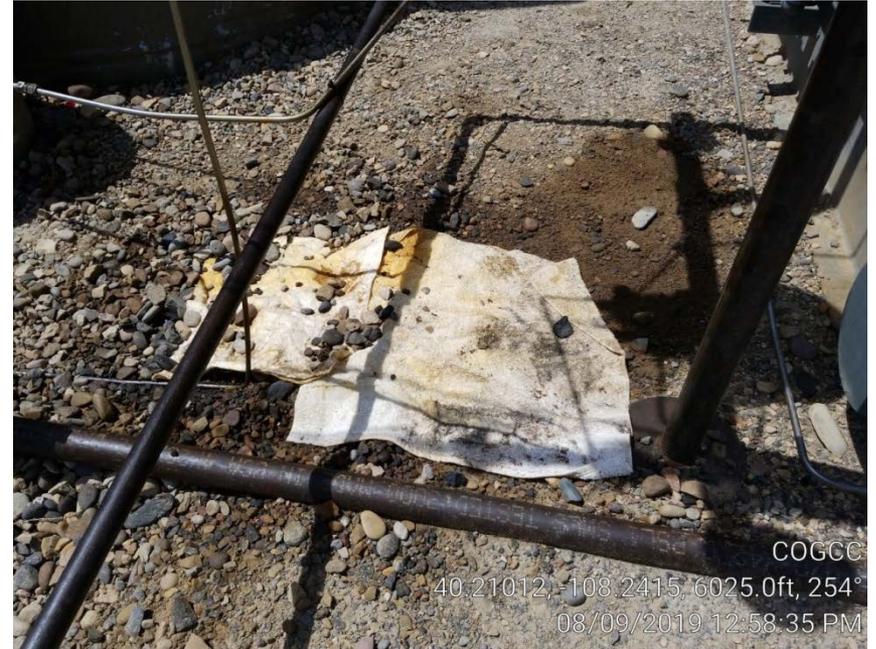
**Photo 3. Stained soil with absorbent pads on top next to separator.**

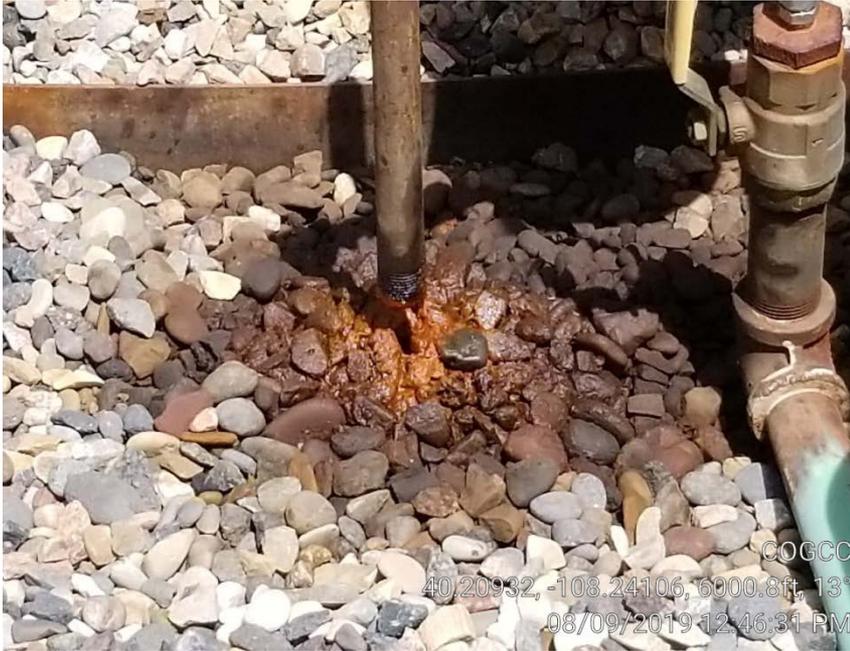
**Photo 4. Stained gravel at base of tubing next to tank burner.**

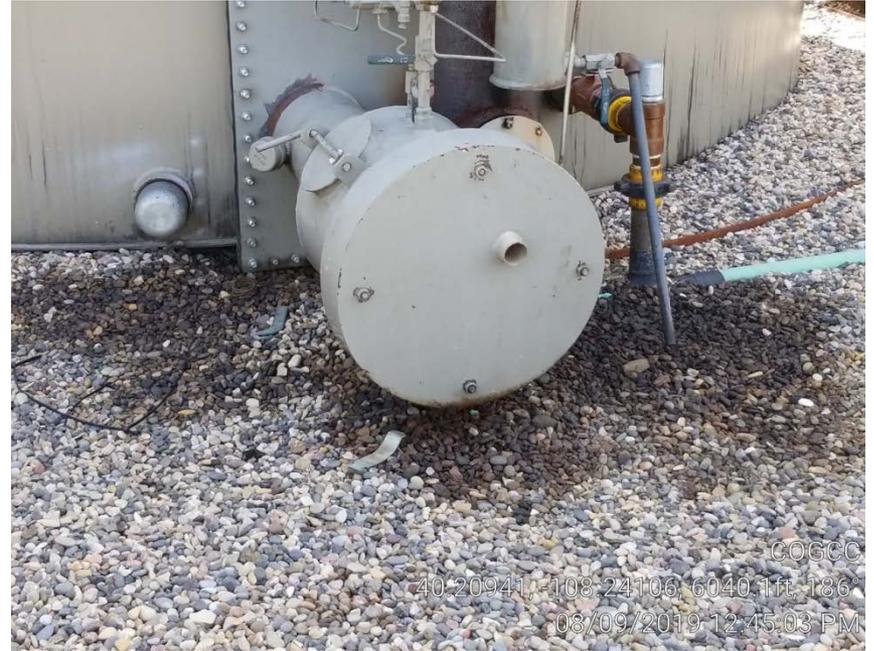
**Photo 5. Stained gravel at base of tubing next to tank burner.**

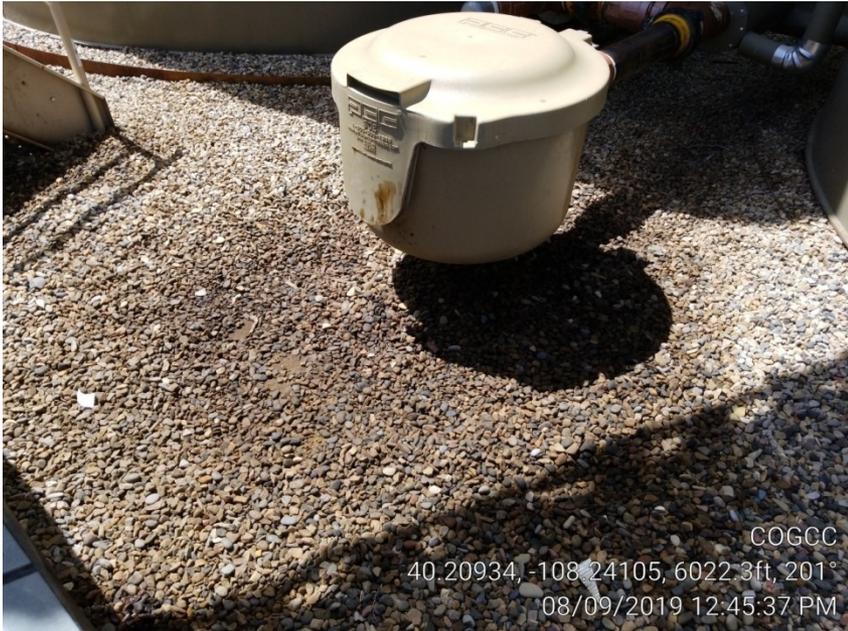
Photo 6. Stained gravel next to oil tank valve.

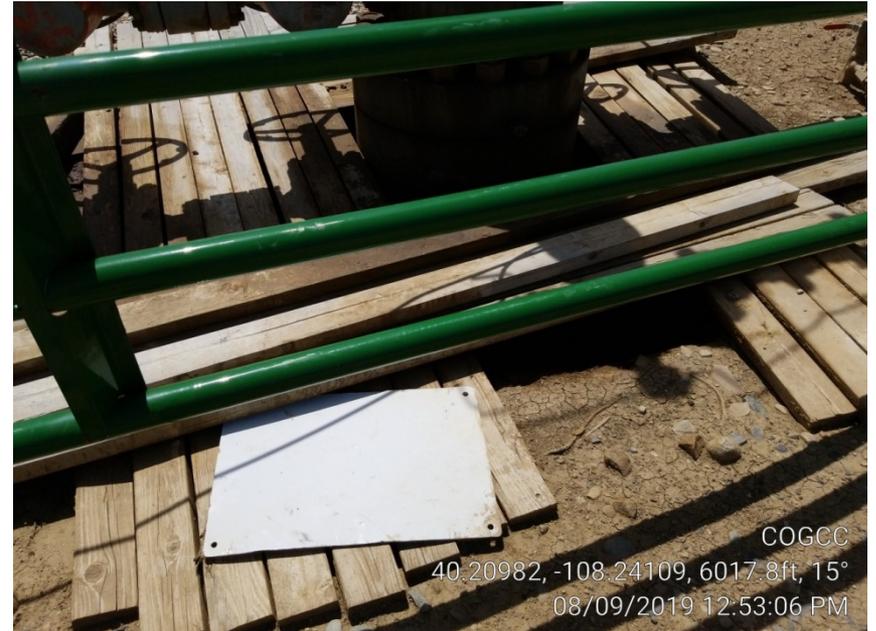
Photo 7. Well head sign lying on ground upside down.

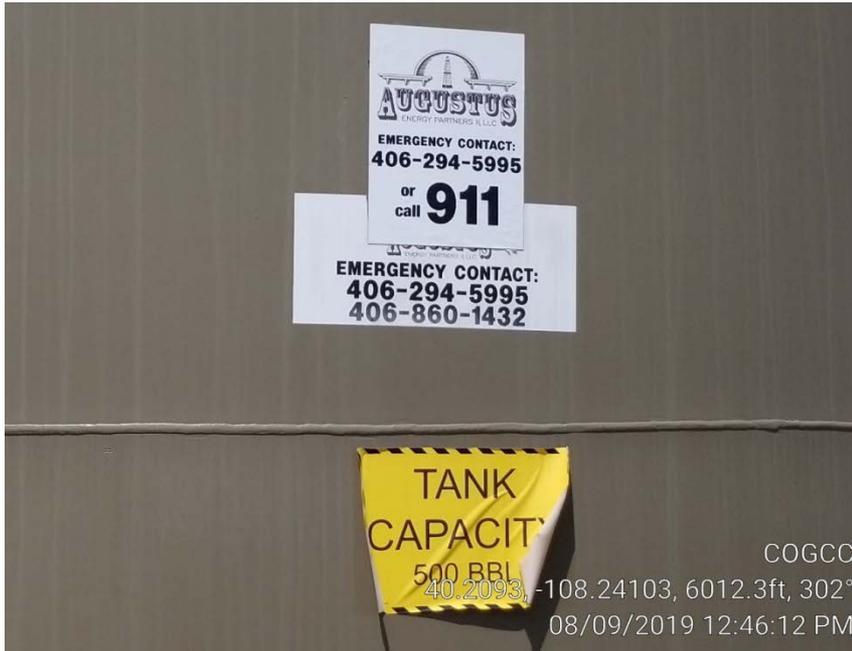
Photo 8. Tank missing contents & NFPA label.

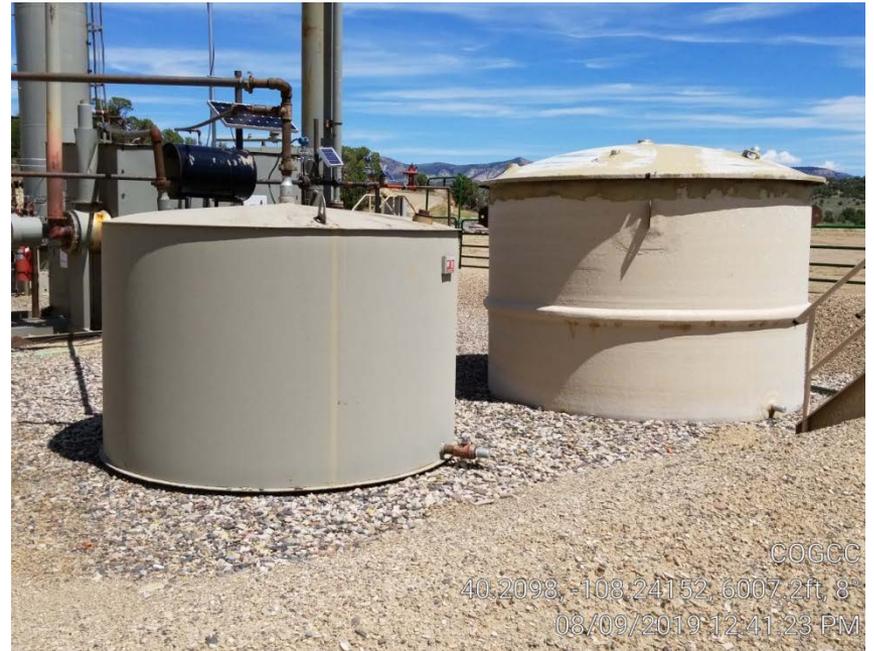
Photo 9. Tanks without labels.

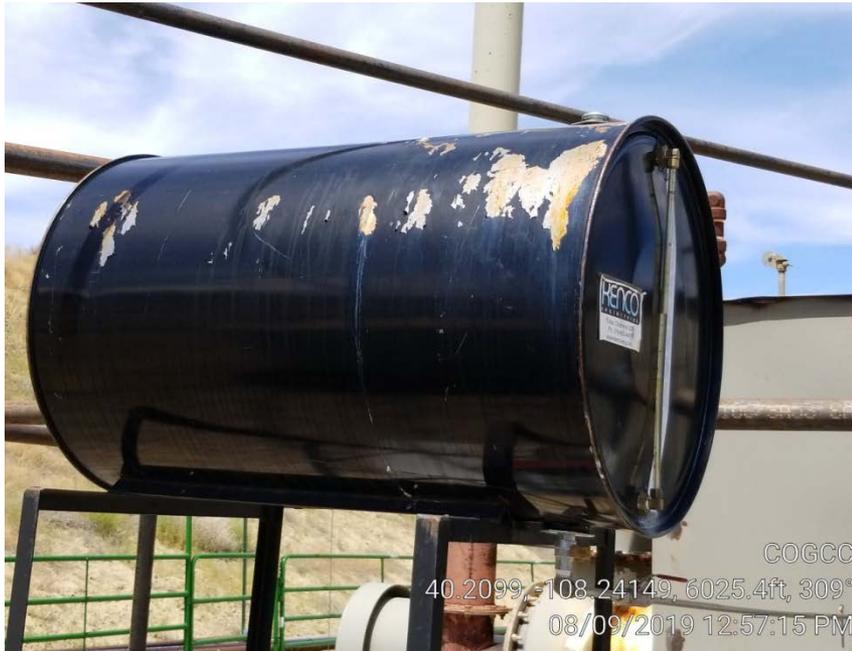
Photo 10. Barrel without label.

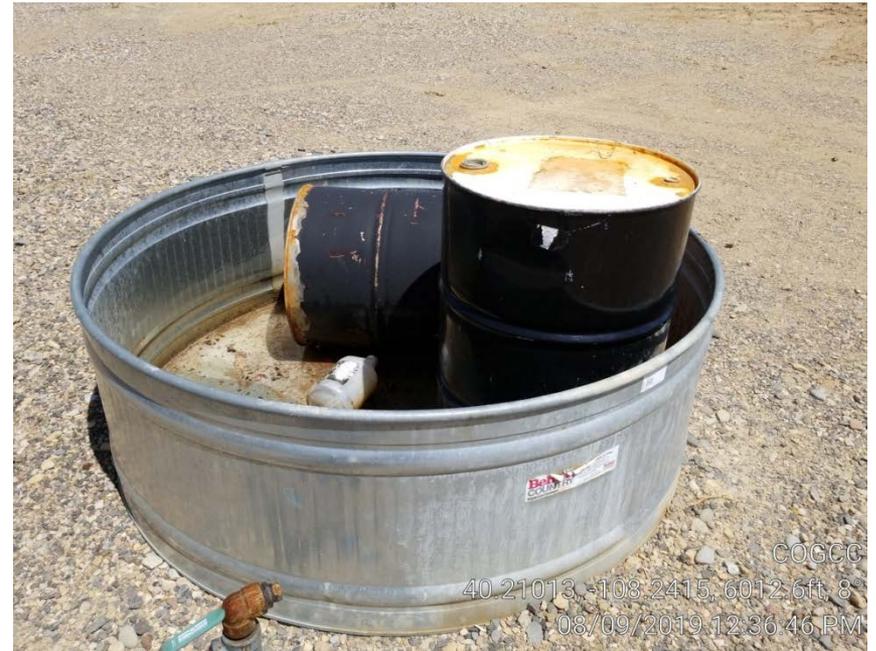
Photo 11. 1 of 2 barrels without label.

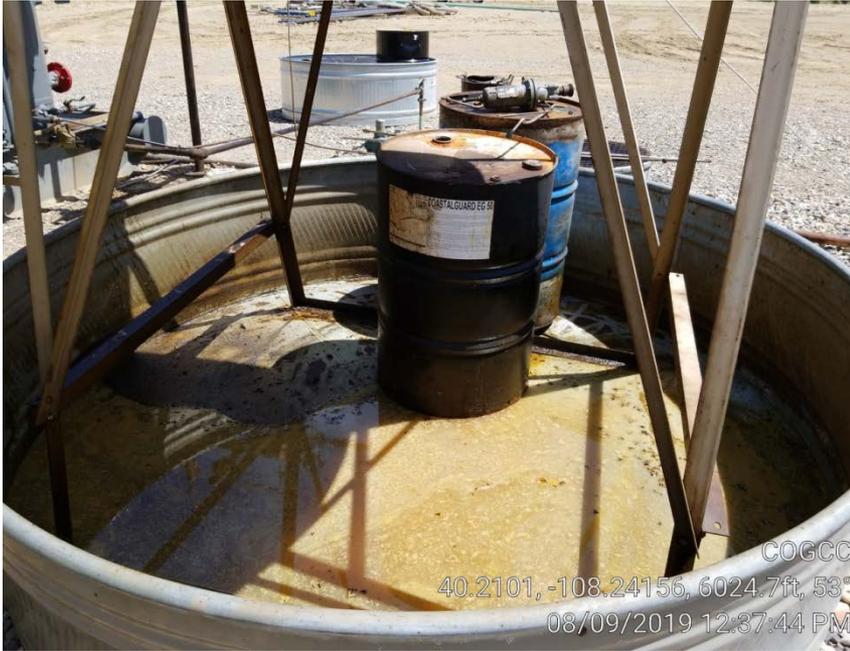
Photo 12. 1 of 2 barrels without label.

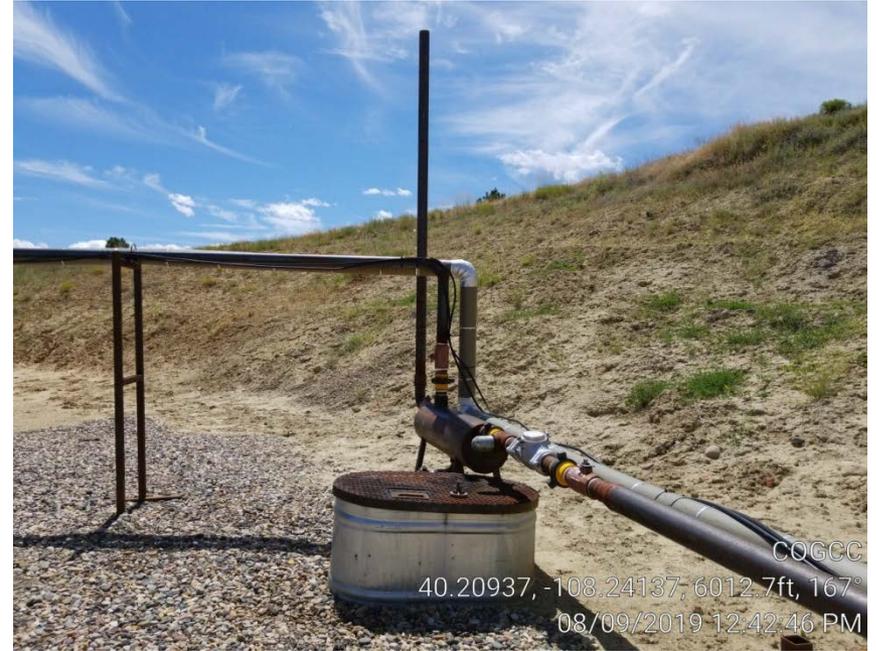
Photo 13. Vent without bird protection.
