Inspection Photos
Location Name: LF Layer Unit #2
Location ID: 318504

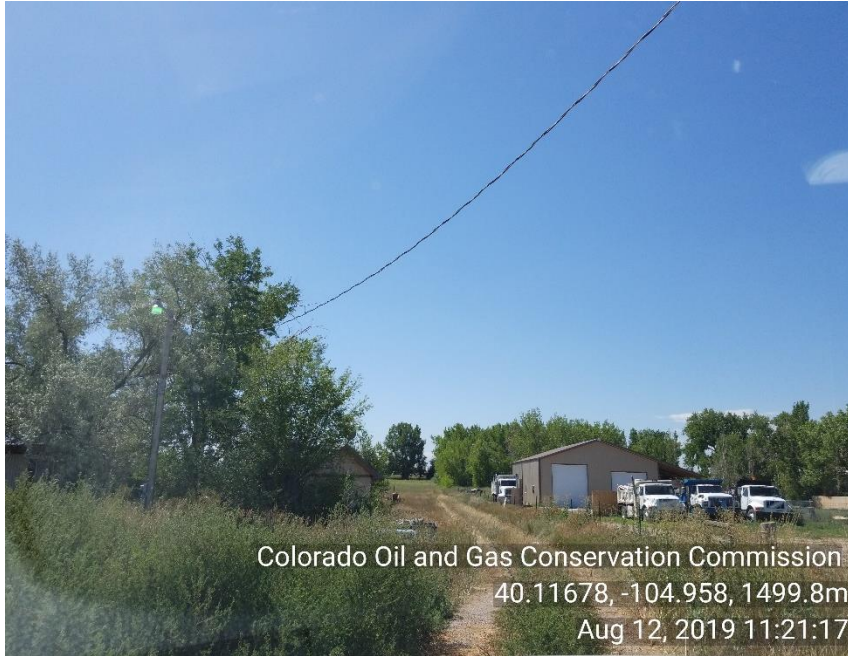
Photo 1 Access road not maintained and weeds.

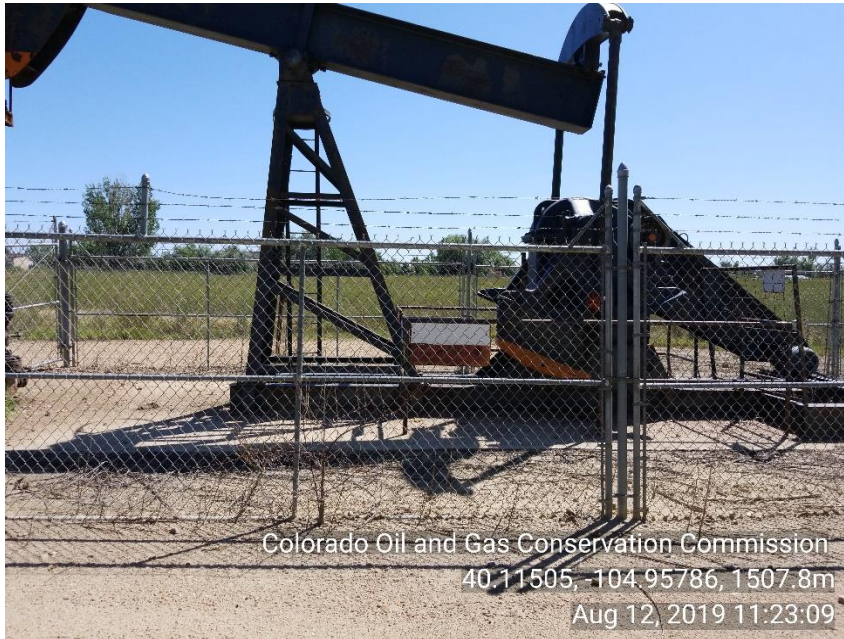
Photo 3 WH sign faded and not legible.

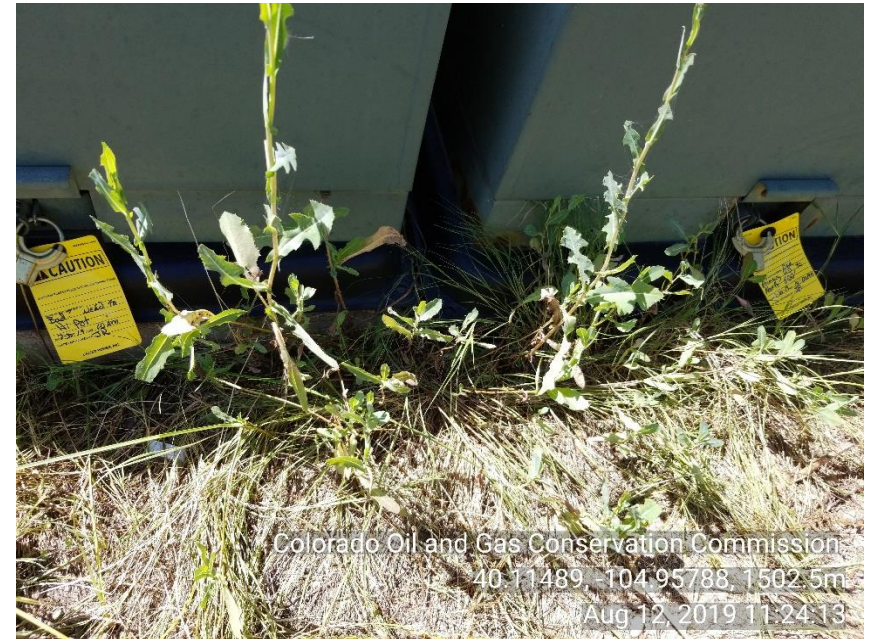
Photo 4 Electric panel LOTO with tags stating bad on each one.

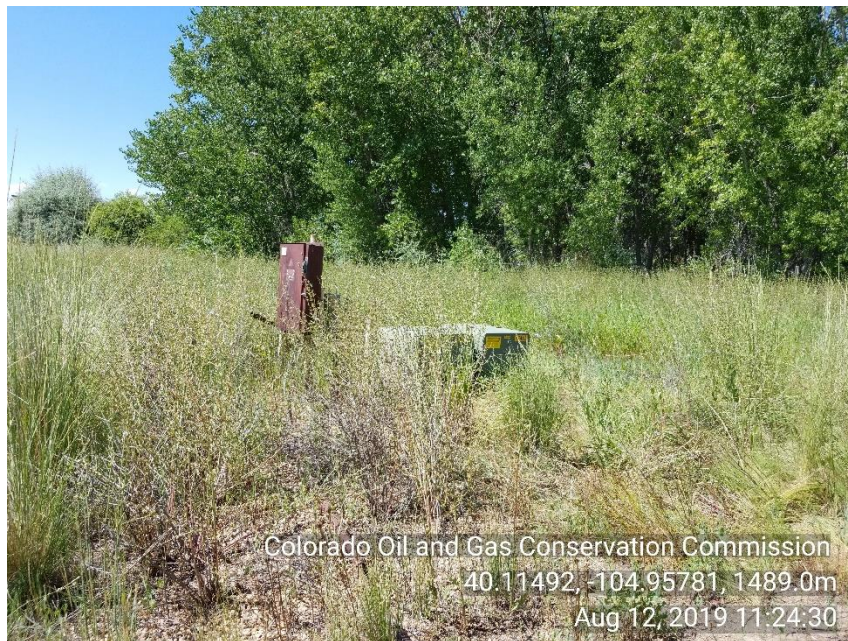
Photo 5 Weeds around electric panel and location.

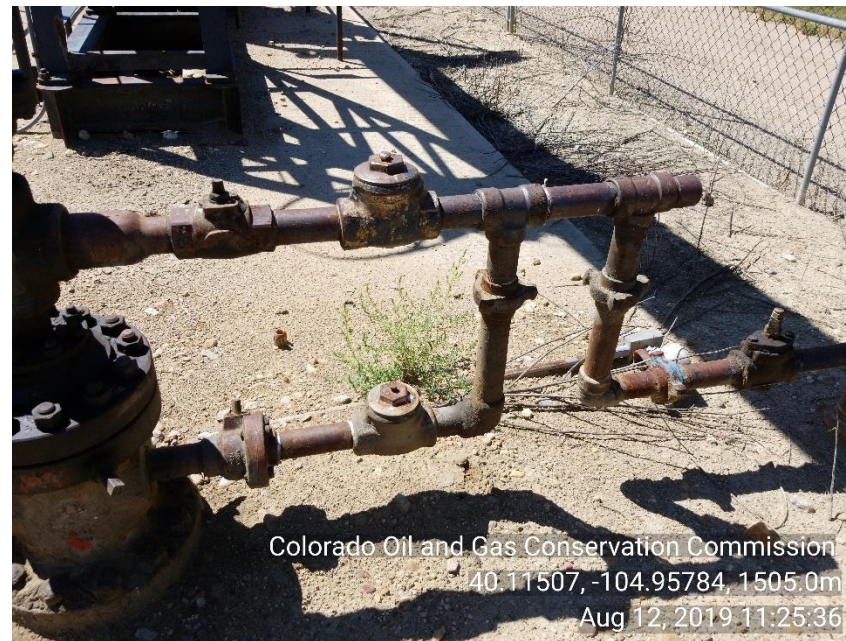
Photo 6 Production records show well as SI at time of inspection flow line valves are open and inspector can hear what appears to be gas flowing through flow lines.

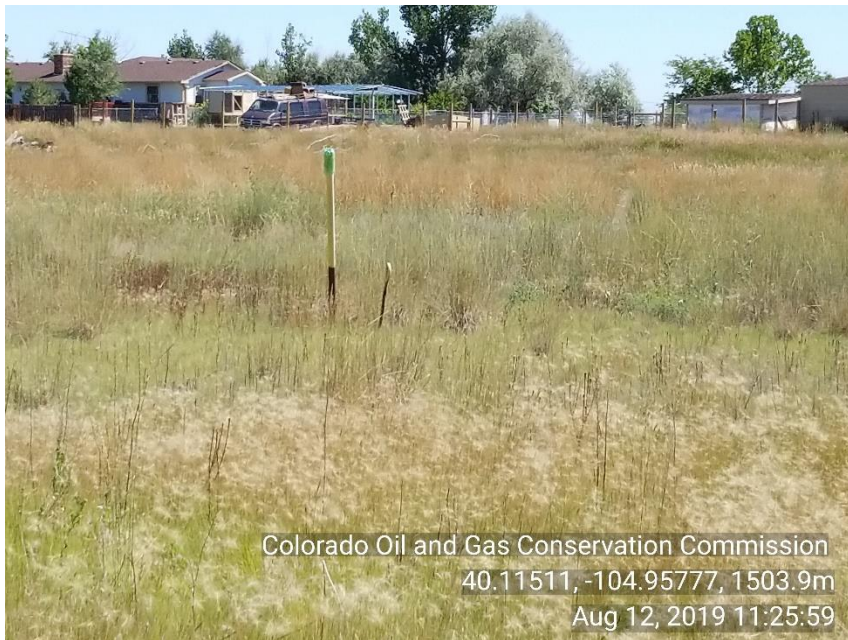
Photo 7 Dead men. Weeds on location.
