Inspection Photos
Location Name: McCallum Unit 109
Location ID: 324671

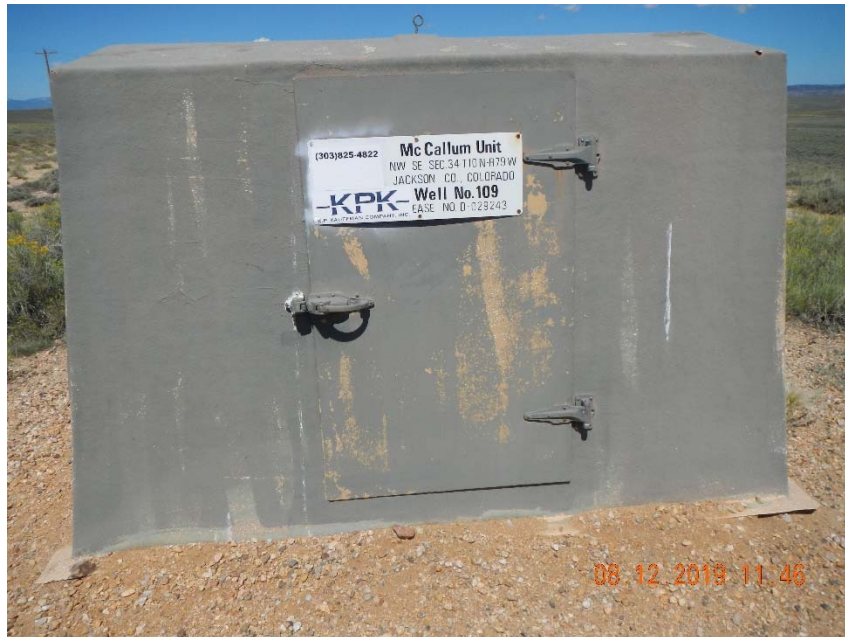
Photo 1. Location overview.

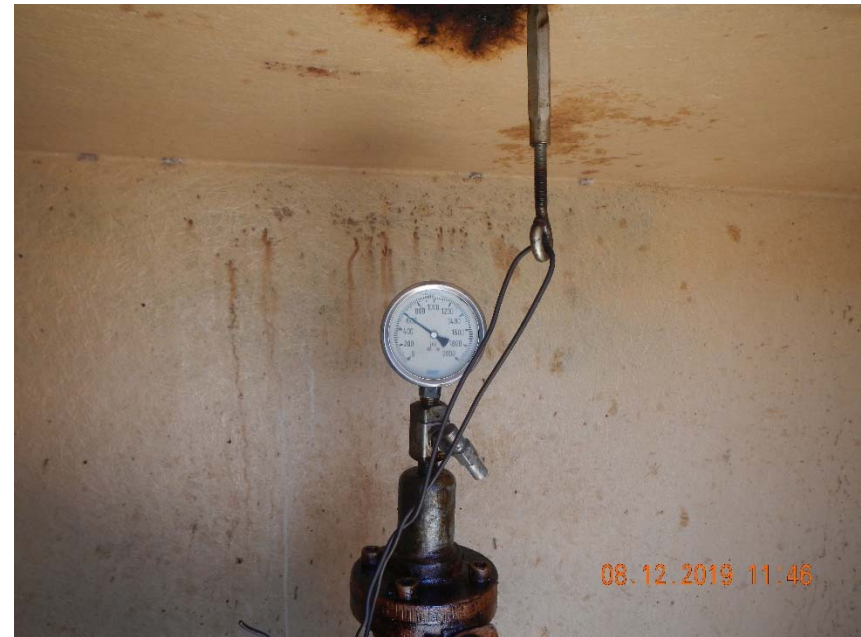
Photo 2. 600 psi on tubing at time of inspection.

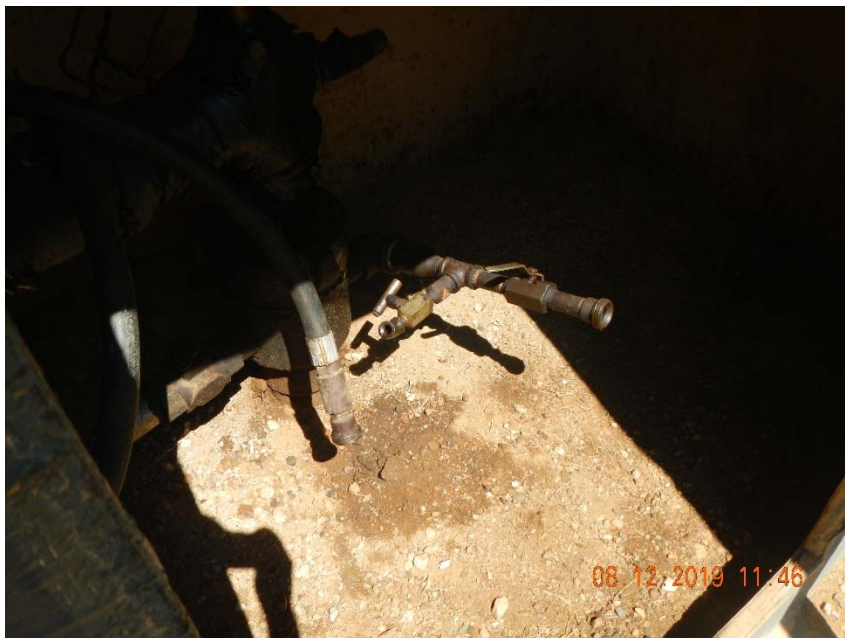
Photo 3. Stained soil.

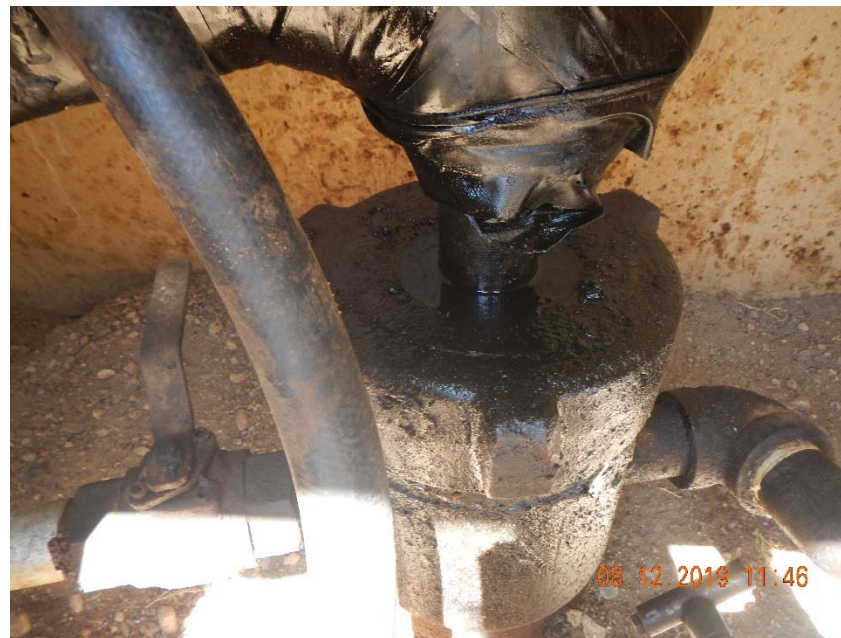
Photo 4. Mechanical conditions leading to stained soil.
