## Inspection Photos

Location Name: Horsetail 07 East CPB Location ID 446980

Inspection Date: 8/13/2019

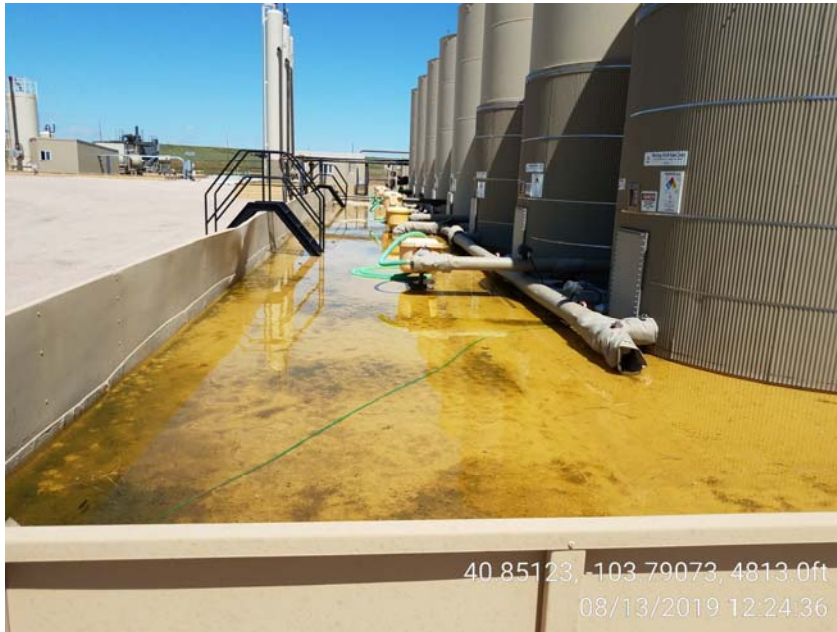
**Photo 1 – Photo of lined containment at tank battery.  
Spilled liquids and impacted pea gravel removed from lined  
containment.**

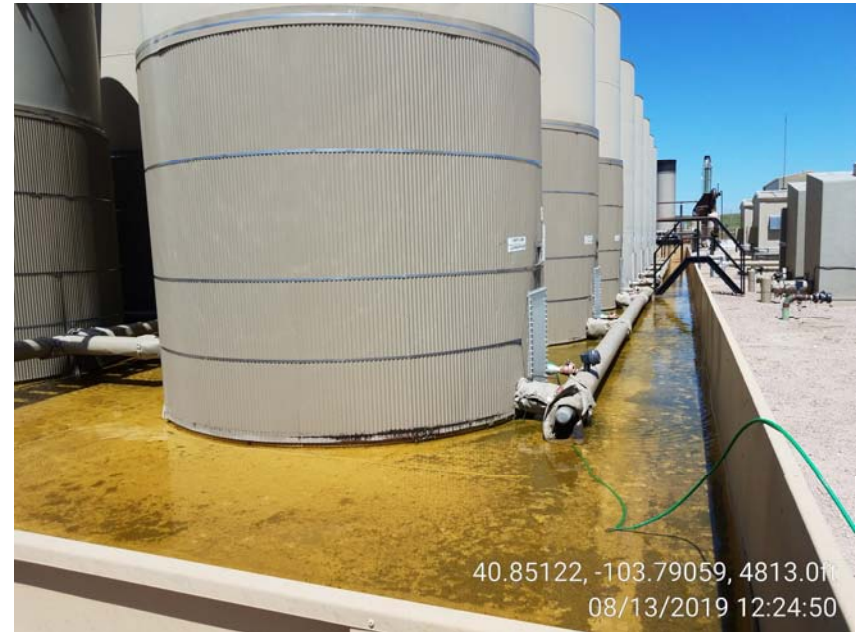
**Photo 2 – Photo of lined containment at tank battery.  
Spilled liquids and impacted pea gravel removed from lined  
containment.**

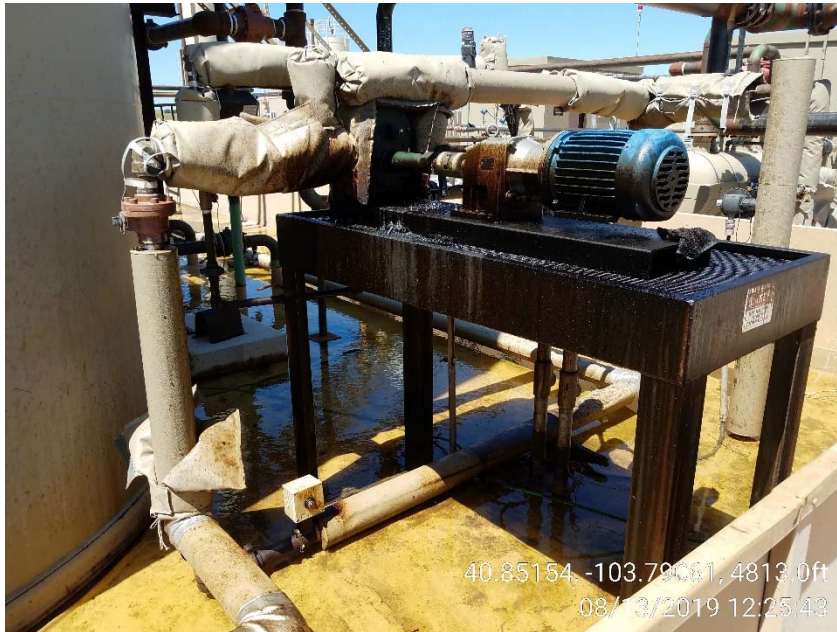
**Photo 3 – Leaky recycle or transfer pump within lined containment.**

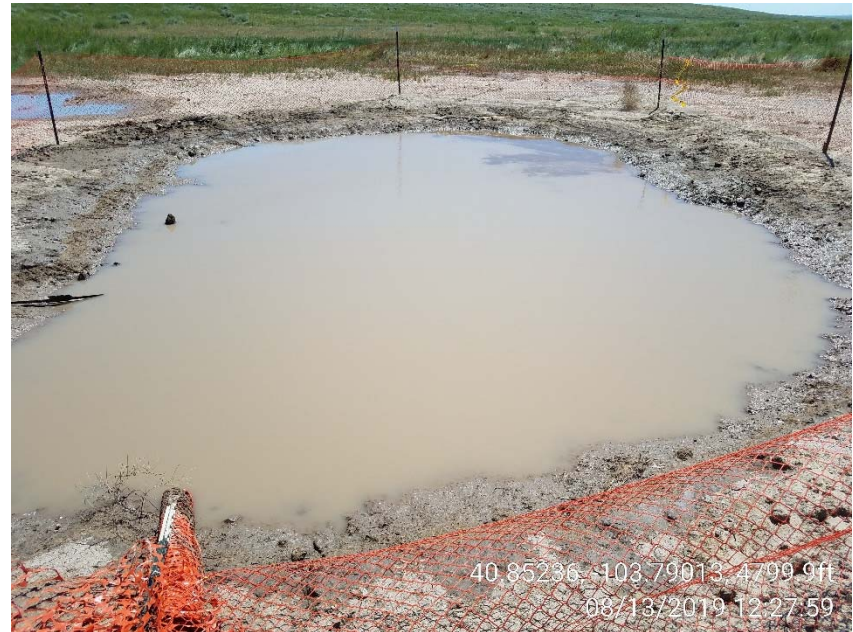
**Photo 4 – Photo of excavation at spill ID 466014, filled with stormwater. Sediment has floated to surface.**

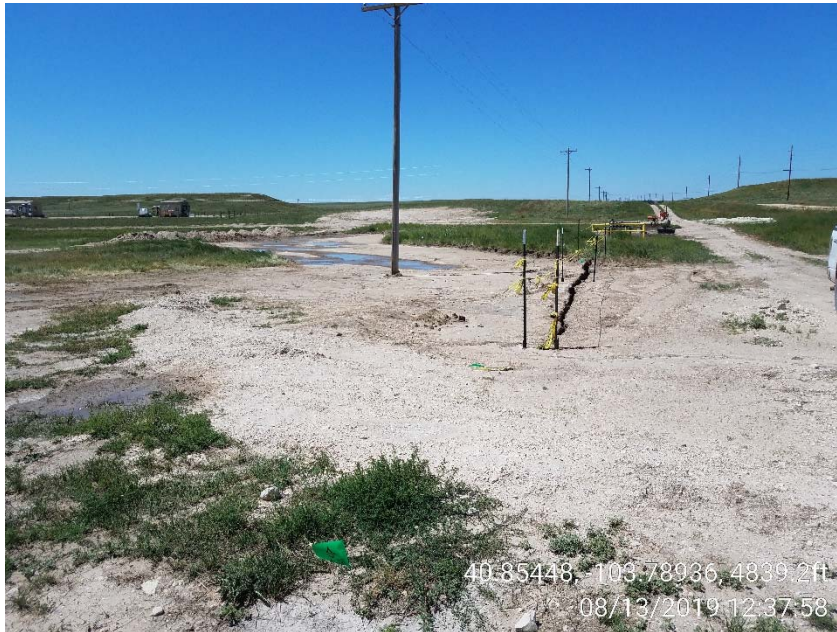
**Photo 5 – Photo of spill 465616 from approximate spill origin viewing surface soil excavation, looking west.**

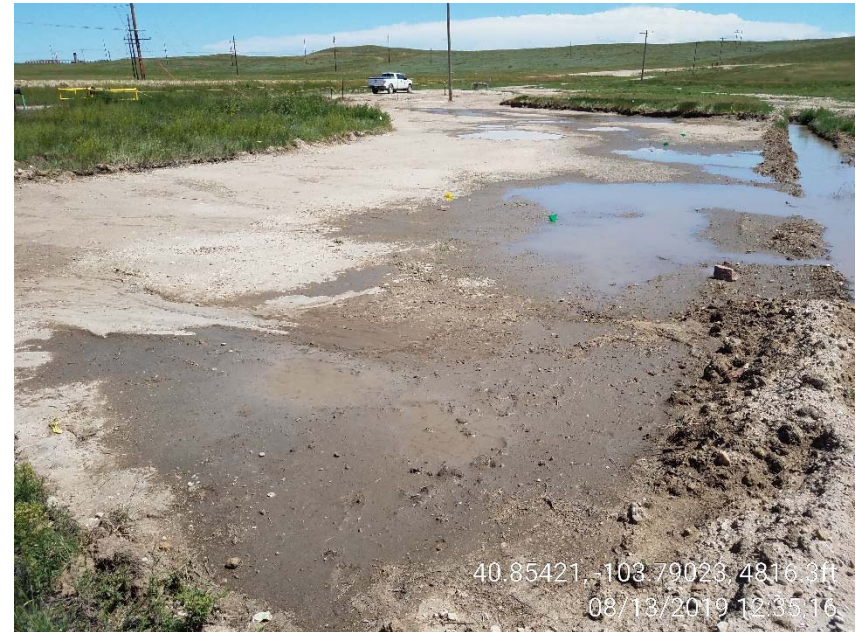
**Photo 6 – Photo of spill 465616 from approximate surface spill termination point viewing surface soil excavation, looking east.**
