Inspection Photos

ID: 441082

Operator: DOVER ATWOOD CORPORATION

Inspection Date: 8/14/2019

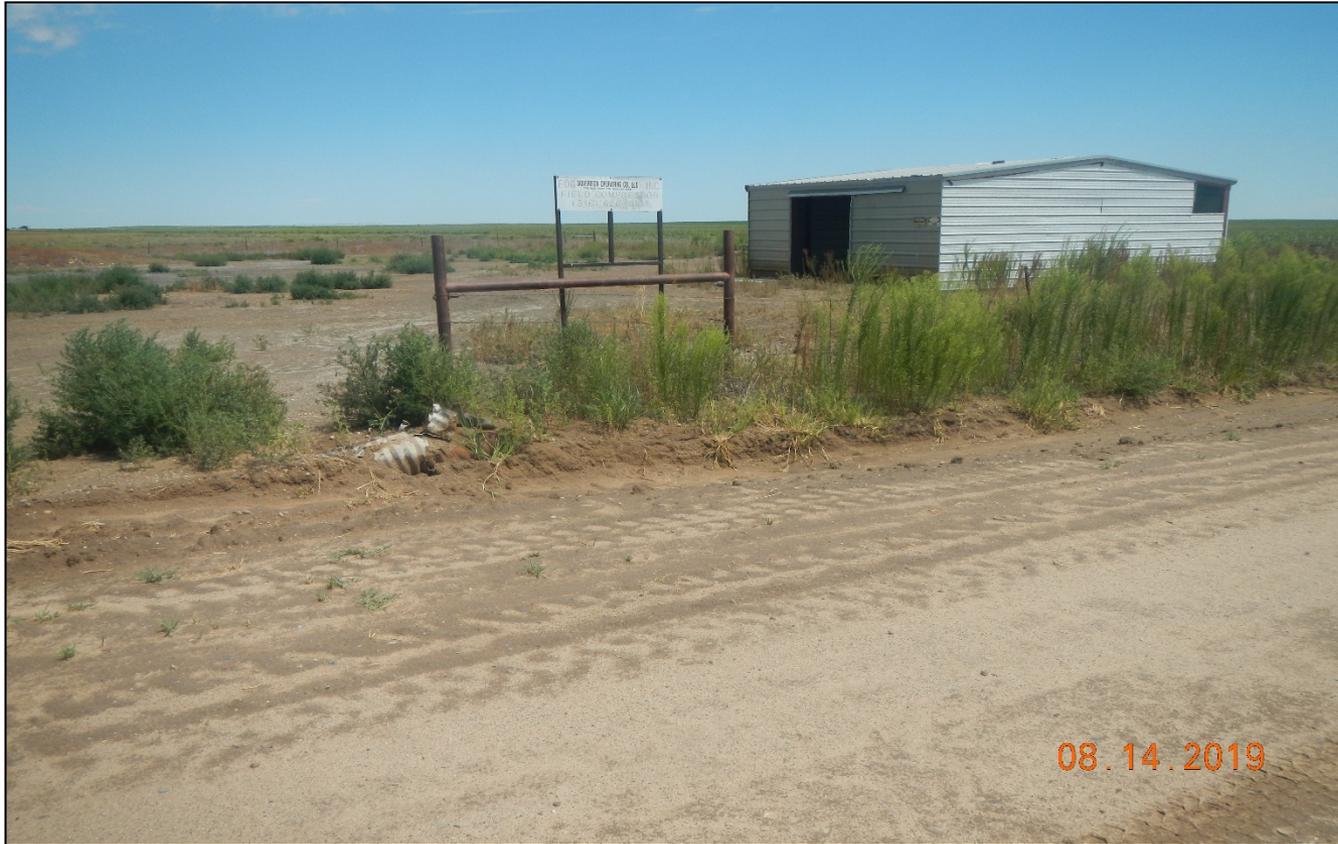
Photo 1. The old operator sign still remains at the location which needs to be removed. Unused GMR sheds have been removed since previous inspection.

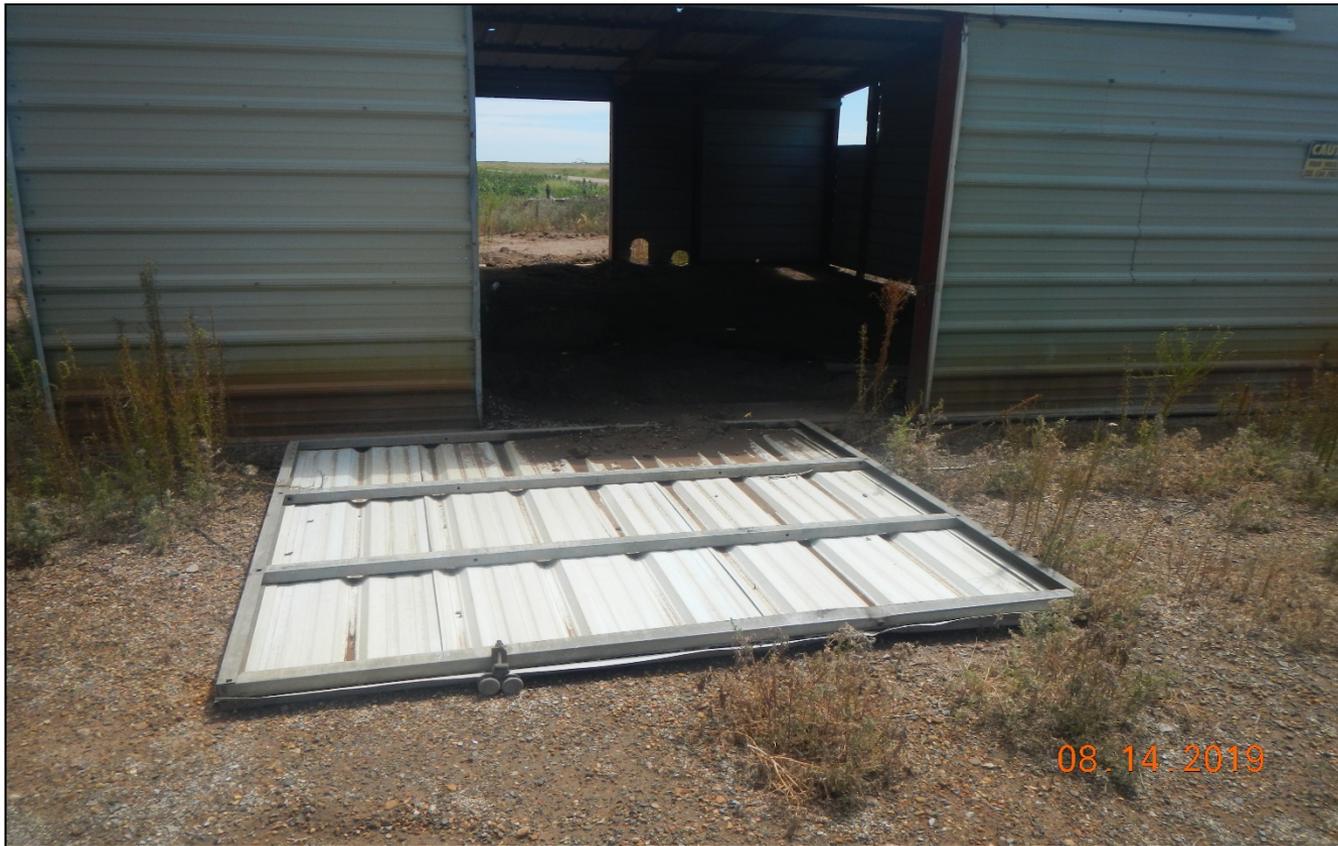
Photo 2. It appears equipment was removed out of the metal shed. Door is laying on the ground.

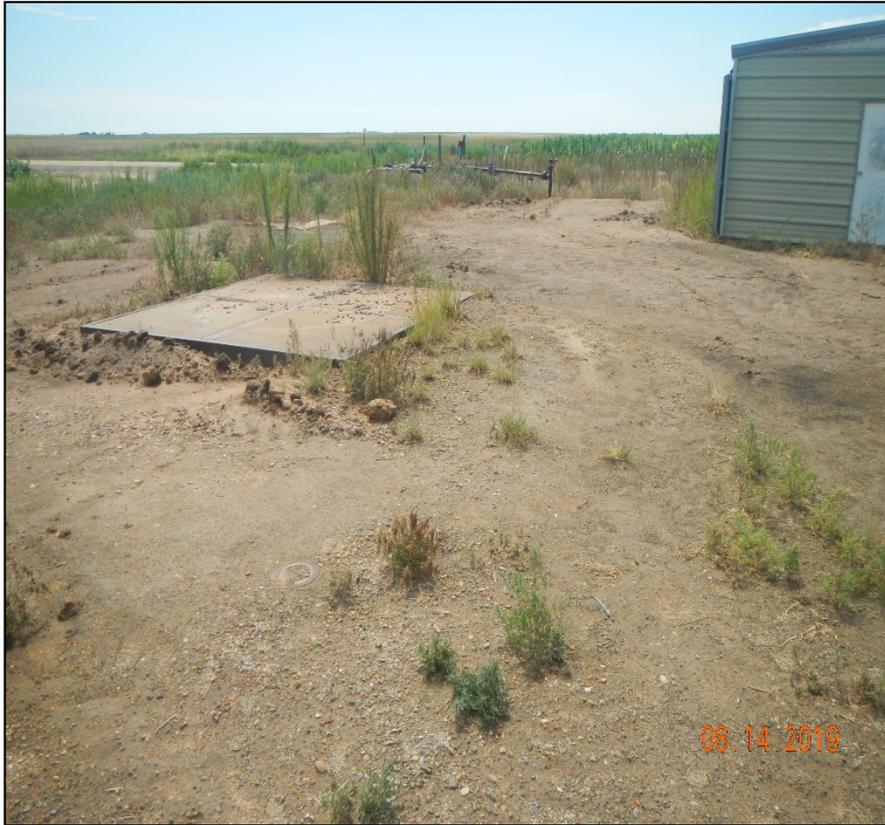
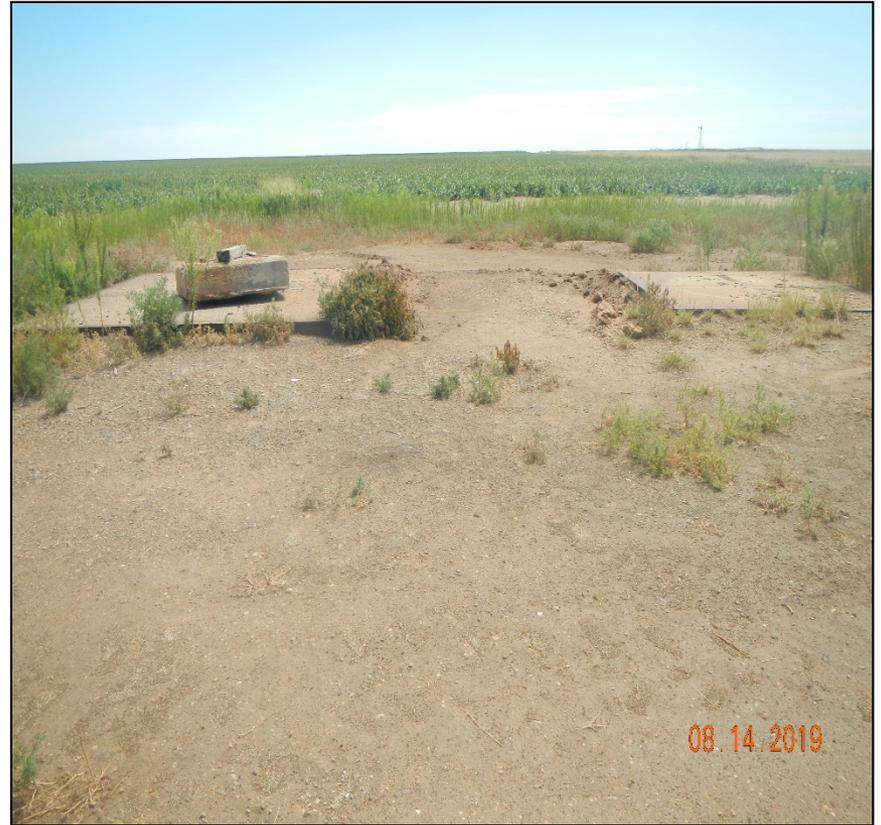
Photo 3 & 4. The pipe risers at the east side of the location were removed. Cement pads remain.

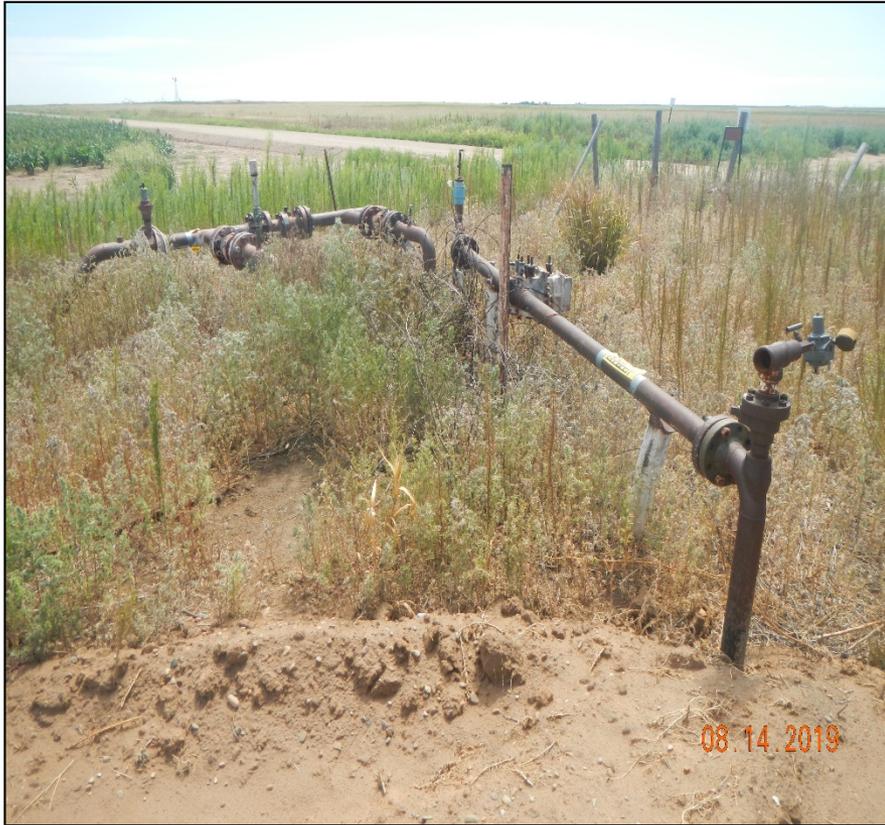
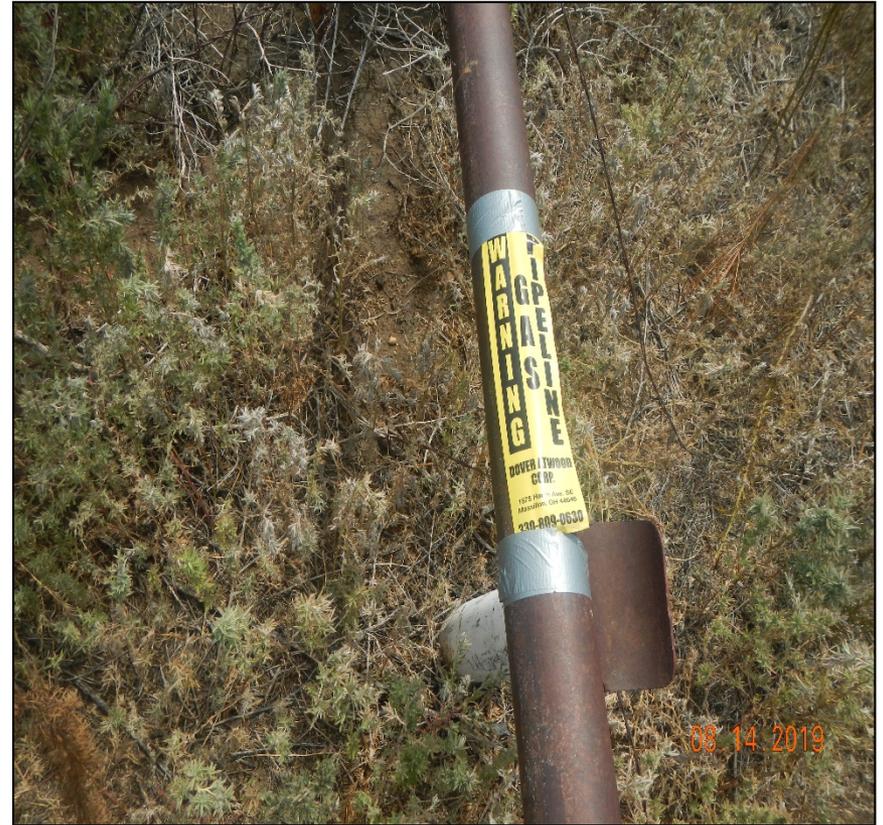
Photo 5 & 6. There is a gas pipeline that remains at the southeast corner of location. Operator sign is taped to the pipeline. This is not a permanent sign and is not sufficient.

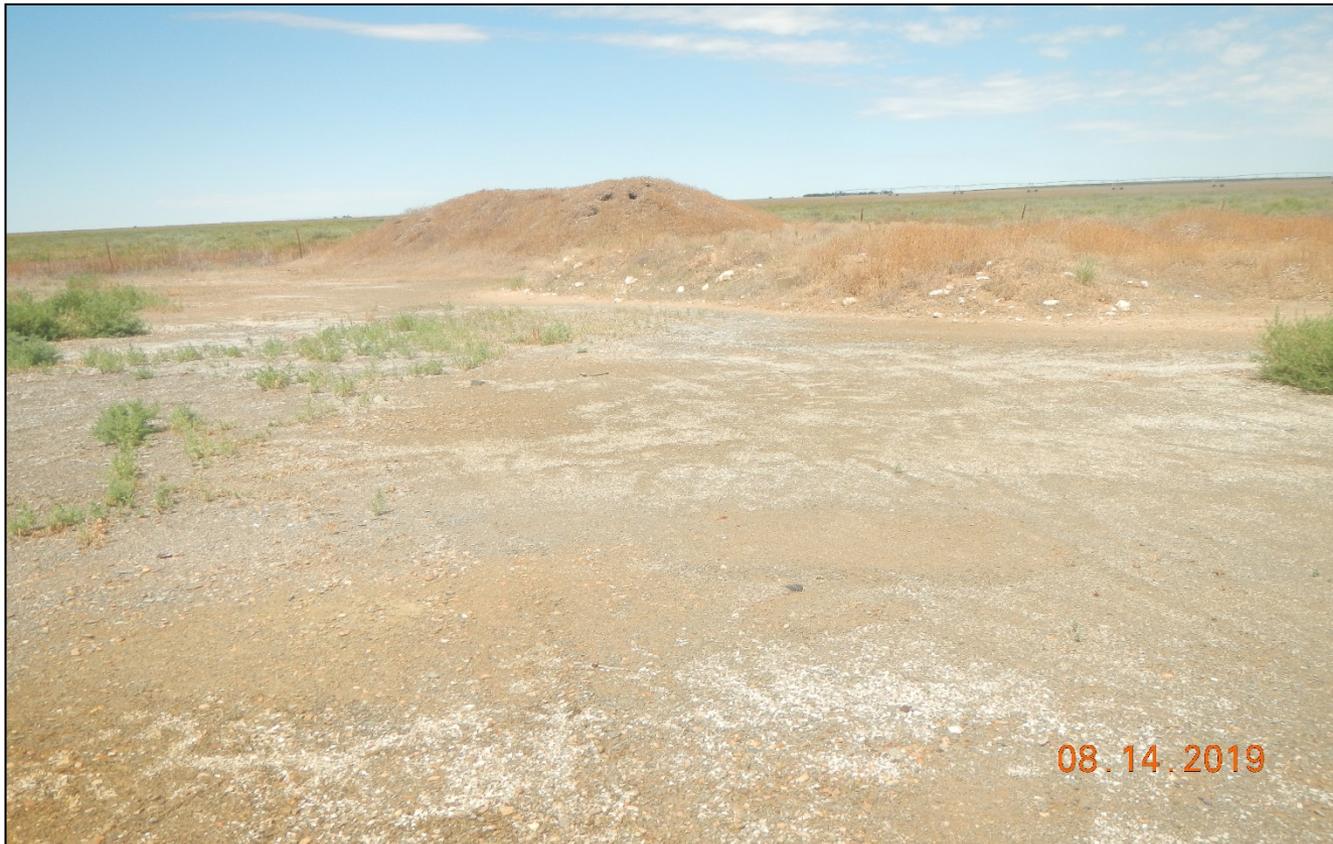
Photo 7. There is material waste piles that remain at the northwest side of the location.

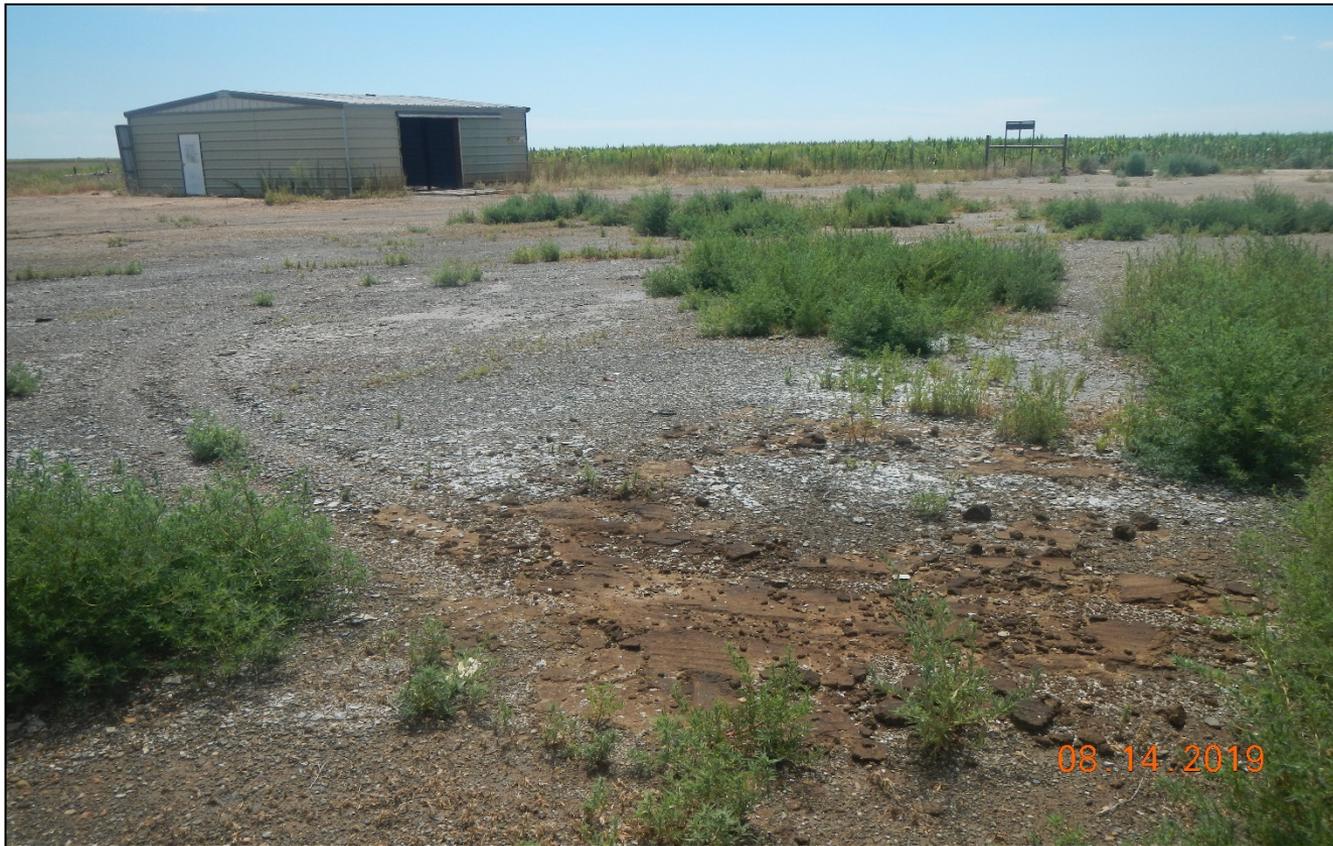
Photo 8. Unused areas of the location must be reclaimed.
