Inspection Photos

API: 05-009-06189

Operator: DOVER ATWOOD CORPORATION

Inspection Date: 8/14/2019

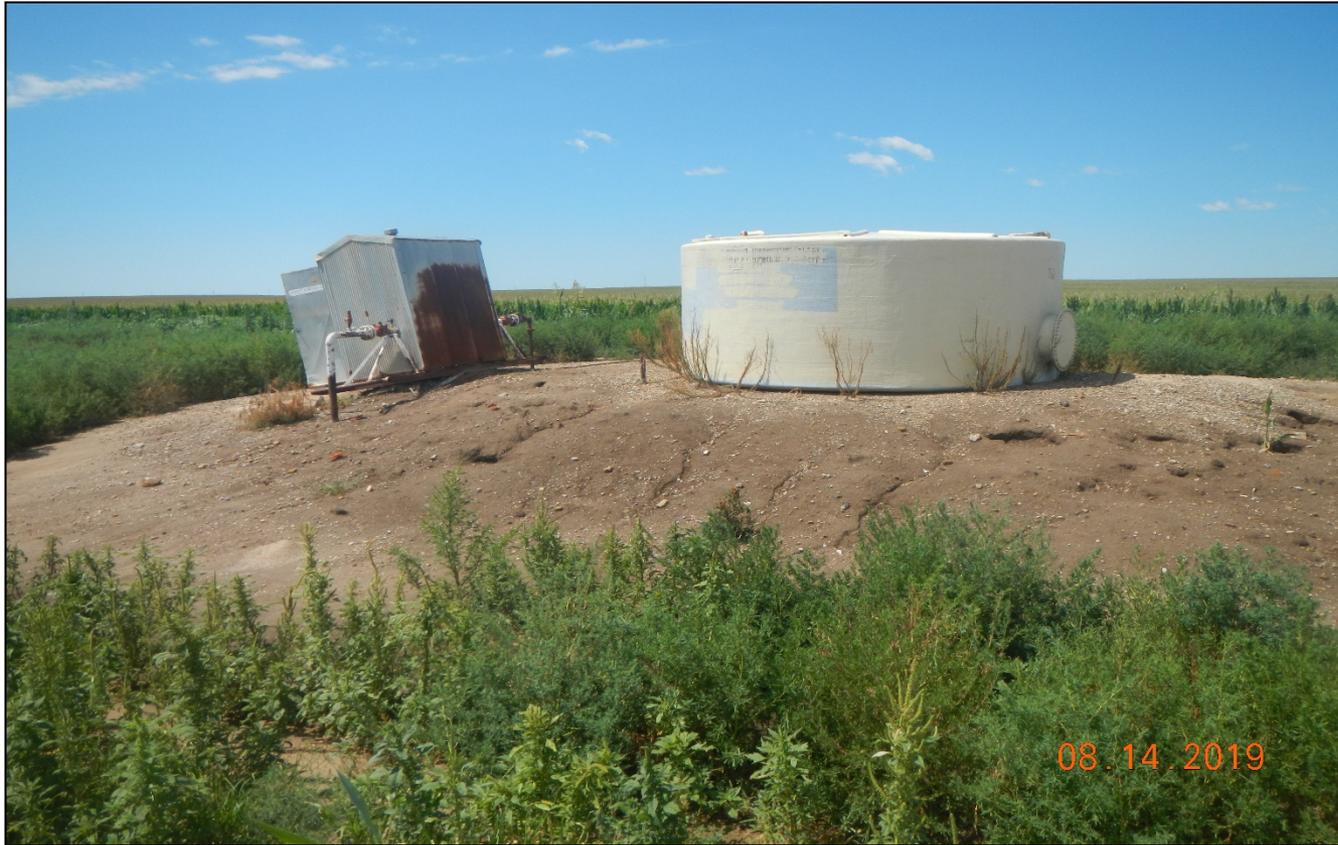
Photo 1. Facing west toward the PW tank and meter shed located adjacent to CR-49 and 575' east of the well. No operator sign installed at the battery site.

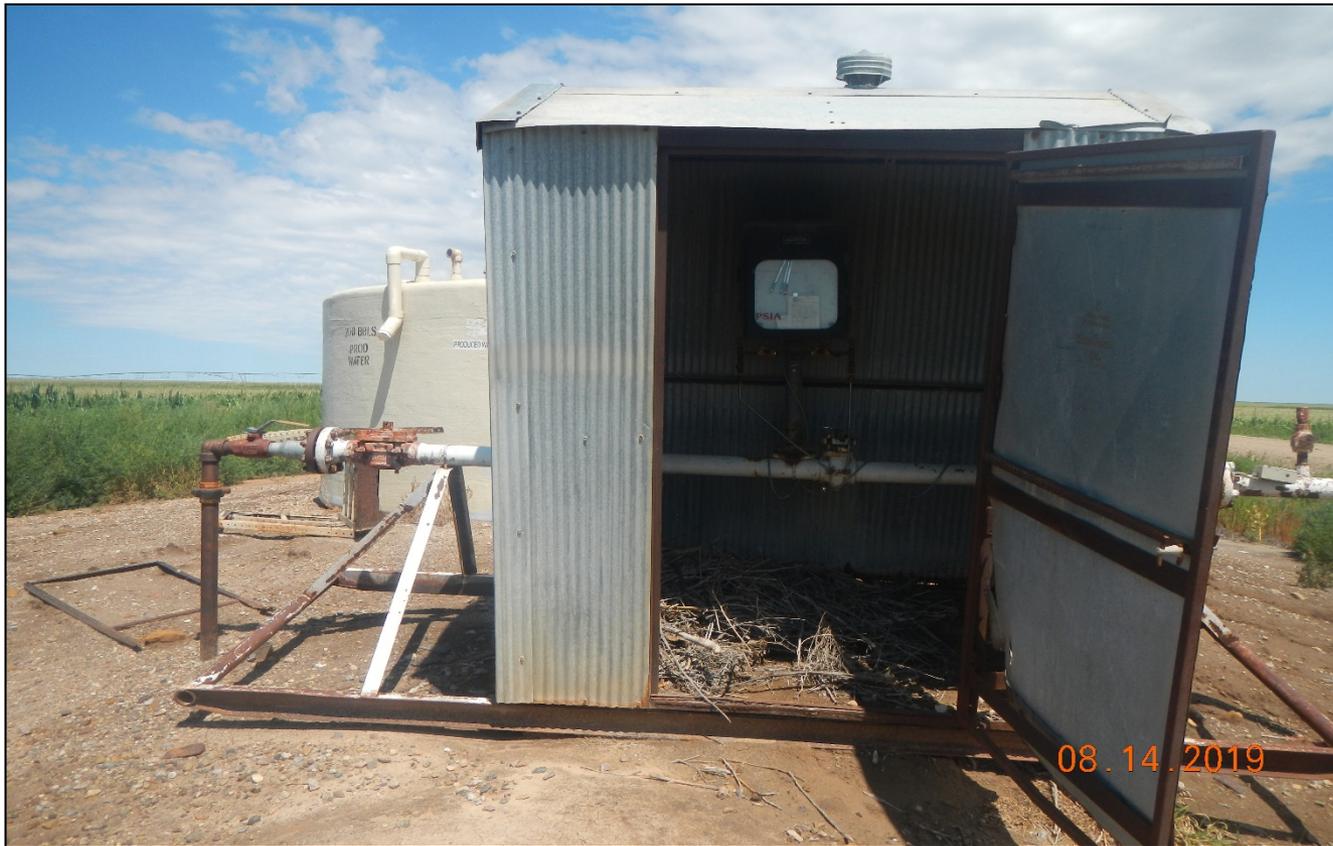
Photo 2. There was a hissing sound and strong odor around the meter shed. Operator was notified by phone the next day. The door is left open at shed and a lot of debris is inside.

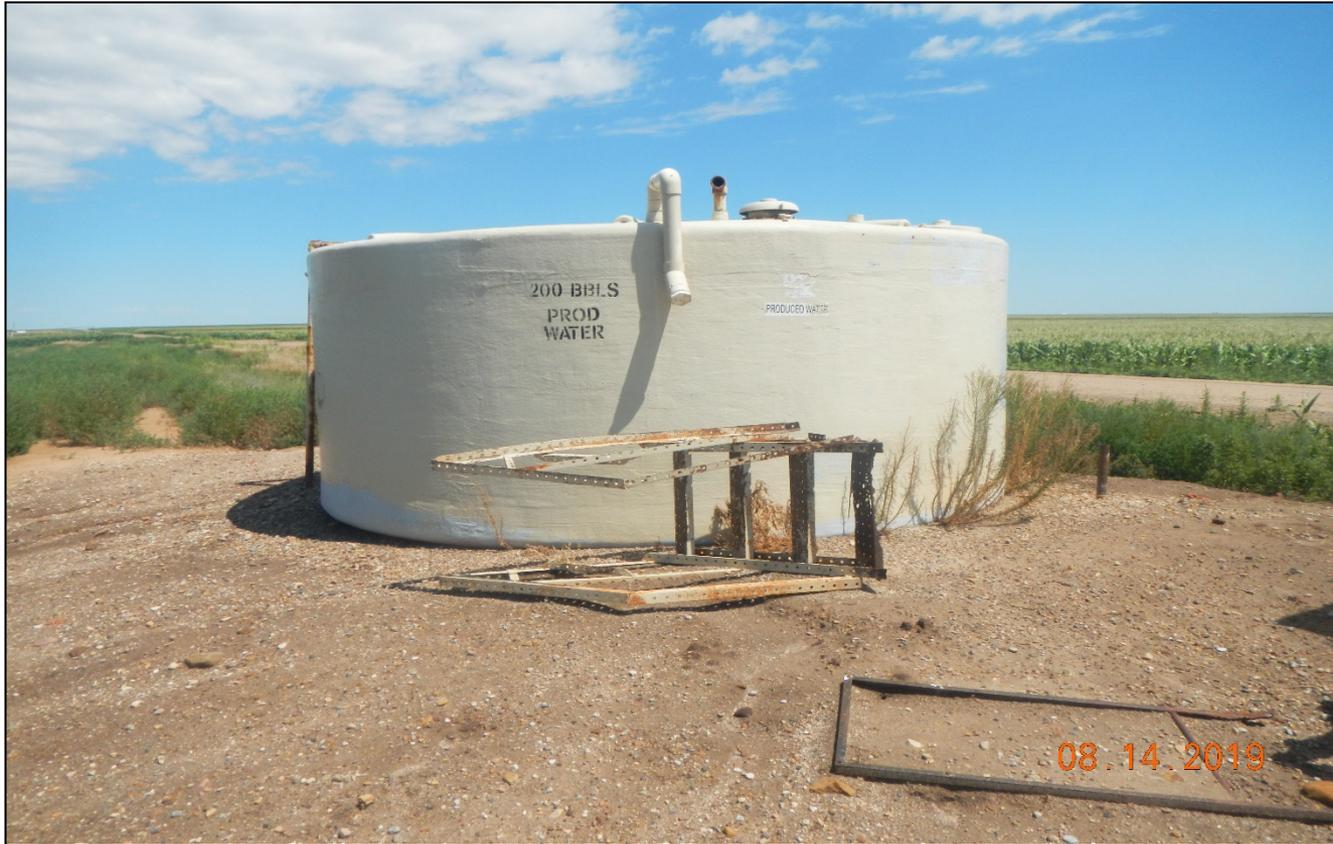
Photo 3. There is no berm around the 200 bbls tank. There is unused equipment at the location.

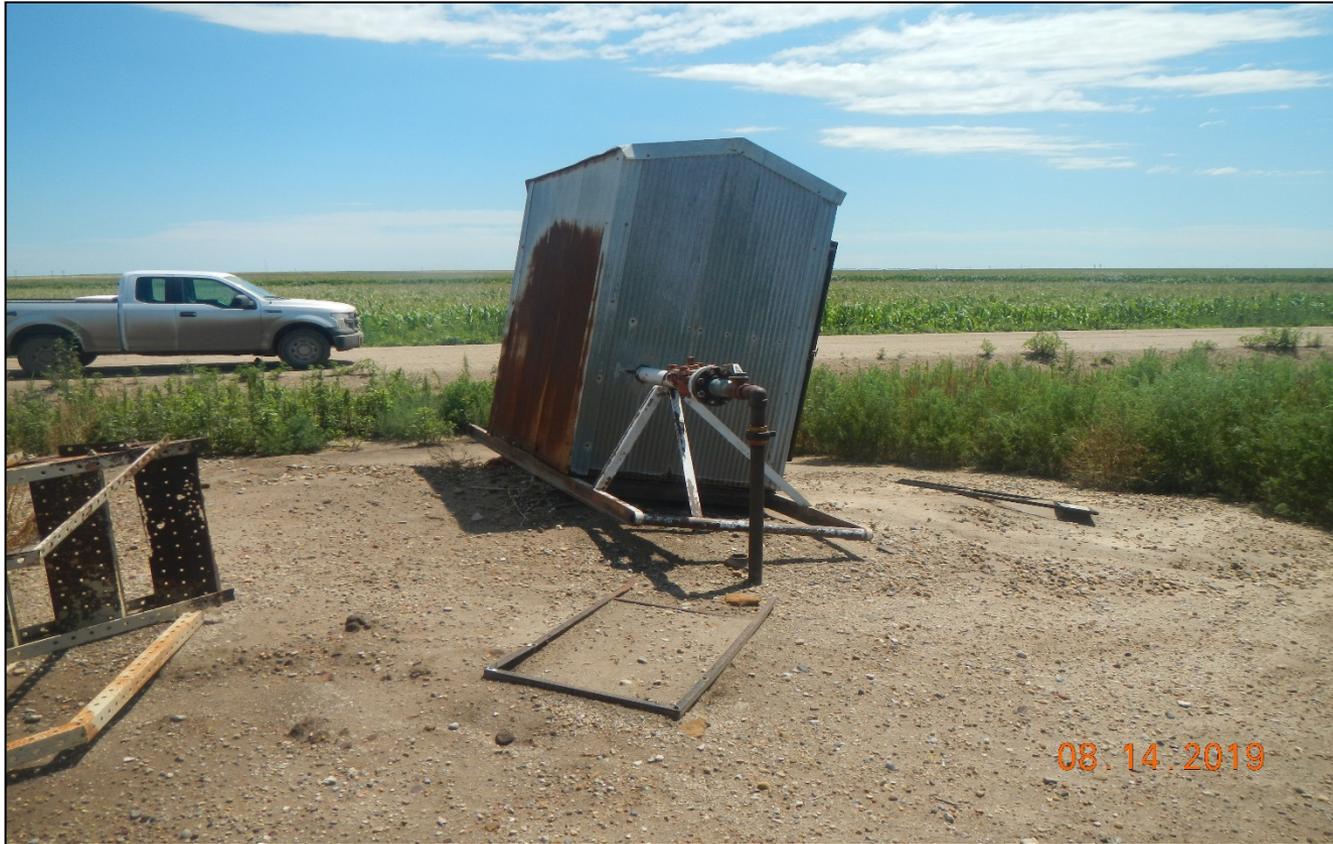
Photo 4. The meter shed does not appear to be stable and is leaning over which is a safety concern.
