Inspection Photos

Location Name: N Parachute EF 12A-19 L19595 Pad and L19-595 Dumpline Spill/Release

Location ID: #335635 & Spill/Release ID: #466606

Inspection Date: August 12, 2019

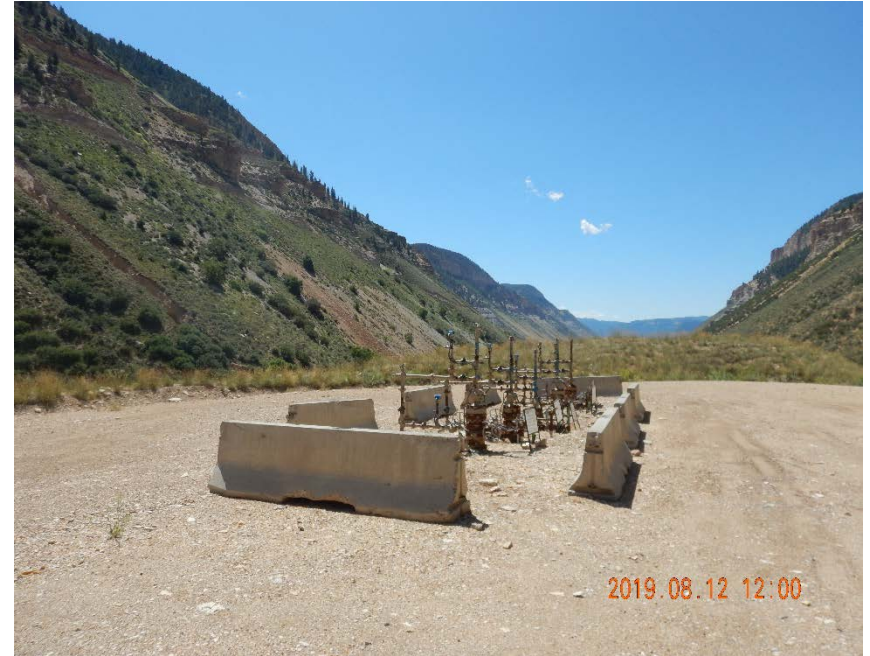
Photo #2 – Overview of wellhead area, from north.

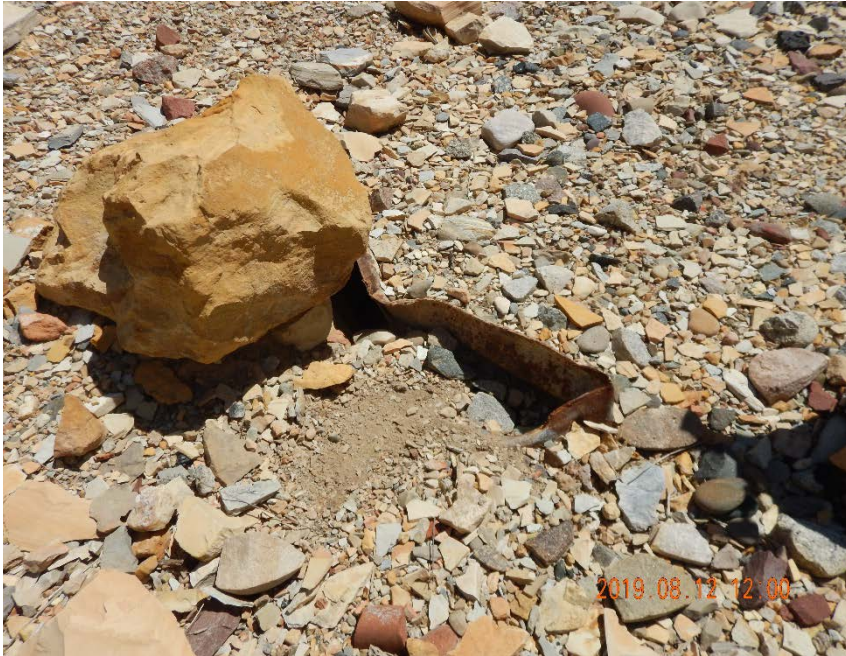
Photo #3 – Metal scraps inside of wellhead area (1).

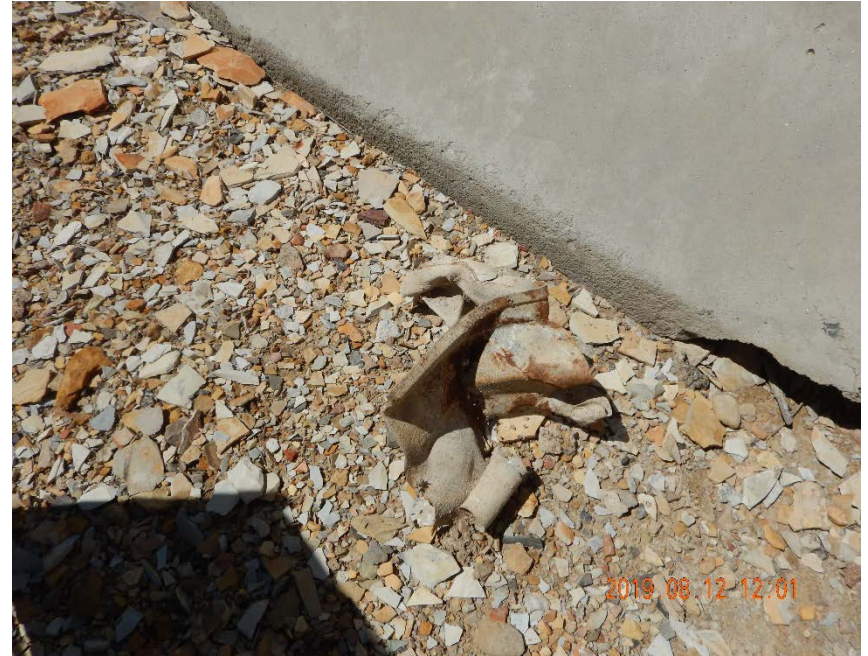
Photo #4 - Metal scraps inside of wellhead area (2).

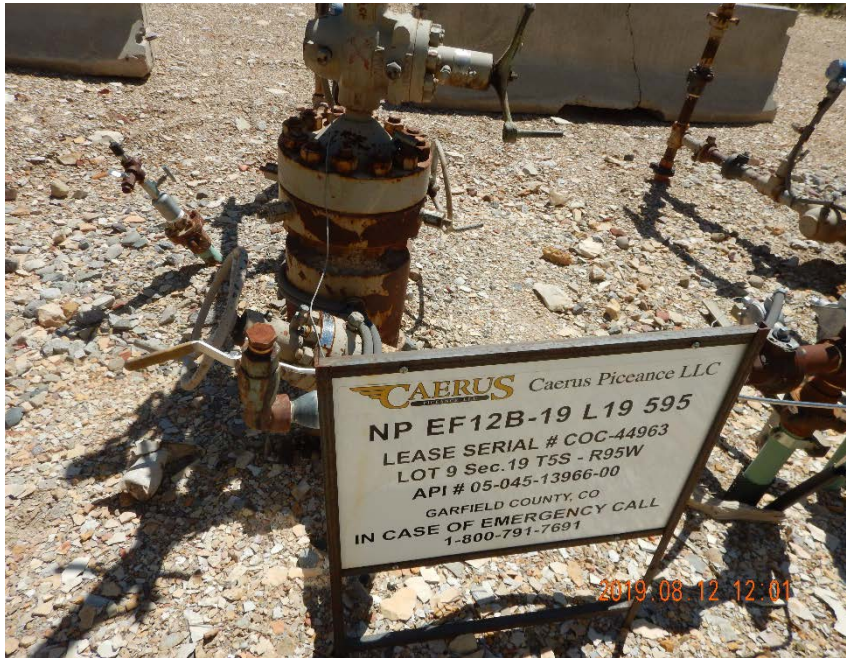
Photo #5 – NP EF12B-19 L19 595 sign and wellhead.

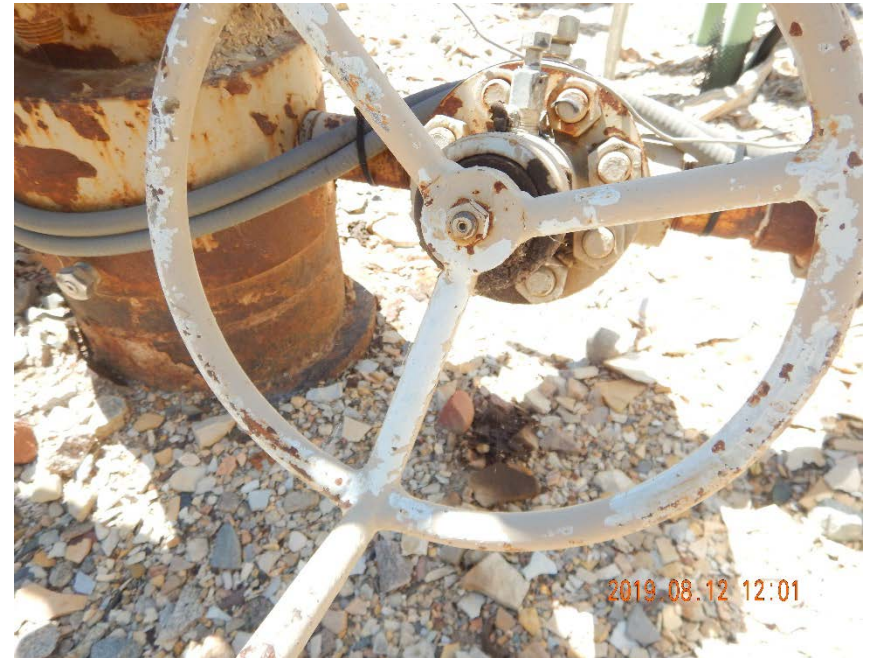
Photo #6 – Accumulation of oily waste beneath NP EF12B-19 L19 595 wellhead equipment.

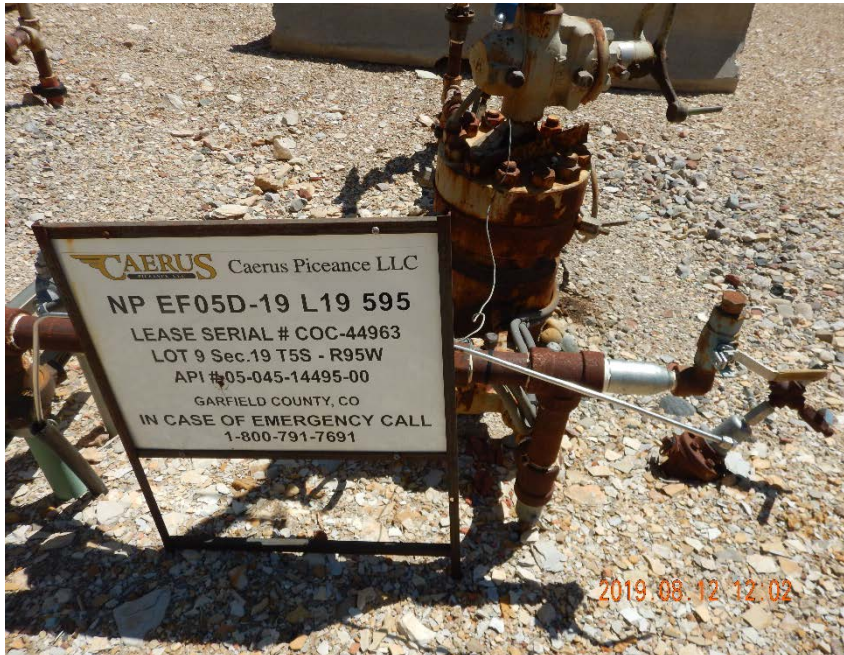
Photo #7 - NP EF05D-19 L19 595 sign and wellhead.

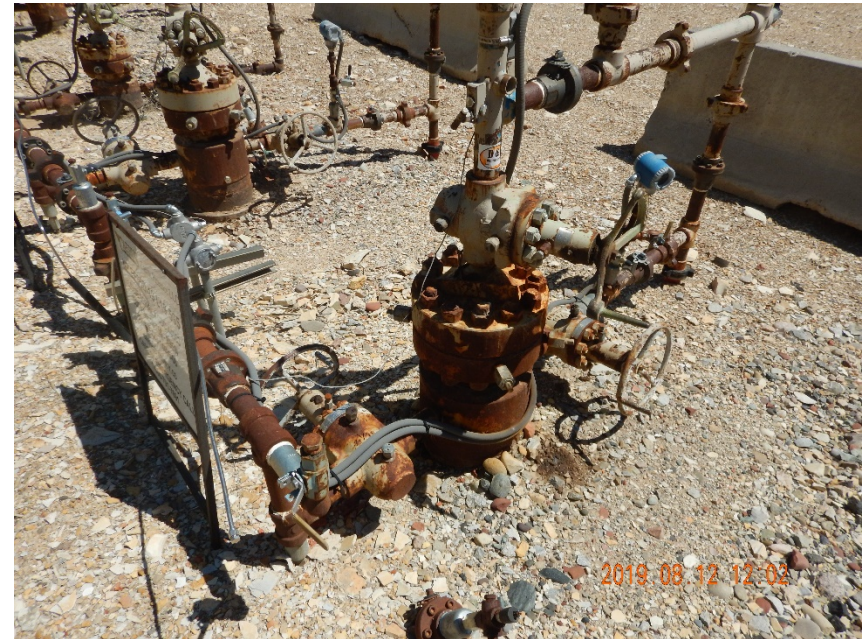
Photo #8 - Accumulation of oily waste beneath NP EF05D-19 L19 595 wellhead equipment.

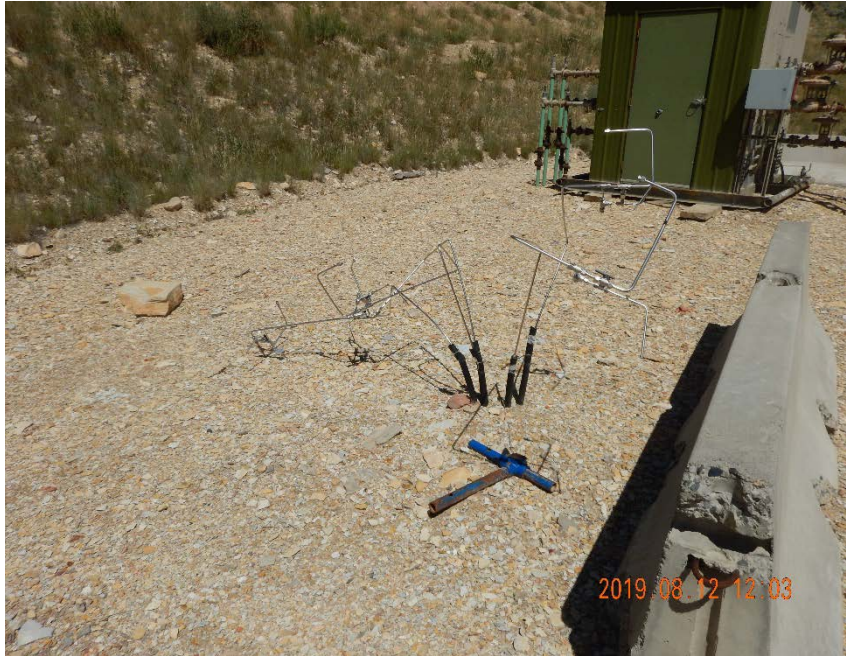
Photo #9 – Process pipe risers located south of gas meter shed.

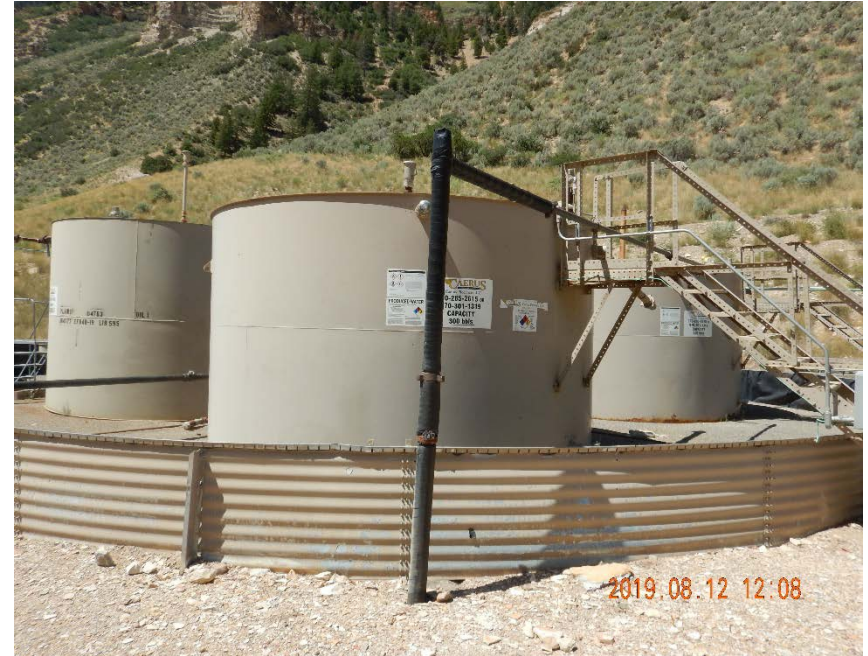
Photo #10 – Overview of tank battery, from northeast.

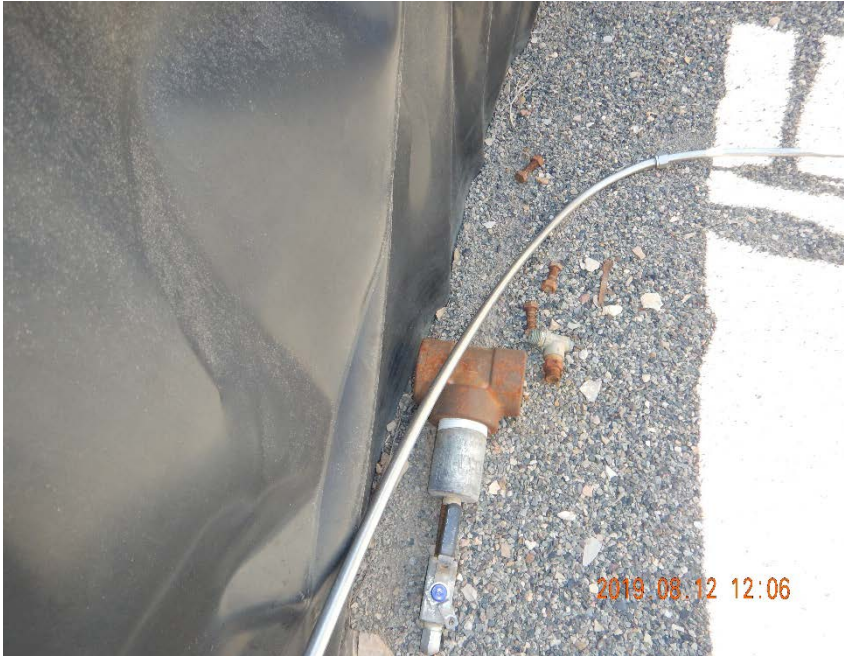
Photo #11 – Assorted metal equipment stored inside of lined tank battery area.

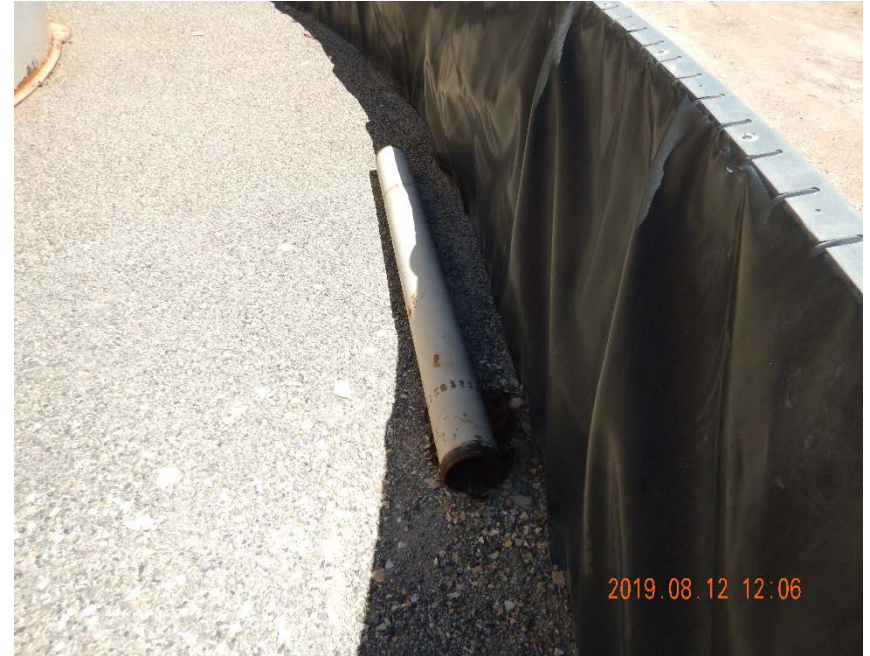
Photo #12 – Unused pipe stored inside of lined tank battery area.

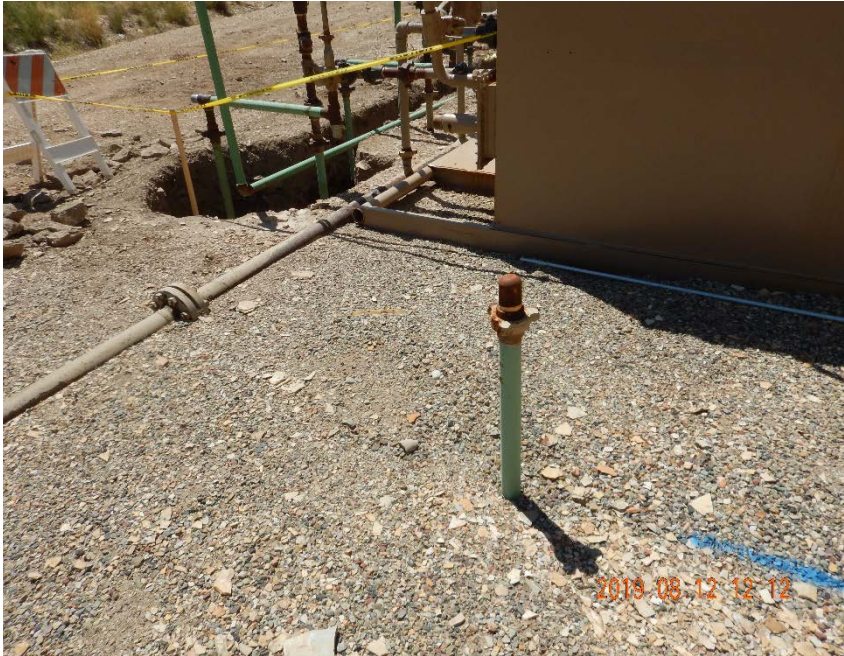
Photo #13 – Unused, unmarked 2" flowline riser north of separators.

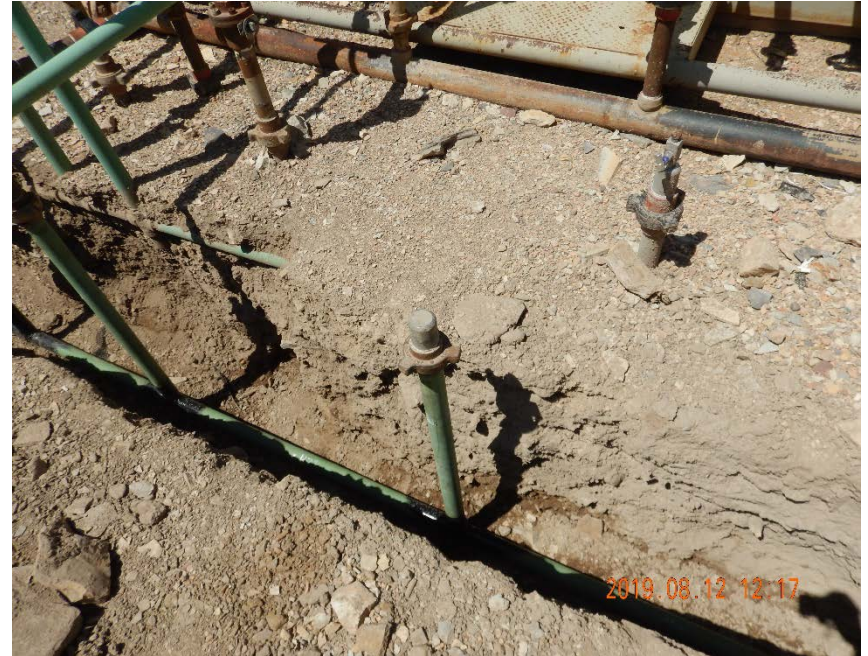
Photo #14 – Unused, unmarked 2" flowline riser east of separators.

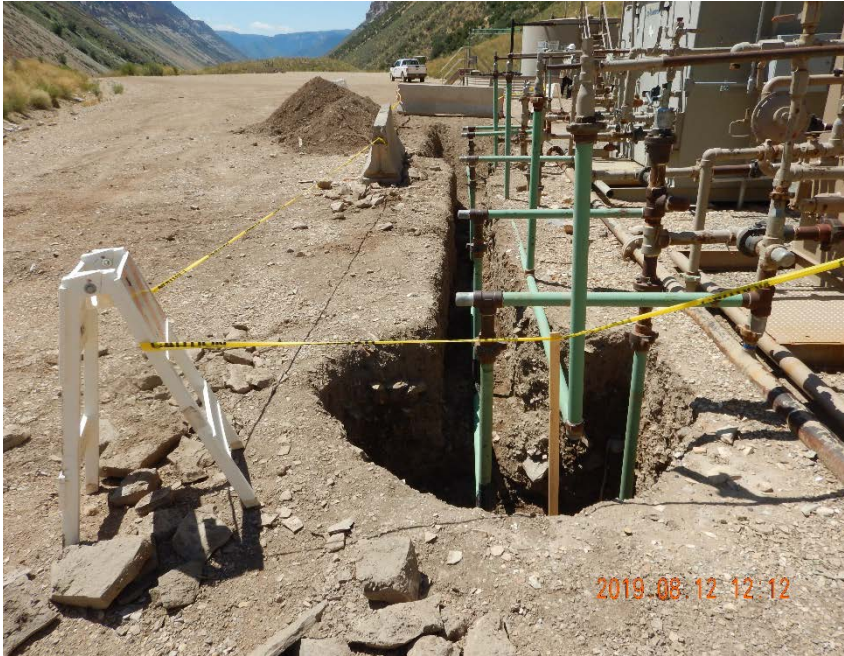
Photo #15 – Overview of open trench and excavation related to Spill/Release ID #466606.

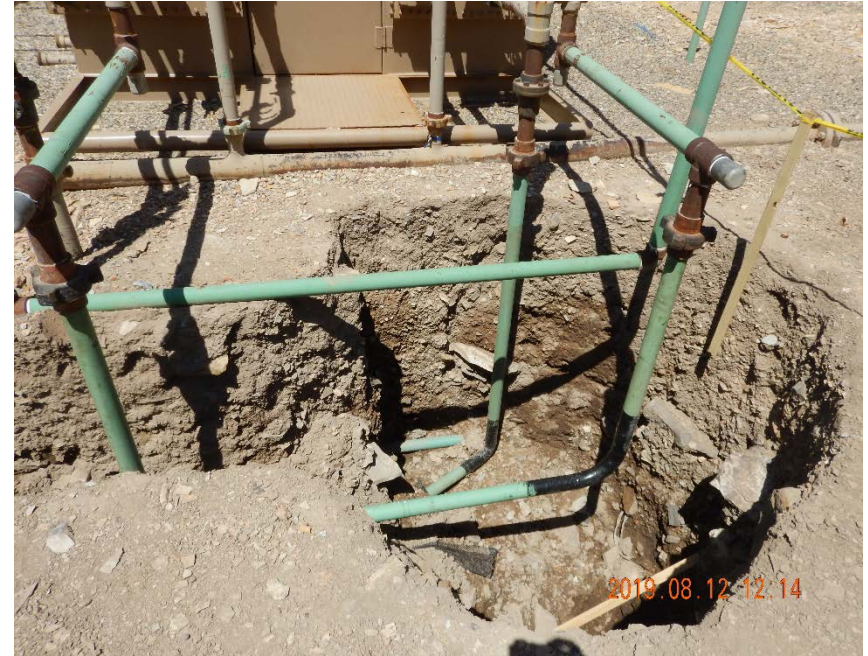
Photo #16 – Moist soil inside of northern end of excavation.
