# UNION ENERGY MINING DIV. GM 34-33

## Location # 334868

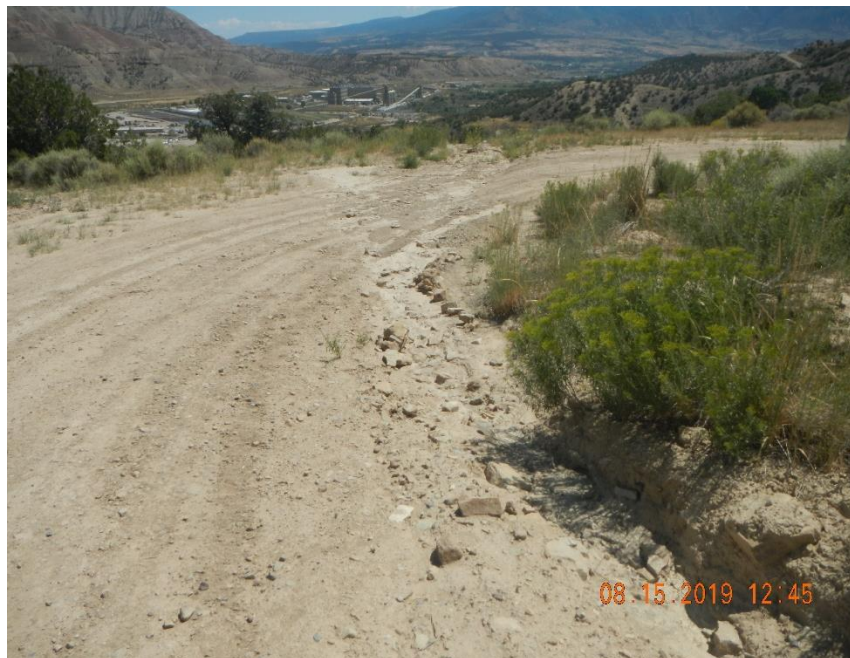
**Ditch north of location.**

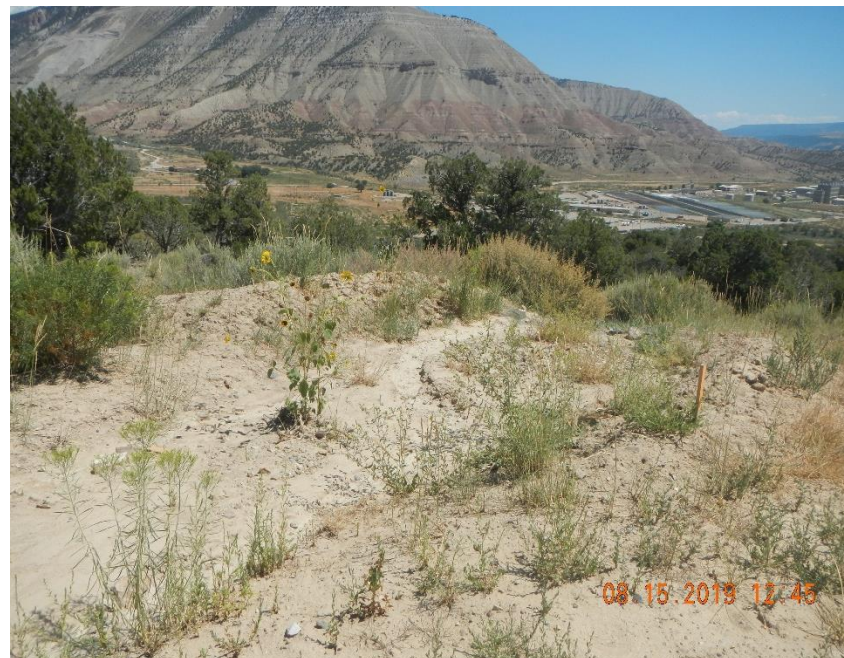
**Sediment in check dam.**

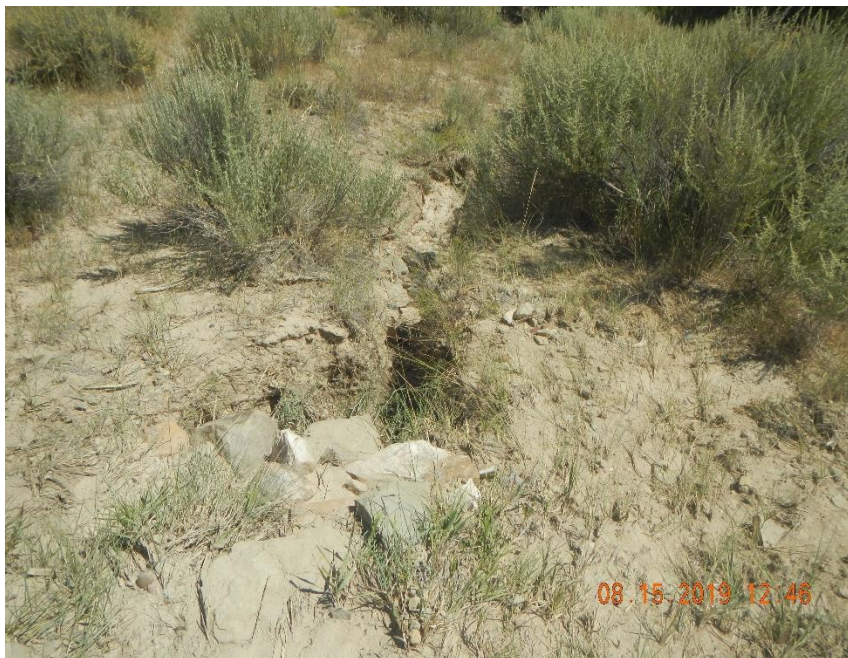
Erosion of check dam outlet.

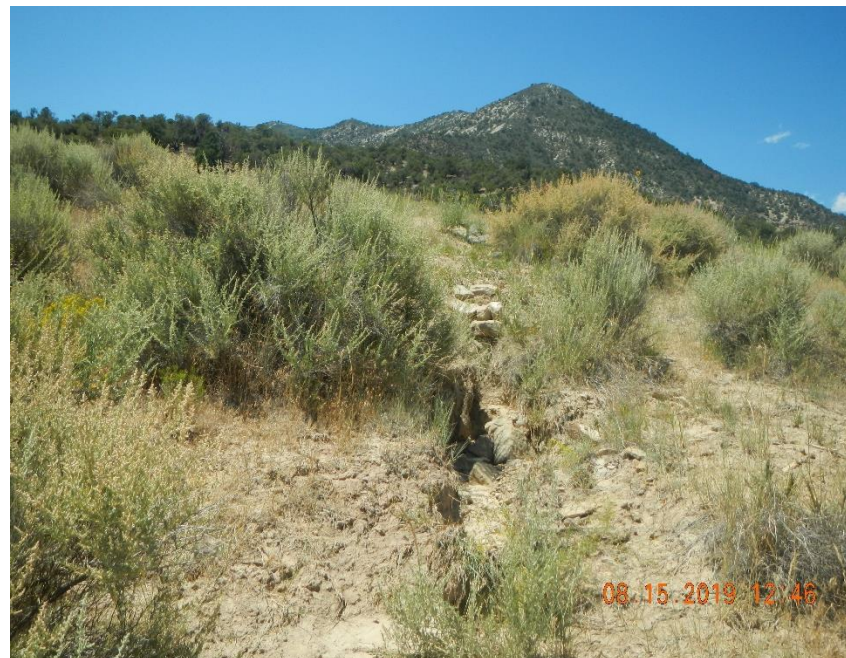
Erosion of check dam outlet.

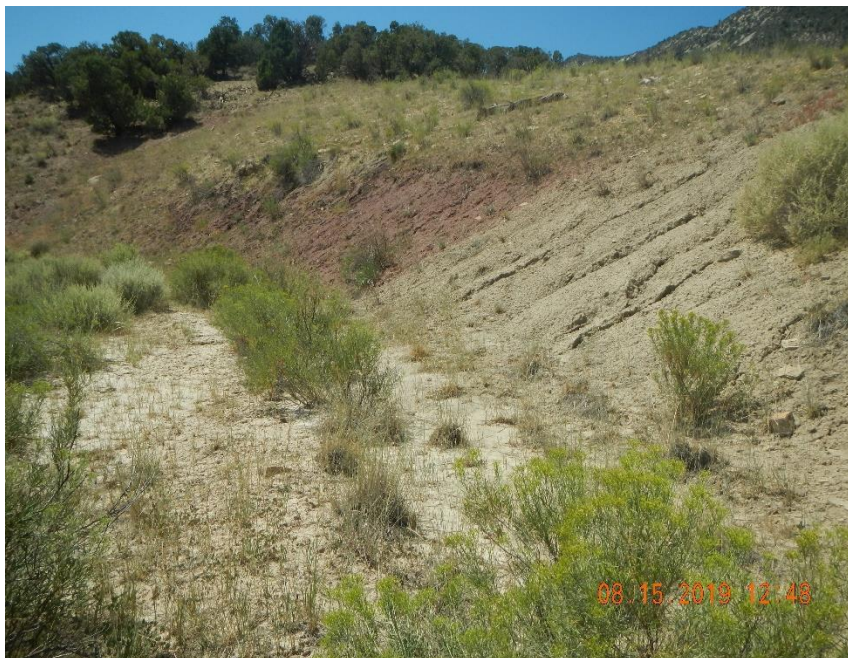
**Sediment movement of slope on west side of wells.**

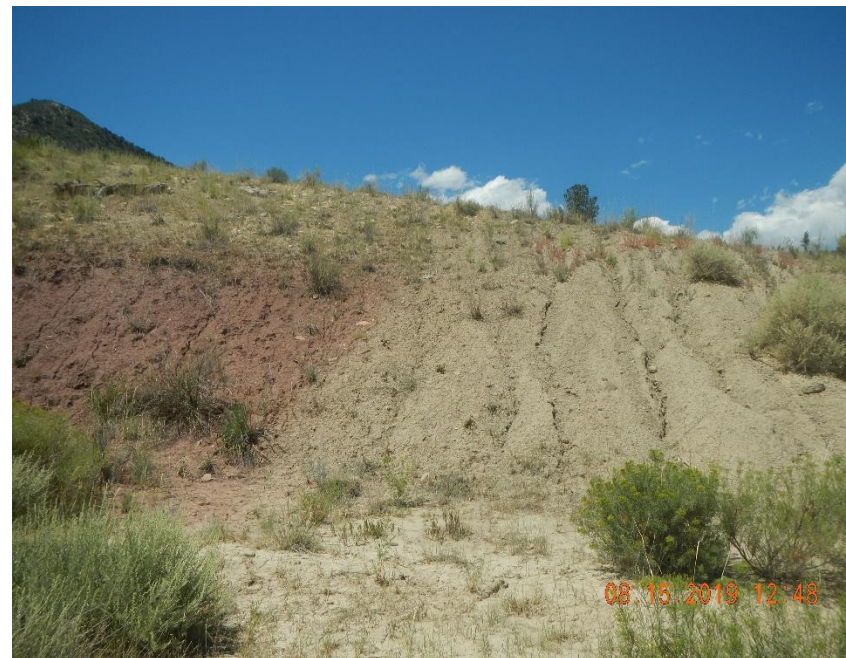
**Sediment build up in ditch.**
