Inspection Photos

08/14/2019

Operator: PHOENIX RESOURCES LLC - 10691

Location ID: 414589

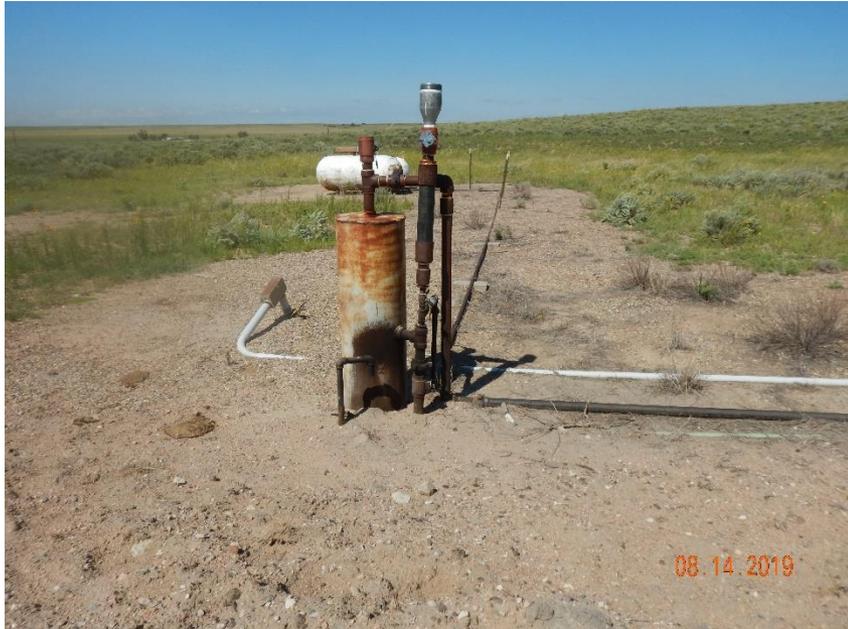
Photo 1: Photo taken from the west end of the location, facing west. Photo shows open 5 gallon container with chemical has been removed and soils appear to have been cleaned.

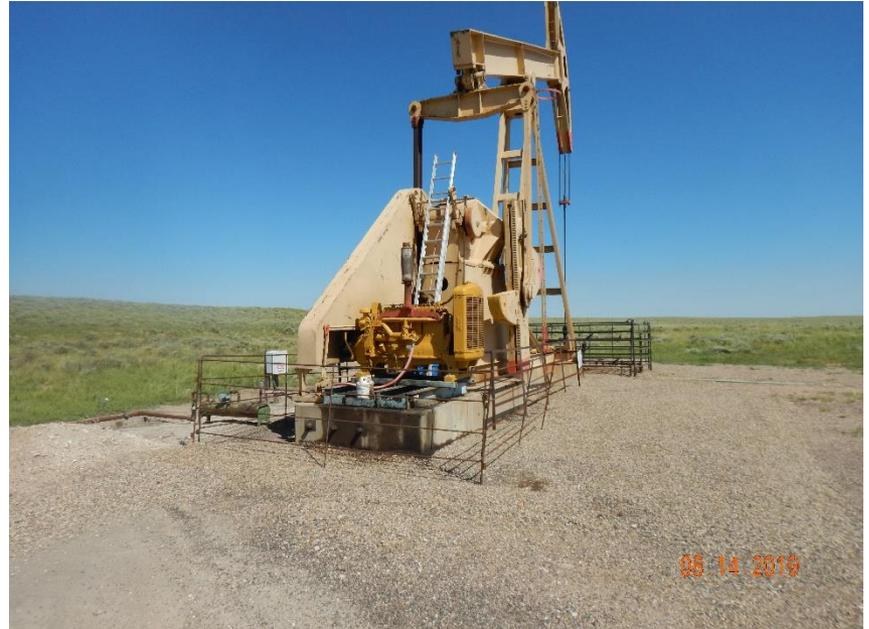
Photo 2: Photo taken from the west end of the location, facing north. Photo shows 5 gallon containers stored outside of secondary containment has been removed, or properly stored.

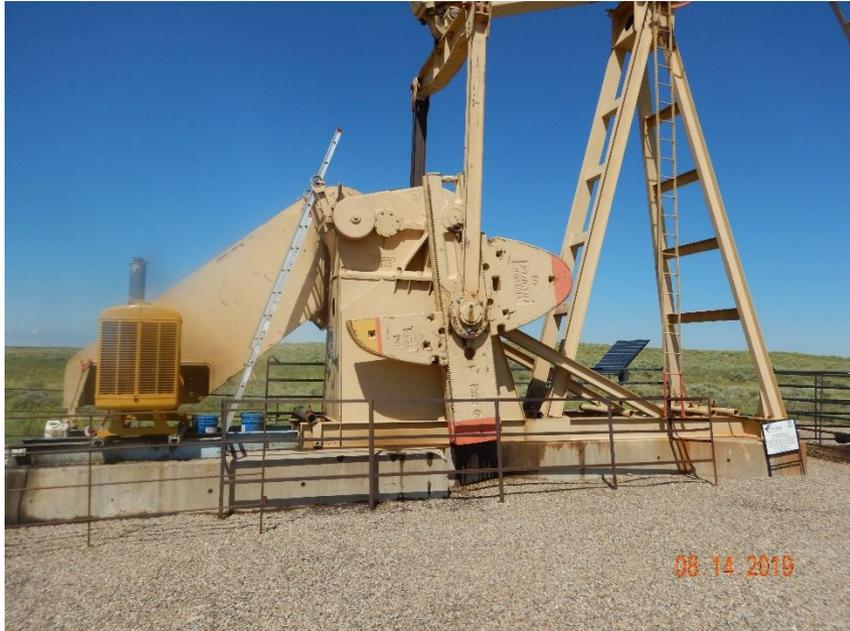
Photo 3: Photo taken from the west end of the location, facing west. Photo shows 5 gallon containers stored outside of secondary containment has been removed, or properly stored.

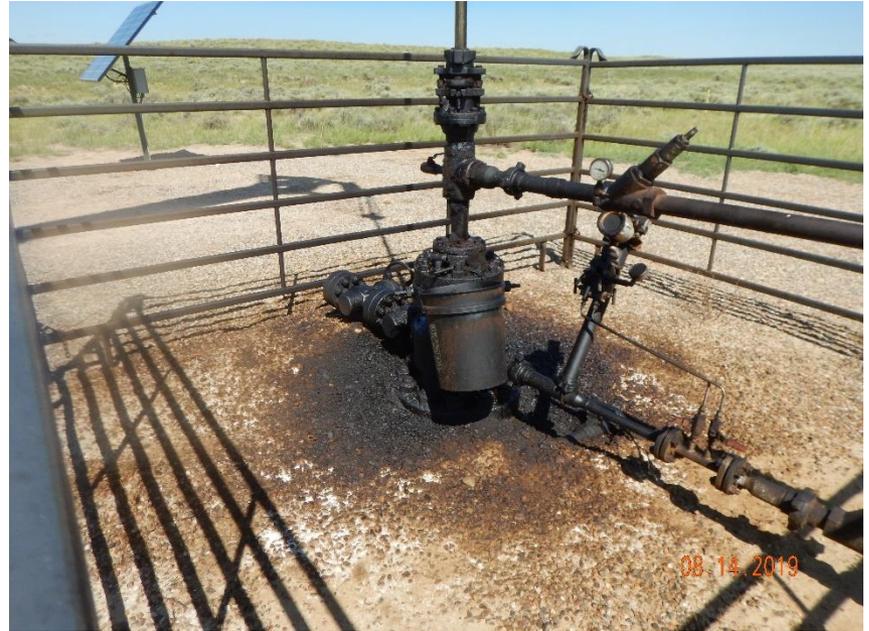
Photo 4: Photo taken from the well head. Photo shows stained soils around wellhead.

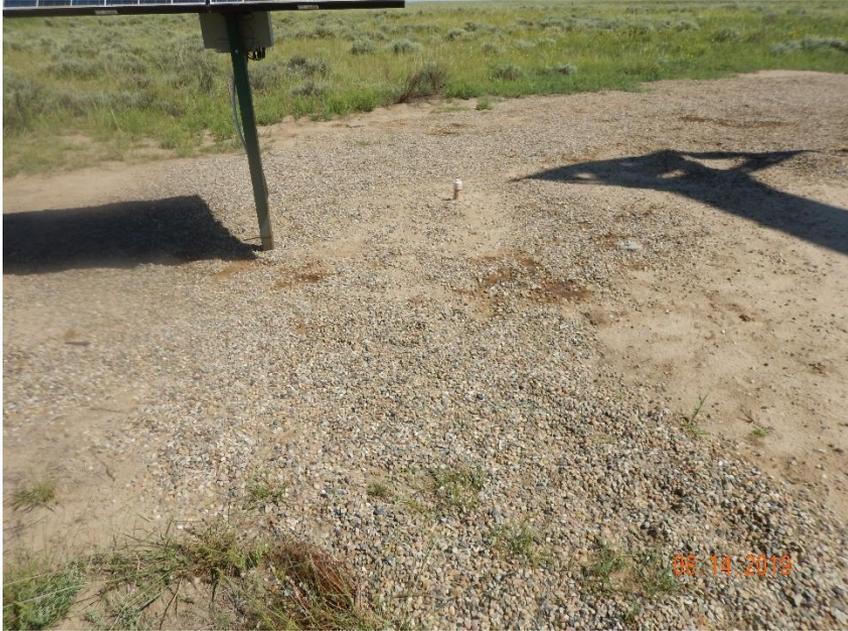
Photo 5: Photo taken from the solar panel to the west of the well head. Photo shows areas impacted by spill. Photo shows stained soils remain evident.

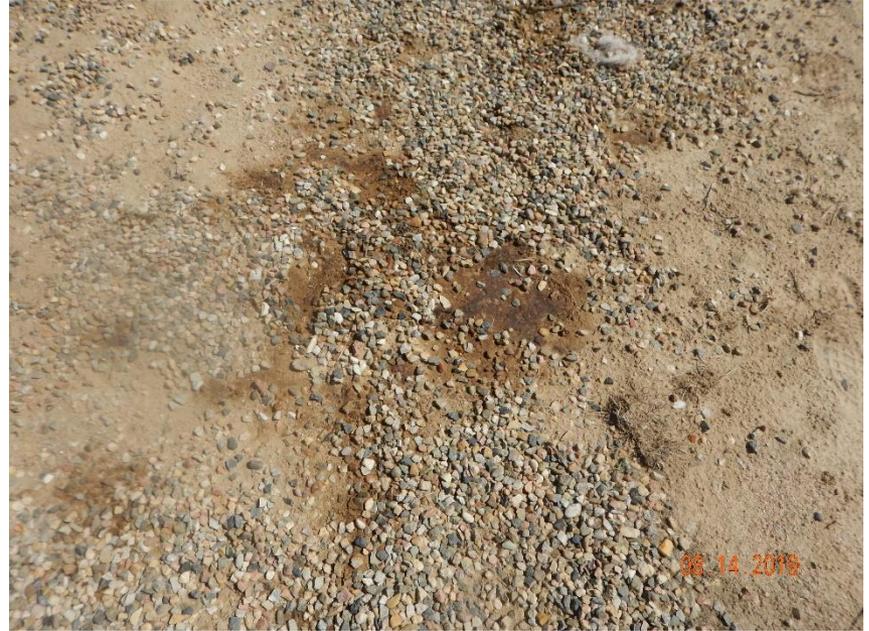
Photo 6: Continued from photo 5. Photo shows stained soils remain evident.

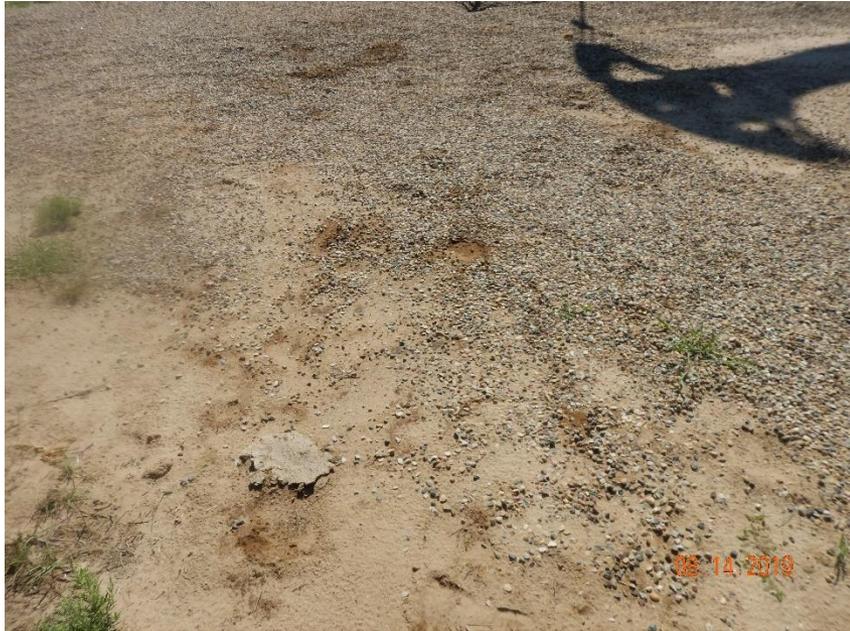
Photo 7: Photo taken from the areas impacted by spill on the north end of the well. Photo shows stained soils remain evident.

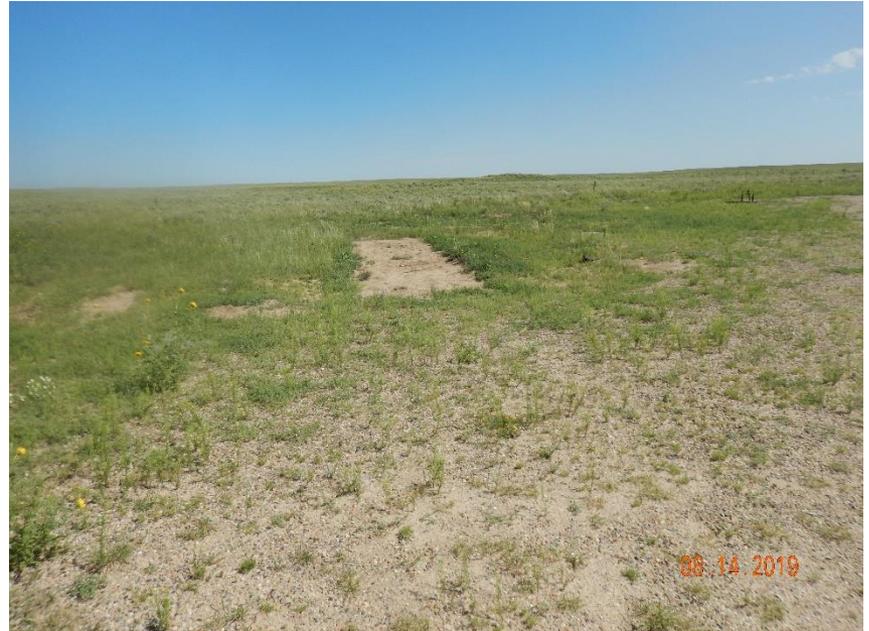
Photo 8: Photo taken from the east end of the location, facing north. Photos 8-10 show equipment not needed for production activities have been removed from the location. Photos also show that additional reclamation activities have not been conducted.

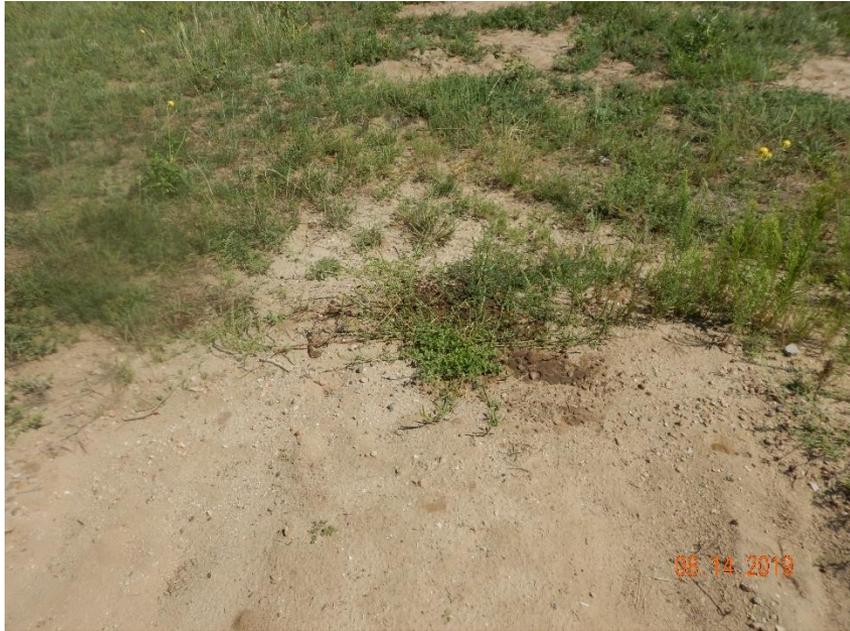
Photo 11: Photo taken from where the container was being stored on the northeast end of the location. Photo shows areas where open 5 gallon containers were stored and contaminated the soils. Photo shows stained soils have not been cleaned.

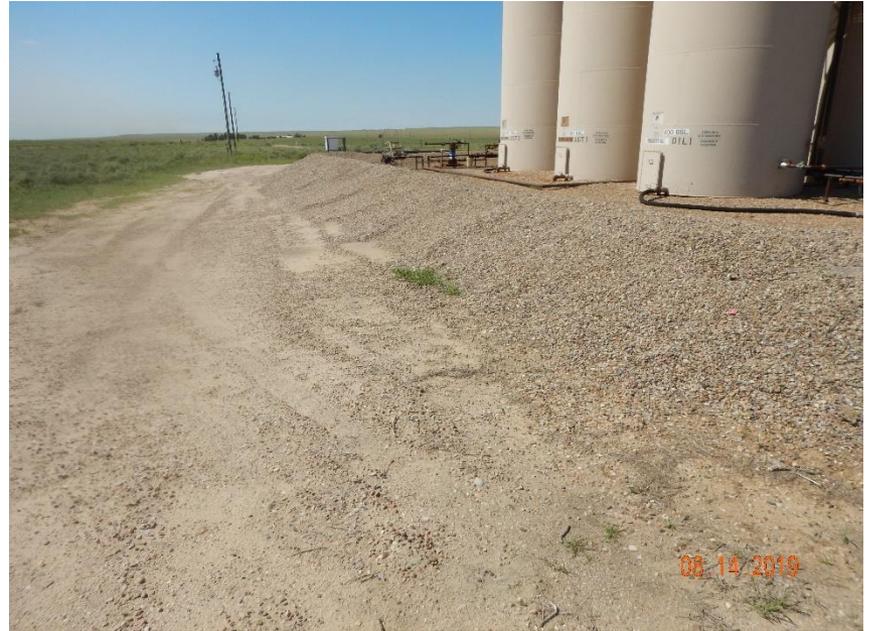
Photo 12: Photo taken from the east end of the tank battery, facing south. Photo shows vegetation has been removed from the berms.

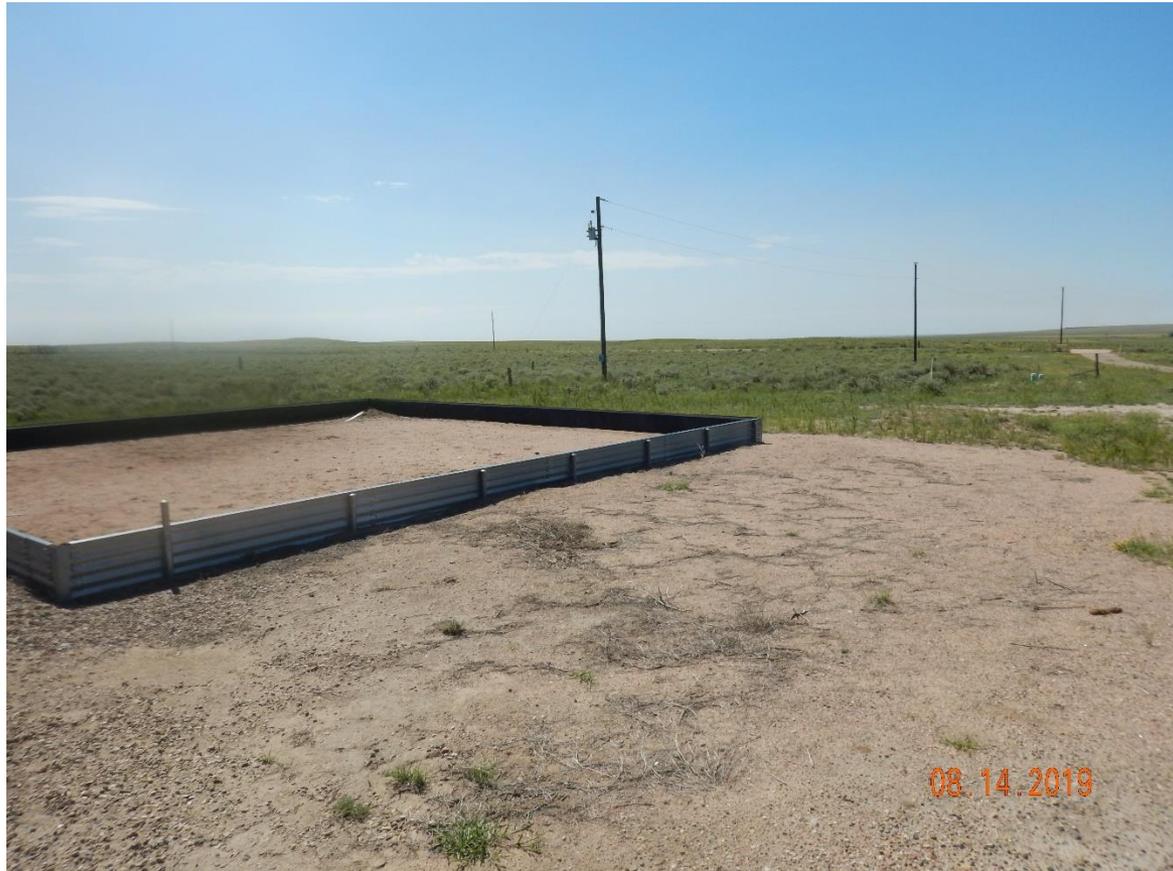
Photo 13: Photo taken from the south end of the location, facing south. Photo shows tubing has been removed from the south end of the location.
