# Inspection Photos

08/14/2019

Operator: ABILENE PERFECT ENERGY JV LLC -  
10581

Location ID: 433129  
Lincoln County, CO

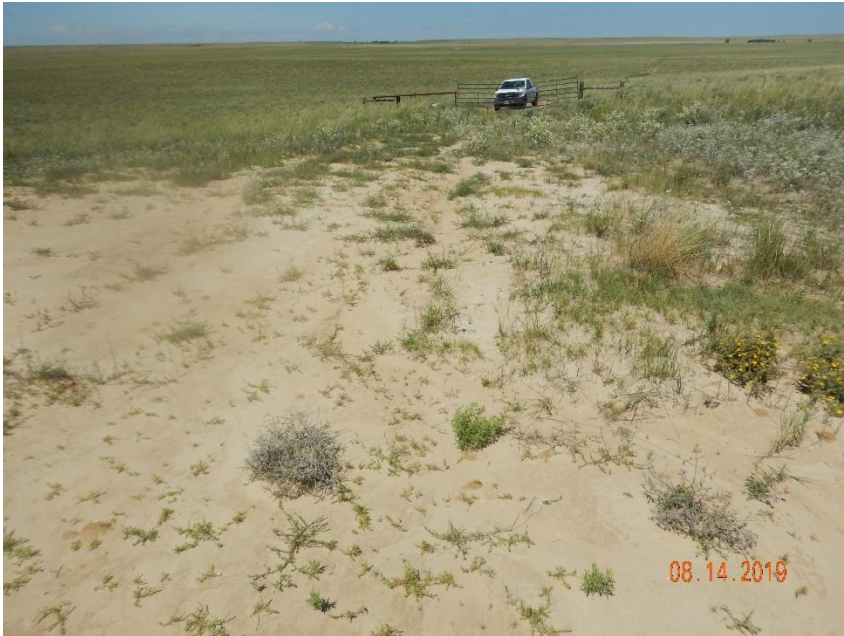
**Photo 1:** Photo taken from the north end of the location, facing north. Photo shows erosion degradation on access road.

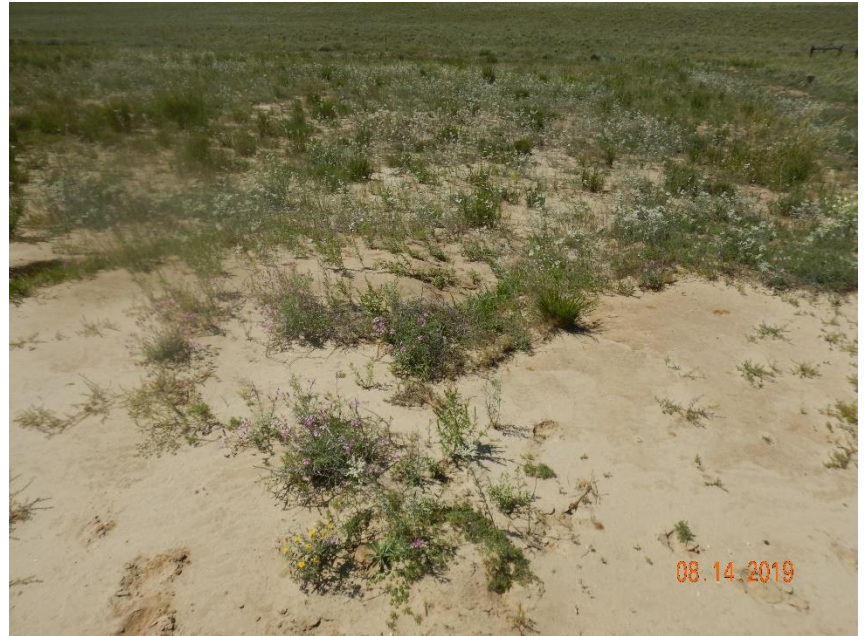
**Photo 2:** Photo taken from the northwest end of the location, facing west. Photo shows erosion degradation due to stormwater runoff from the pad into the interim areas.

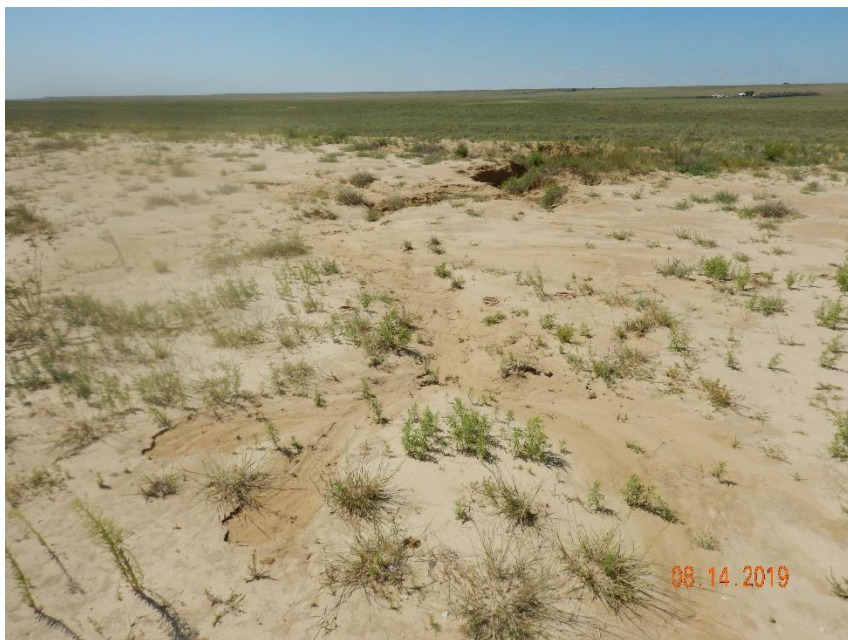
**Photo 3:** Photo taken from the northwest end of the production area, facing west. Photo shows erosion degradation due to stormwater runoff from the pad into the interim areas.

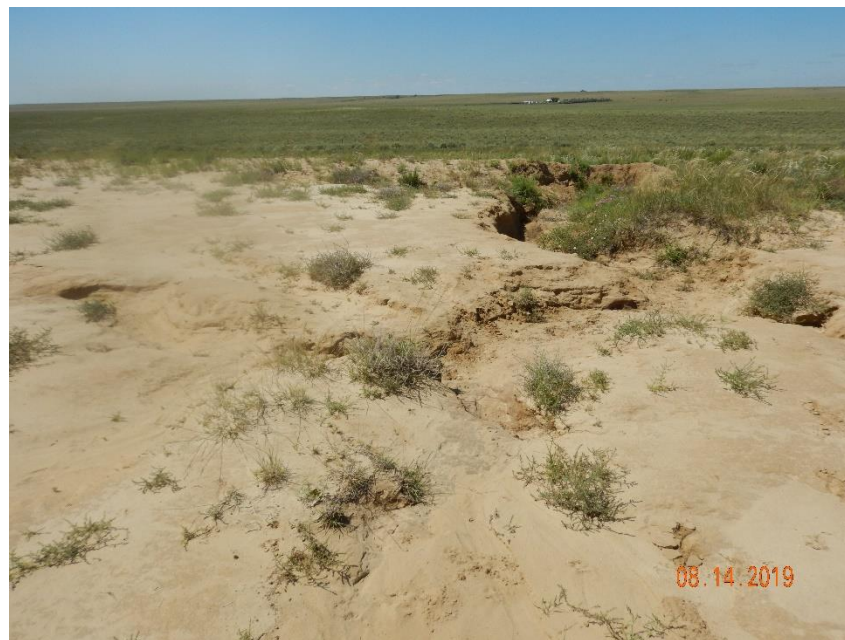
**Photo 4:** Continued from photo 3.

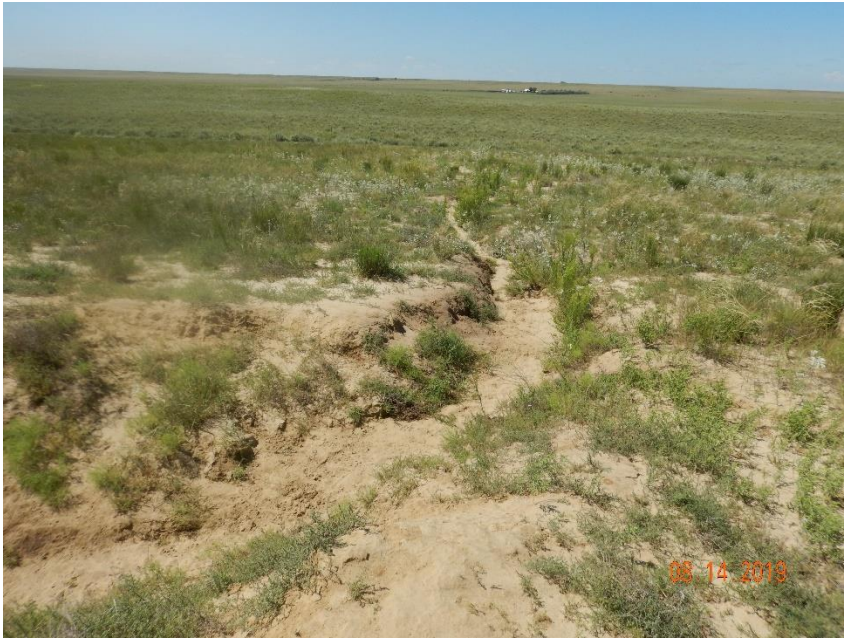
**Photo 5:** Continued from photo 3.

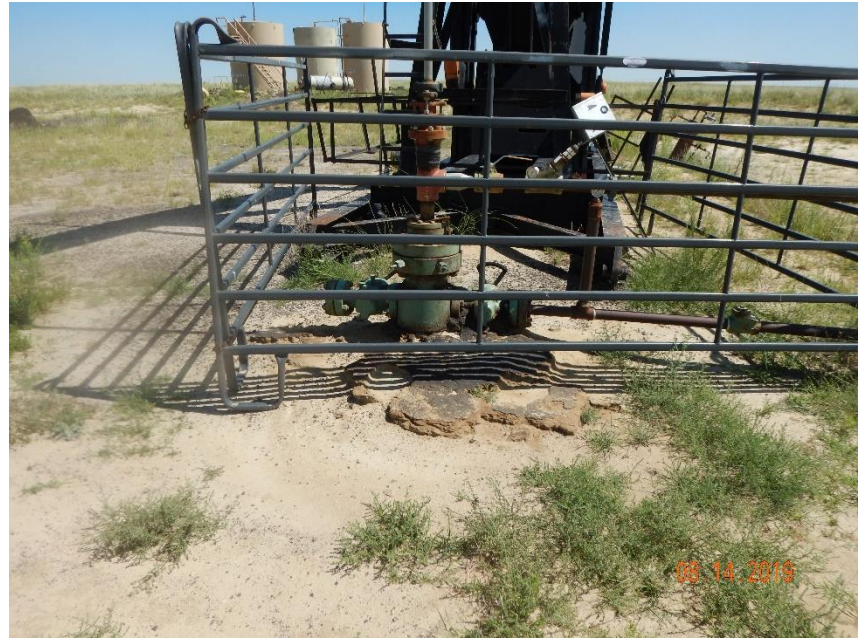
**Photo 6:** Photo shows stained soils at wellhead.

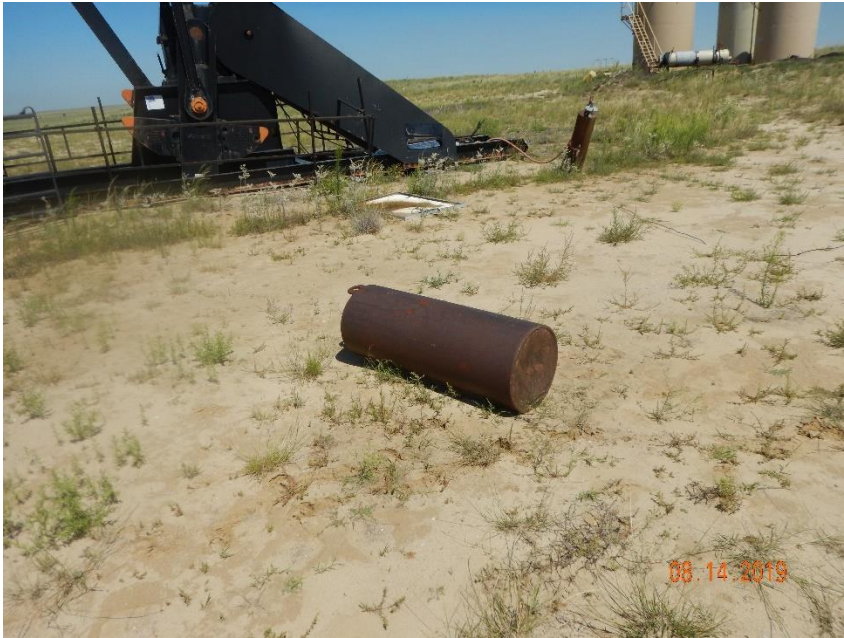
**Photo 7:** Photo shows trash debris at pump unit.

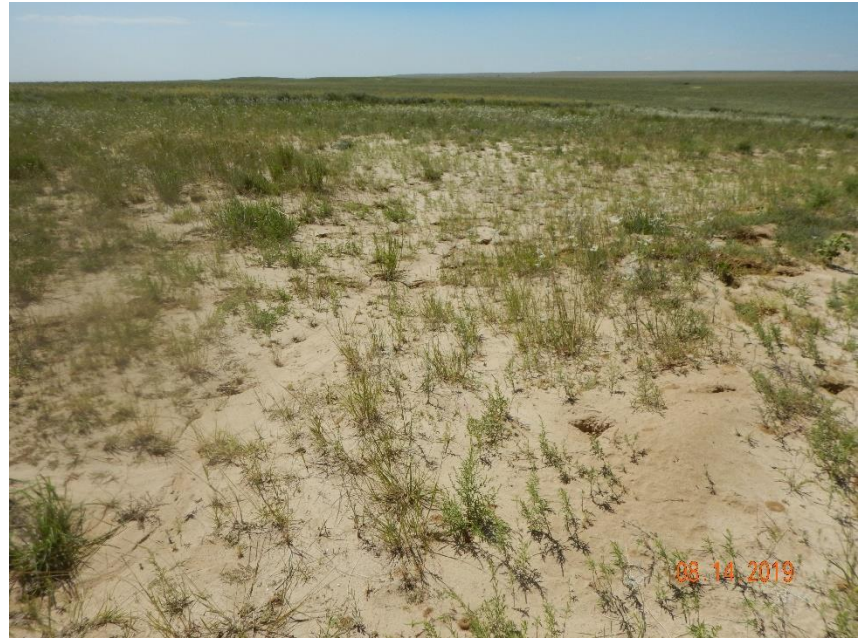
**Photo 8:** Photo taken from the south end of the production area, facing southwest. Photo shows erosion degradation due to stormwater runoff from the pad into the interim areas.

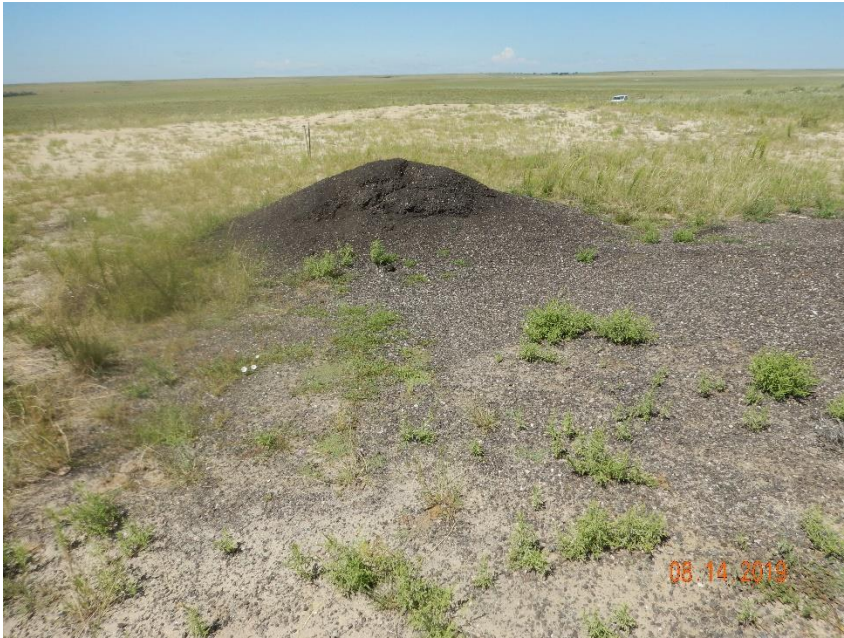
**Photo 9:** Photo taken from the central area of the pad, facing northwest. Photo shows gravel pile remaining on location.

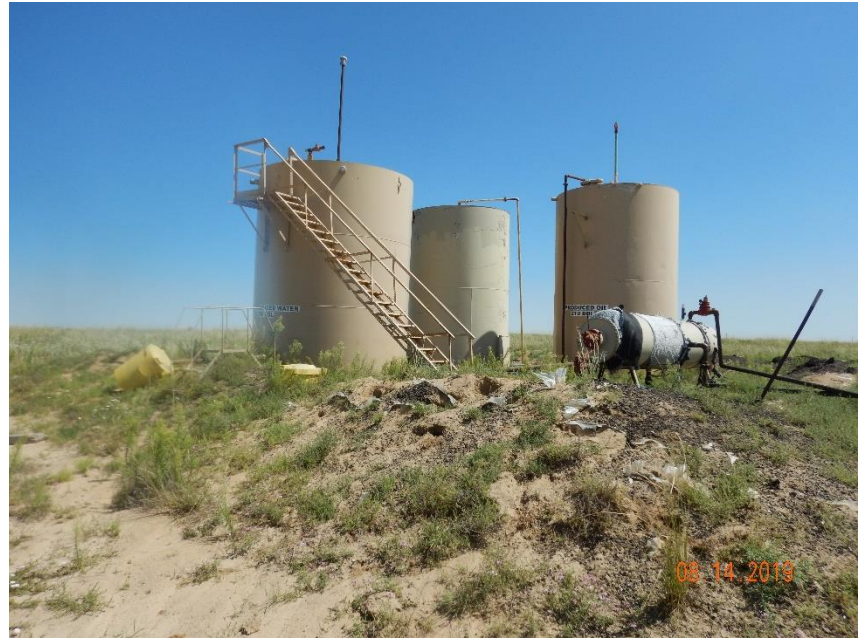
**Photo 10:** Photo taken from the east end of the location, facing northeast. Photo shows insufficient signage at tanks.

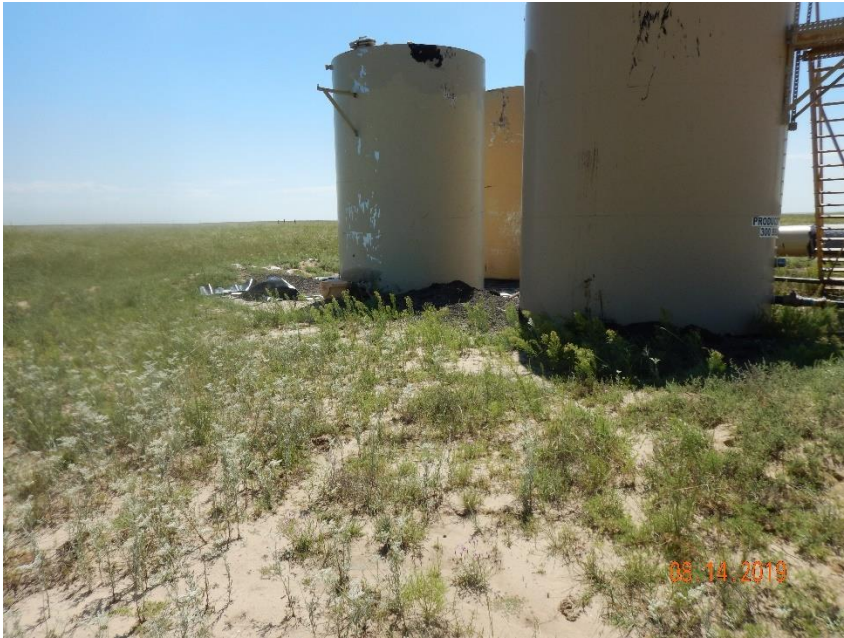
**Photo 11:** Photo taken from the northwest corner of the tank battery, facing southeast. Photo shows inadequate (missing) berms/secondary containment at north end of the tank battery. Photo also shows insufficient signage on tanks.

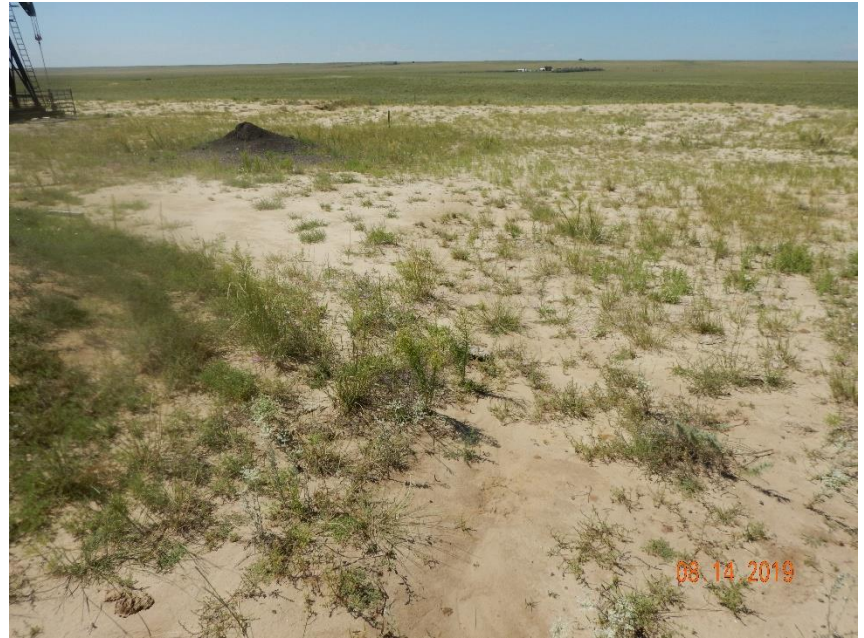
**Photo 12:** Photo taken from the northwest corner of the tank battery, facing west. Photo shows stormwater erosion on the location.

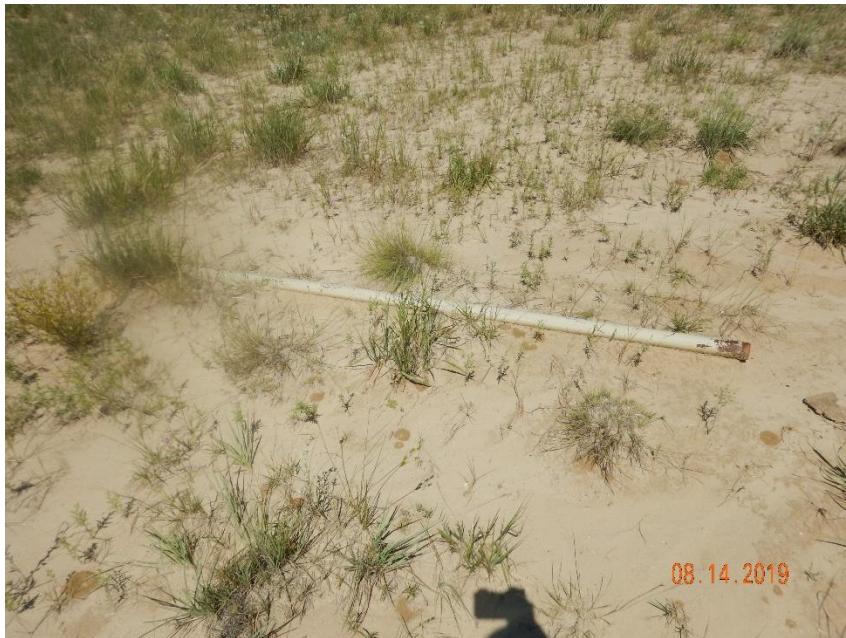
**Photo 13:** Photo taken from the north end of the location. Photo shows trash debris/equipment being stored on the interim area.

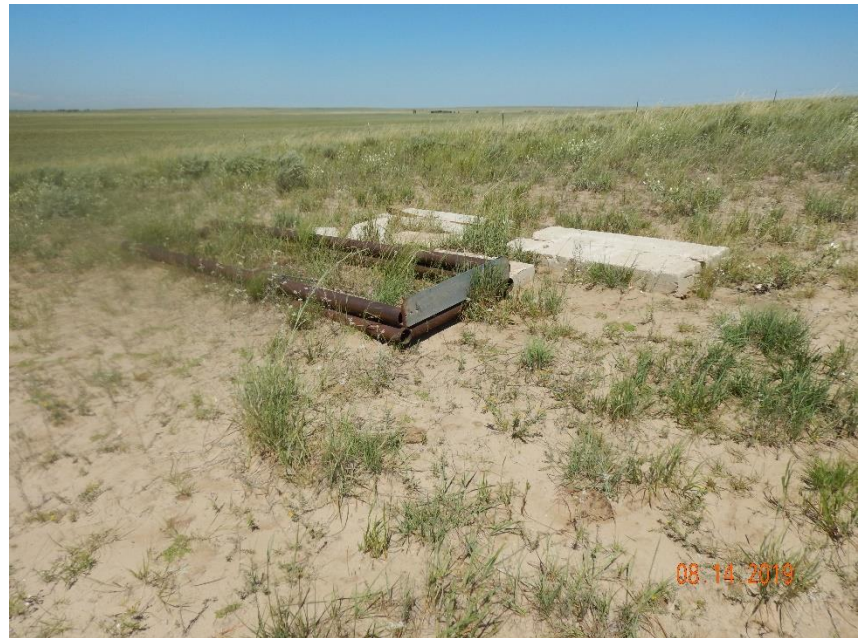
**Photo 14:** Photo taken from the north end of the location, facing northwest. Photo shows trash debris/equipment being stored on the interim area.

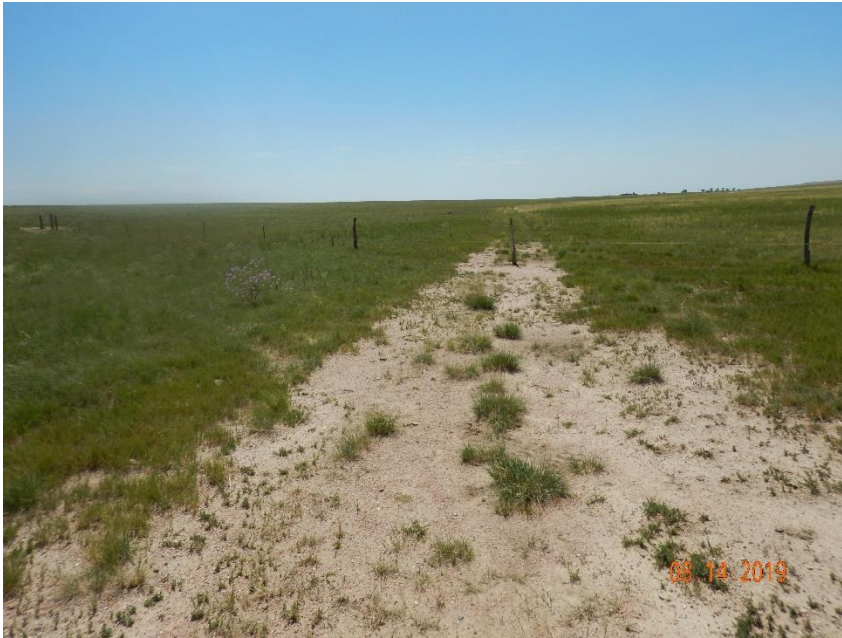
**Photo 15:** Photo taken from the access road at 39.94974/-103.39839. Previous inspections documented that the fence blocks off the access road, forcing vehicles to travel off the road at a corner of the fence to the east. Previous inspections required operator to install a gate to minimize and mitigate surface disturbance in accordance with 1002.e(4). Photo shows gate has not been installed to mitigate surface disturbance; access road remains blocked.

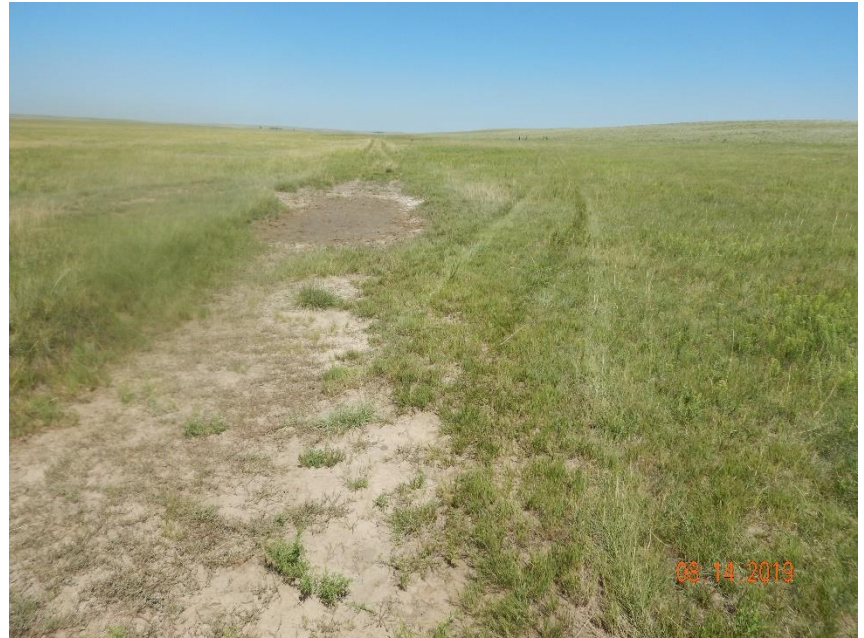
**Photo 16:** Photo taken from the access road, facing north. Photo shows a new road is forming from the access road due to a fence preventing sufficient access.

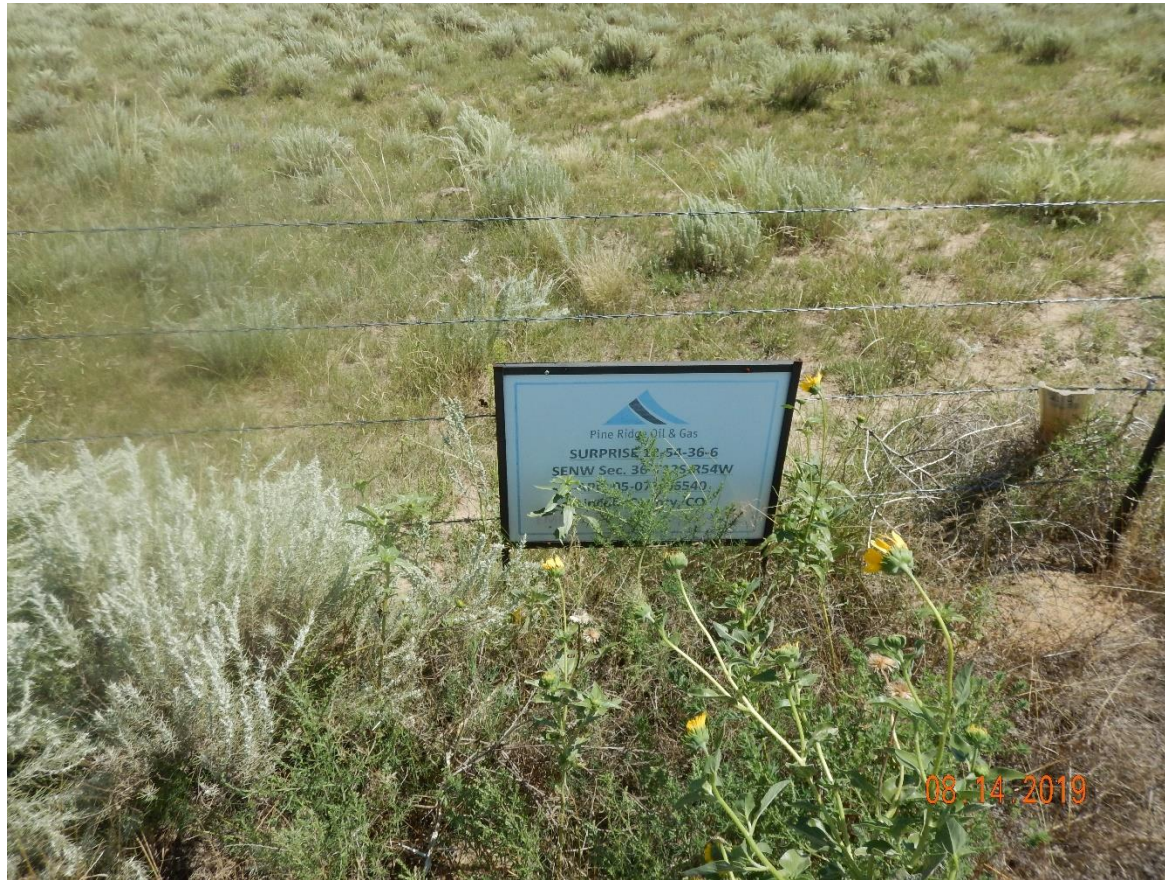
**Photo 17:** Photo taken from the access road entrance at CR-26. Previous inspections required operator to update signage with correct operator information. Photo shows signage has not been updated.
