Inspection Photos

API: 05-009-06553

Operator: LORENTZ OIL & GAS

Inspection Date: 8/14/2019

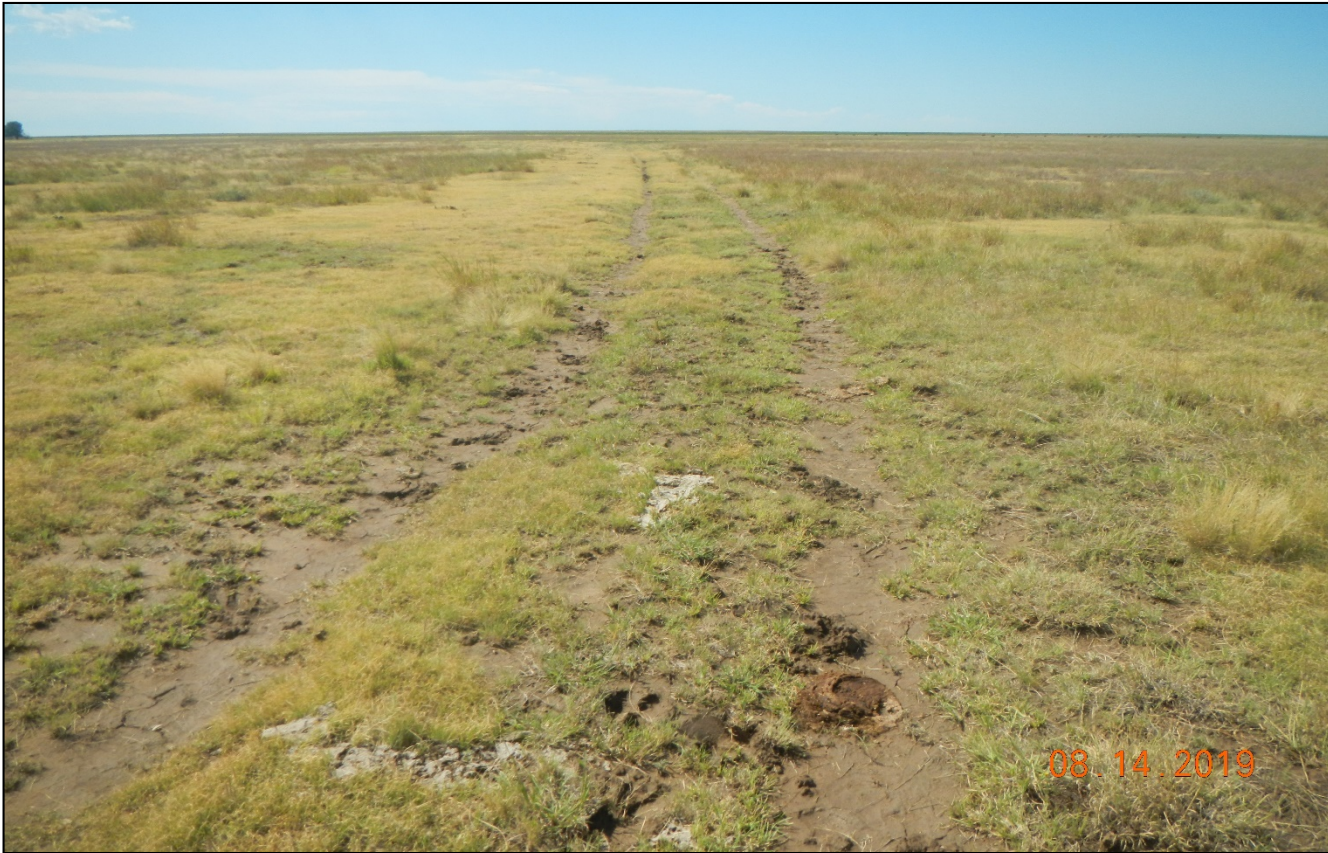
Photo 1. There is a two track road that goes south to the location.

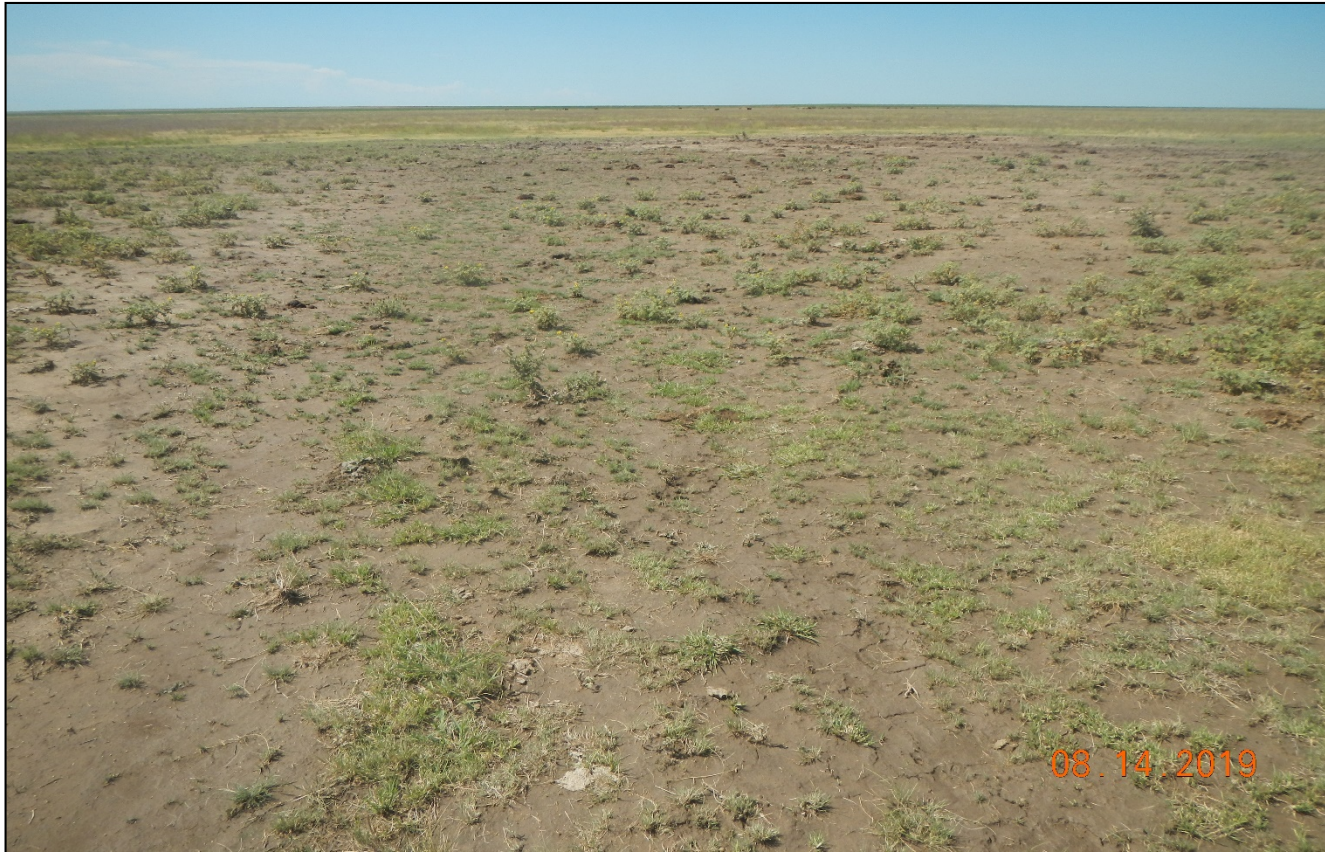
Photo 2. Facing south at the location. Vegetation has not reestablished. Does not appear reclamation has been performed.

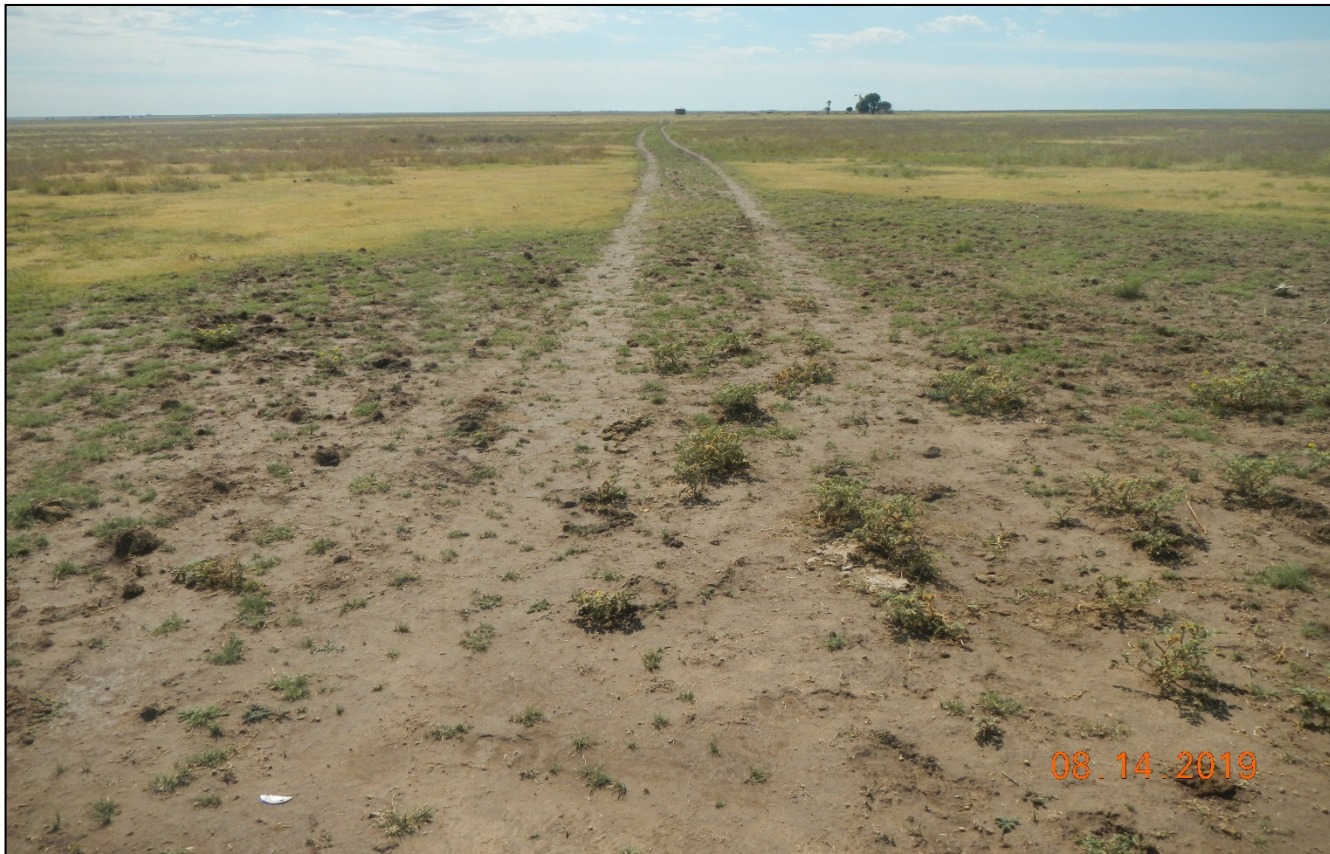
Photo 3. Facing south at the location. A two track road remains to the location.

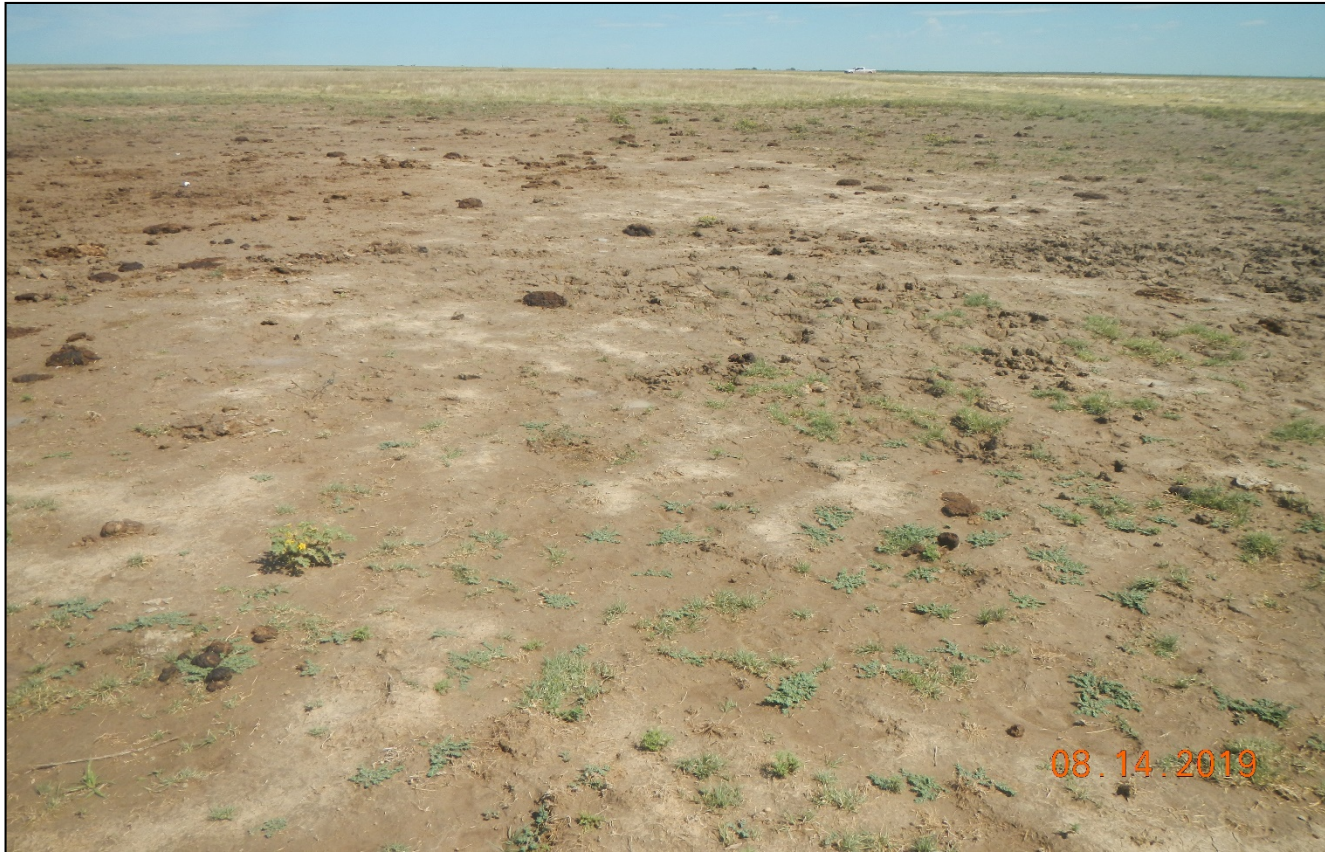
Photo 4. Facing north at the location. The location is bare and there appears to be cattle activity.

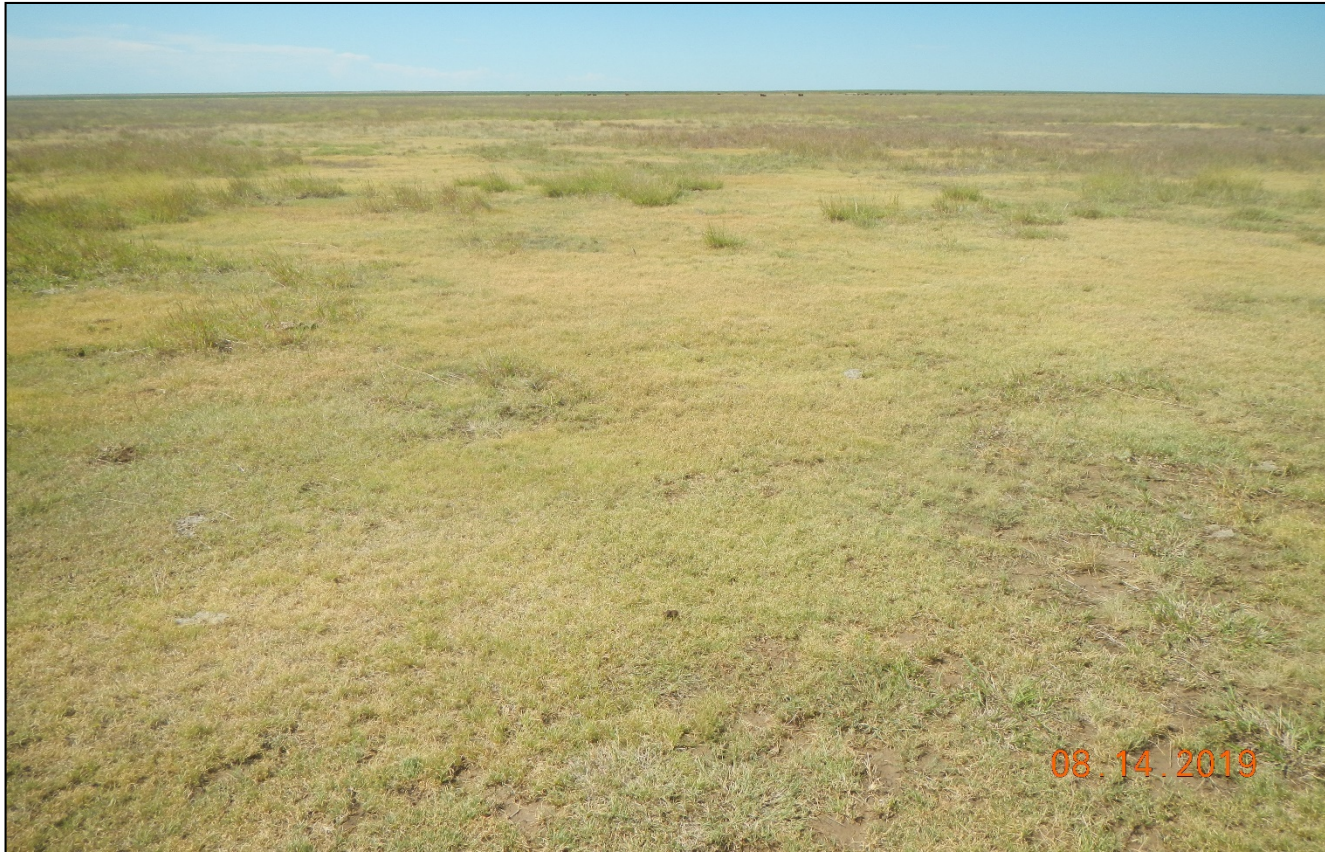
Photo 5. Facing south at the surrounding pasture adjacent pasture.
