COGCC Inspection Photos.

API # 077-09685

Inspection # 696600497

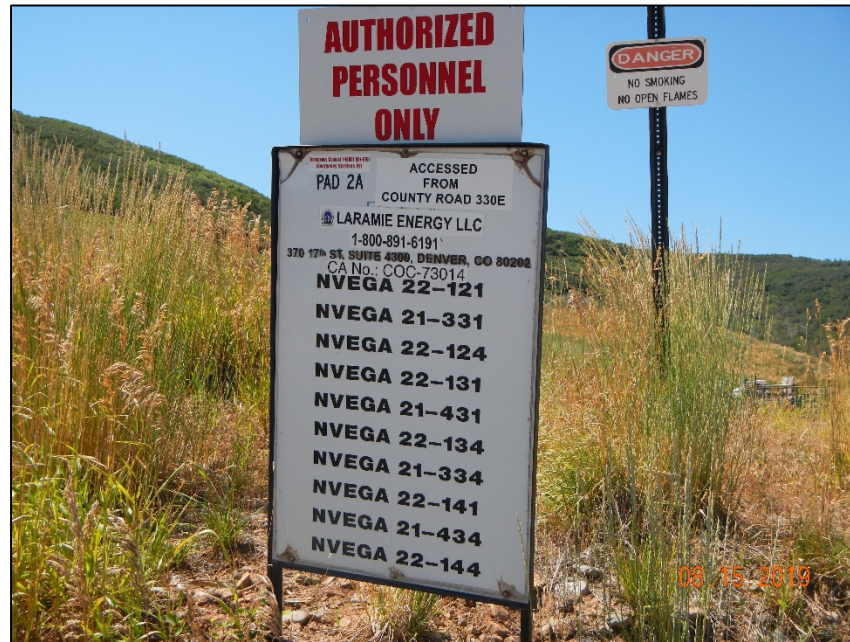
Photo #1. Sign is posted at the entrance to location.

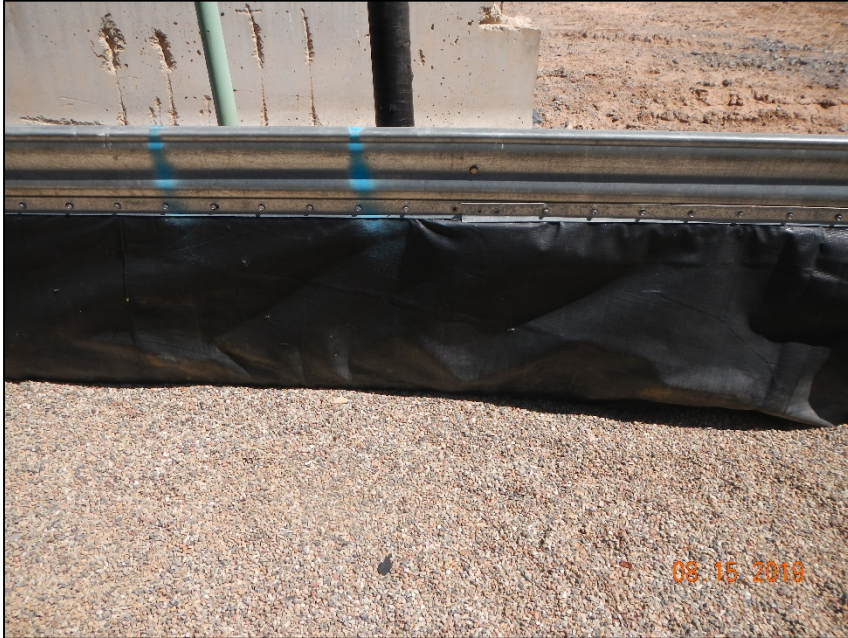
Photo#6. Holes inside of containment liner.

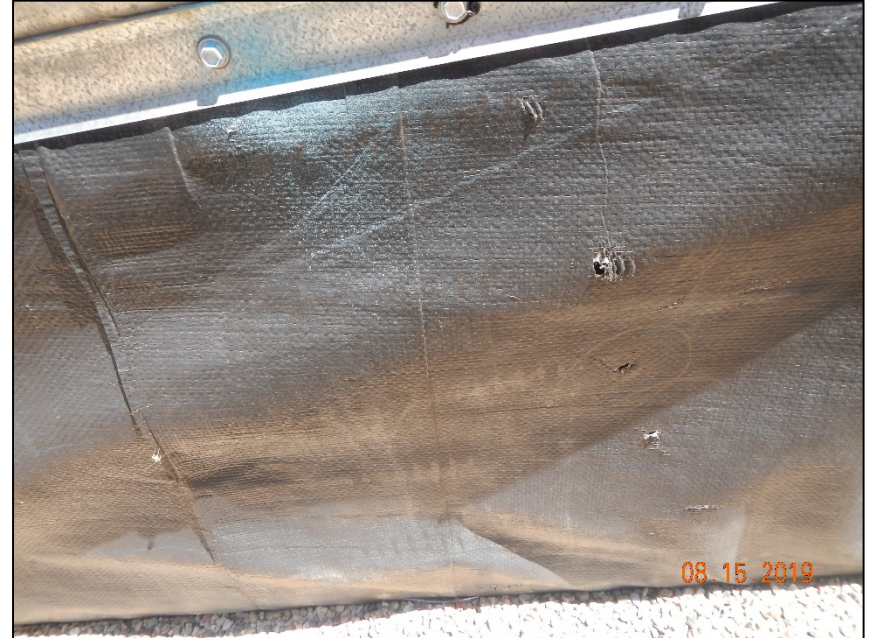
Photo#7. Holes inside of containment liner.

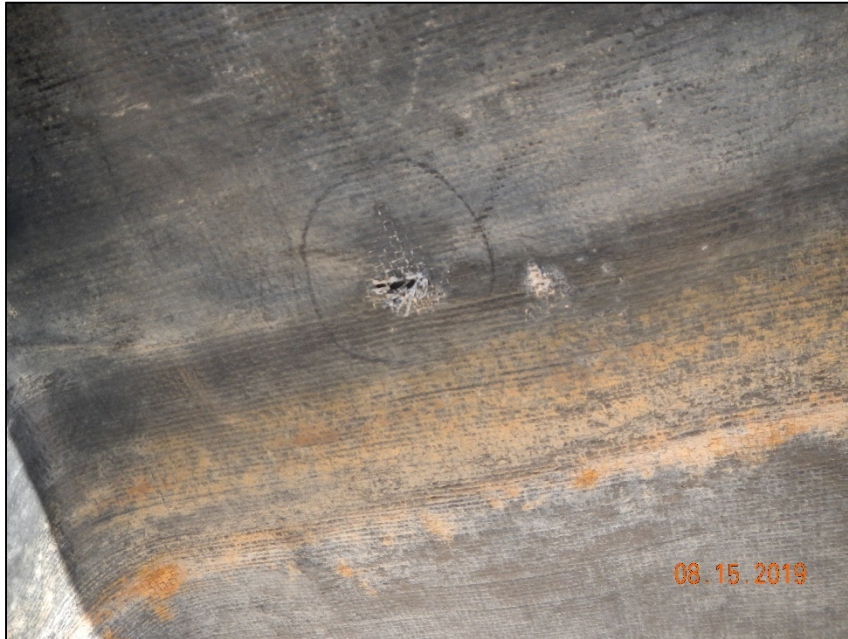
Photo # 8. Holes inside of containment liner.

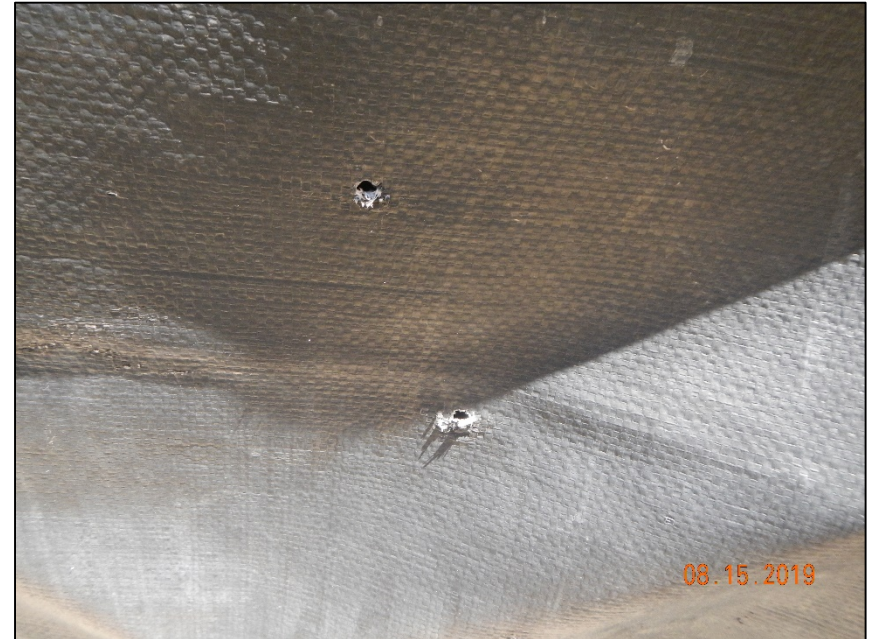
Photo # 9. Holes inside of containment liner.

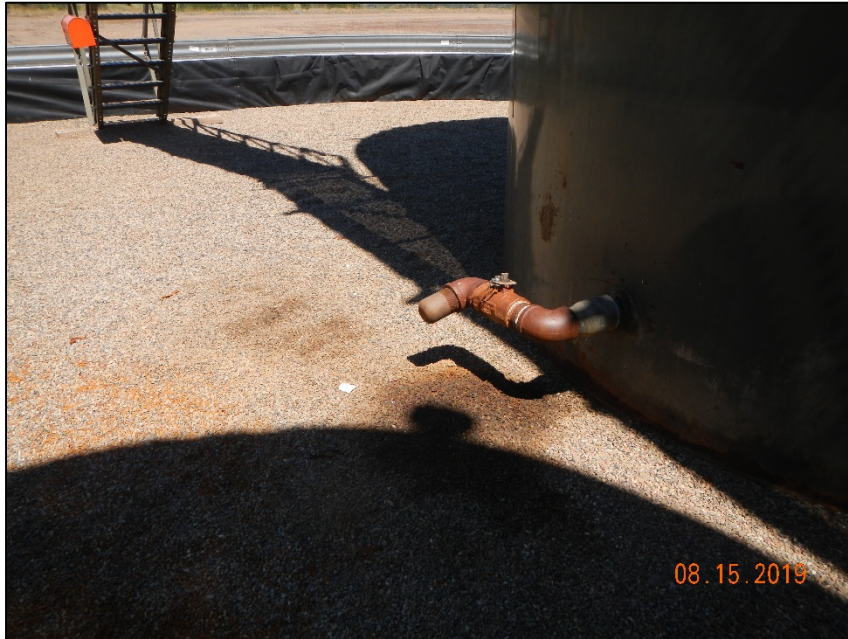
Photo# 10. Stained soil or gravel inside of containment liner.

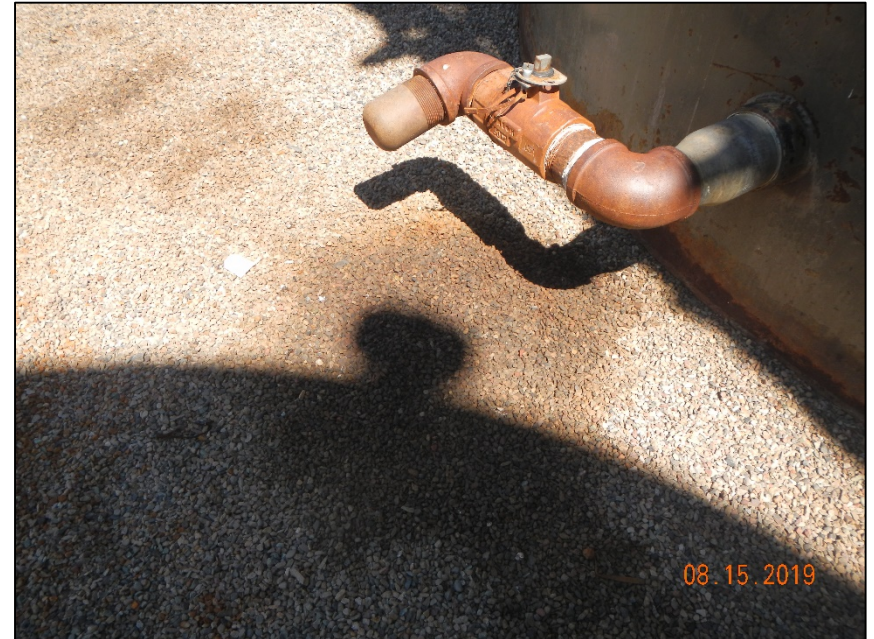
Photo# 11. Stained soil or gravel inside of containment liner.

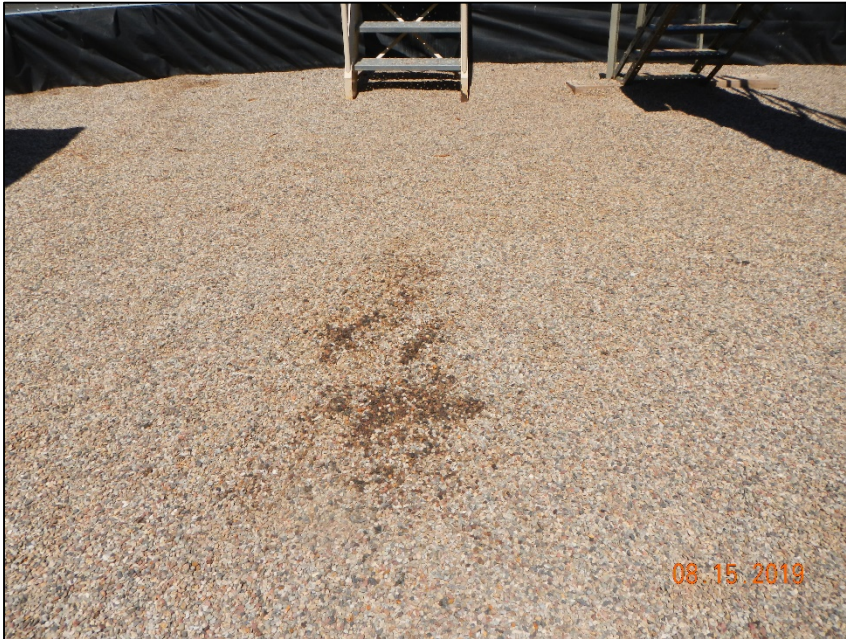
Photo# 12. Stained soil or gravel inside of containment liner.

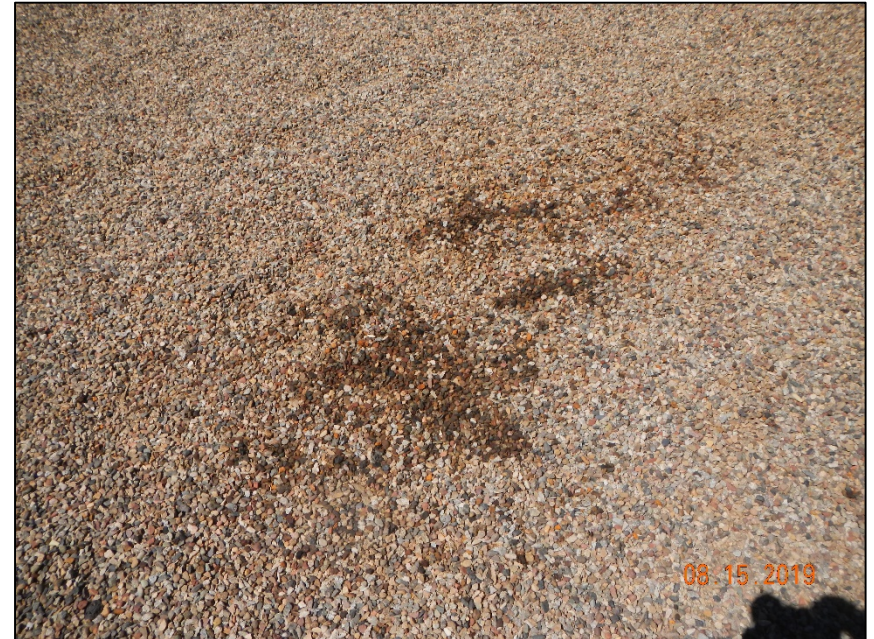
Photo #13 Stained soil or gravel inside of containment liner.

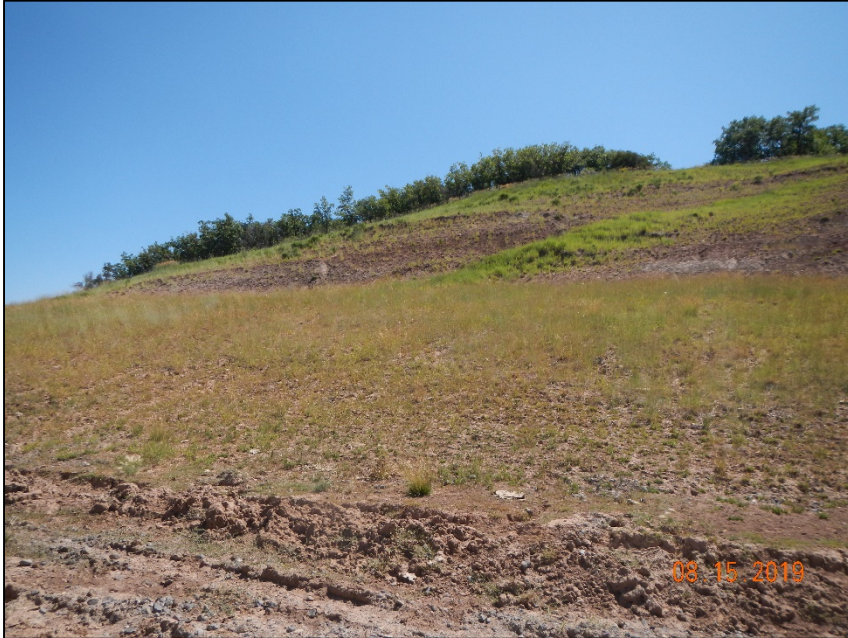
Photo# 14. Erosion is evident along un-stabilized slope on the South/East side of location. Erosion channeling and sediment moving off slope and choking out vegetation.

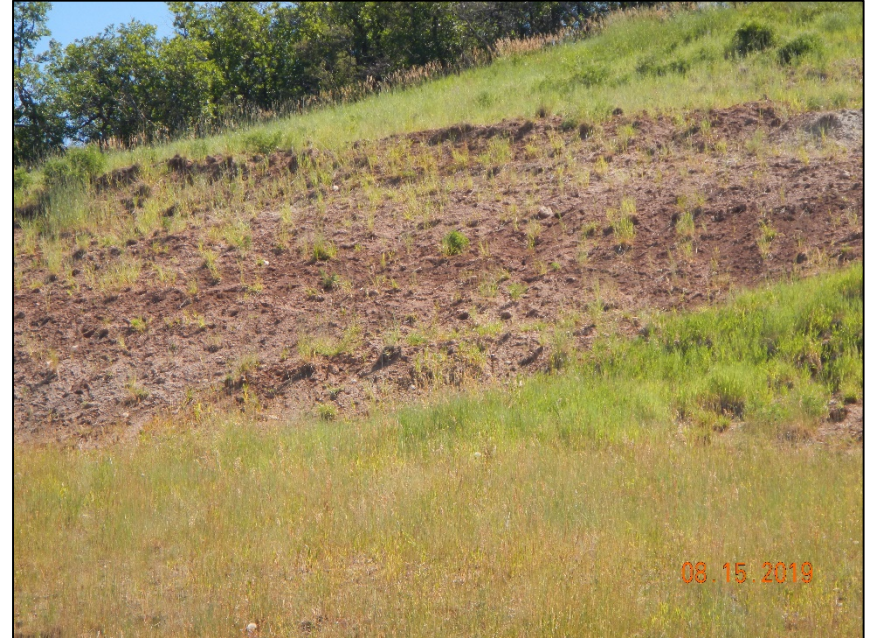
Photo# 15. Erosion is evident along un-stabilized slope on the South/East side of location. Erosion channeling and sediment moving off slope and choking out vegetation.

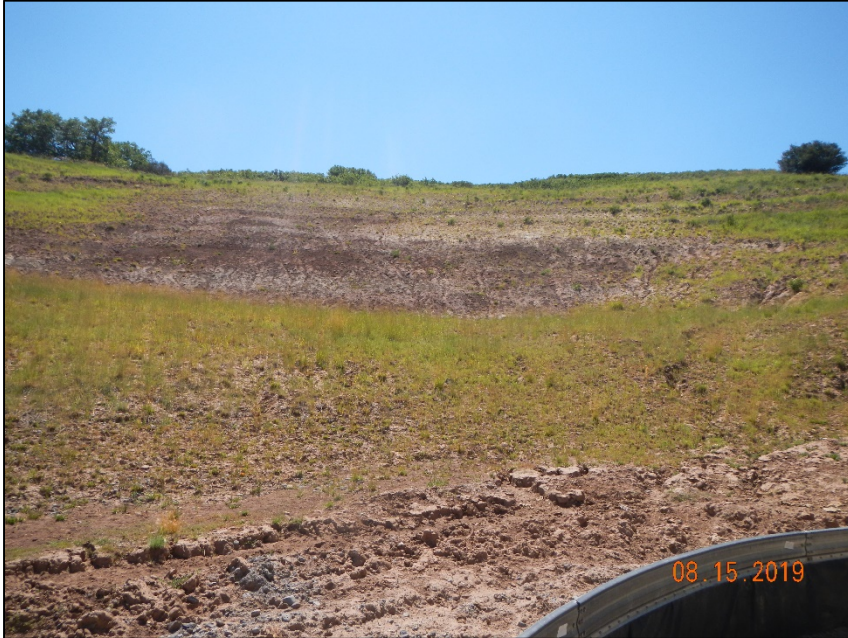
Photo# 16. Erosion is evident along un-stabilized slope on the South side of location. Erosion channeling and sediment moving off slope and choking out vegetation.

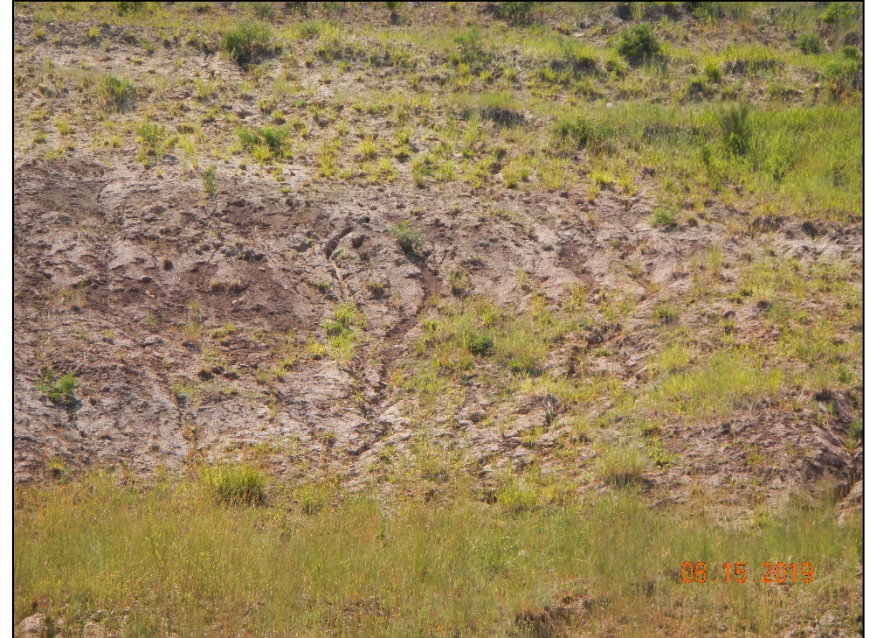
Photo# 17. Erosion is evident along un-stabilized slope on the South side of location. Erosion channeling and sediment moving off slope and choking out vegetation.

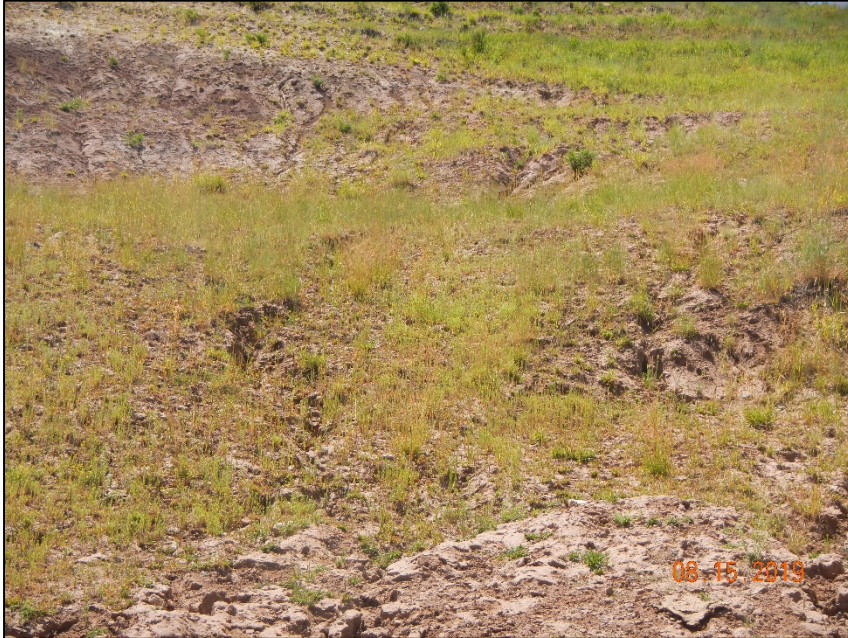
Photo# 18. Channels from erosion moving down unstabilized south slope.

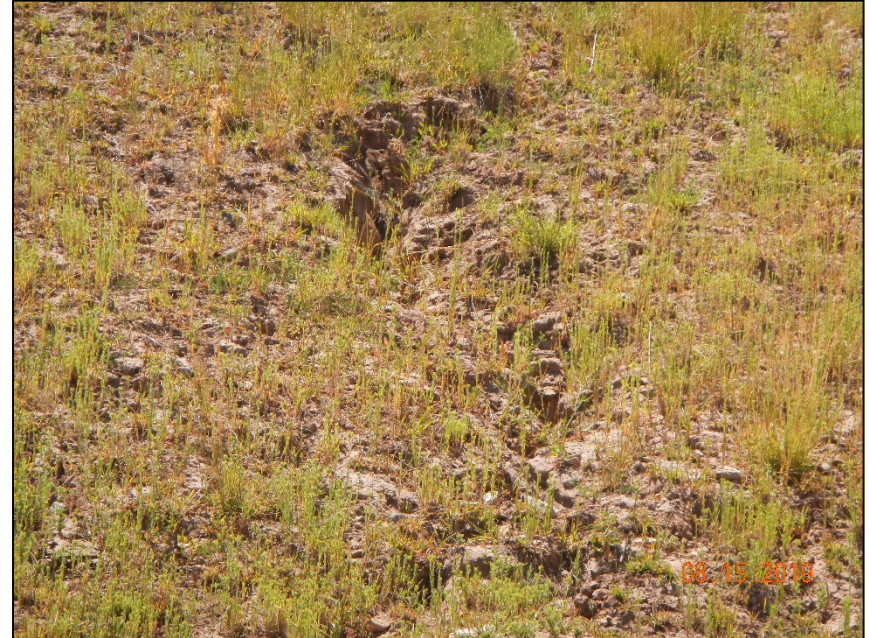
Photo# 19. Channels from erosion moving down unstabilized south slope.

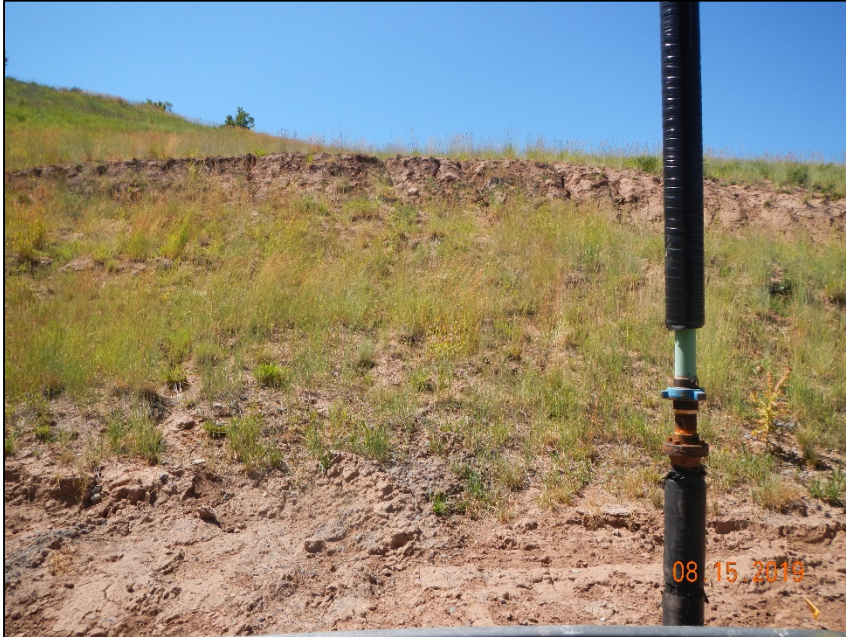
Photo# 20. Erosion channels from un-stabilized slope on West side of location behind tank battery. Slopes need BMP maintenance for stabilization.

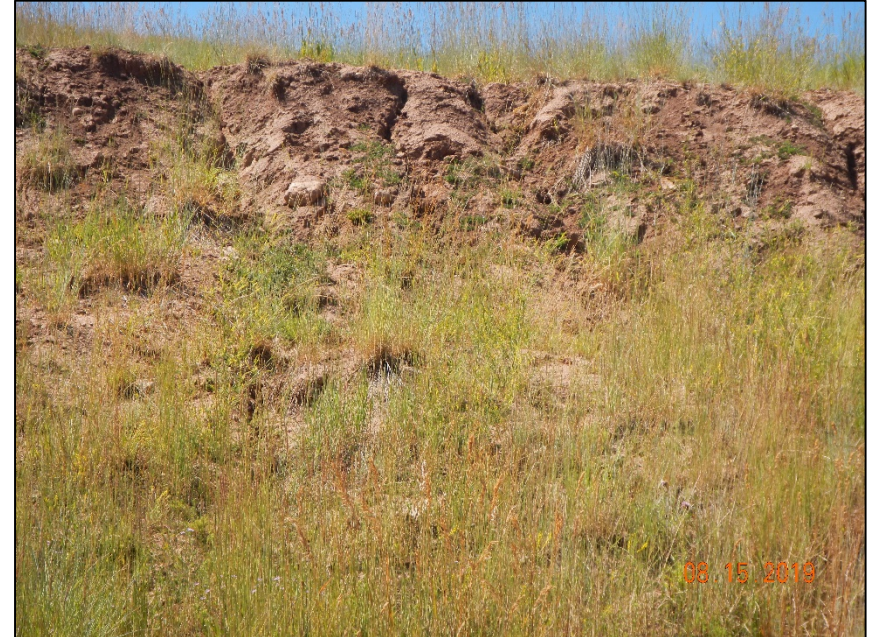
Photo# 21. Erosion channels from un-stabilized slope on West side of location behind tank battery. Slopes need BMP maintenance for stabilization

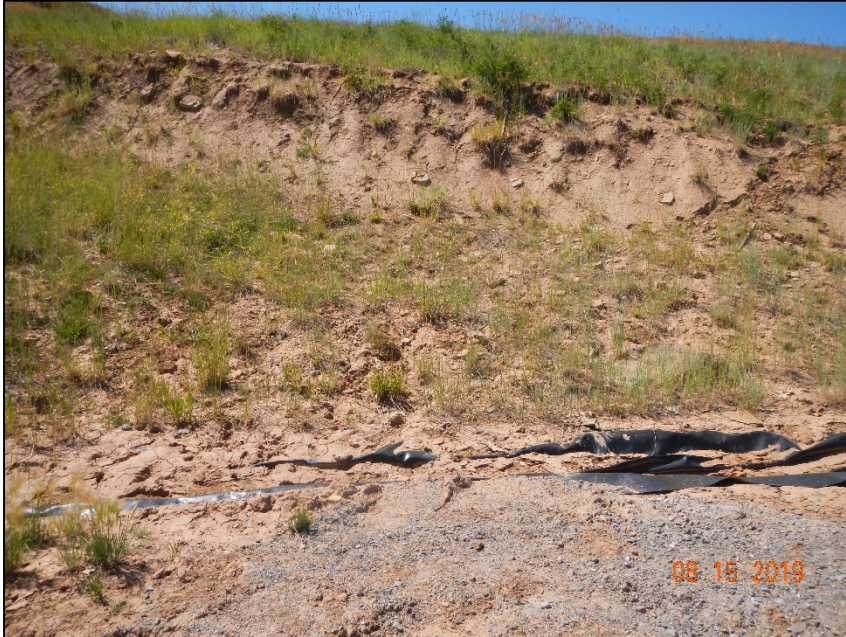
Photo #22. Erosion sediment moving off un-stabilized west side slope and filling in lined ditch.

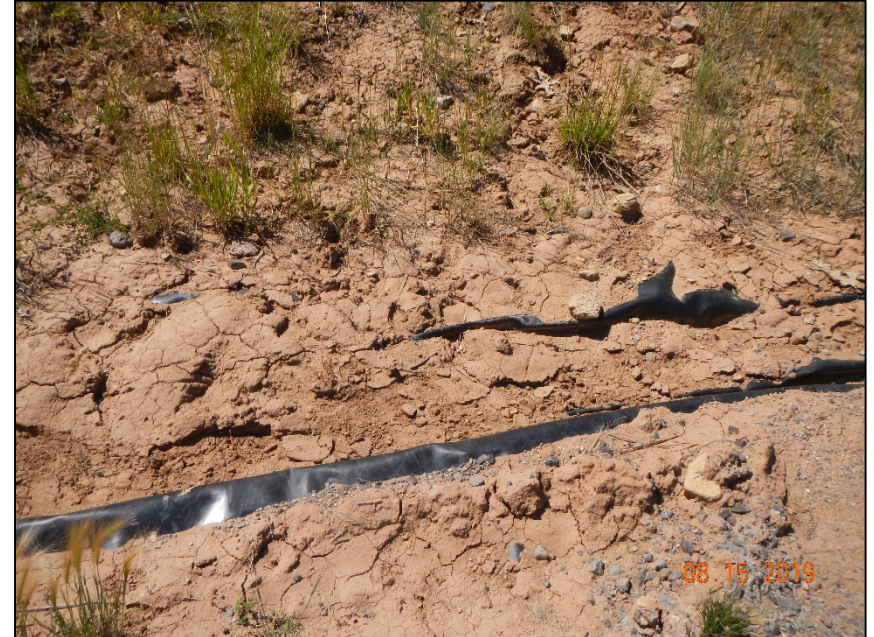
Photo #23. Erosion sediment moving off un-stabilized west side slope and filling in lined ditch.
