COGCC Inspection Photos.

API # 077-09712

Inspection # 696600499

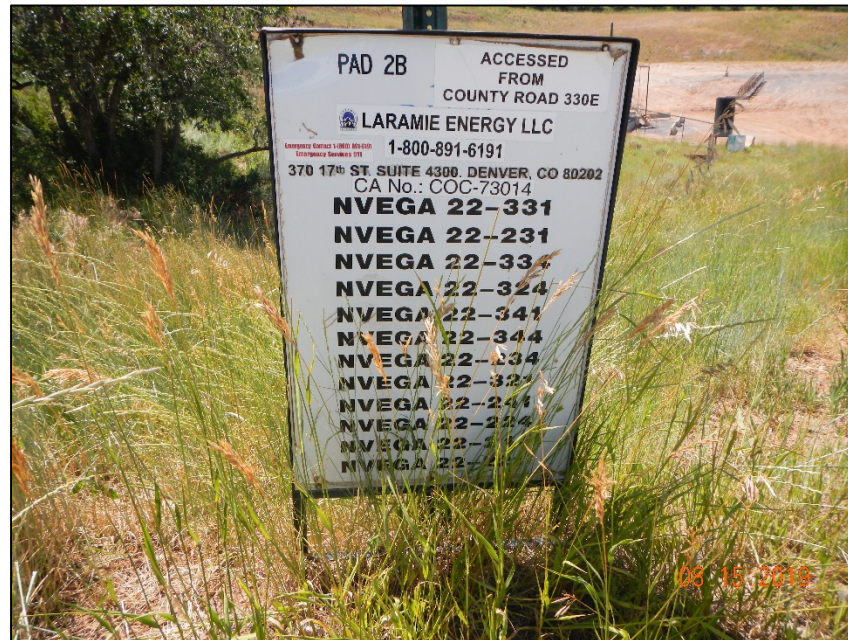
Photo #1. Sign is posted at the entrance to location.

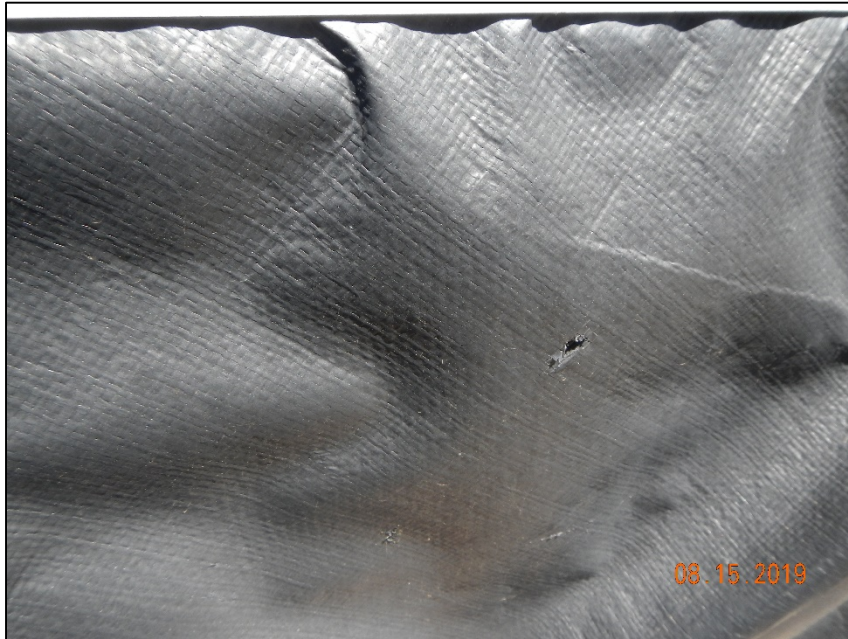
Photo#6. Holes inside of containment liner.

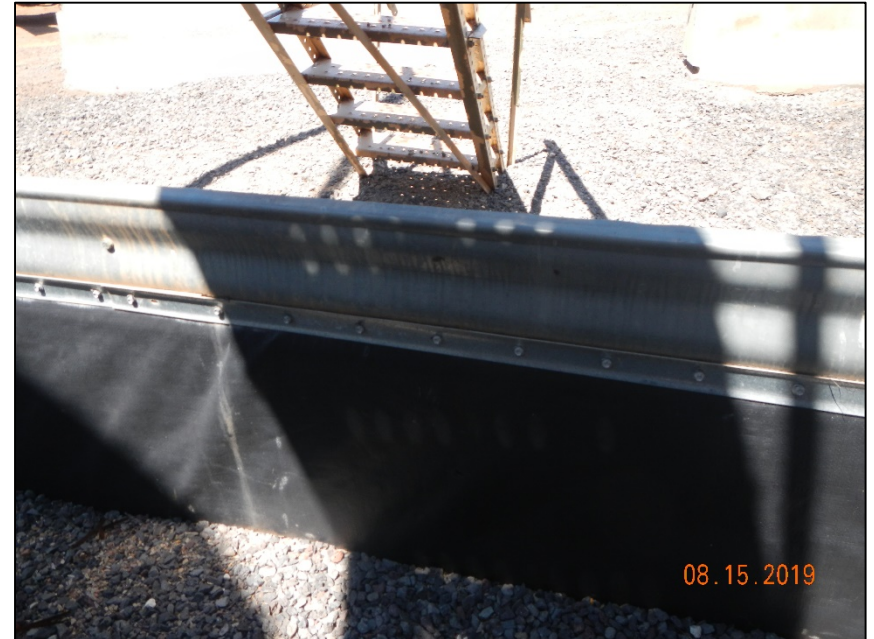
Photo#7. Holes inside of containment liner.

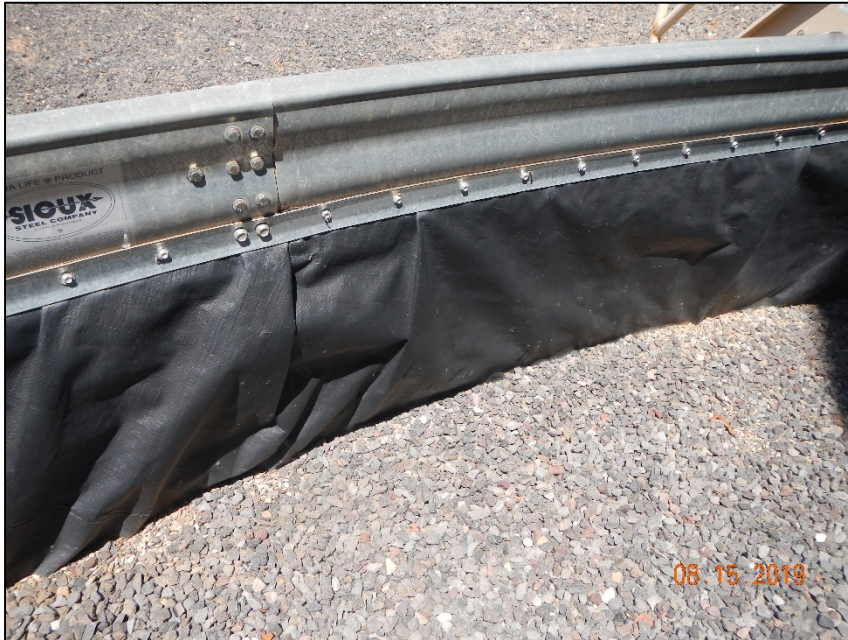
Photo # 8. Holes inside of containment liner.

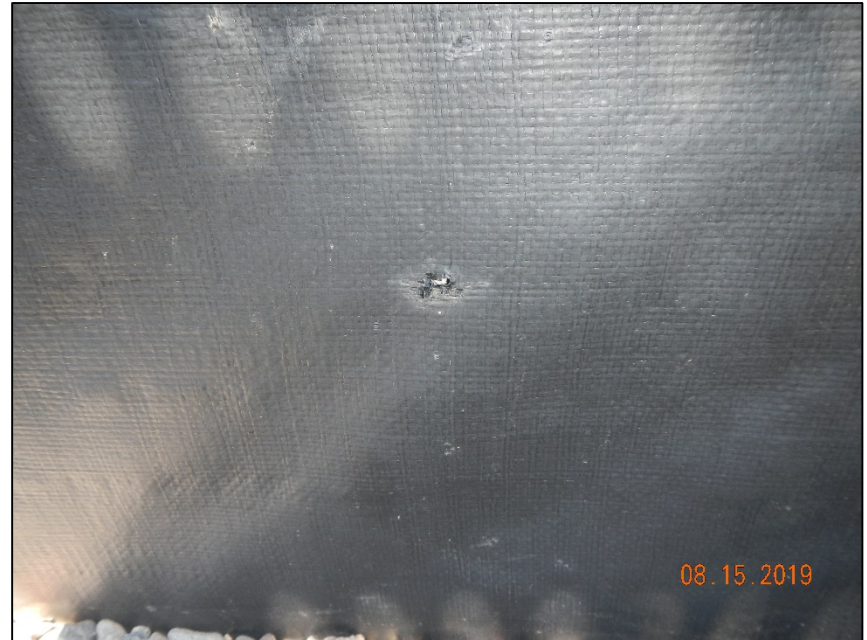
Photo # 9. Holes inside of containment liner.

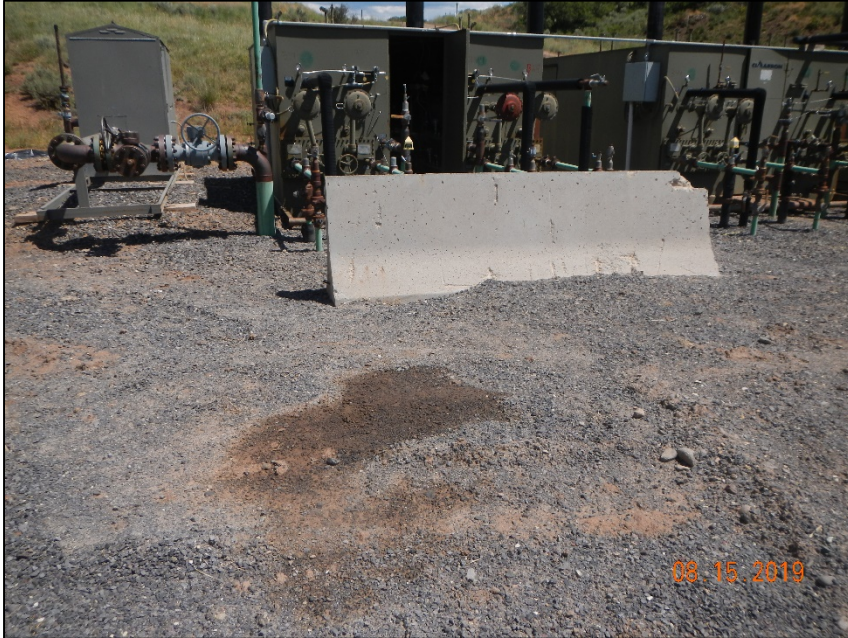
Photo# 10. Stained soil or gravel be the separators.

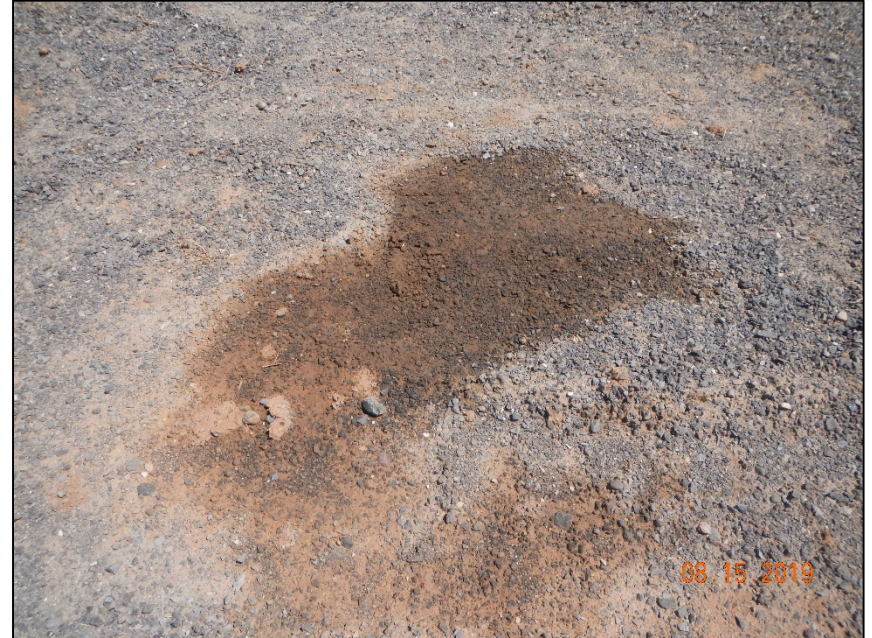
Photo# 11. Stained soil or gravel be the separators.

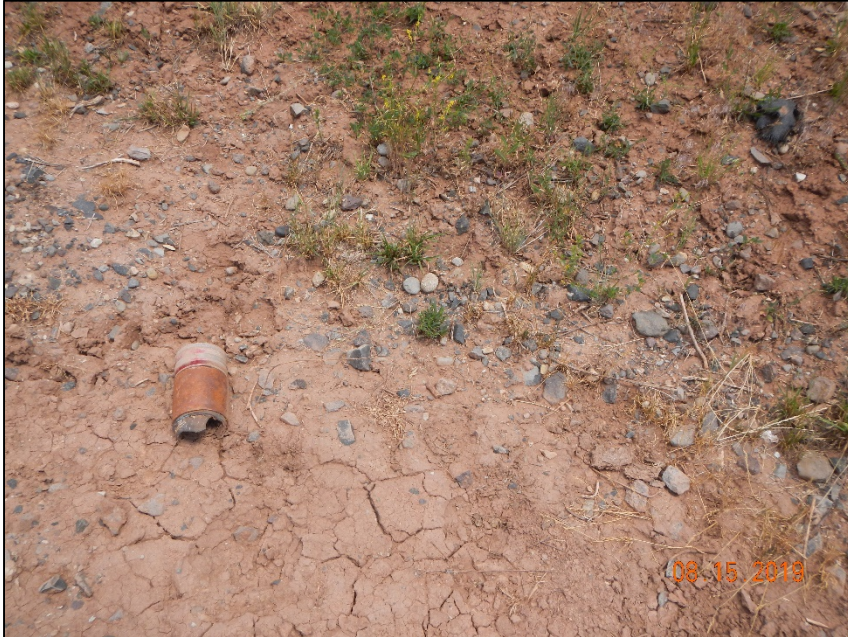
Photo# 12. Trash left on location

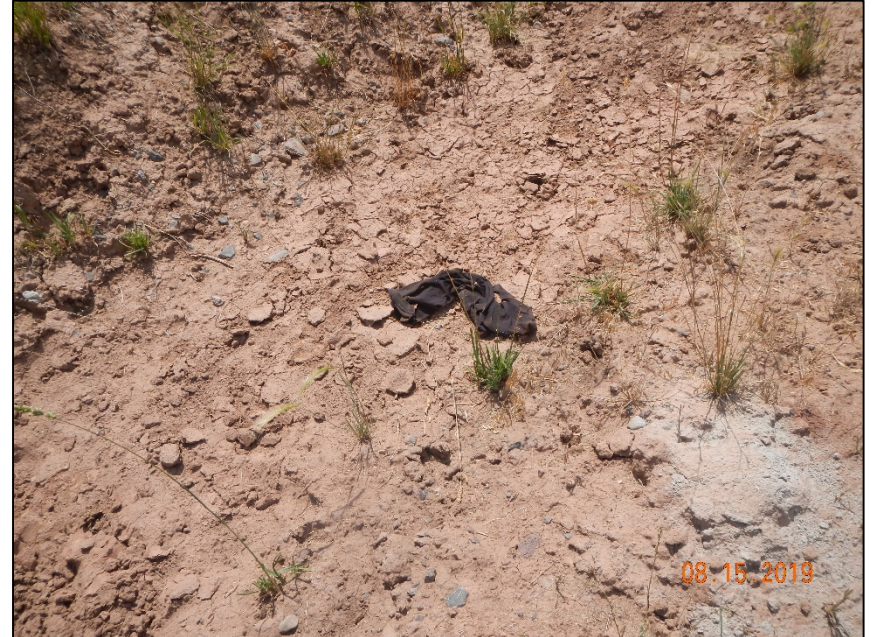
Photo #13 Trash left on location

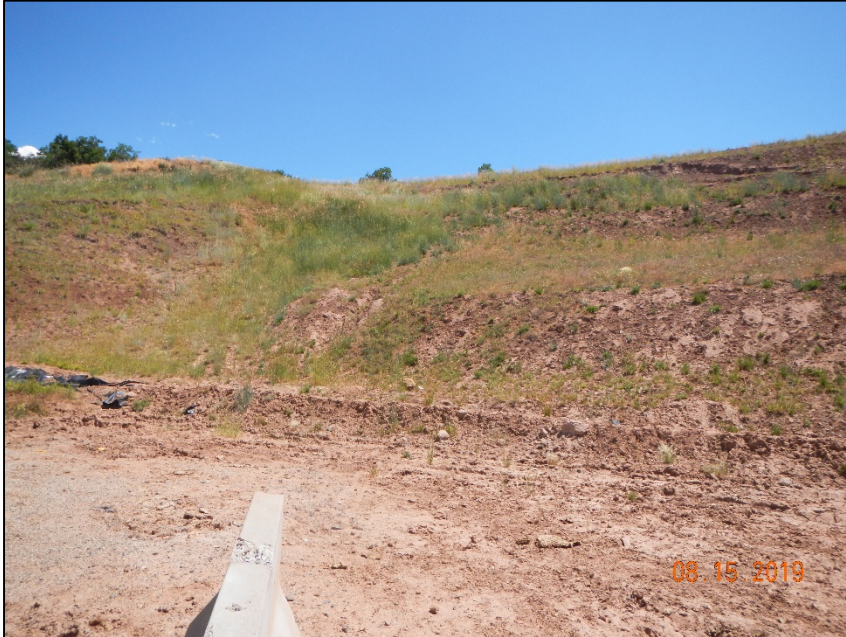
Photo# 14. Erosion is evident along un-stabilized slope on the South side of location. Erosion sediment moving off slope and choking out vegetation.

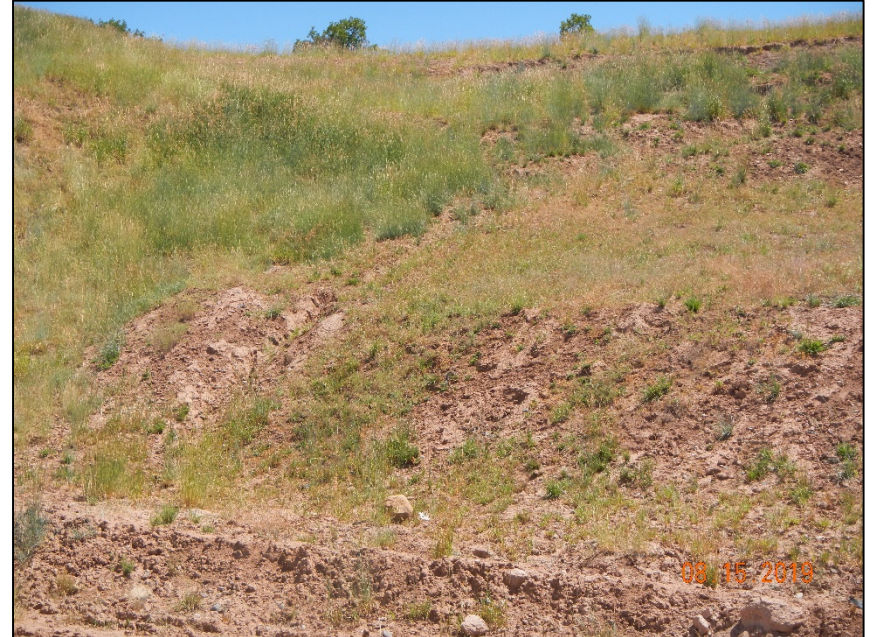
Photo# 15. Erosion is evident along un-stabilized slope on the South side of location. Erosion sediment moving off slope and choking out vegetation.

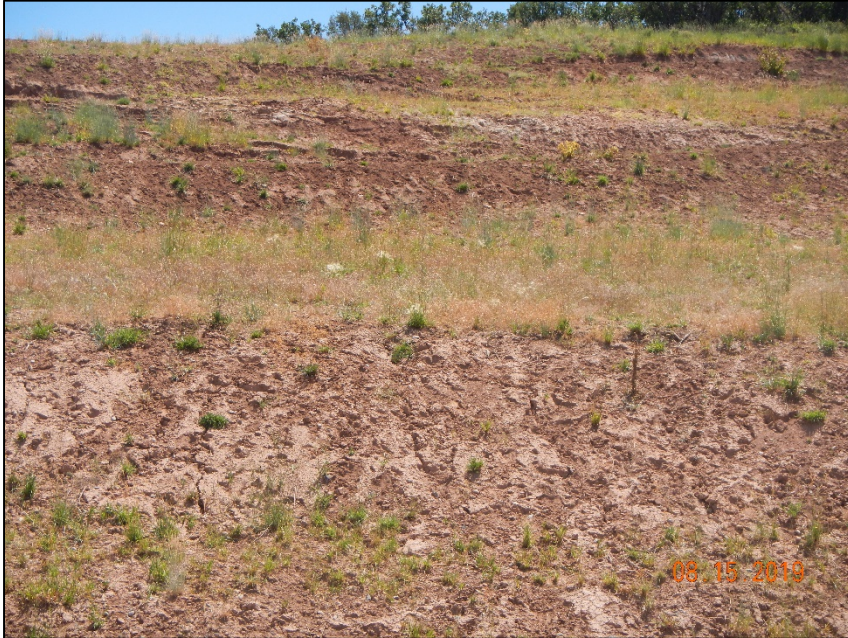
Photo# 16 Erosion is evident along un-stabilized slope on the South side of location. Erosion sediment moving off the slope and choking out vegetation.

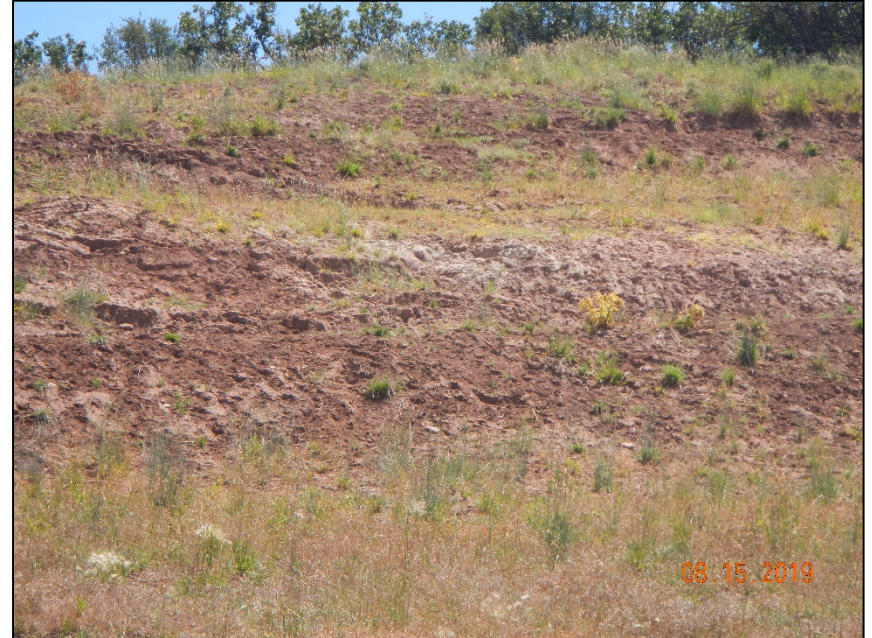
Photo# 17. Erosion is evident along un-stabilized slope on the South side of location. Erosion sediment moving off the slope and choking out vegetation.

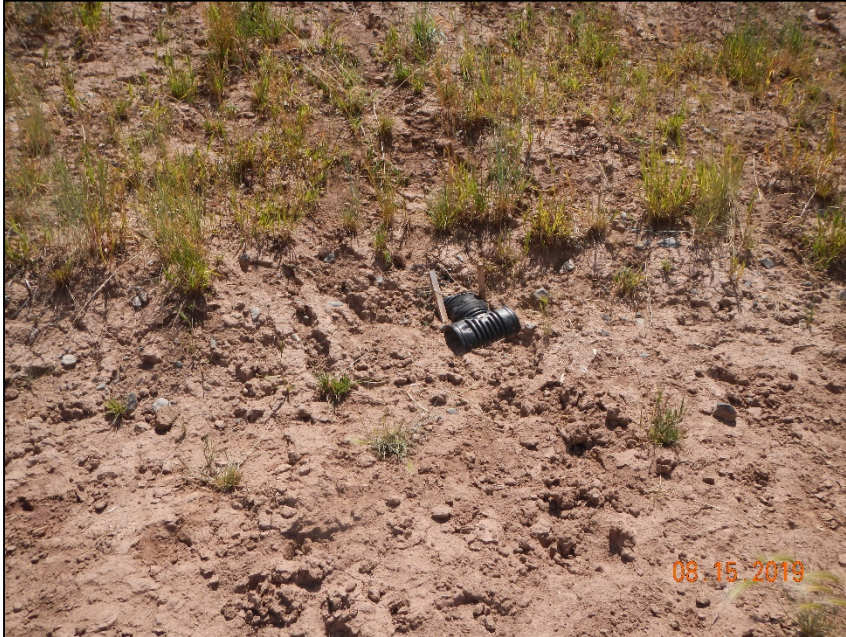
Photo# 18. Drain pipe is being used as a BMP and is in need of maintenance.

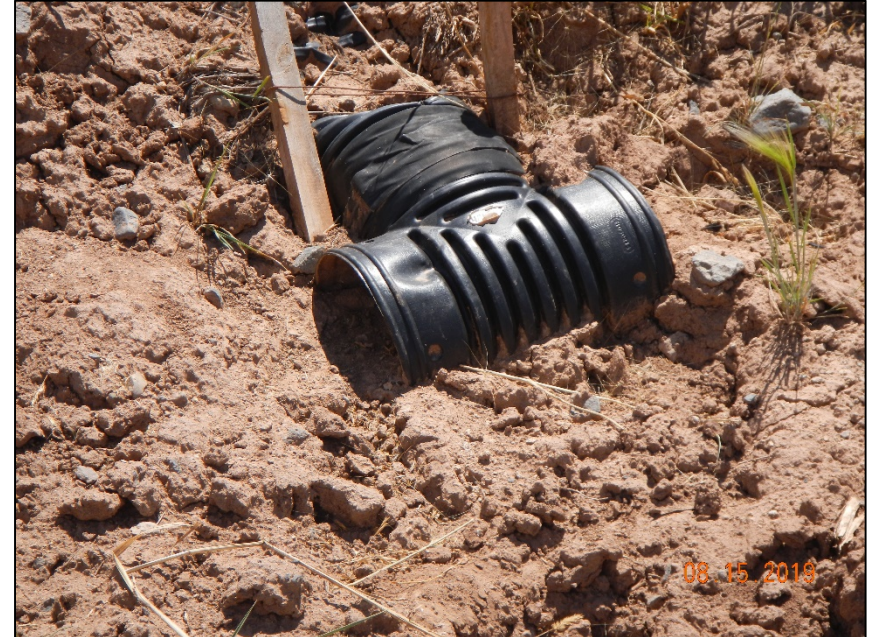
Photo# 19. Drain pipe is being used as a BMP and is in need of maintenance.

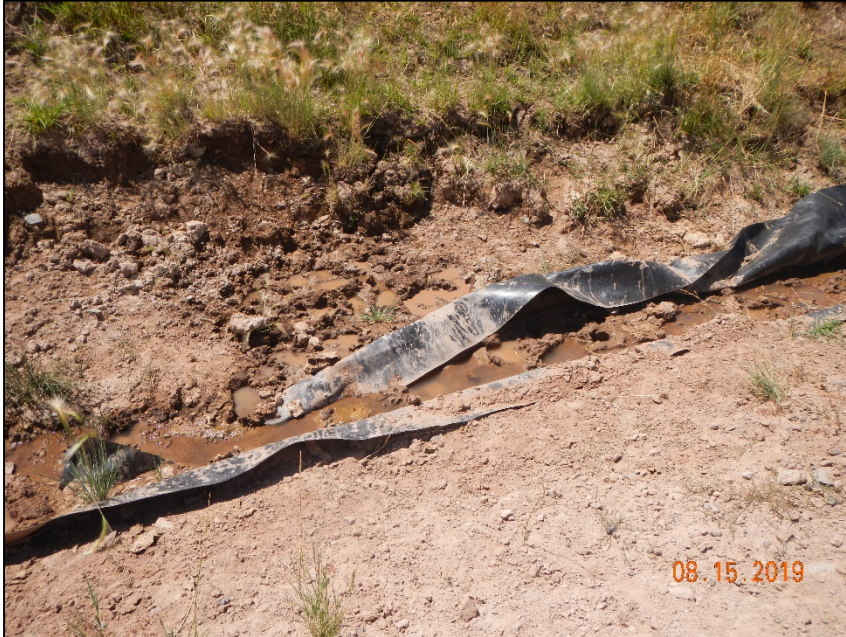
Photo# 20. Lined ditch on the West side of location, is being used as a BMP and is in need of maintenance.

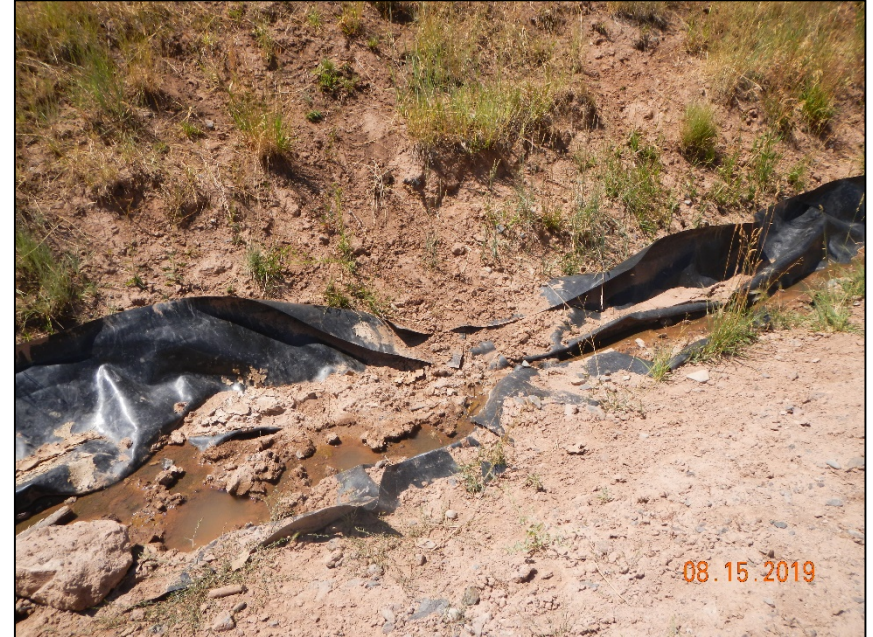
Photo# 21 Lined ditch on West the side of location, is being used as a BMP and is in need of maintenance.

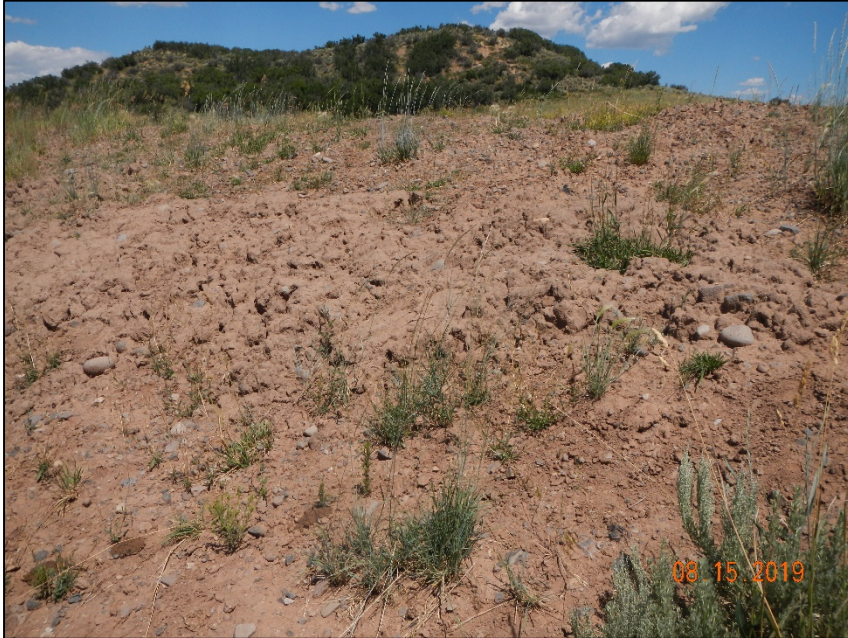
Photo #22. Erosion sediment is moving off un-stabilized berm on the west side of location below the berm, and is choking out vegetation

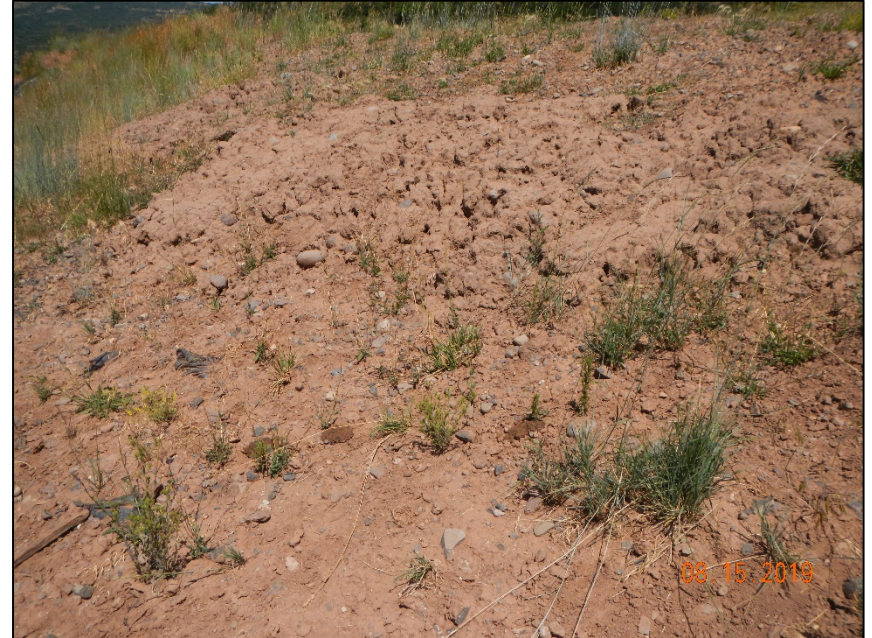
Photo #23. . Erosion sediment is moving off un-stabilized berm on the west side of location below the berm, and is choking out vegetation

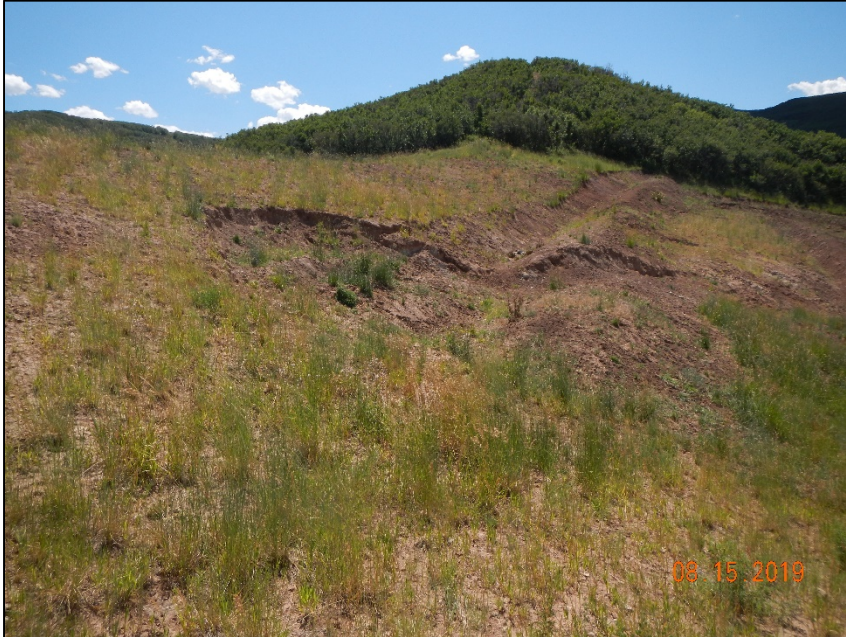
Photo #24. South/East has become un-stabilized and erosion is moving soil down the hill. Vegetation is being choke out. BMP needs maintenance.

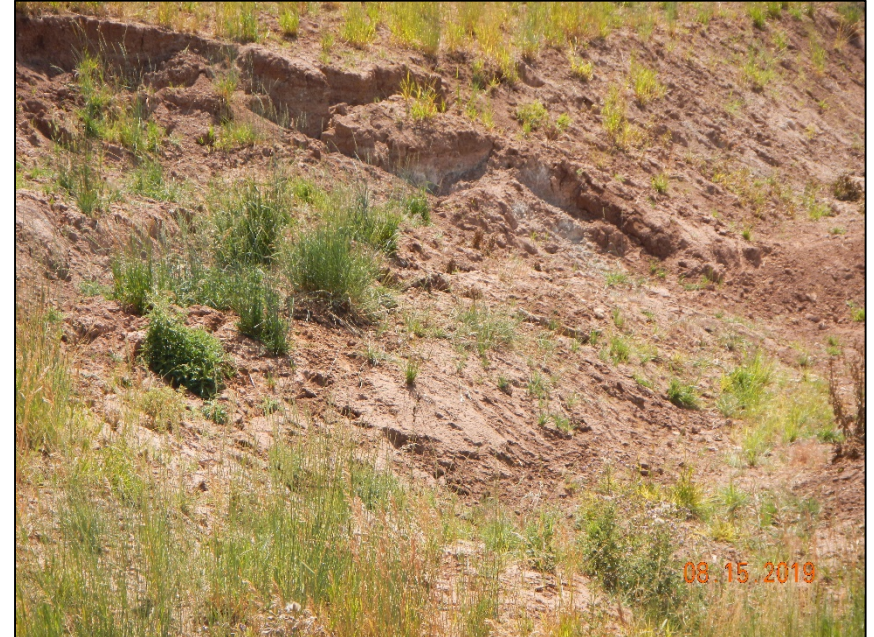
Photo #25. South/East has become un-stabilized and erosion is moving soil down the hill. Vegetation is being choke out. BMP needs maintenance.

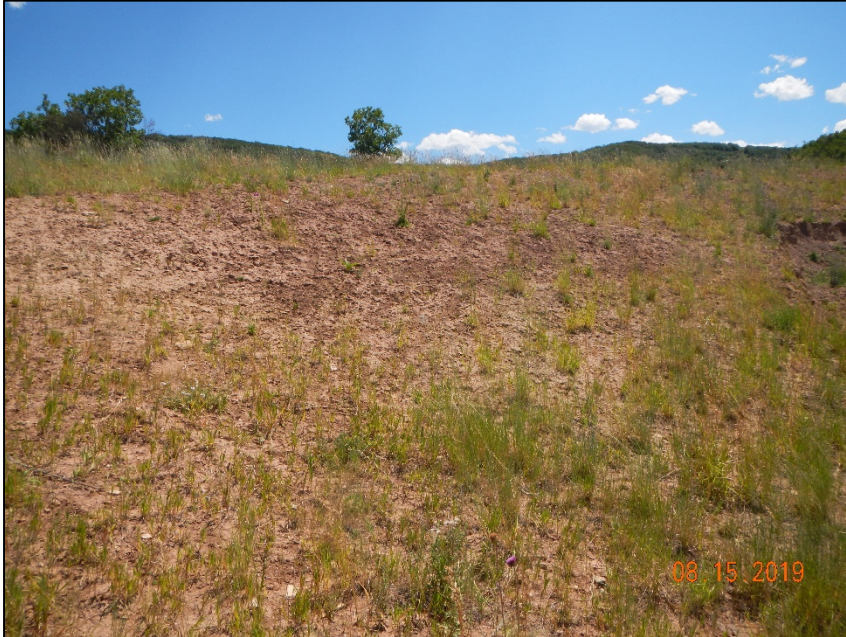
photo #26. On top of the South/East slope, erosion sediment is moving down the slope and is choking out sediment.

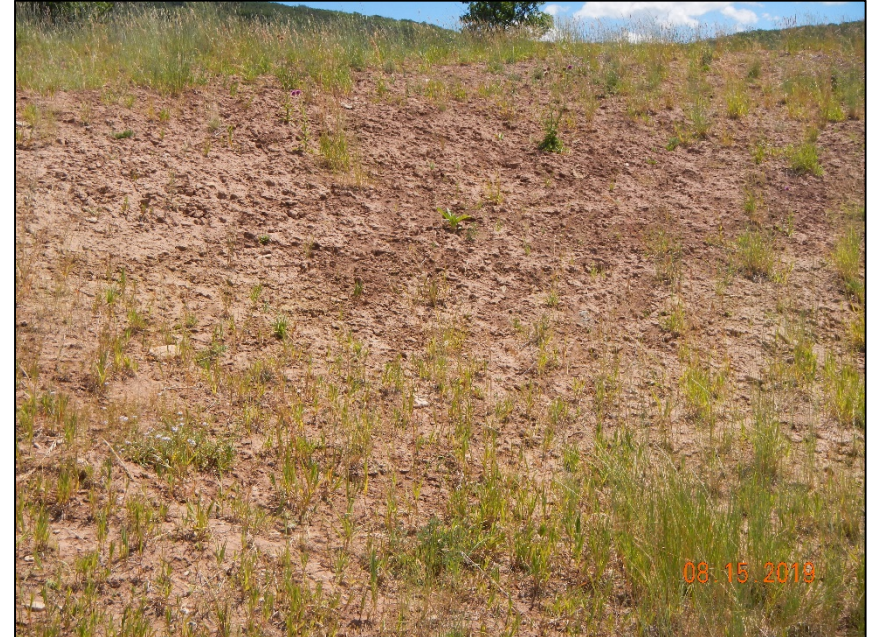
photo #27. On top of the South/East slope, erosion sediment is moving down the slope and is choking out sediment.

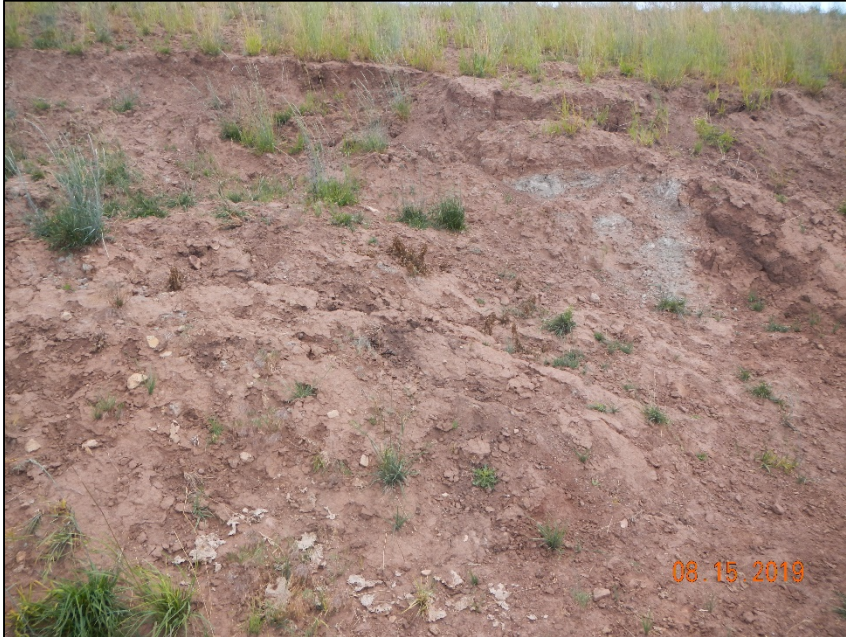
photo #28. South/East has become un-stabilized and erosion is moving soil down the hill. Vegetation is being choke out. BMP needs maintenance.

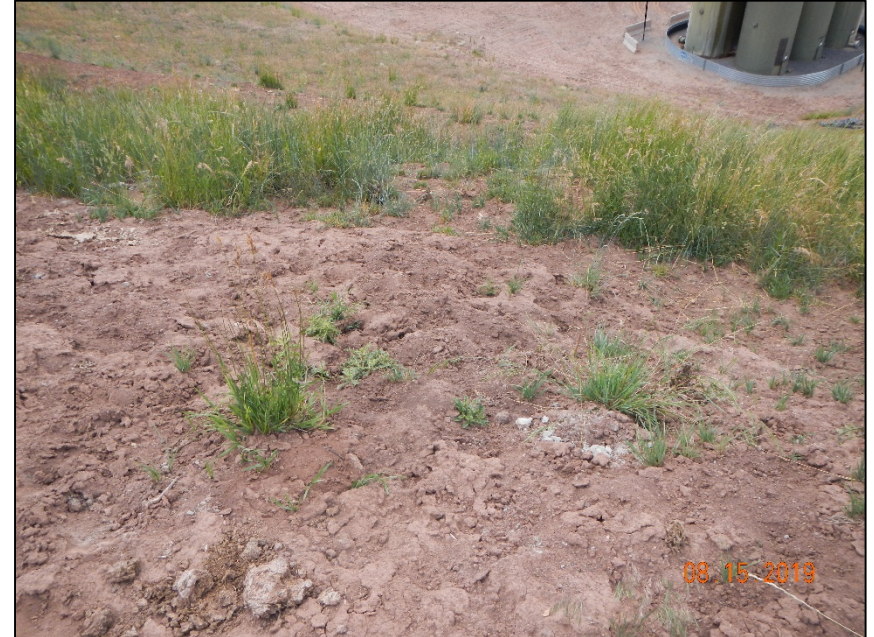
photo #29. South/East has become un-stabilized and erosion is moving soil down the hill. Vegetation is being choke out. BMP needs maintenance.
