# Inspection Photos

08/16/2019

Operator: BISON OIL & GAS II LLC # 10661

Location ID: 452871

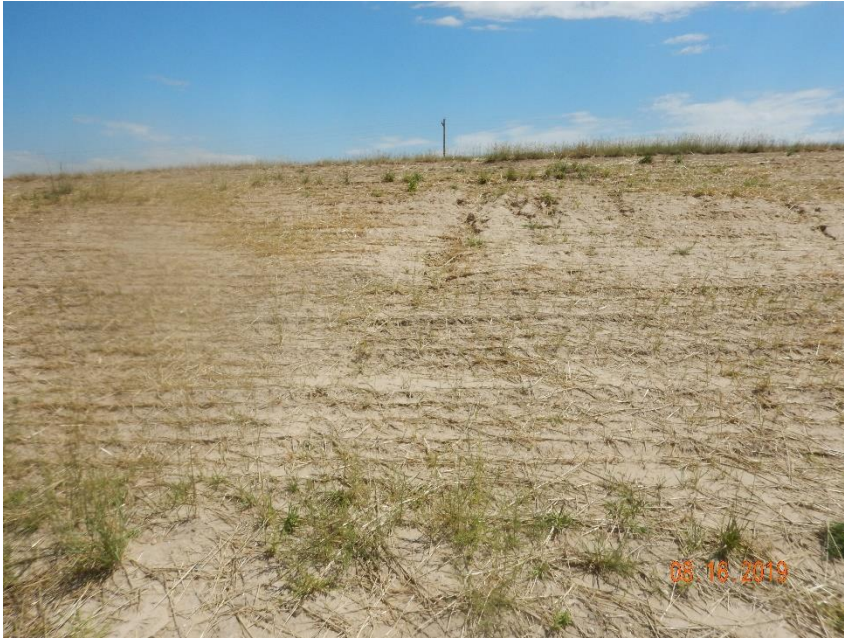
**Photo 1:** Photo taken from the east end of the location, facing east. Photo shows erosion degradation on slopes. Operator has failed to conduct sufficient and ongoing stormwater management and monitoring; Operator has failed install or maintain sufficient stormwater and erosion control BMPs based on the sites conditions and in accordance with good engineering practices.

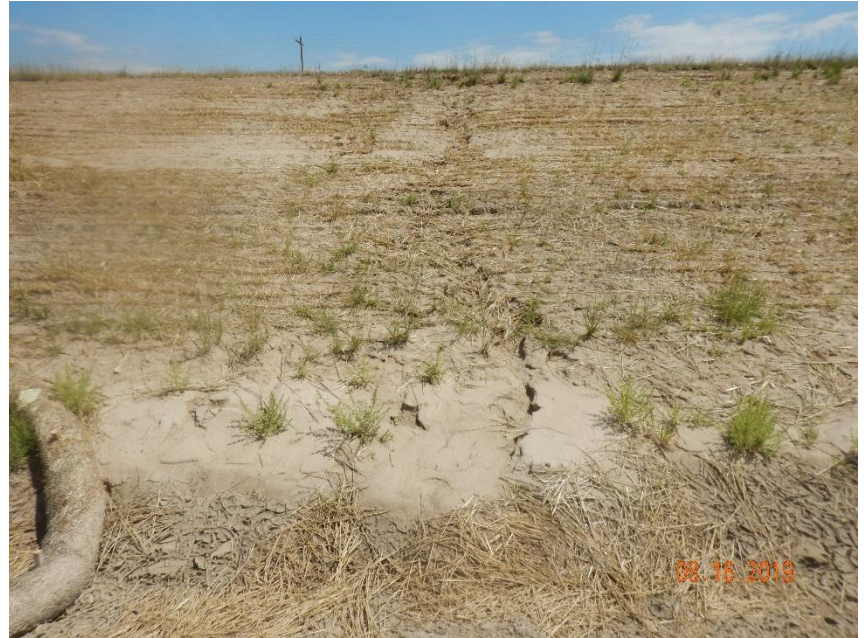
**Photo 2:** See comments under photo 1.

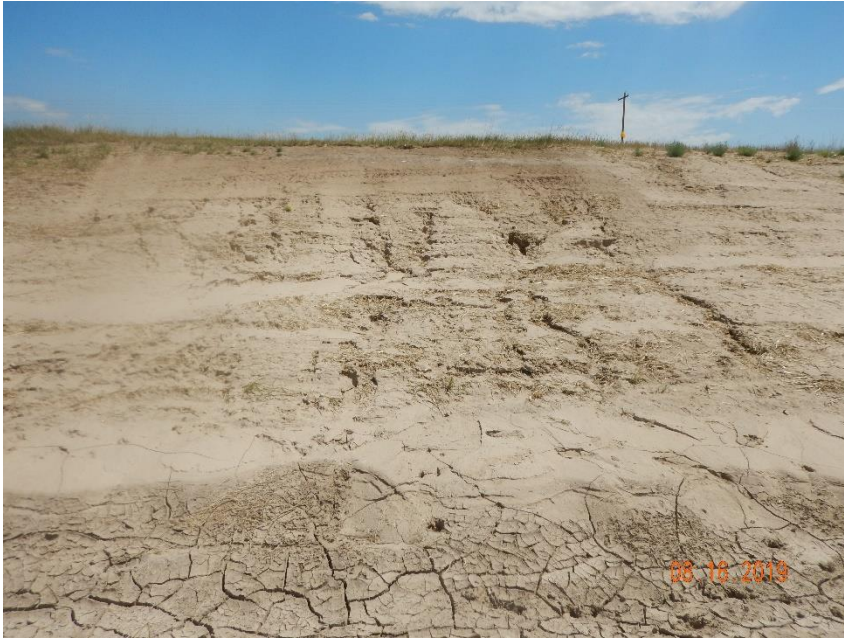
**Photo 3:** Photo taken from the southeast end of the location.  
See comments under photo 1.

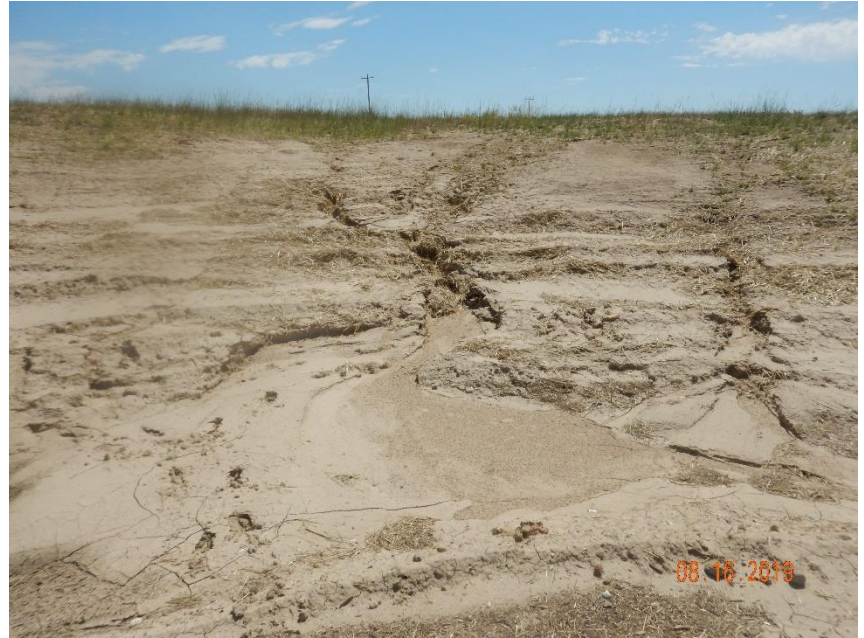
**Photo 4:** Photo taken from the southeast end of the location.  
See comments under photo 1. Photo also shows ditch remains  
filled with sediment and is not in proper functioning  
condition.

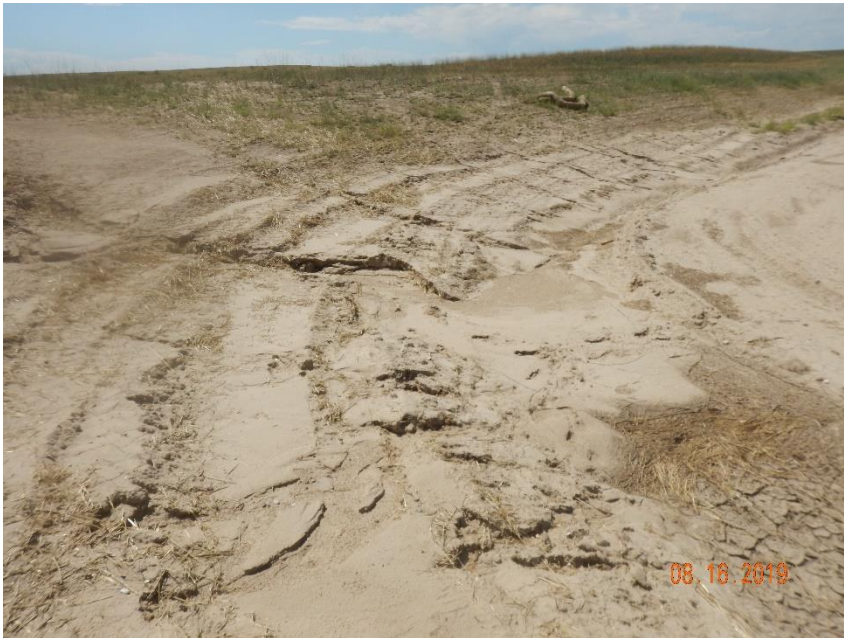
**Photo 5:** Photo taken from the southeast end of the location, facing west. See comments under photo 1. Photo also shows ditch remains filled with sediment and is not in proper functioning condition.

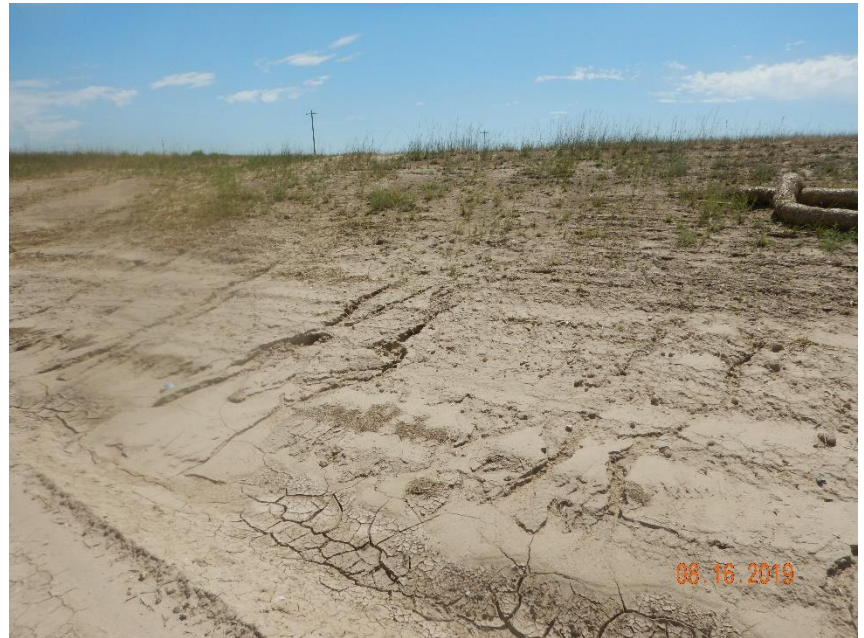
**Photo 6:** Photo taken from the south end of the location. See comments under photo 1.

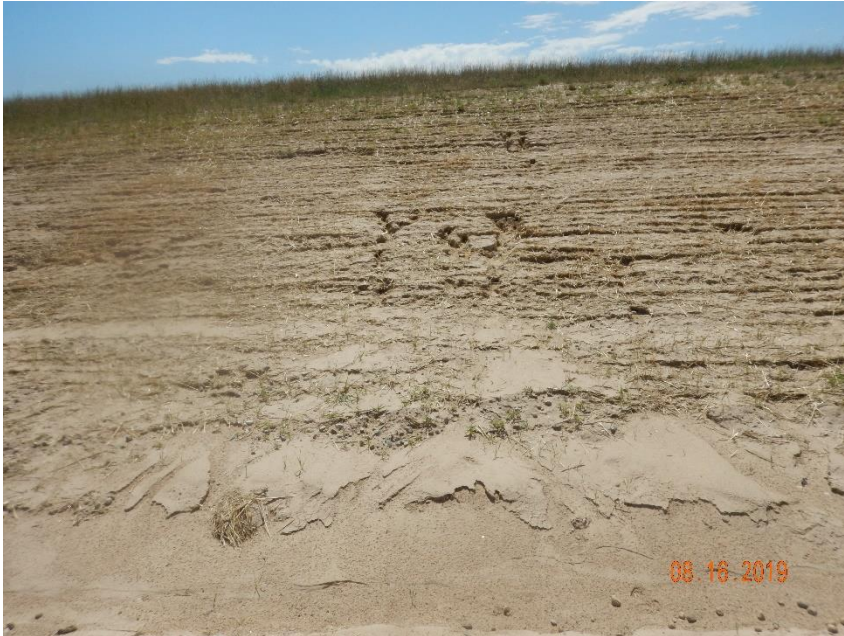
**Photo 7:** Photo taken from the south end of the location. See comments under photo 1.

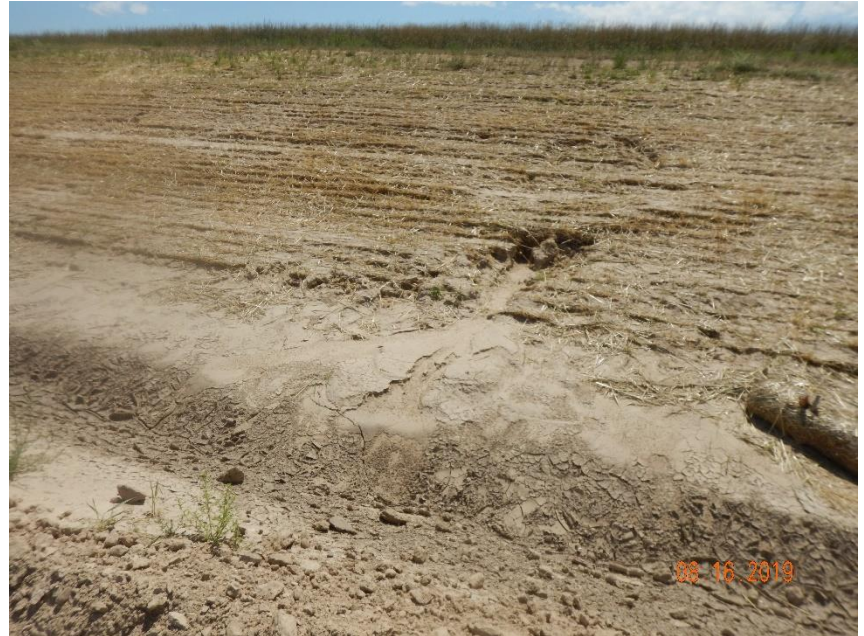
**Photo 8:** Photo taken from the south end of the location. See comments under photo 1. Photo also shows ditch remains filled with sediment and is not in proper functioning condition.

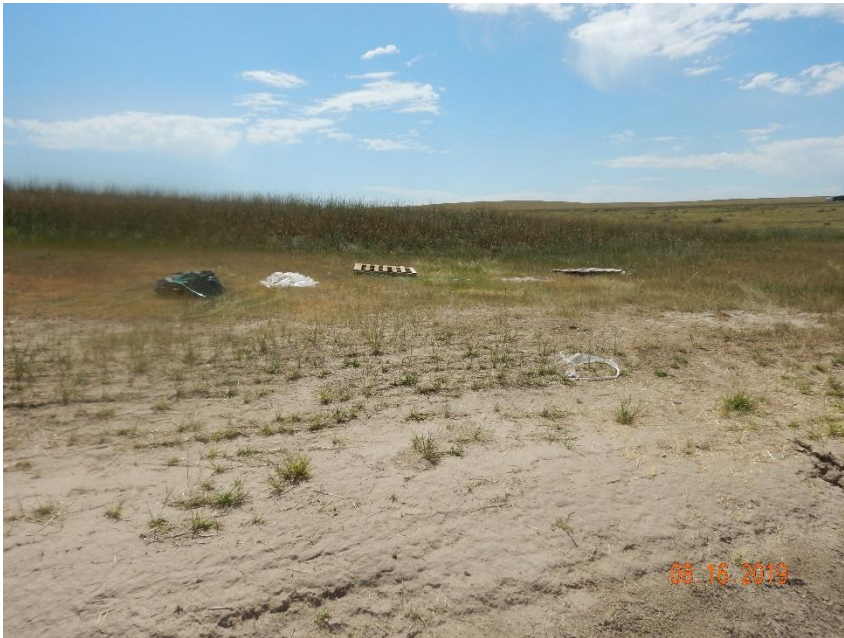
**Photo 9:** Photo taken from the southwest end of the location, facing southwest. Photo shows trash debris on location.

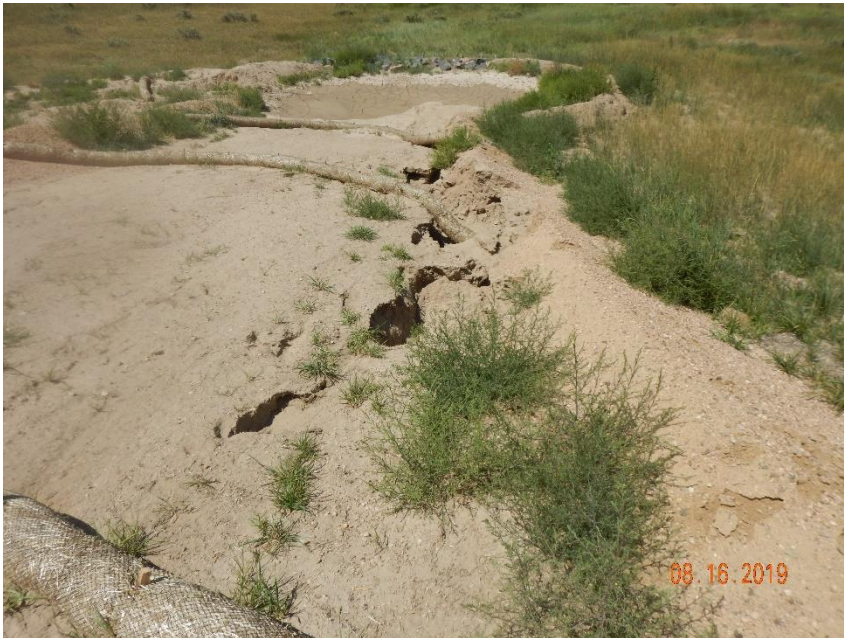
**Photo 11:** Photo taken from the northwest corner of the location. Photos 11-19 show the Stormwater sediment traps constructed on location have not been constructed in accordance with good engineering practices. BMPs were not constructed to an appropriate size for the site's conditions, or with sufficient inlet/outlet and slope protection. As a result, stormwater has degraded the trap and BMP is no longer in proper functioning condition. Sediment transport off location evident.

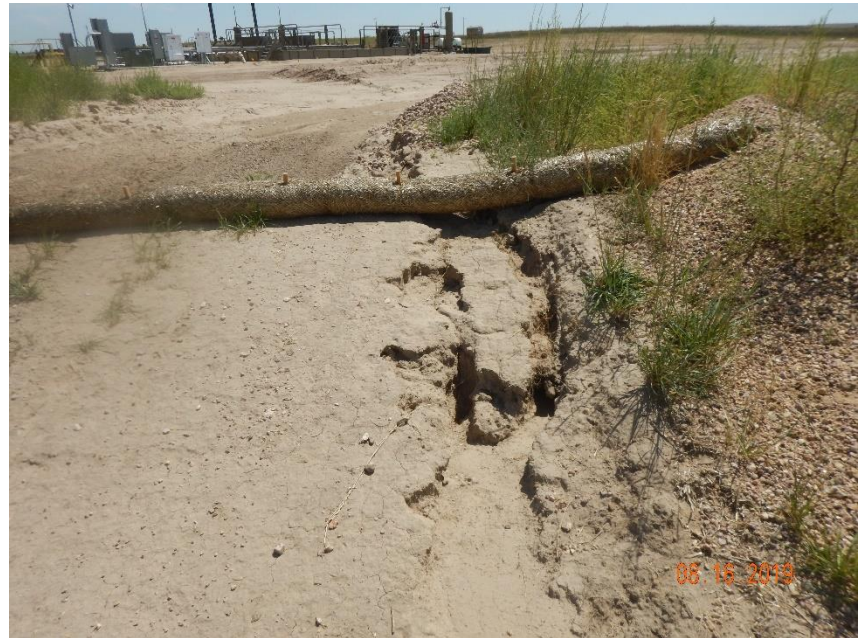
**Photo 12:** See comments under photo 11. Photo shows insufficient inlet protection (BMP not installed in accordance with good engineering practices) has contributed to the failure of the sediment trap.

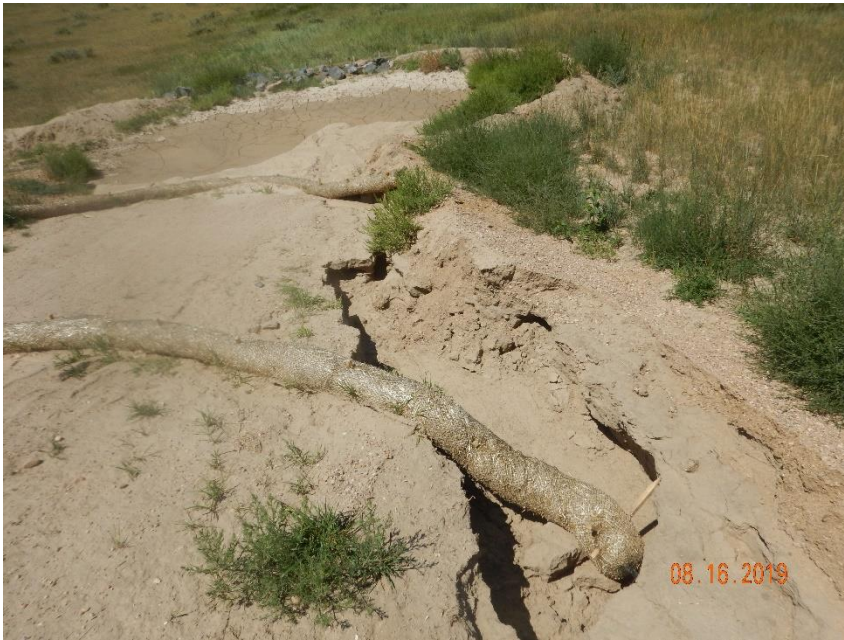
**Photo 13:** See comments under photo 11. Photo shows insufficient inlet protection (BMP not installed in accordance with good engineering practices) has contributed to the failure of the sediment trap.

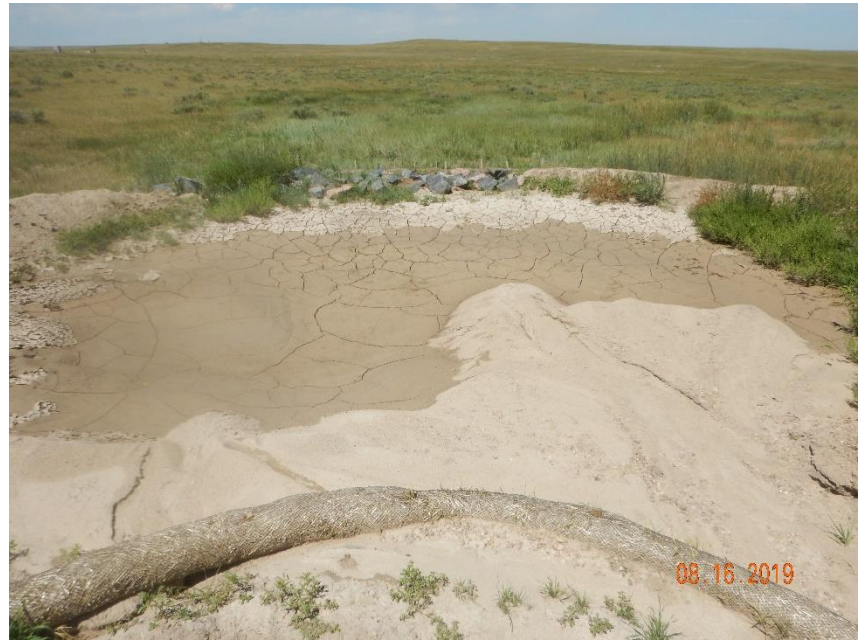
**Photo 14:** See comments under photo 11. Photo shows sediment has filled the trap. BMP was not installed in accordance with good engineering practices and is no longer in proper functioning condition.

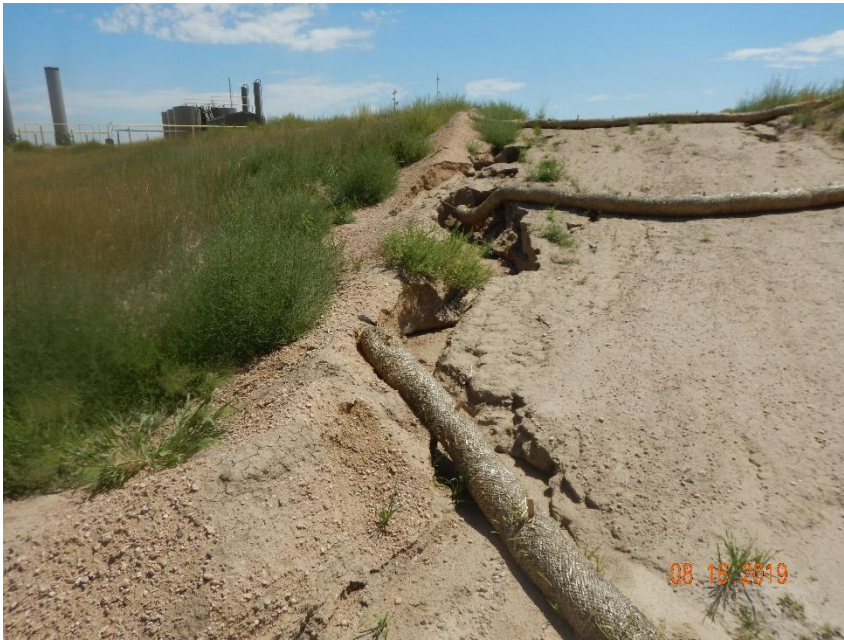
**Photo 15:** See comments under photo 11. Photo shows sediment has filled the trap. BMP was not installed in accordance with good engineering practices and is no longer in proper functioning condition.

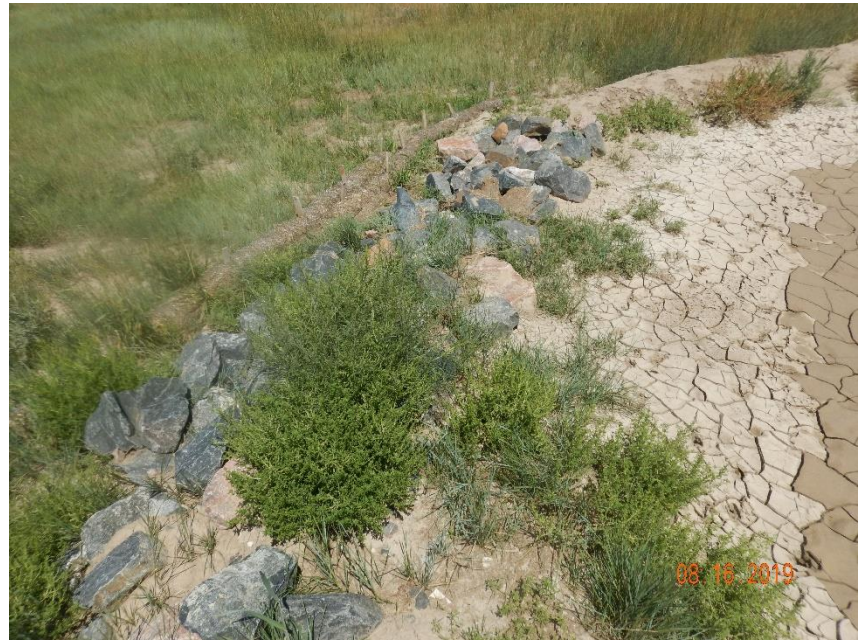
**Photo 16:** See comments under photo 11. Photo shows insufficient outlet protection (BMP not installed in accordance with good engineering practices) has contributed to the failure of the sediment trap and allowed for sediment discharge from location.

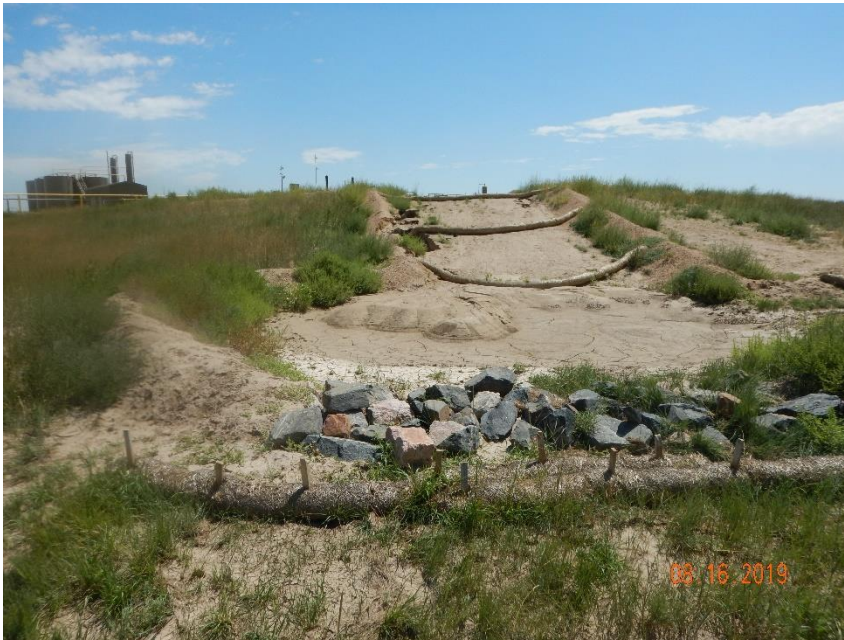
**Photo 17:** See comments under photo 16.

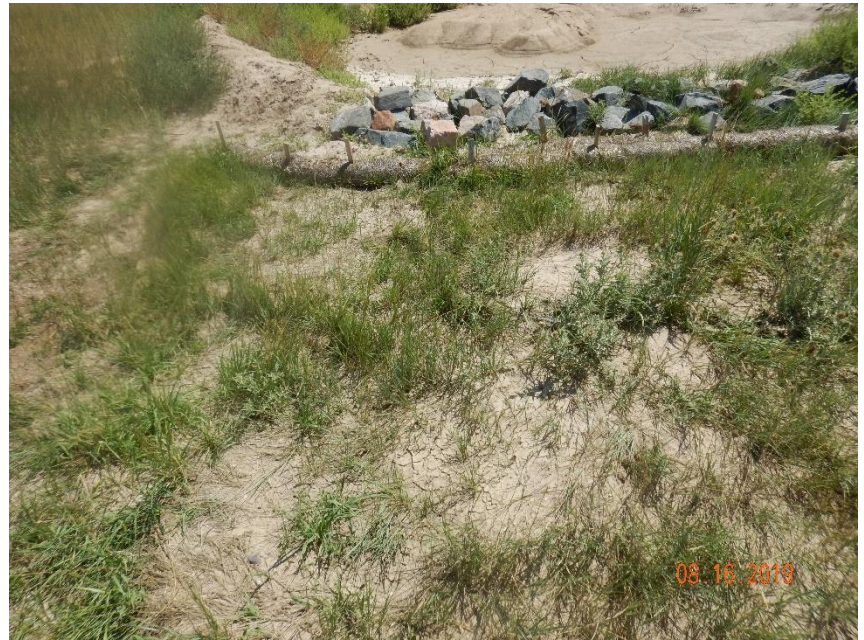
**Photo 18:** Continued from photo 16. Photo shows insufficient outlet protection (BMP not installed in accordance with good engineering practices) has contributed to the failure of the sediment trap and allowed for sediment discharge from location.

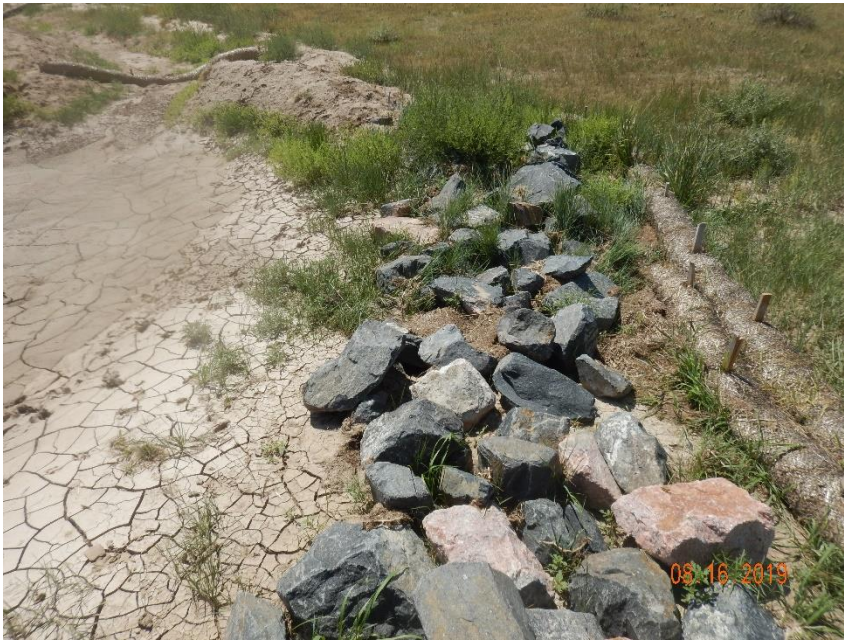
**Photo 19:** See comments under photo 18.

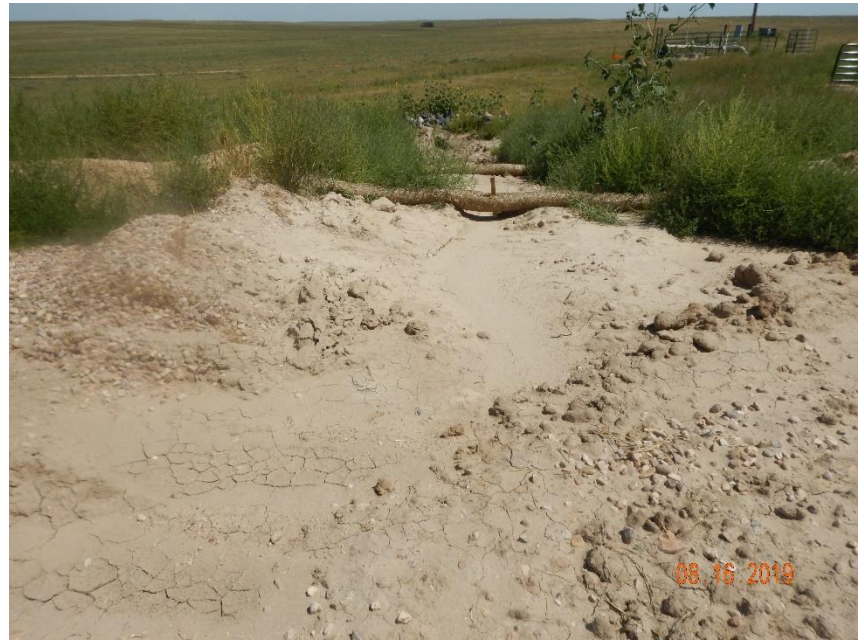
**Photo 20:** Photo taken from the sediment trap on the northeast end of the location. Photos 20- 22 show the Stormwater sediment traps constructed on location have not been constructed in accordance with good engineering practices. BMPs were not constructed to an appropriate size for the site's conditions, or with sufficient inlet/outlet and slope protection. As a result, stormwater has degraded the trap and BMP is no longer in proper functioning condition. Sediment transport off location evident.

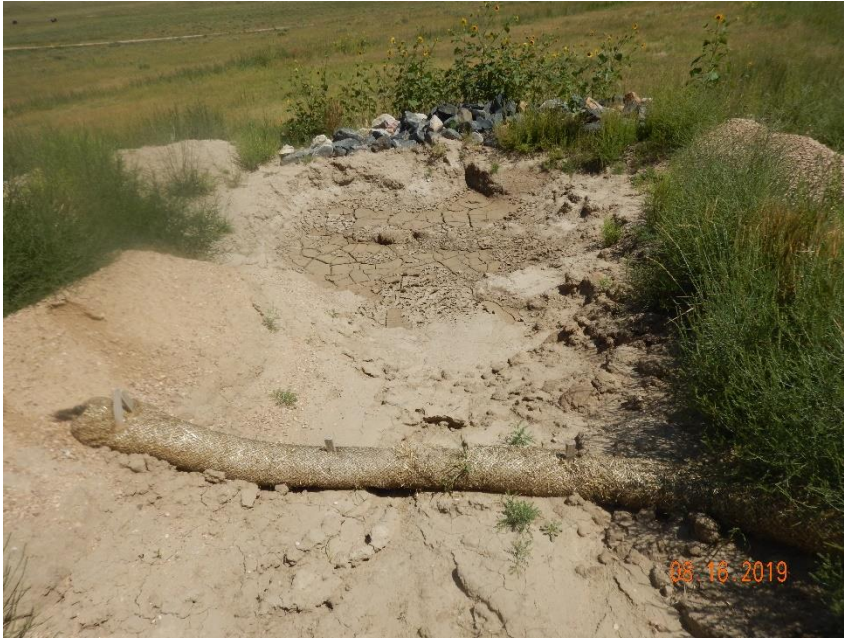
**Photo 21:** See comments under photo 20.

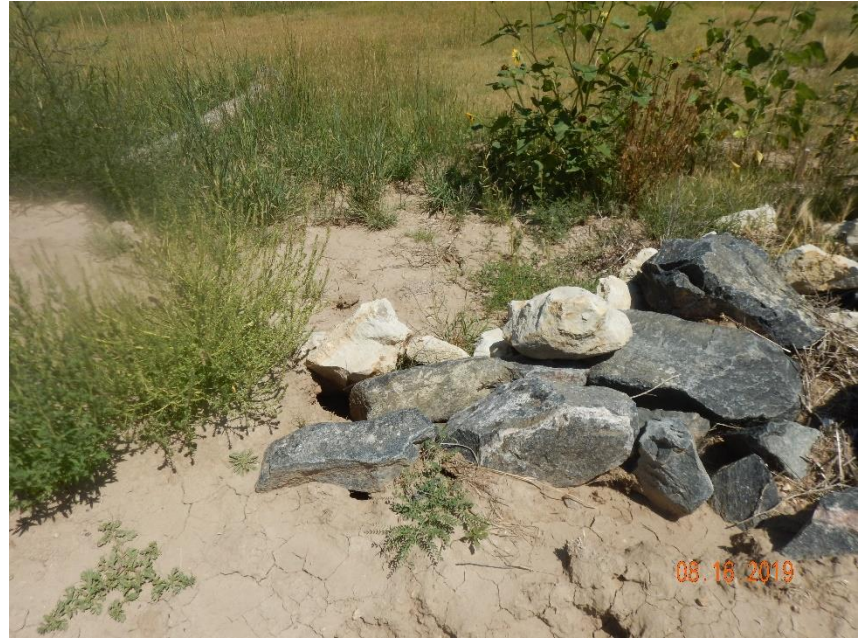
**Photo 22:** Continued from photo 21. Photo shows insufficient outlet protection (BMP not installed in accordance with good engineering practices) has contributed to the failure of the sediment trap and allowed for sediment discharge from location.
