Inspection Photos

08/16/2019

Operator: BISON OIL & GAS II LLC # 10661

Location ID: 455519

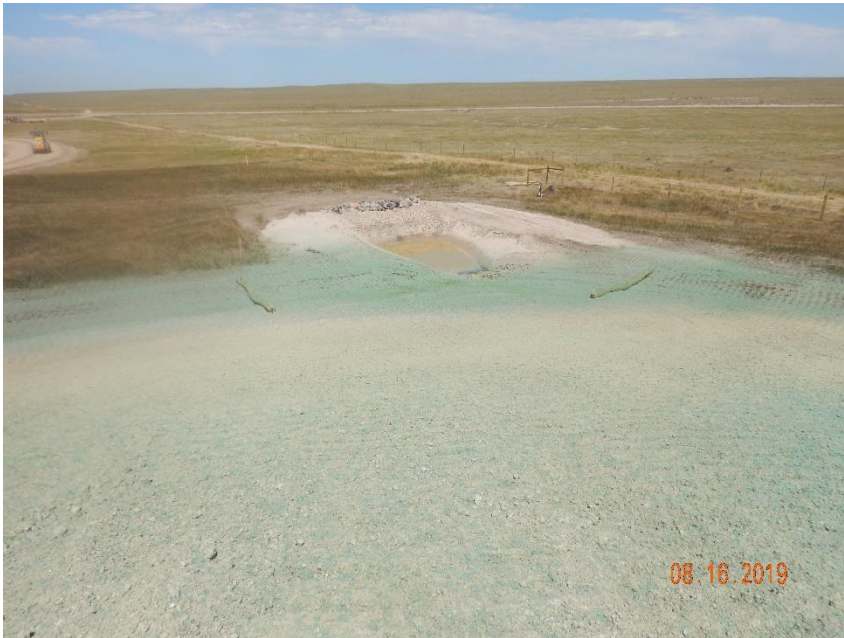
Photo 1: Photo taken from the north east end of the location, facing northeast. Photo shows 1 of the 4 sediment traps on the location. Photo also shows tracking has been re-installed up and down the slopes and is now being used in conjunction with a tackifier.

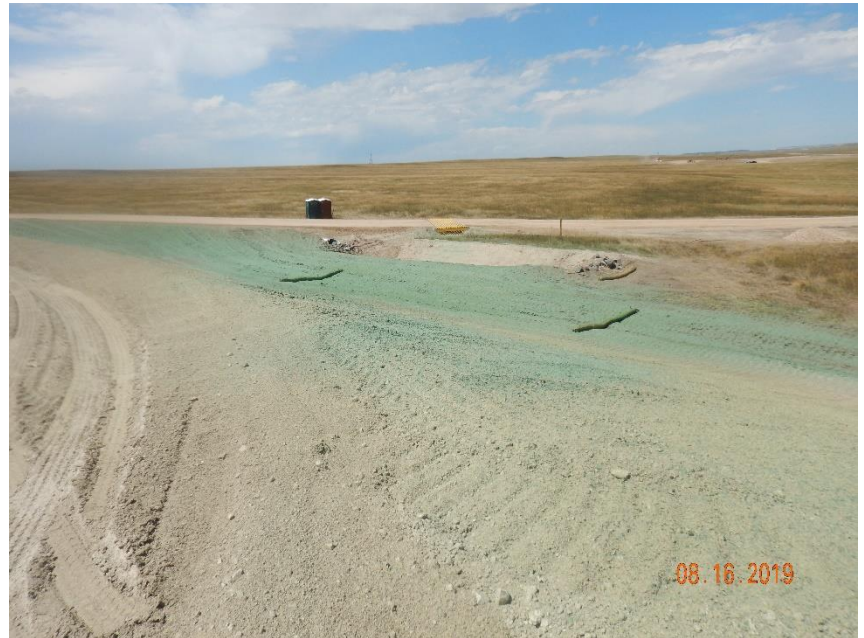
Photo 2: Photo taken from the north east end of the location, facing northwest. See comments under photo 1.

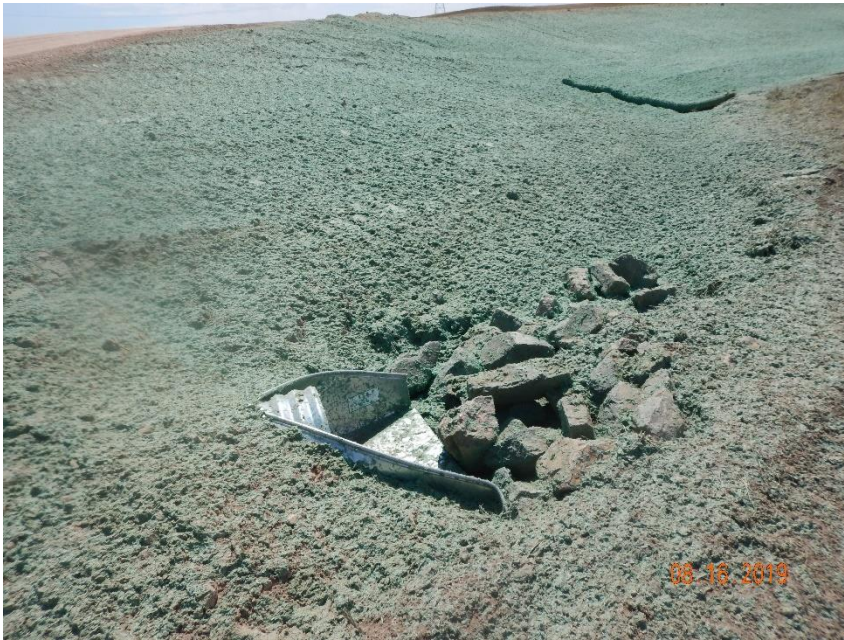
Photo 3: Photo of culvert at the north end of the location. Photo shows armorment/stormwater protection remains missing/insufficient.

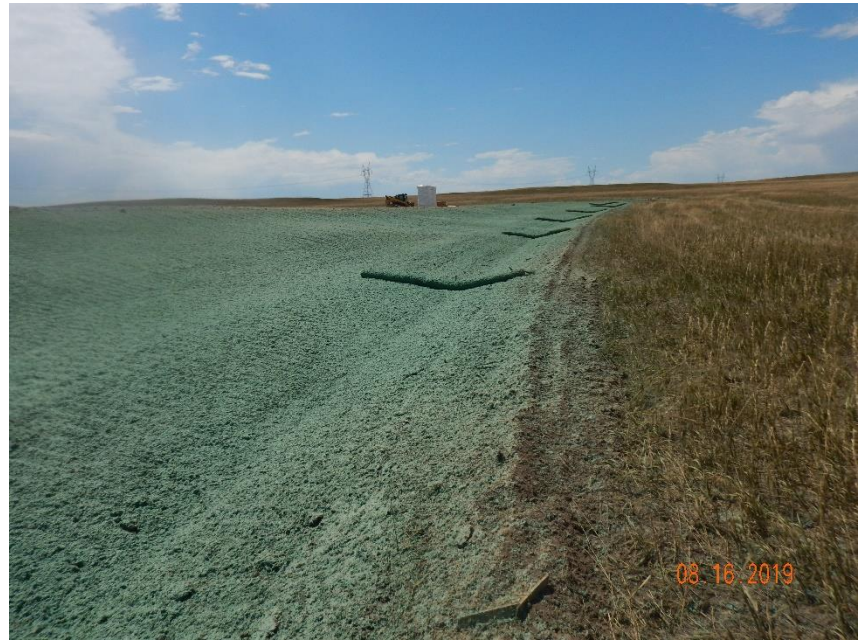
Photo 4: Photo taken from the north end of the location, facing west. Photo shows ditch appear to have been installed in accordance with good engineering practices; ditch appears sufficiently consolidated/compacted. Operator has installed a tackifier as an additional stabilization within ditch.

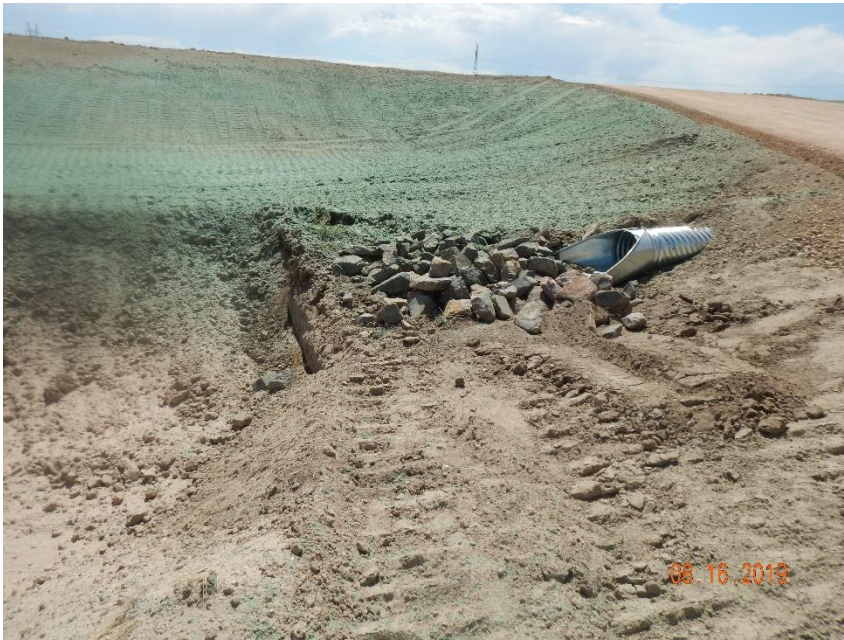
Photo 5: Photo of culvert at the north end of the location. Photo shows armoring/stormwater protection remains missing/insufficient. Photo also shows sediment trap has not been constructed in accordance with good engineering practices and is missing sufficient inlet and outlet protection.

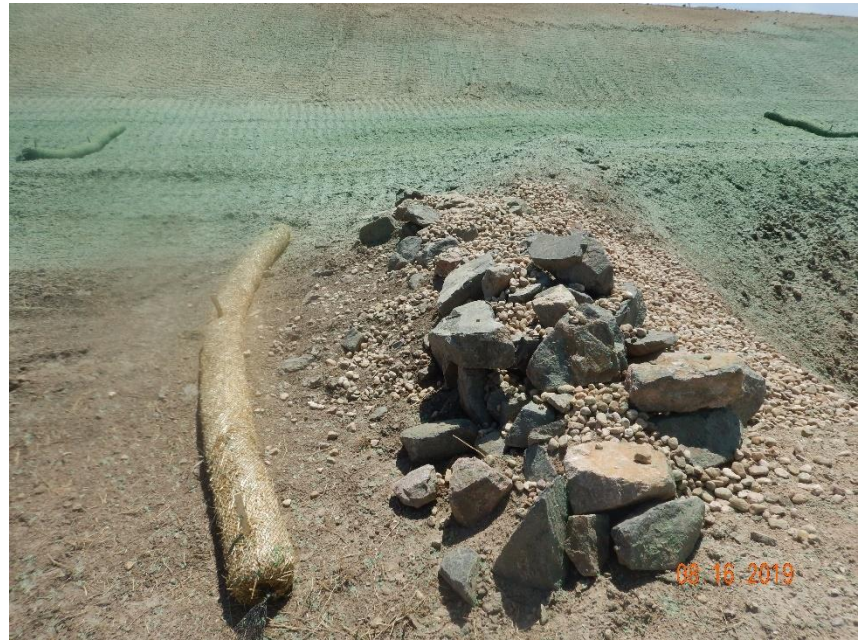
Photo 6: Photo taken from the sediment trap on the north end of the location. Photo shows sediment trap has not been constructed in accordance with good engineering practices and is missing sufficient inlet and outlet protection. Additional smaller sized rip-rap has been placed at outlet in conjunction with the larger aggregate material observed in the previous inspection however, it does not appear as though operator has installed a geotextile lining beneath the coarse aggregate and rip-rap. Wattle has only been placed and staked upon surface, and has not been trenched/backfilled in accordance with good engineering practices.

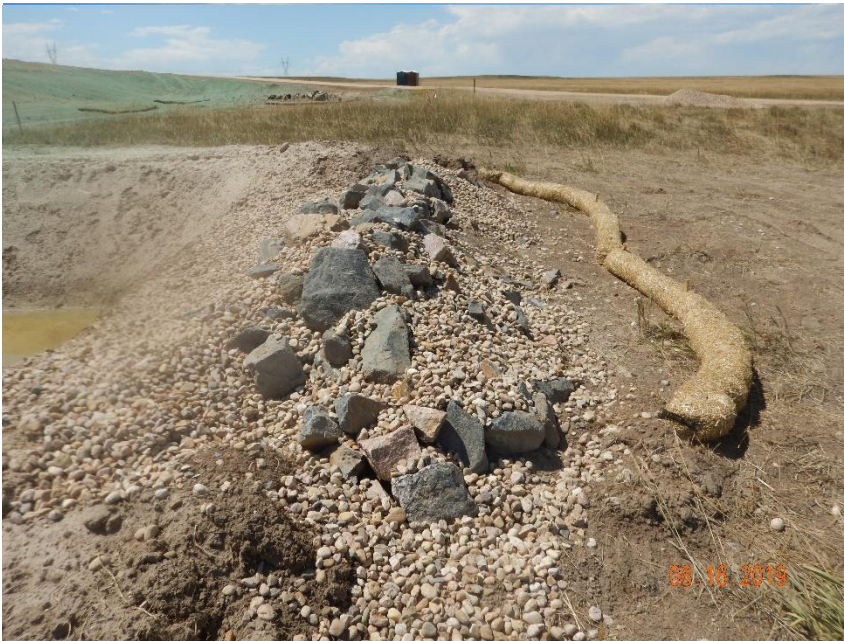
Photo 7: Photo taken from the sediment trap on the northeast end of the location. See comments under photo 6.

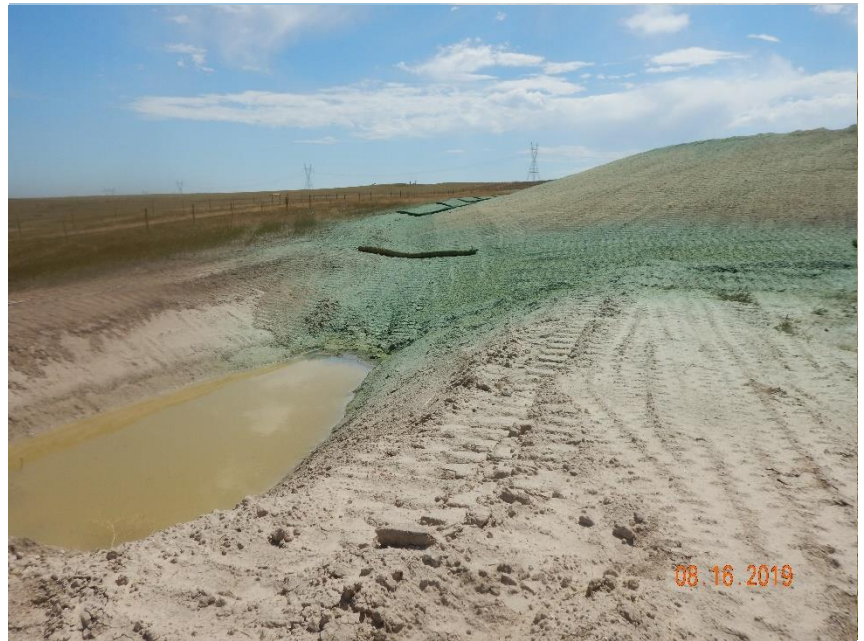
Photo 8: Photo taken from the sediment trap on the northeast end of the location. See comments under photo 6.

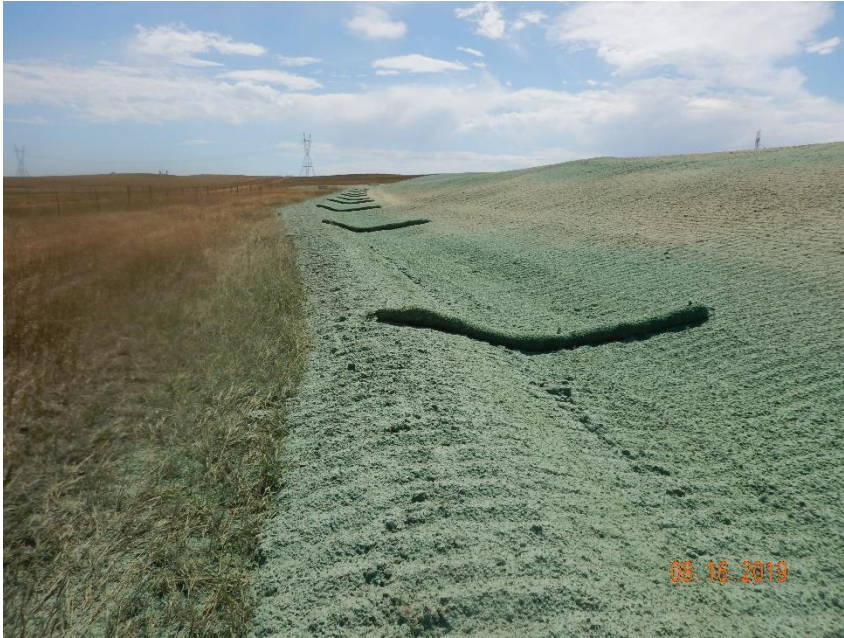
Photo 9: Photo taken from the ditch along the east end of the location. Photo shows ditch appear to have been installed in accordance with good engineering practices; ditch appears sufficiently consolidated/compacted. Operator has installed a tackifier as an additional stabilization within ditch. Photo also shows Operator has selected/placed straw wattles within the ditch of the location. Wattles appear to have been placed as a "Velocity Check". Straw wattles have not been installed in accordance with good engineering practices. Wattles are required to be trenched and back-filled in order to be in proper functioning condition. Insufficient trenching/backfilling will result in degradation to the ditch due to stormwater cutting and passing beneath the wattle.

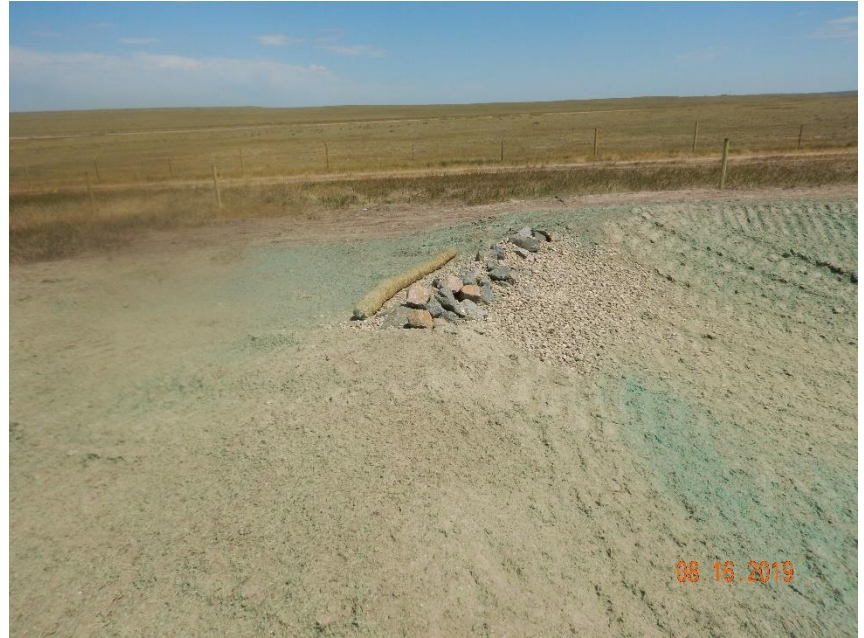
Photo 10: Photo taken from the sediment trap on the east end of the location facing east. See comments under photo 6.

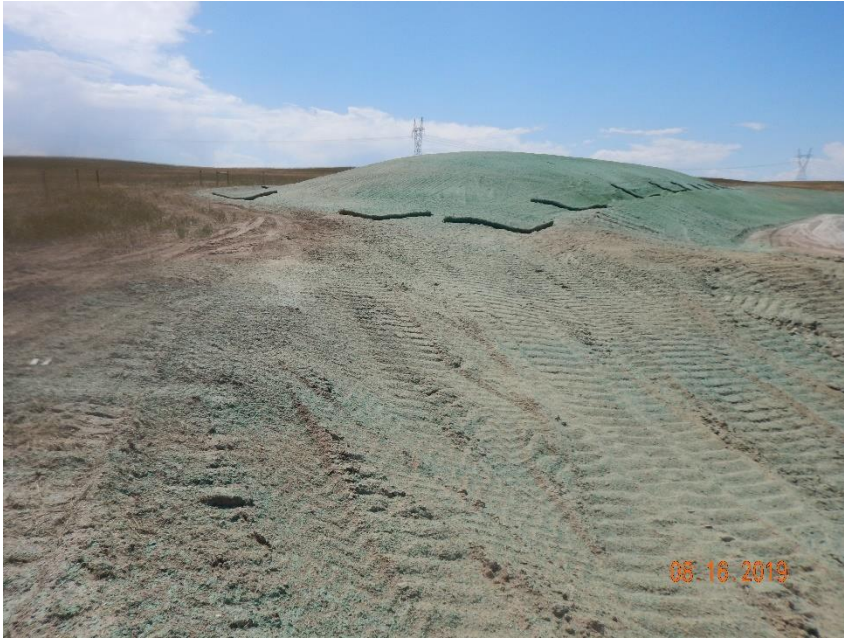
Photo 11: Photo taken from the sediment trap on the east end of the location, facing south. See comments under photo 6.

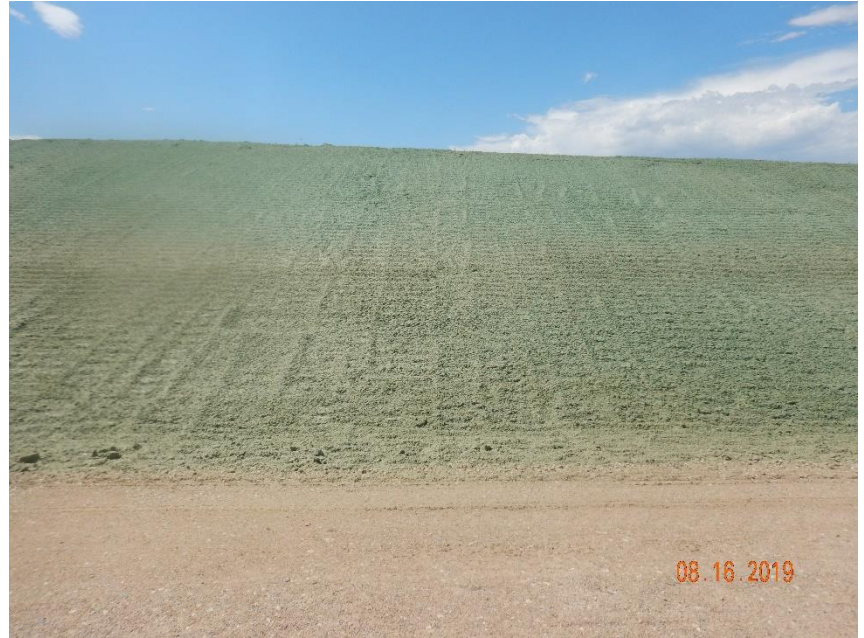
Photo 12: Photo taken from the south end of the location, facing south. Photo shows tracking has been re-installed up and down the slopes and is now being used in conjunction with a tackifier.

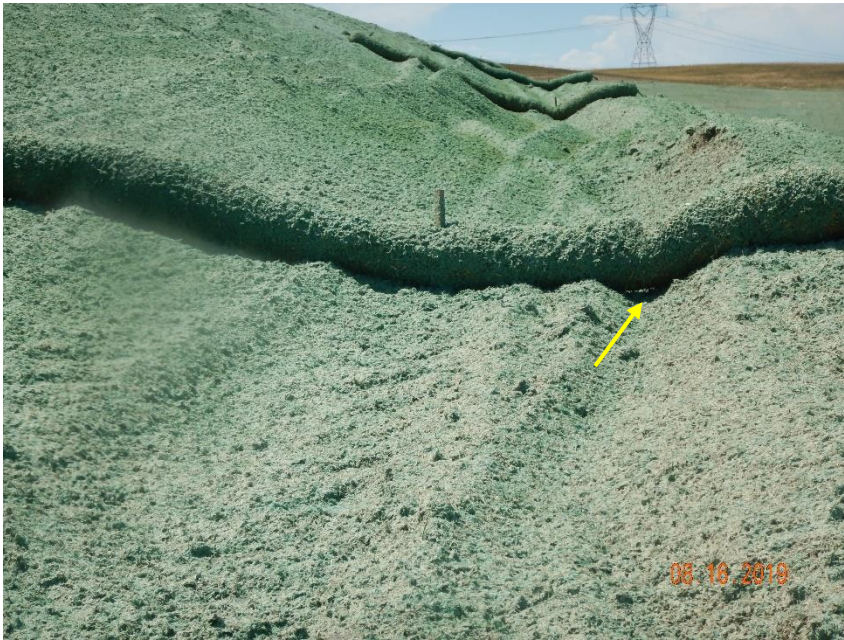
Photo 13: Photo taken from the ditch at base of the soil stockpile on the south end of the location. Photo shows Operator has selected/placed straw wattles within the ditch of the location. Wattles appear to have been placed as a "Velocity Check". Straw wattles have not been installed in accordance with good engineering practices. Wattles are required to be trenched and back-filled in order to be in proper functioning condition. Insufficient trenching/backfilling will result in degradation to the ditch due to stormwater cutting and passing beneath the wattle. Arrow pointing at daylight observed from under the wattle.

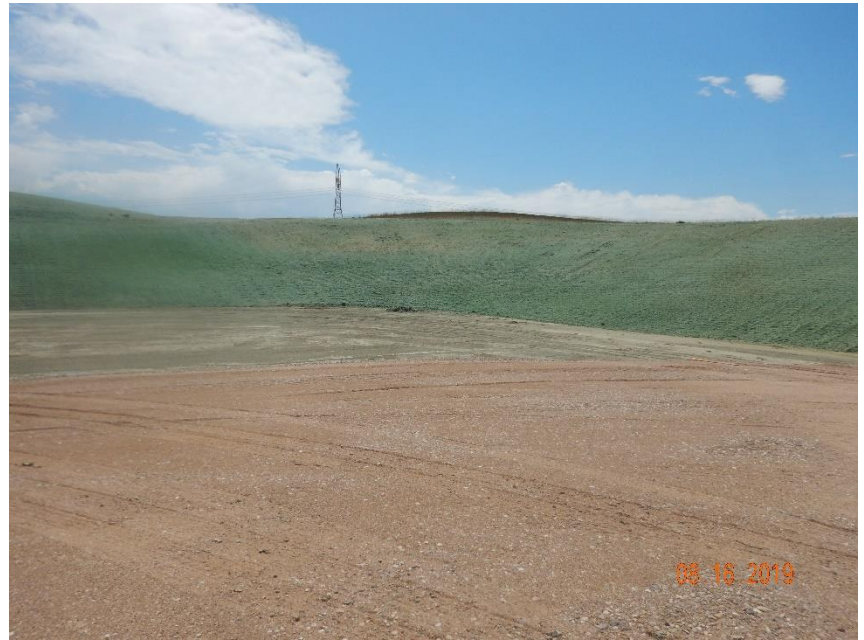
Photo 14: Photo taken from the southwest end of the location, facing southwest. Photo shows tracking has been re-installed up and down the slopes and is now being used in conjunction with a tackifier.

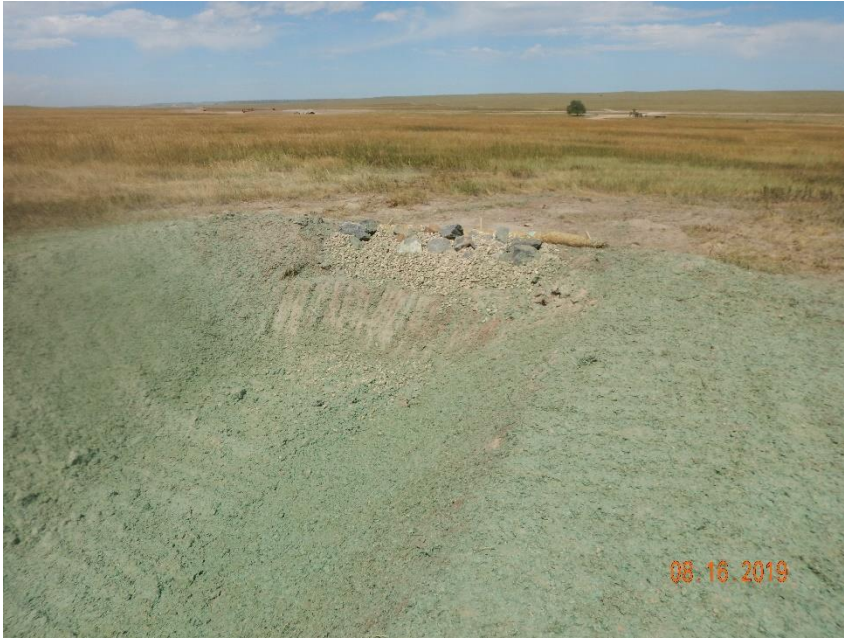
Photo 15: Photo taken from the sediment trap on the northwest end of the location. See comments under photo 7.

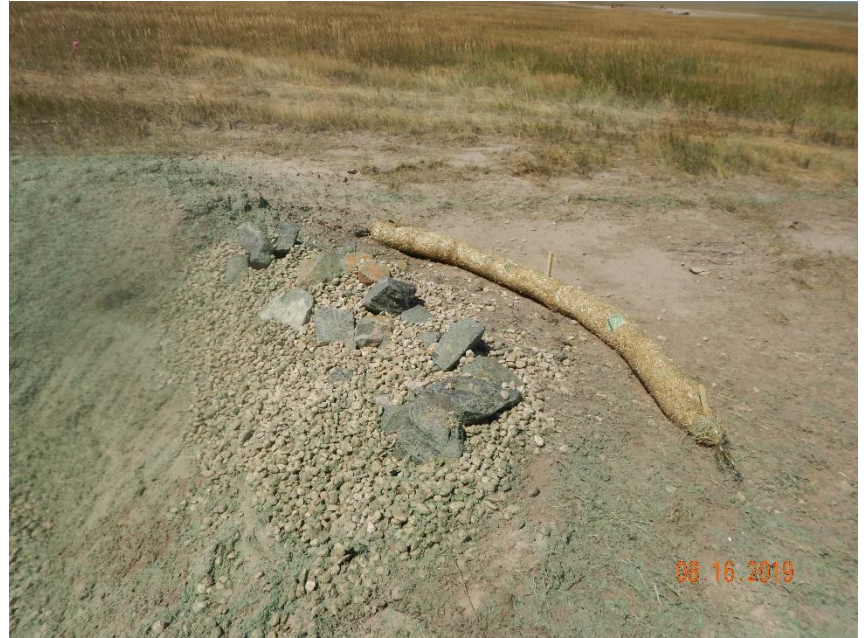
Photo 16: Photo taken from the sediment trap on the northwest end of the location. See comments under photo 7.
