Inspection Photos

08/16/2019

Operator: BISON OIL & GAS II LLC # 10661

Location ID: 454591

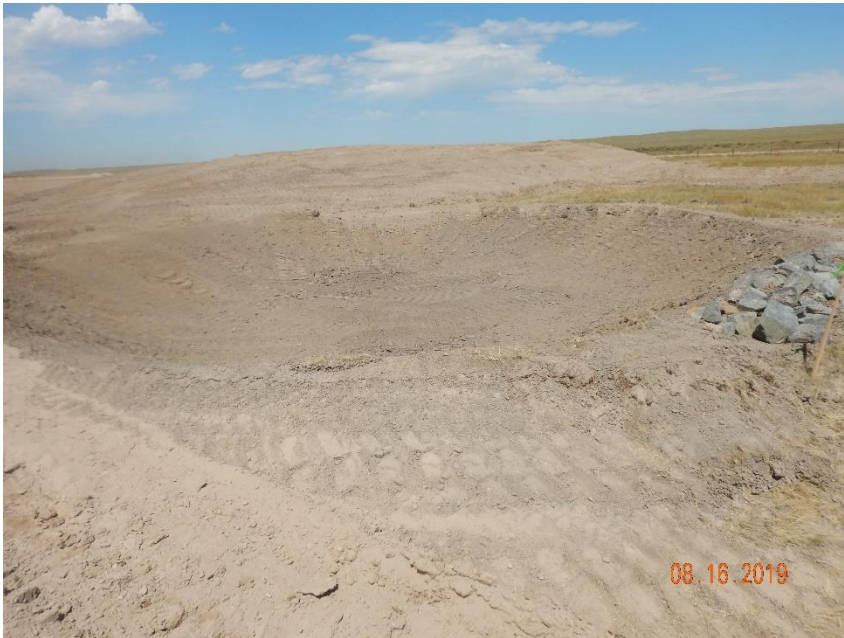
Photo 1: Photo taken from the south end of the location, facing east. Photo shows 1 of the 4 sediment traps on the location. Sediment trap has been enlarged, however, sediment trap has not been constructed in accordance with good engineering practices and is missing sufficient inlet and outlet protection. Coarse rock aggregate used appears too large to slow stormwater discharge. No geotextile lining has been installed beneath the rip-rap

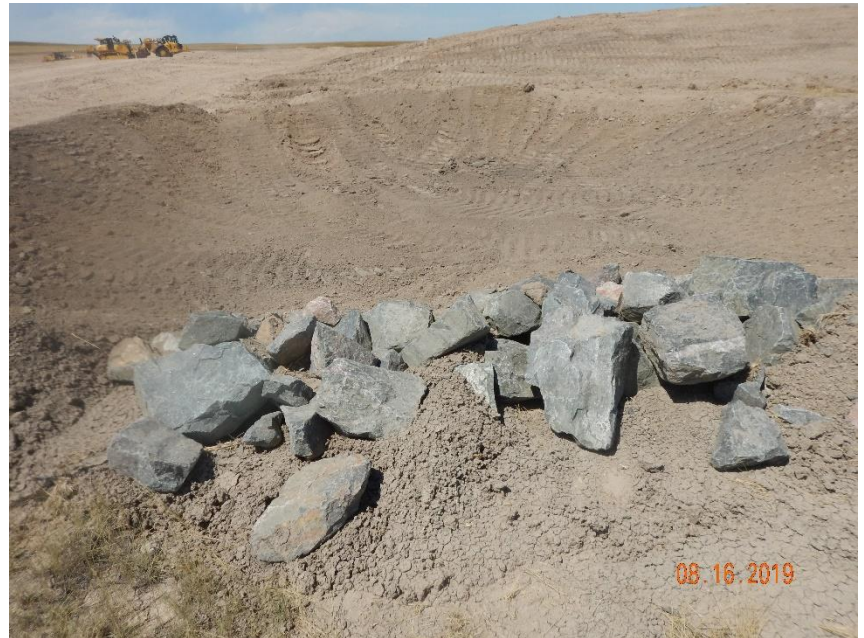
Photo 2: Photo taken from the south end of the location. See comments under photo 1.

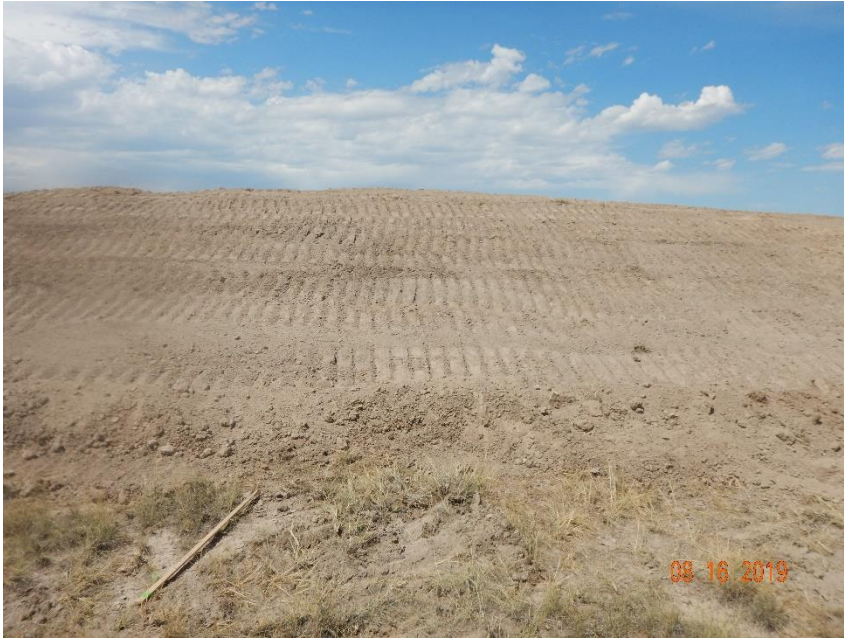
Photo 3: Photo taken from the topsoil stockpile on the south end of the location. Photo shows operator has installed surface roughening (tracking) on slopes. Tracking has been installed along the contour of the slopes, rather than up and down.

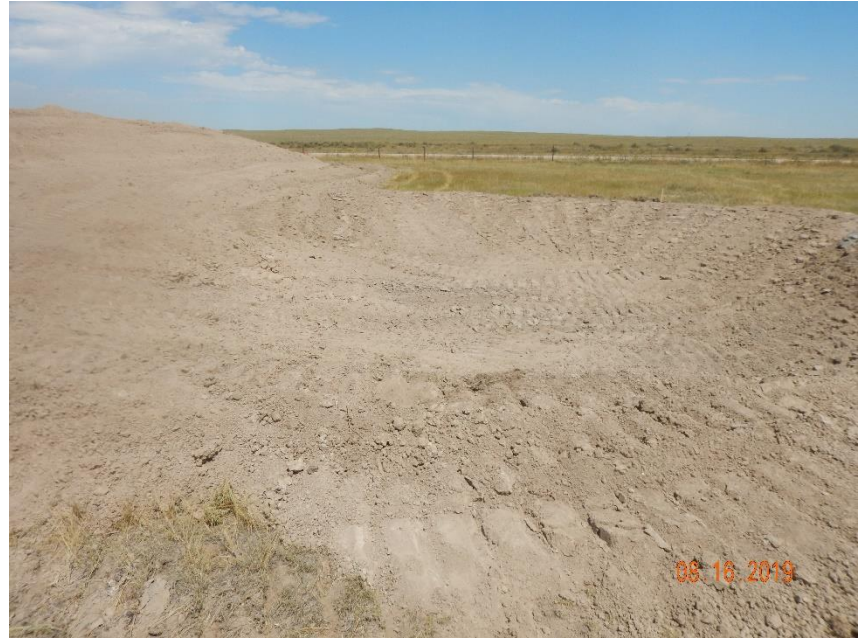
Photo 4: Photo taken from the southeast end of the location, facing east. Photo shows 1 of the 4 sediment traps on the location. See comments under photo 1.

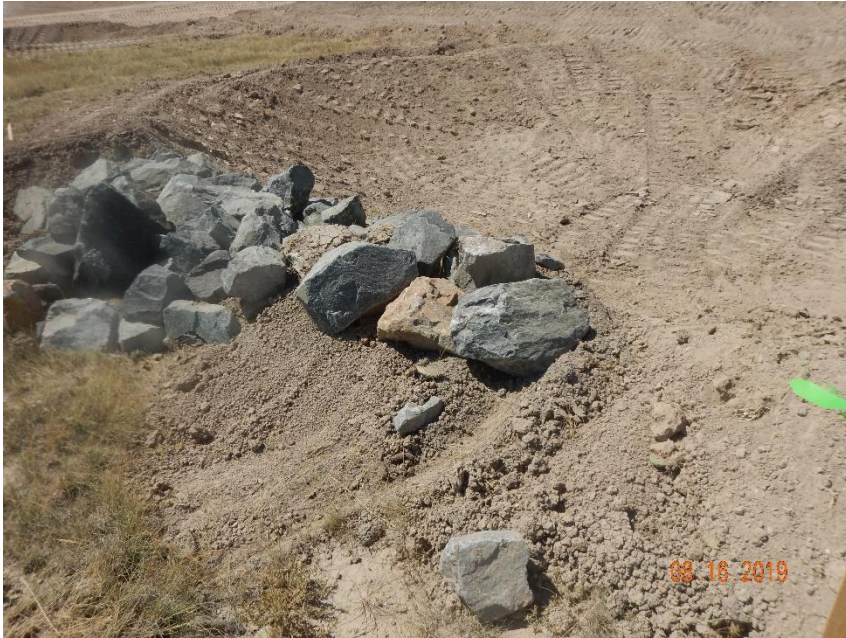
Photo 5: Continued from photo 4. See comments under photo 1.

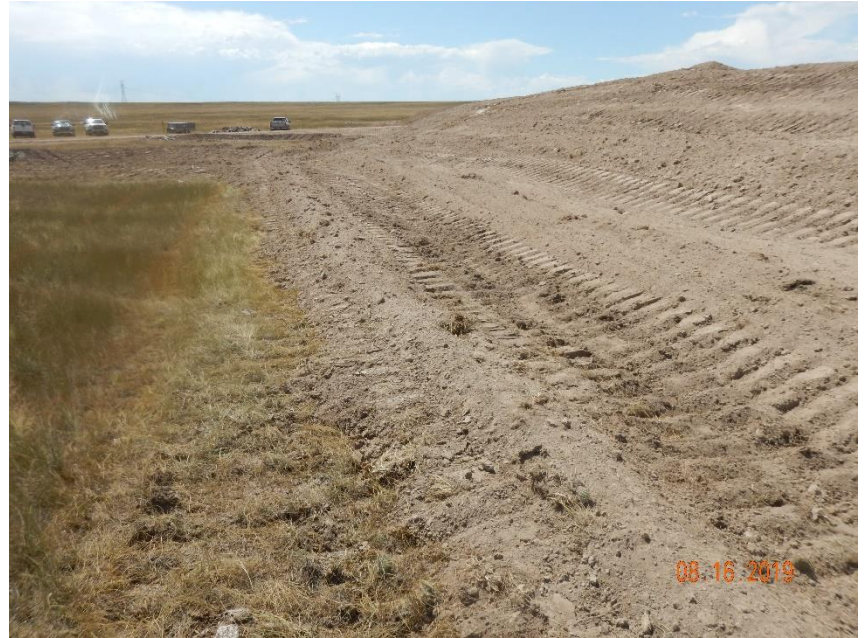
Photo 6: Photo shows stormwater diversion ditch on the southeastern perimeter of the location. Photo shows stormwater has not been constructed in accordance with good engineering practices and remains predominantly loose, unconsolidated/uncompacted material.

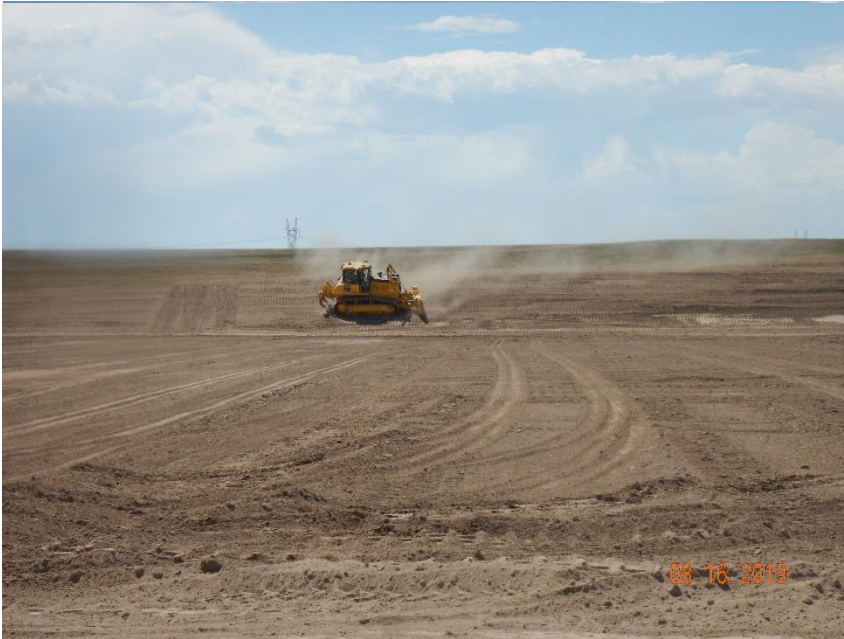
Photo 7: Photo taken from the east end of the location, facing west. Photo shows operator has installing surface roughening (tracking) on slopes. Tracking has been installed along the contour of the slopes, rather than up and down.

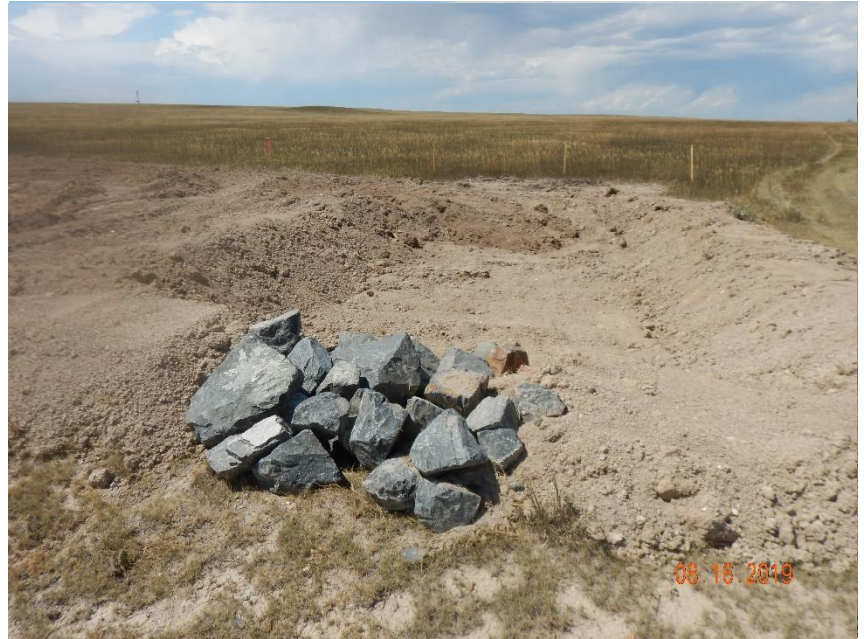
Photo 8: Photo of sediment trap on the northeast end of the location. Photo shows sediment trap has not been constructed in accordance with good engineering practices.

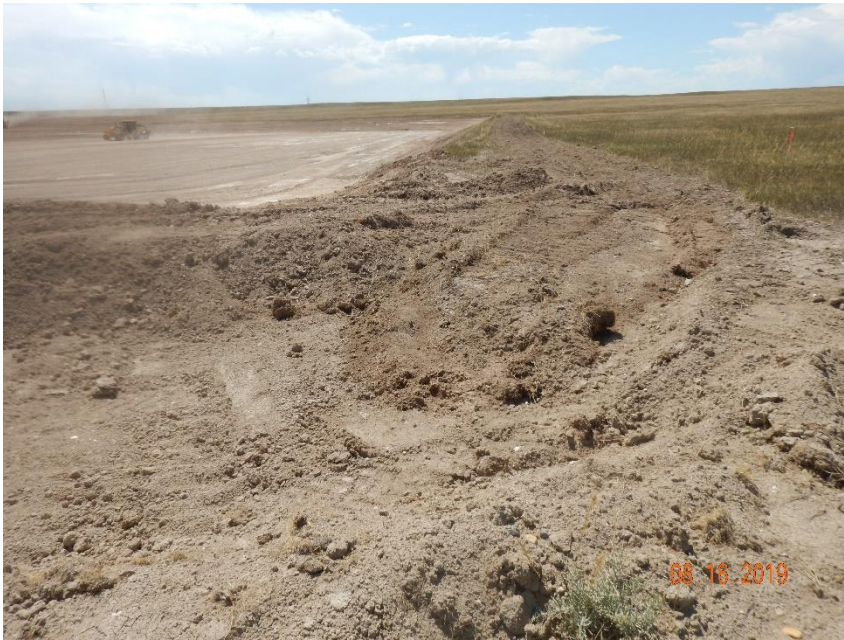
Photo 9: Photo taken from the sediment trap on the northeast corner of the location. See comments under photo 1. Photo also shows ditch on the northeast end of the location remains predominantly loose, unconsolidated/uncompacted material.

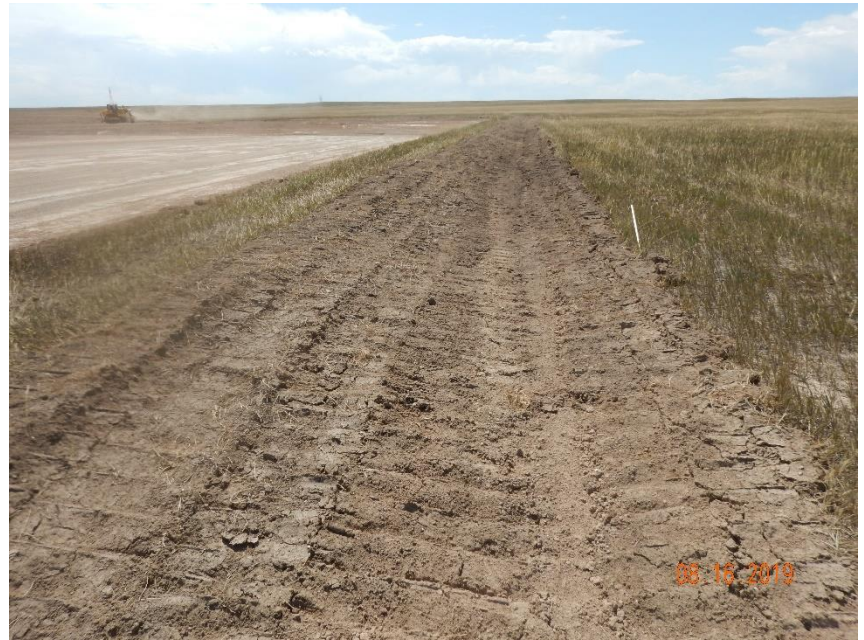
Photo 10: Photo taken from the north end of the location, facing west. Photo shows section of perimeter stormwater diversion ditch that appear to be constructed in accordance with good engineering practices.

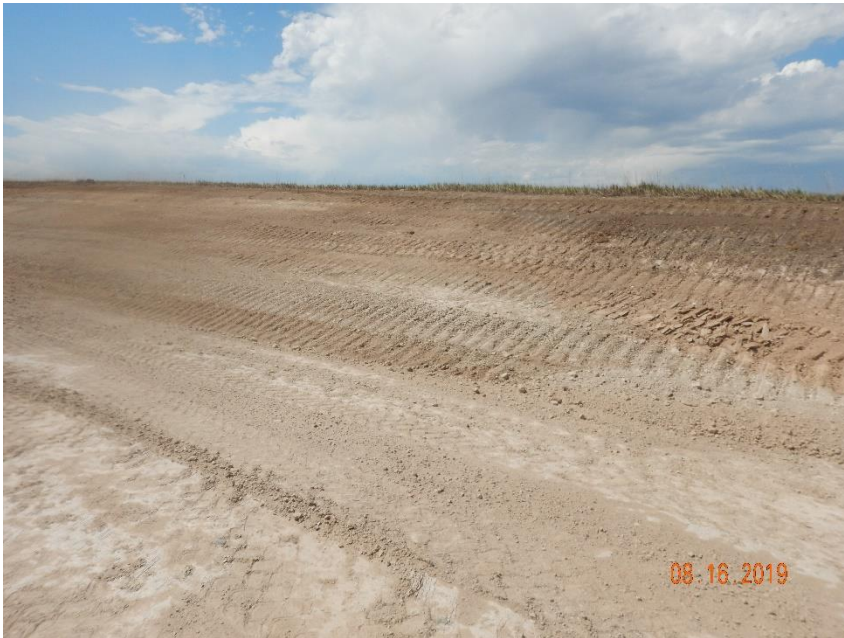
Photo 11: Photo taken from the slopes on the north end of the location. See comments under photo. 3

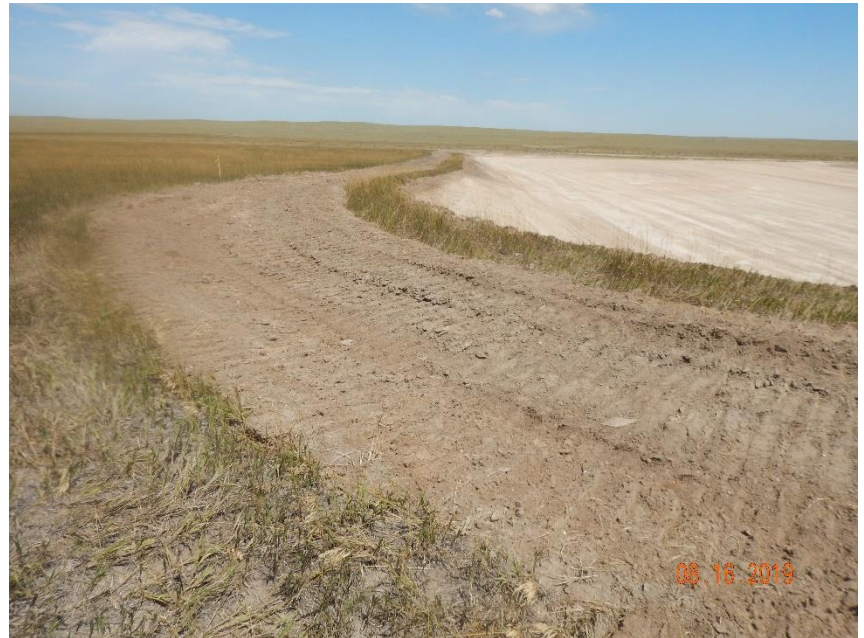
Photo 12: Photo taken from the northwest corner of the location, facing east. Photo shows section of perimeter stormwater diversion ditch that appear to be constructed in accordance with good engineering practices.

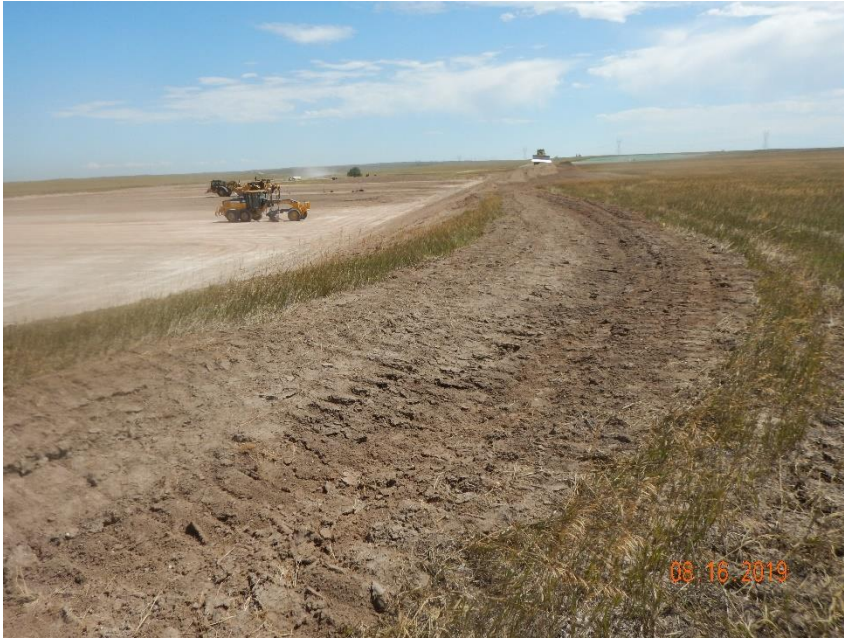
Photo 13: Photo taken from the northwest corner of the location, facing south. See comments under photo 12.

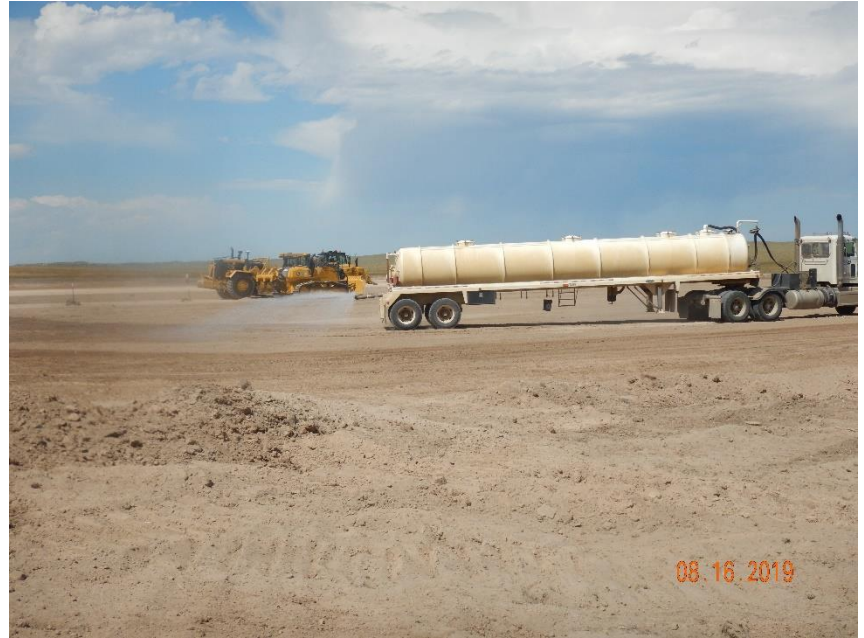
Photo 14: Photo shows operator using a water truck to mitigate fugitive dust from the location.

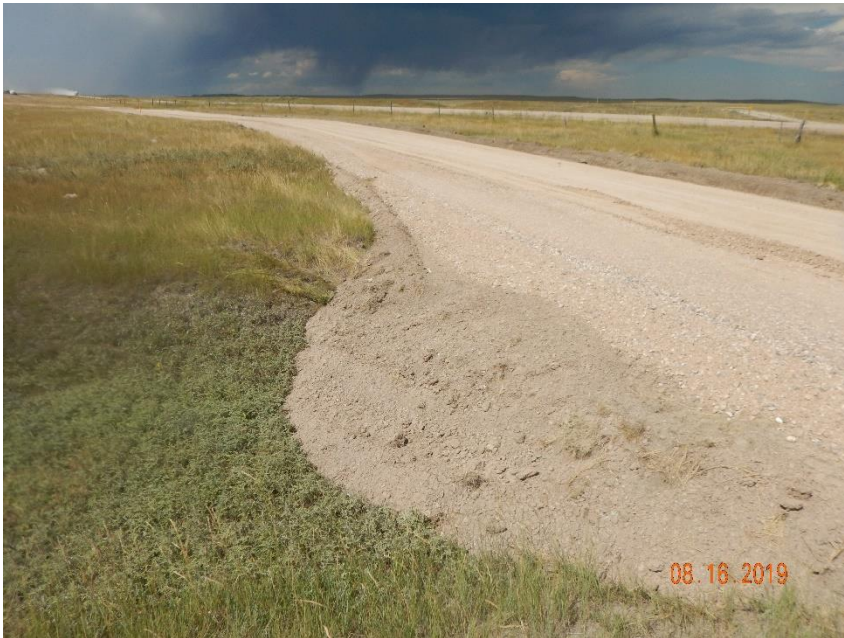
Photo 15: Photo taken from section of access road that was constructed over a drainage. Photo shows no BMPs have been installed to prevent stormwater ponding, and allow for water movement under access road .

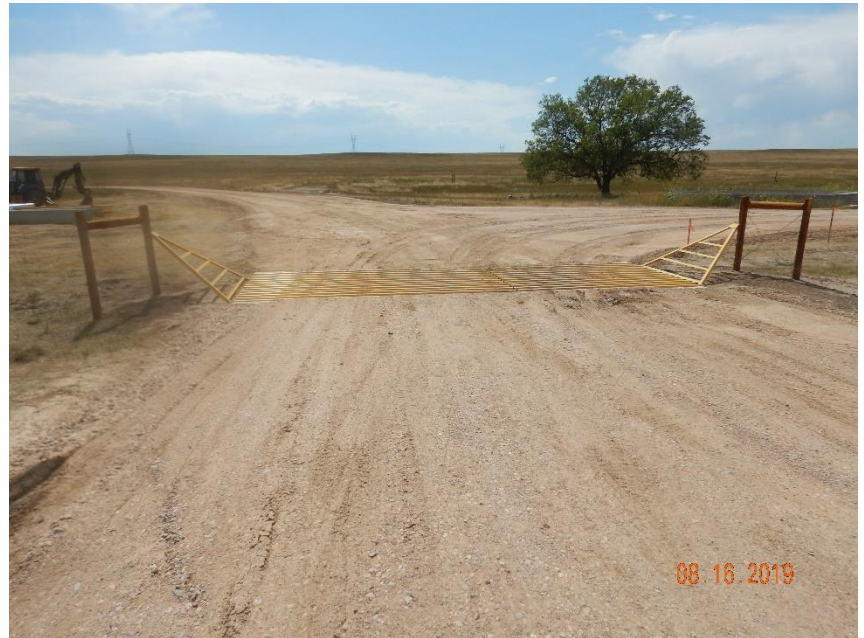
Photo 16: Photo taken from where the access road intersects with County Road 390, facing west. Photo shows vehicle tracking BMPs remain missing/insufficient at access road to motivate sediment transport from the disturbance areas (location/access road).
