Inspection Photos
Location Name:UPRR Pan AM F 1
Location ID:317660

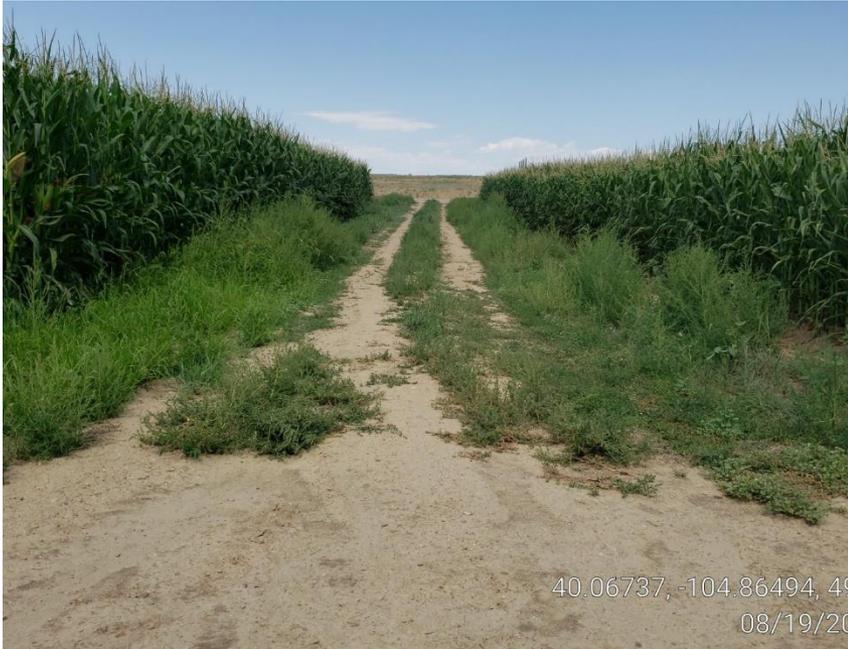
Photo #1 Weeds growing on access road

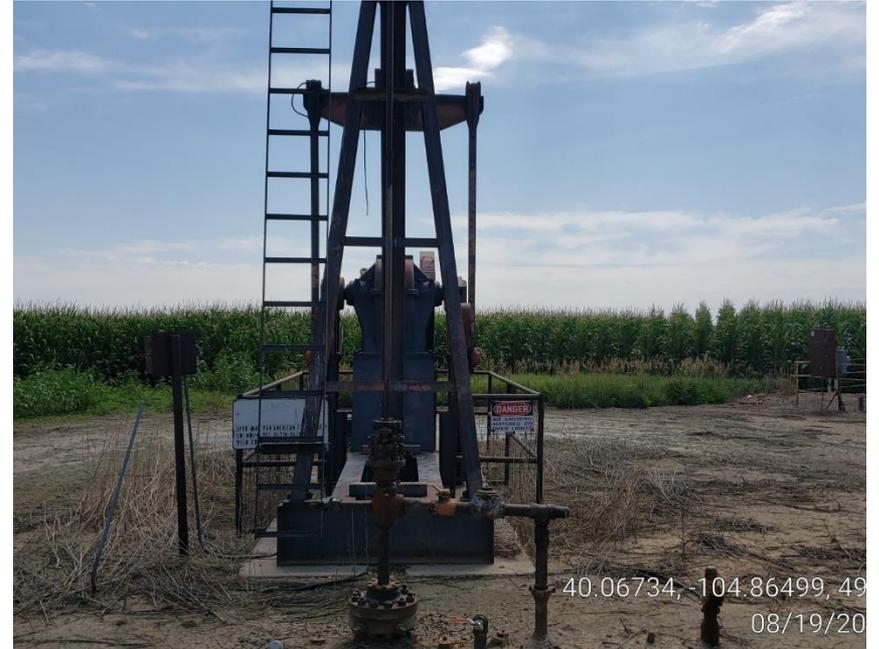
Photo #@ WH Sign

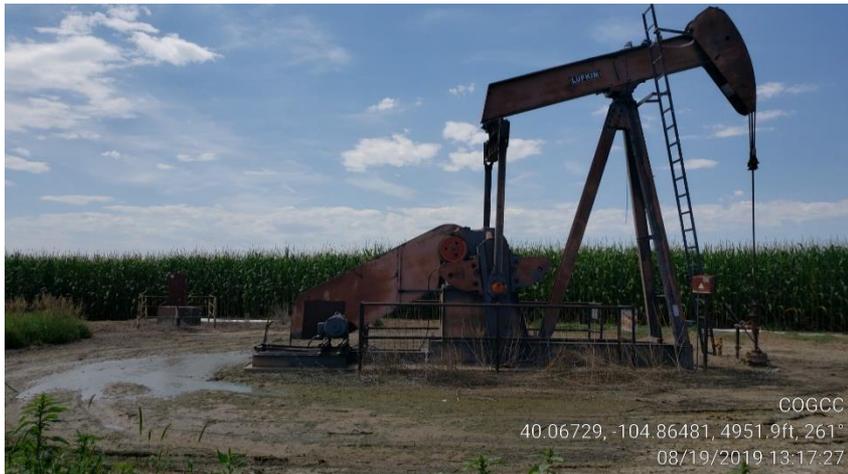
Photo #3 Pump jack

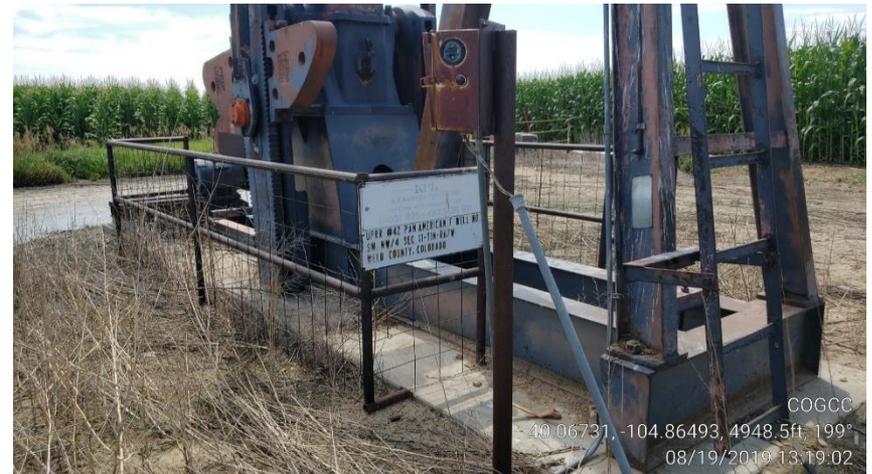
Photo #4 debris around pump jack and electric motor
