Inspection Photos
Operator: Southland Royalty
Location/API #: 067-09450
Date: 8-14-2019

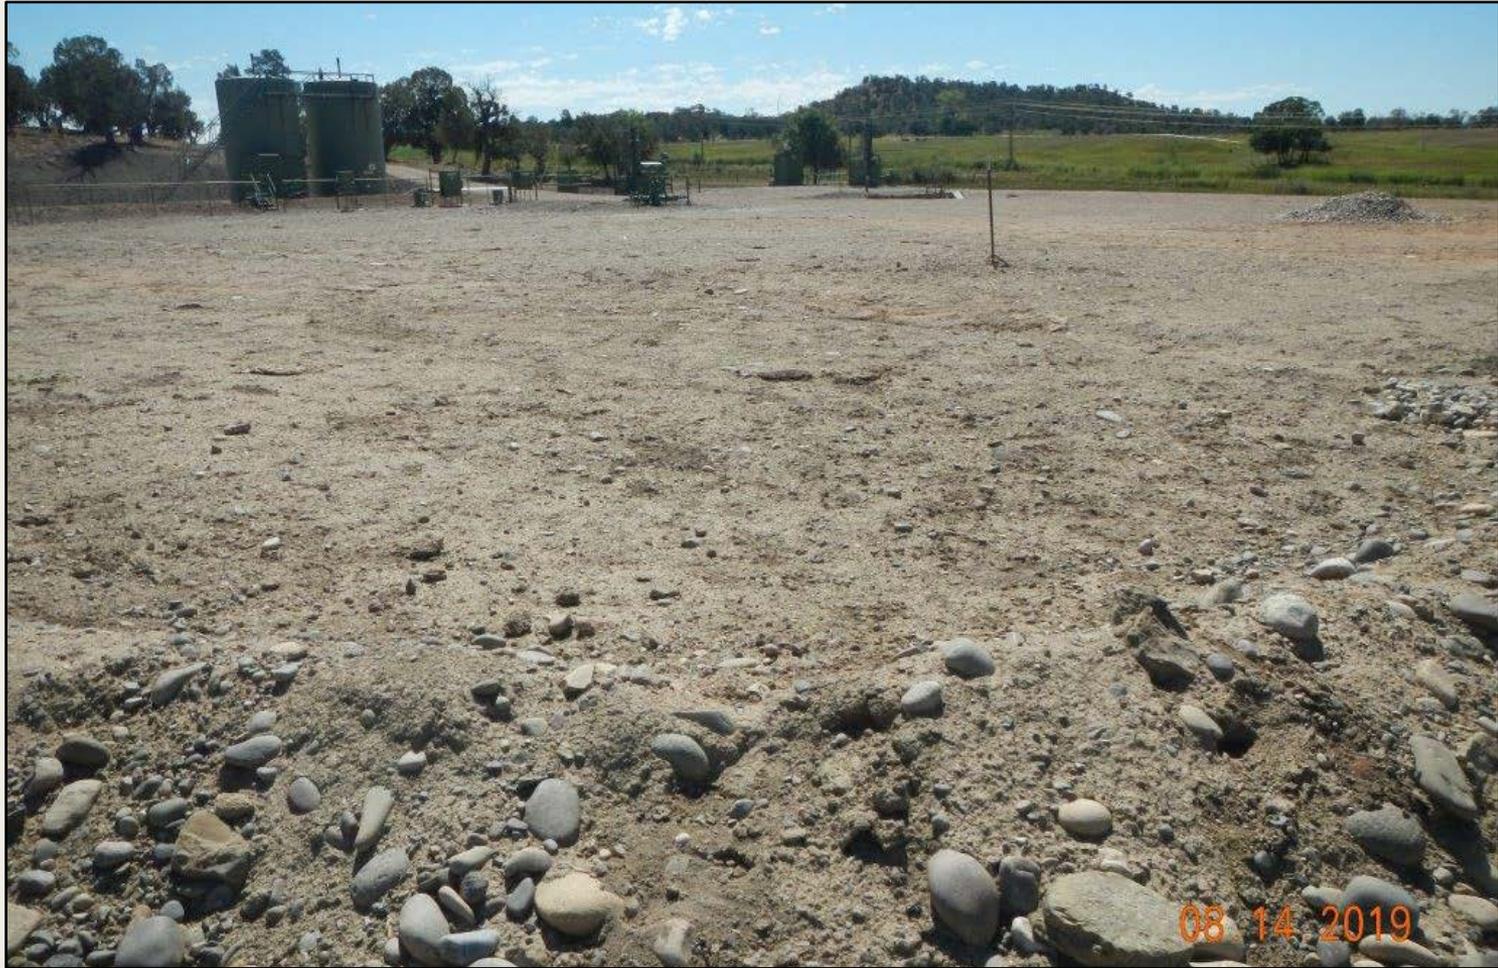
Photo 1. View of the project area from the northwestern corner facing center.

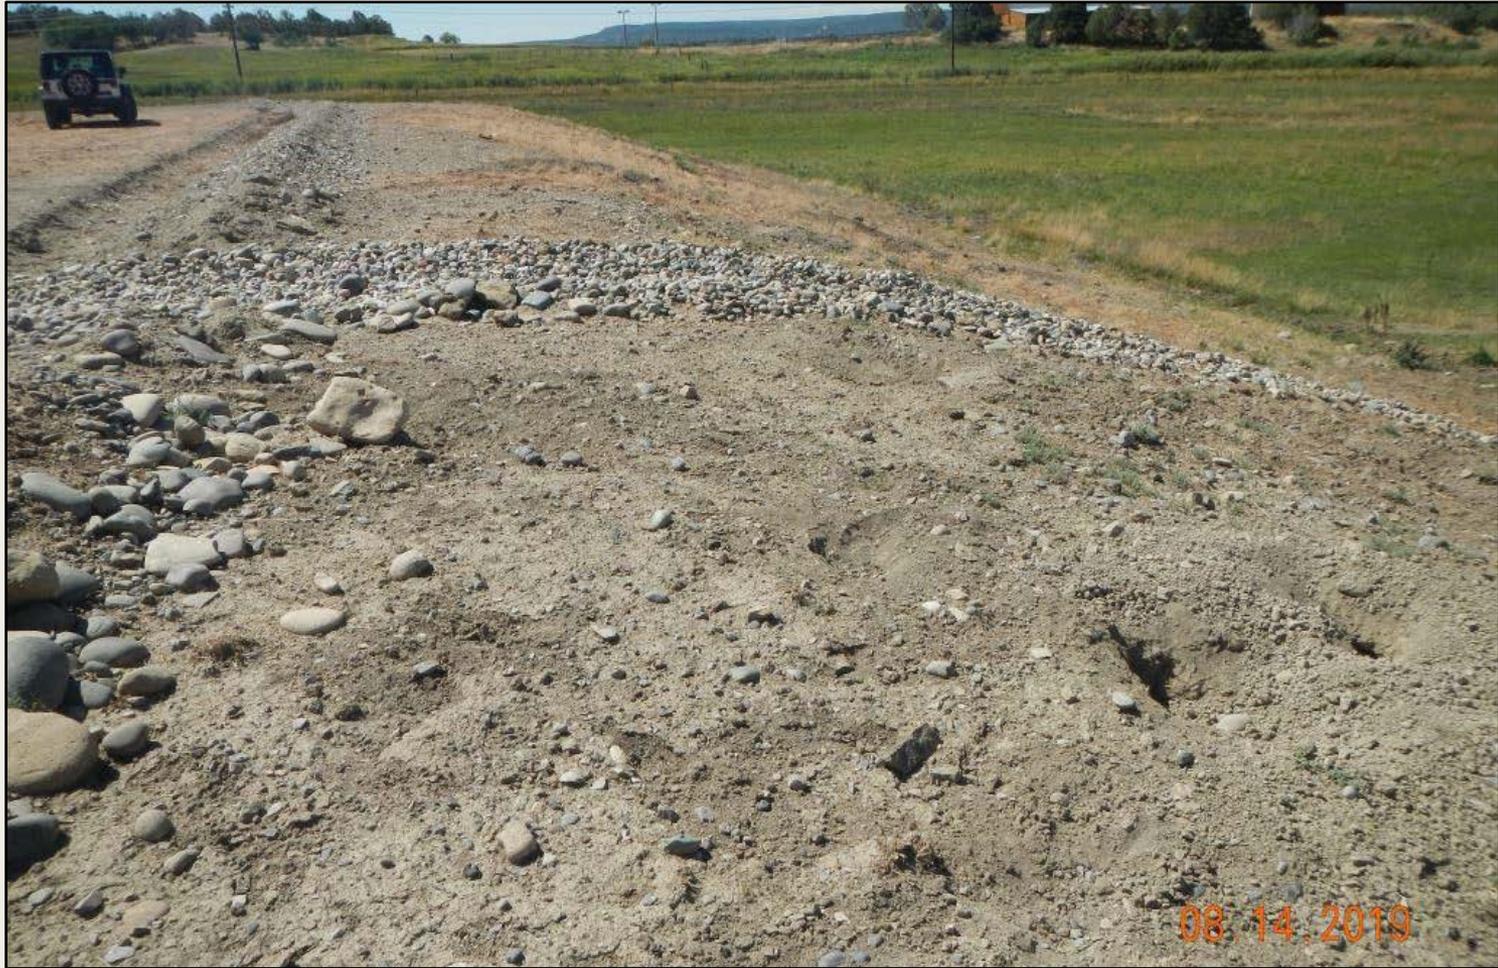
Photo 2. View of the western project area from the northwestern corner facing southward. Little desirable vegetation within interim reclamation areas.

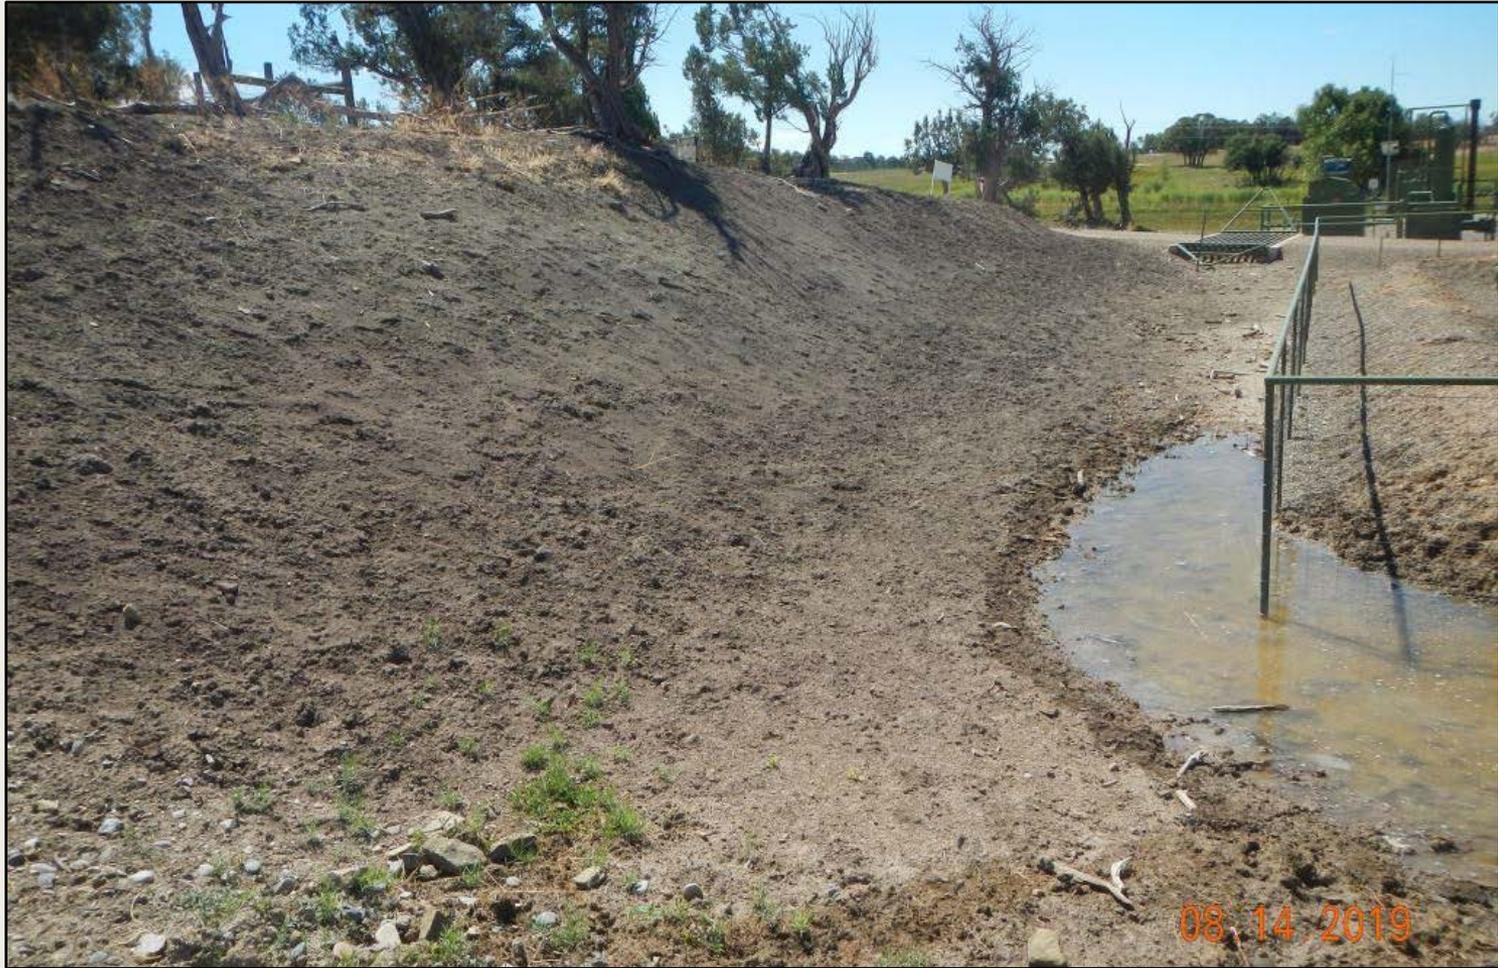
Photo 3. View of the eastern project area from the northeastern edge facing southward. Cut-slope is not stabilized.

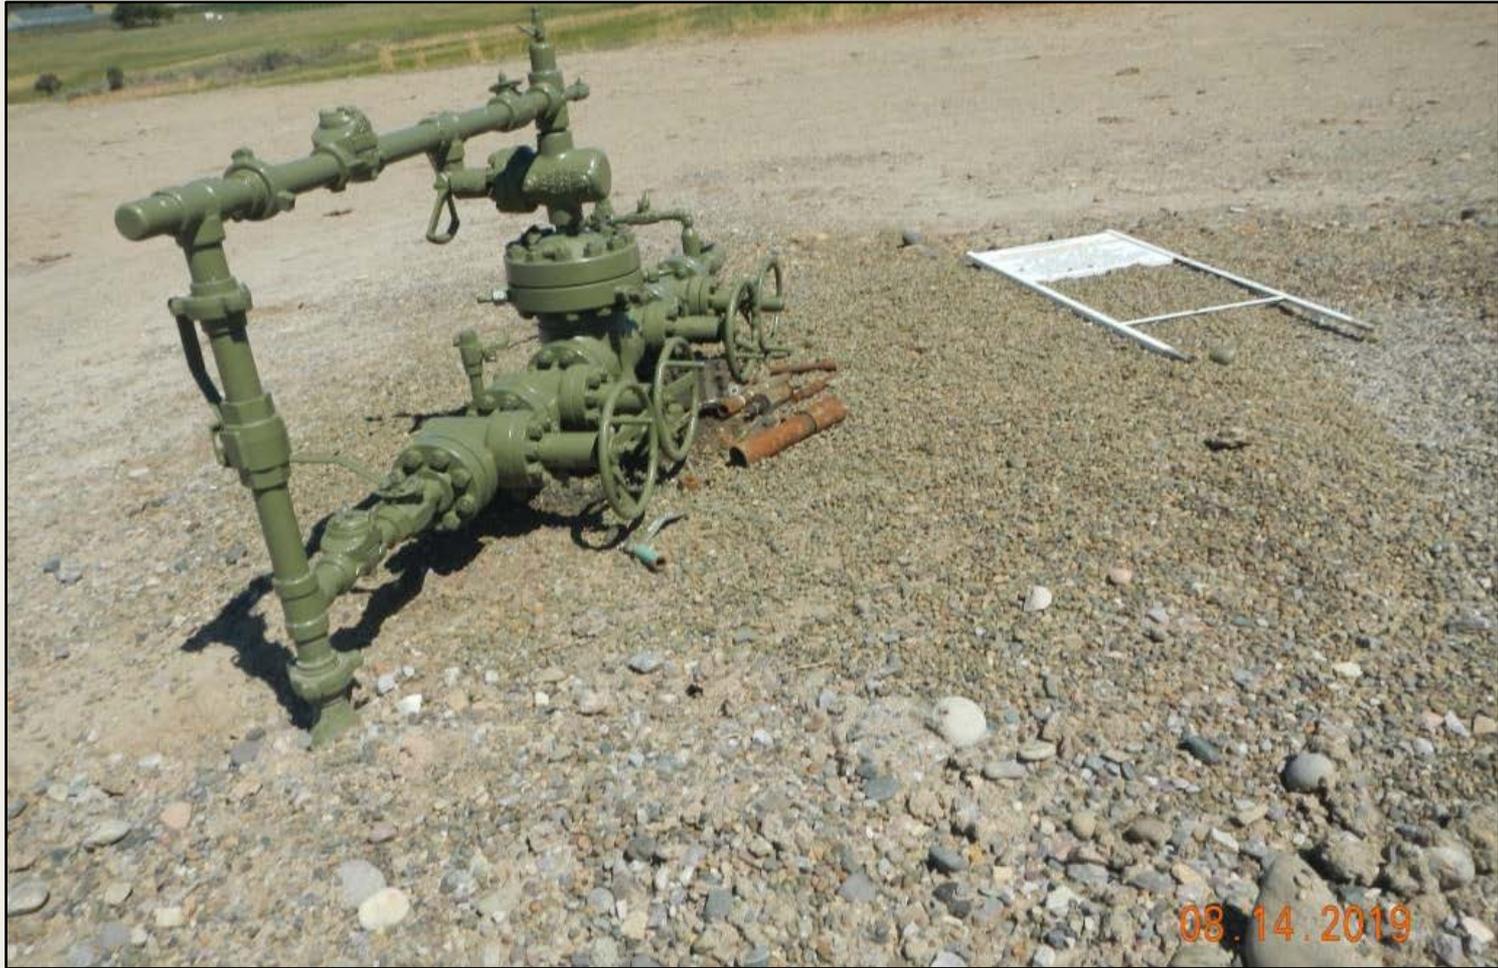
Photo 4. View of sign that is knocked down, and debris around wellhead.
