# Interim Reclamation and Stormwater Inspection

August 19, 2019

Operator: SUNBURST INC- 83555

Location ID: 417959

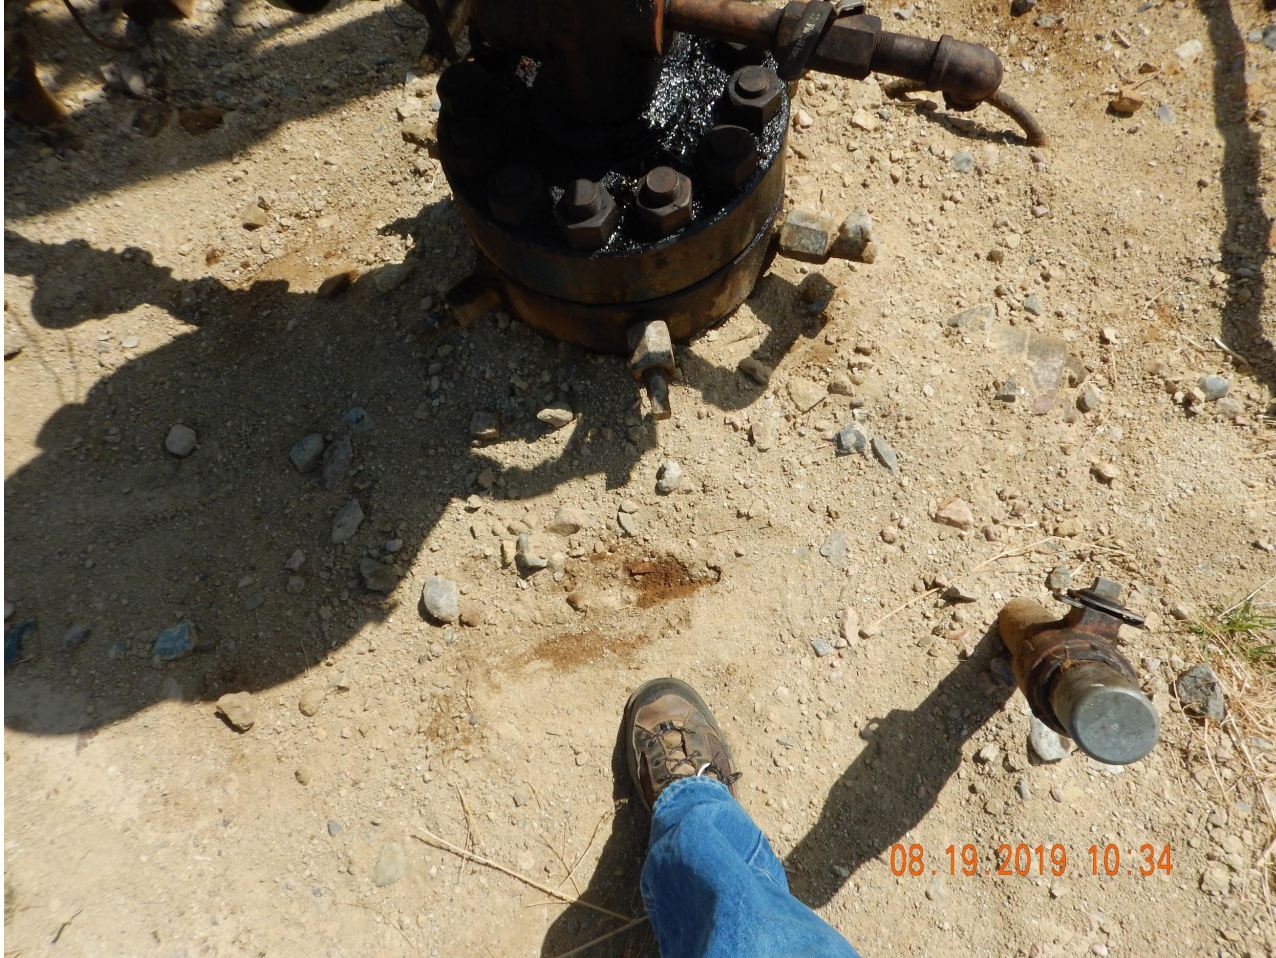
**Photo 1.** Photo taken of the wellhead. Wellhead appears to be leaking and has not been fixed since the previous inspection. Also, Operator has not properly treated or disposed of the oily waste in accordance with 907.e.; Operator has only put gravel on top of oily waste.

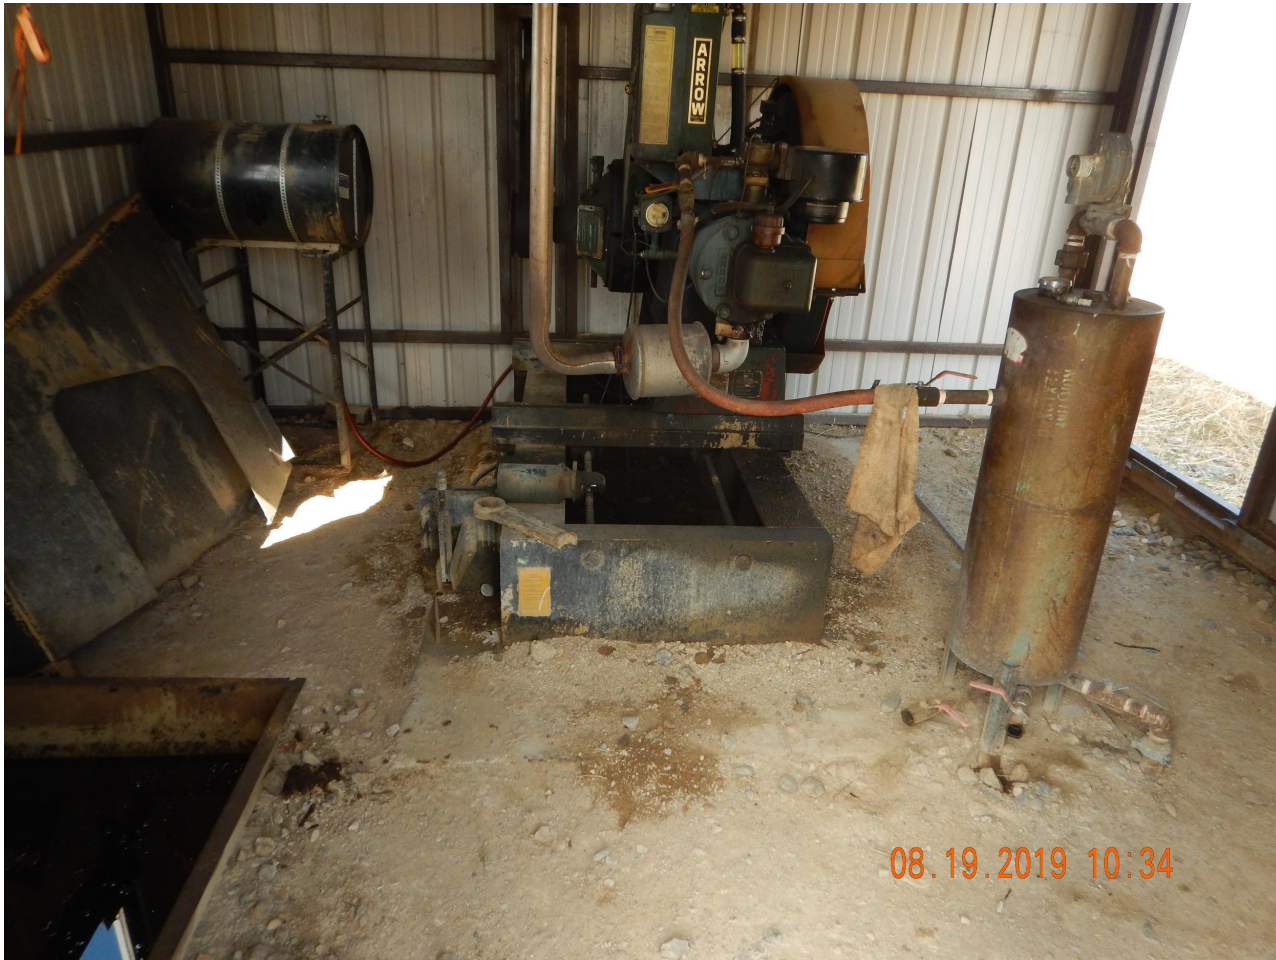
**Photo 2.** Photo taken from the pumping unit engine house. Operator has not properly treated or disposed of the oily waste in accordance with 907.e.; Operator has only put gravel on top of oily waste.

Operator did remove the trash inside the pumping unit engine house.

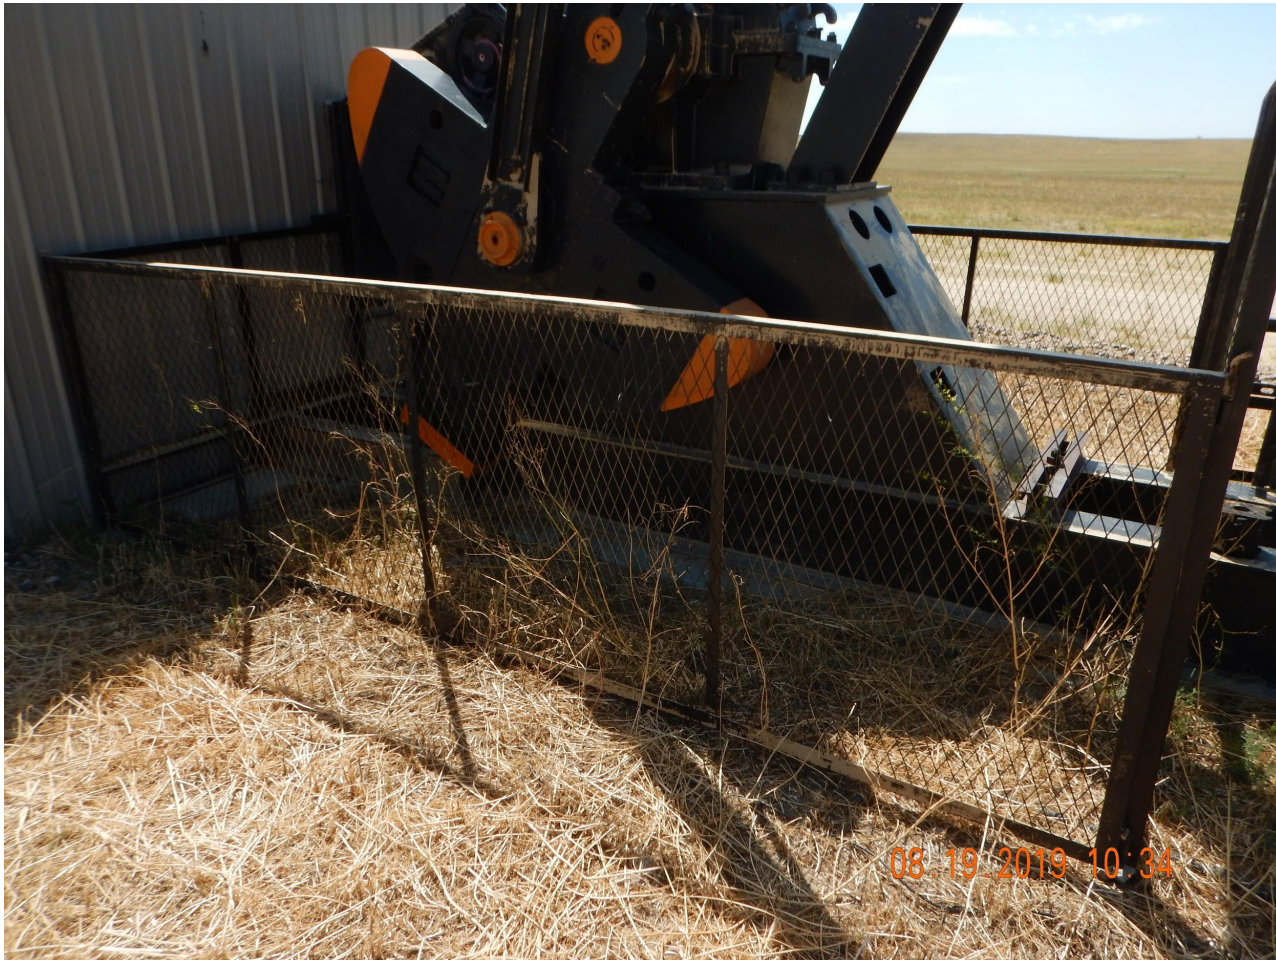
**Photo 3.** Photo taken from the pumping unit, facing South. Photo illustrates the Operator has controlled weeds.

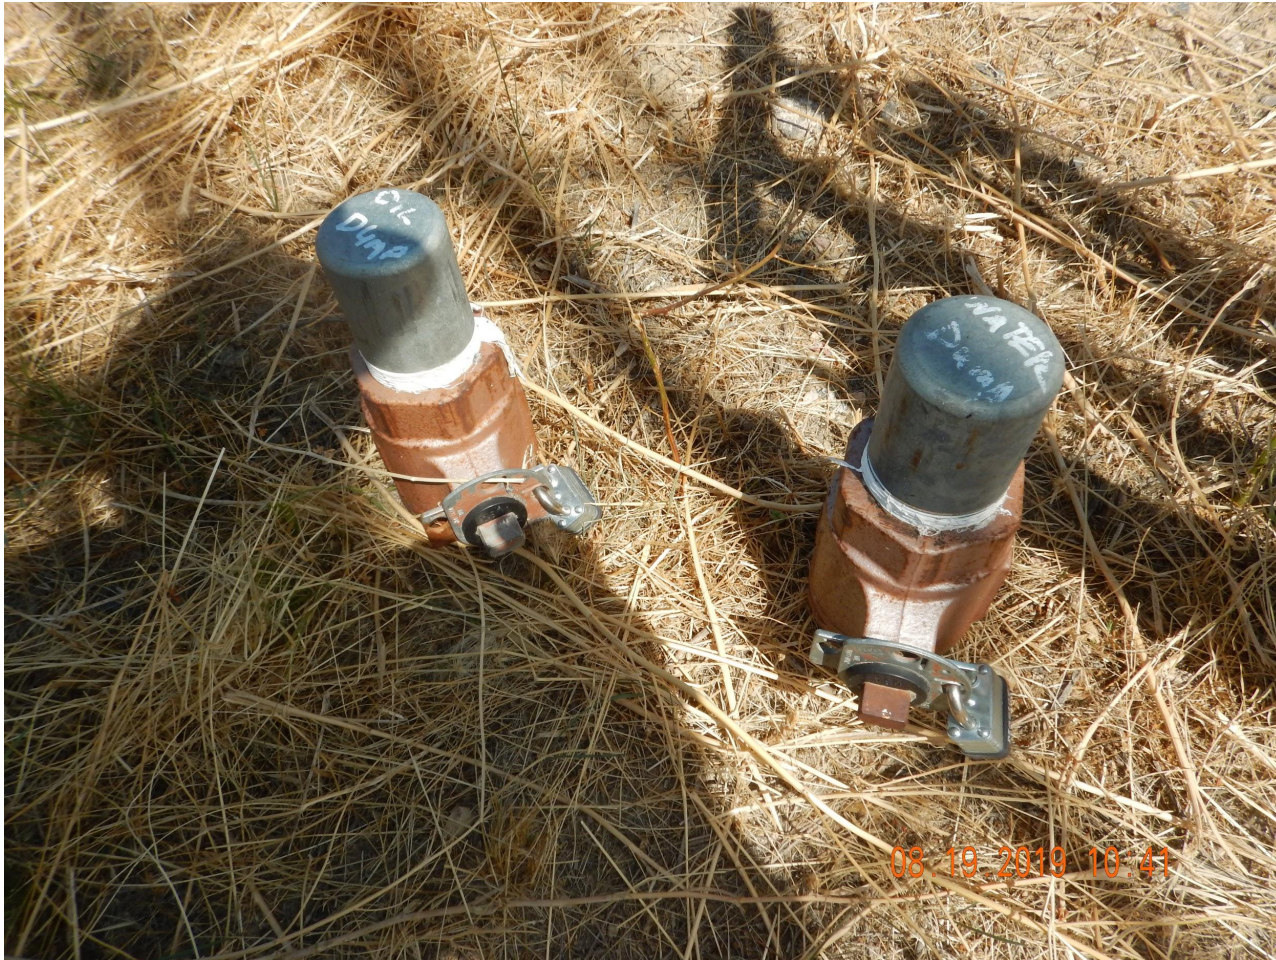
**Photo 4.** Photo taken from the north side of the treater shed. Photo illustrates that 2 of the risers have been locked out but not tagged out.

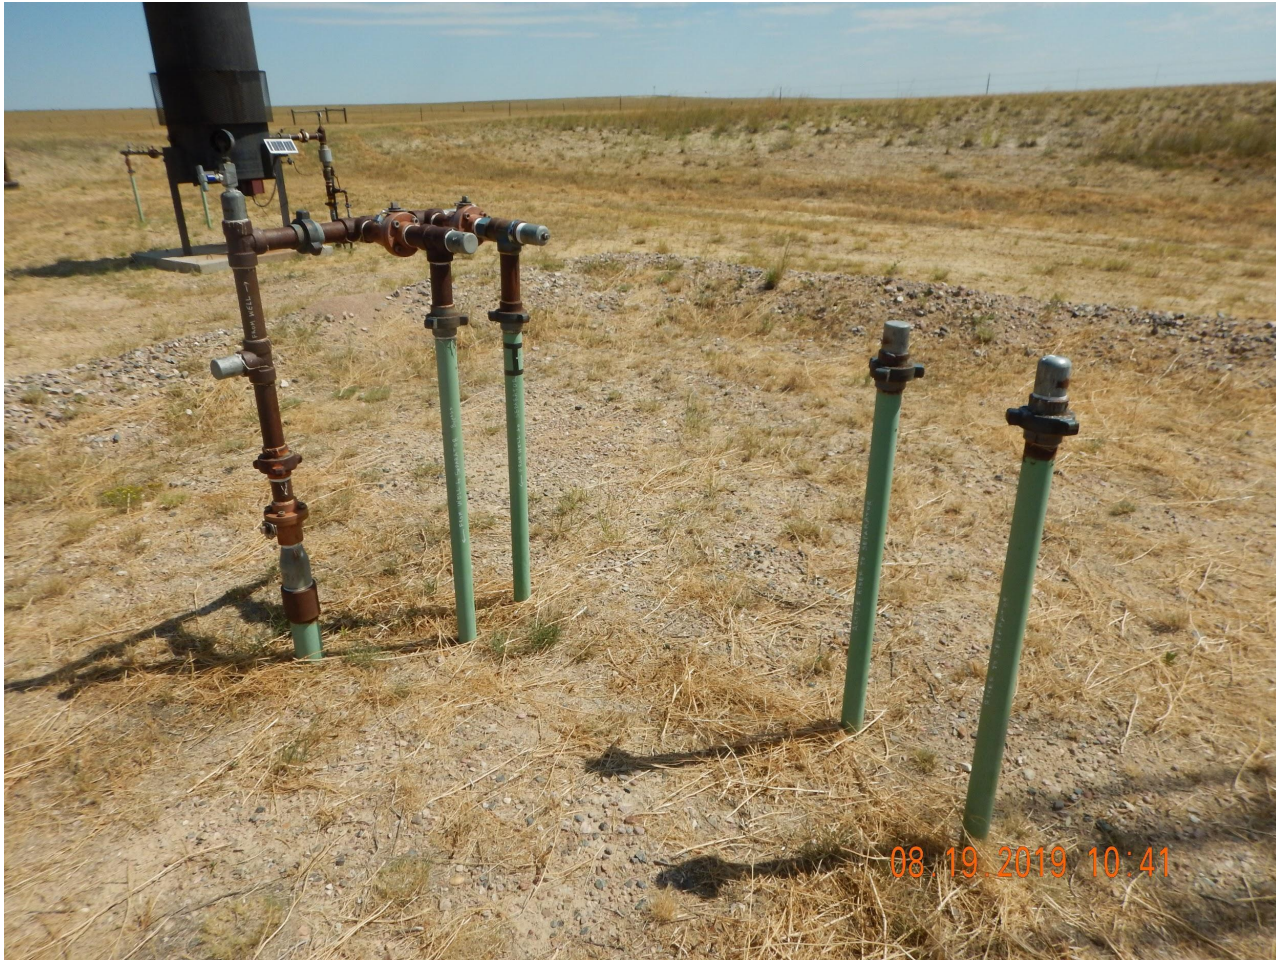
**Photo 5.** Photo taken from the north side of the treater shed, facing Northeast. Photo illustrates risers remain at location.

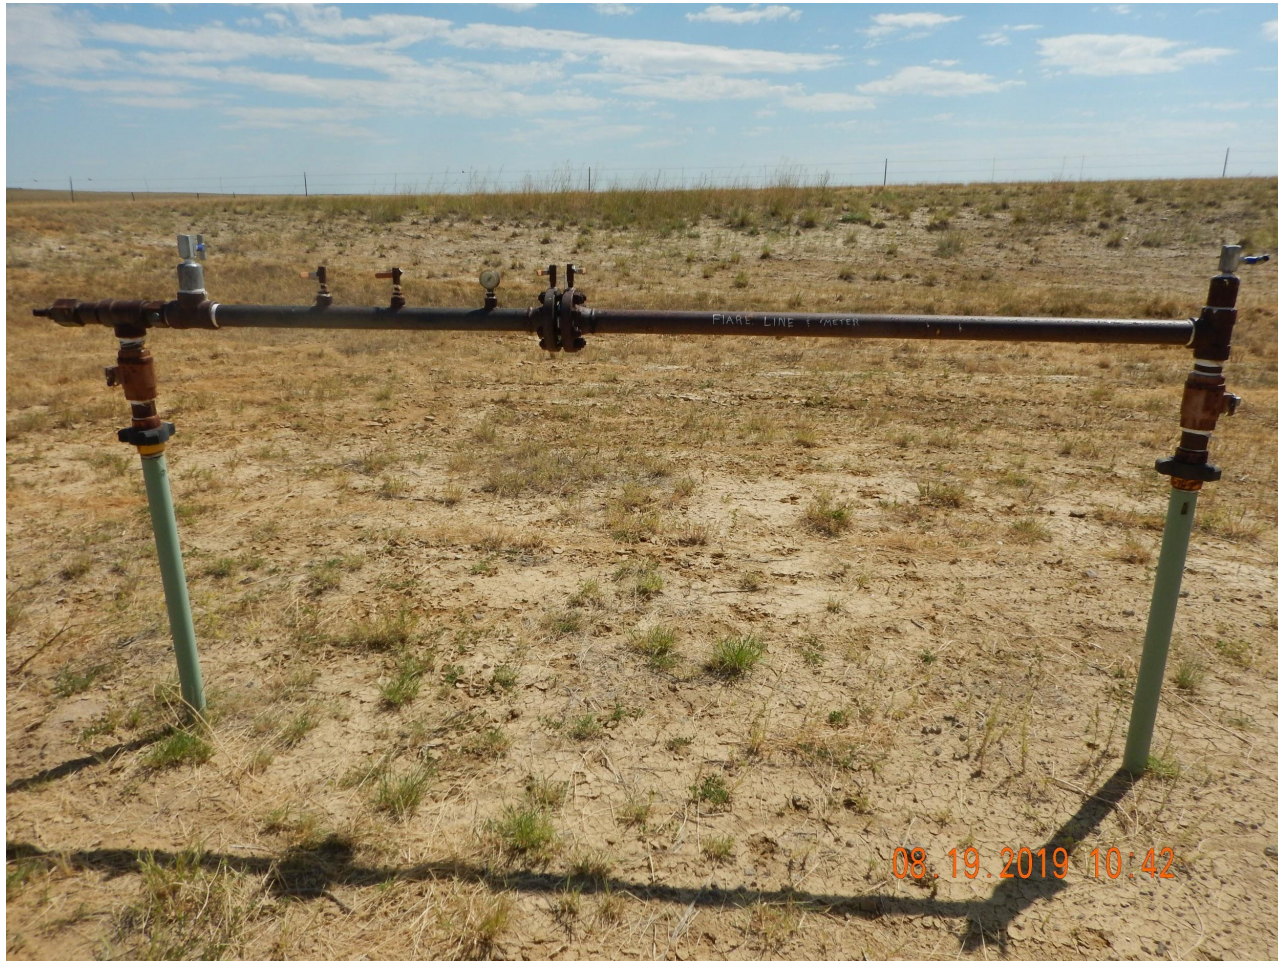
**Photo 6.** Photo taken from the north side of the treater shed, facing East. Photo illustrates unused meter run set with no meter.

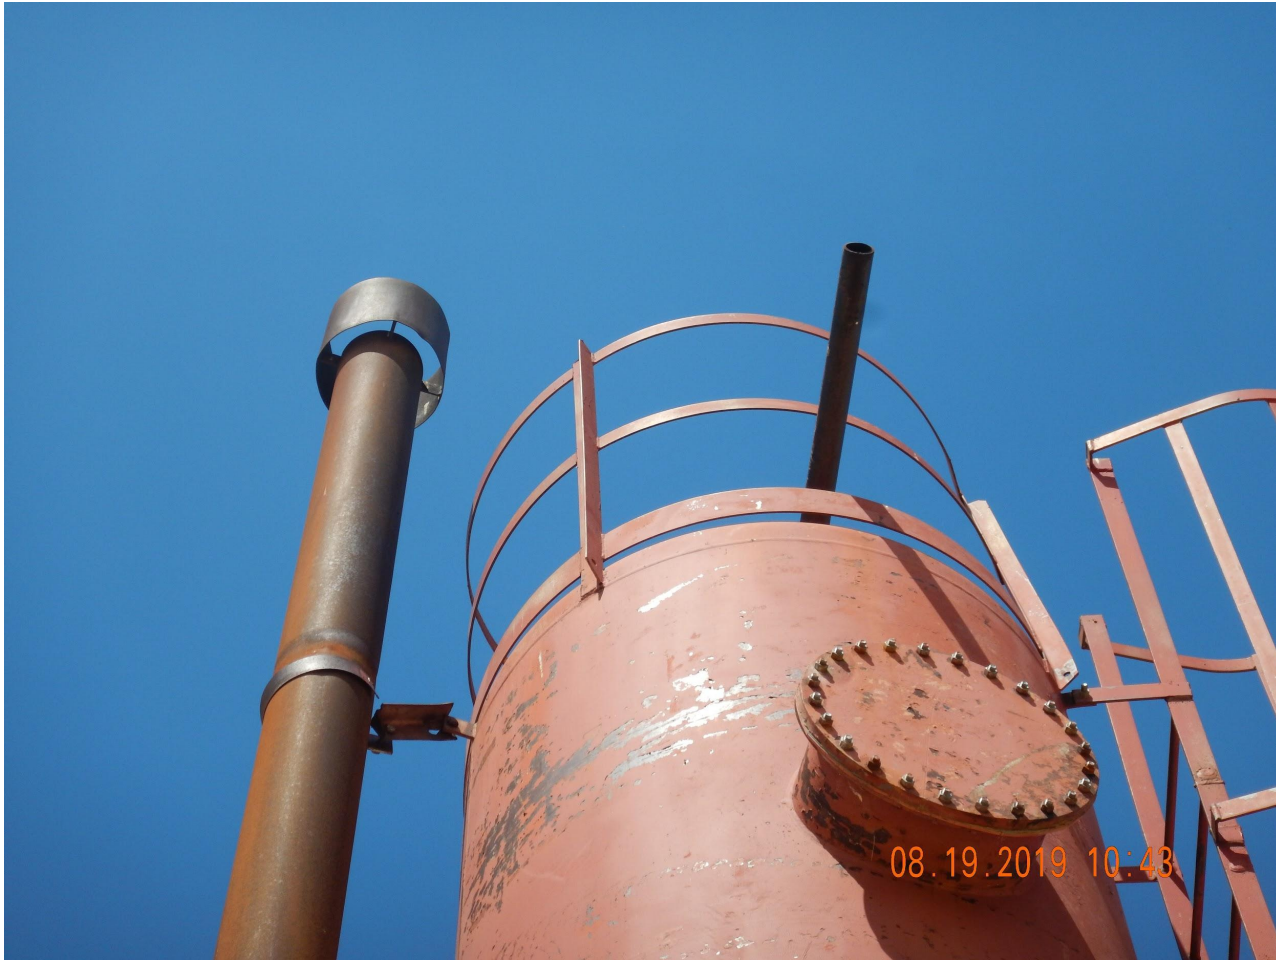
**Photo 7.** Photo taken of the heater treater stack. Photo illustrates Operator has failed to install wildlife intrusion mitigation device on top of the heater treater stack.

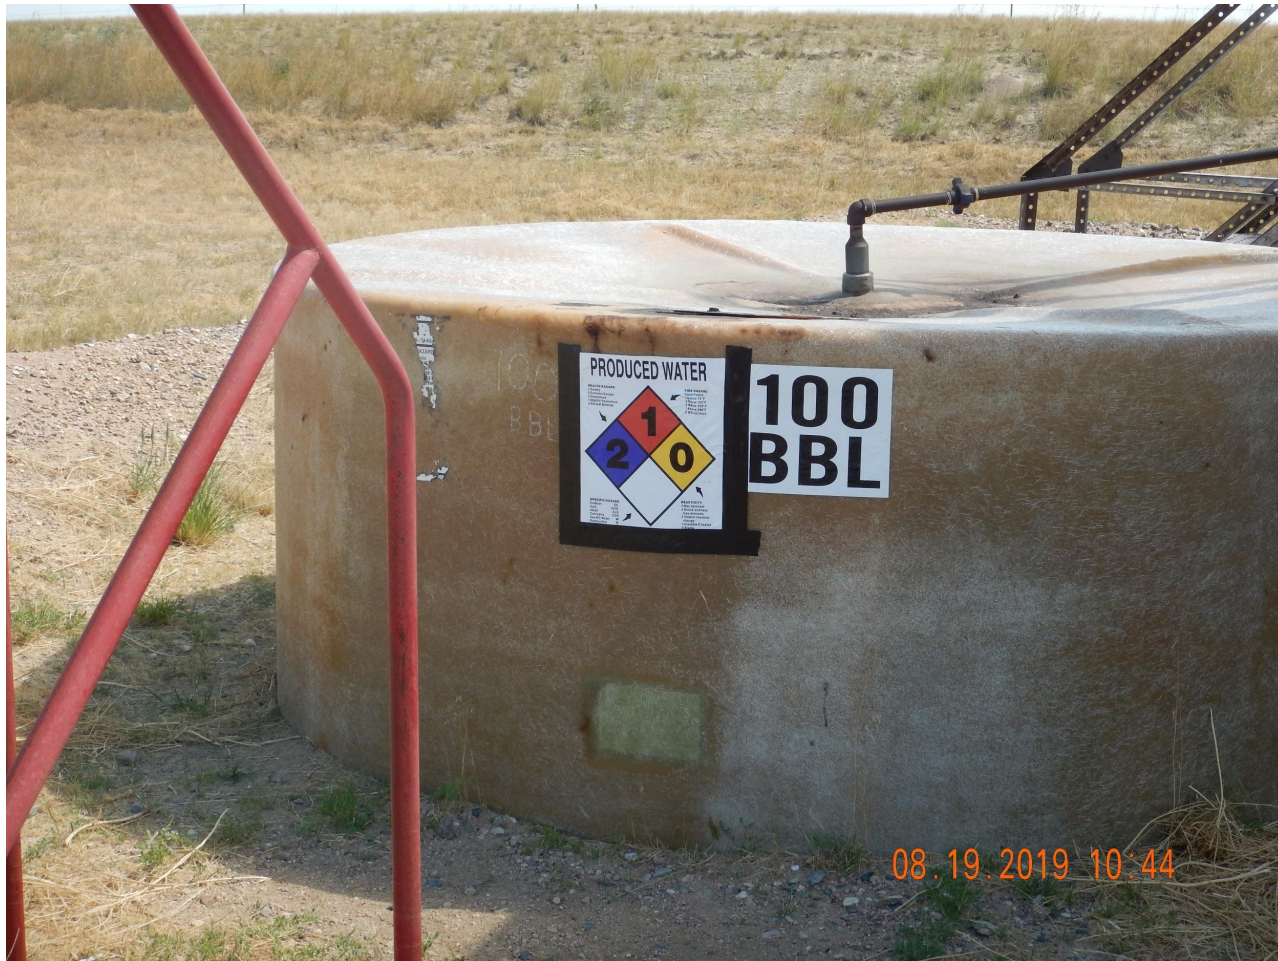
**Photo 8.** Photo taken of the production water tank on location. Operator has installed NFPA label.

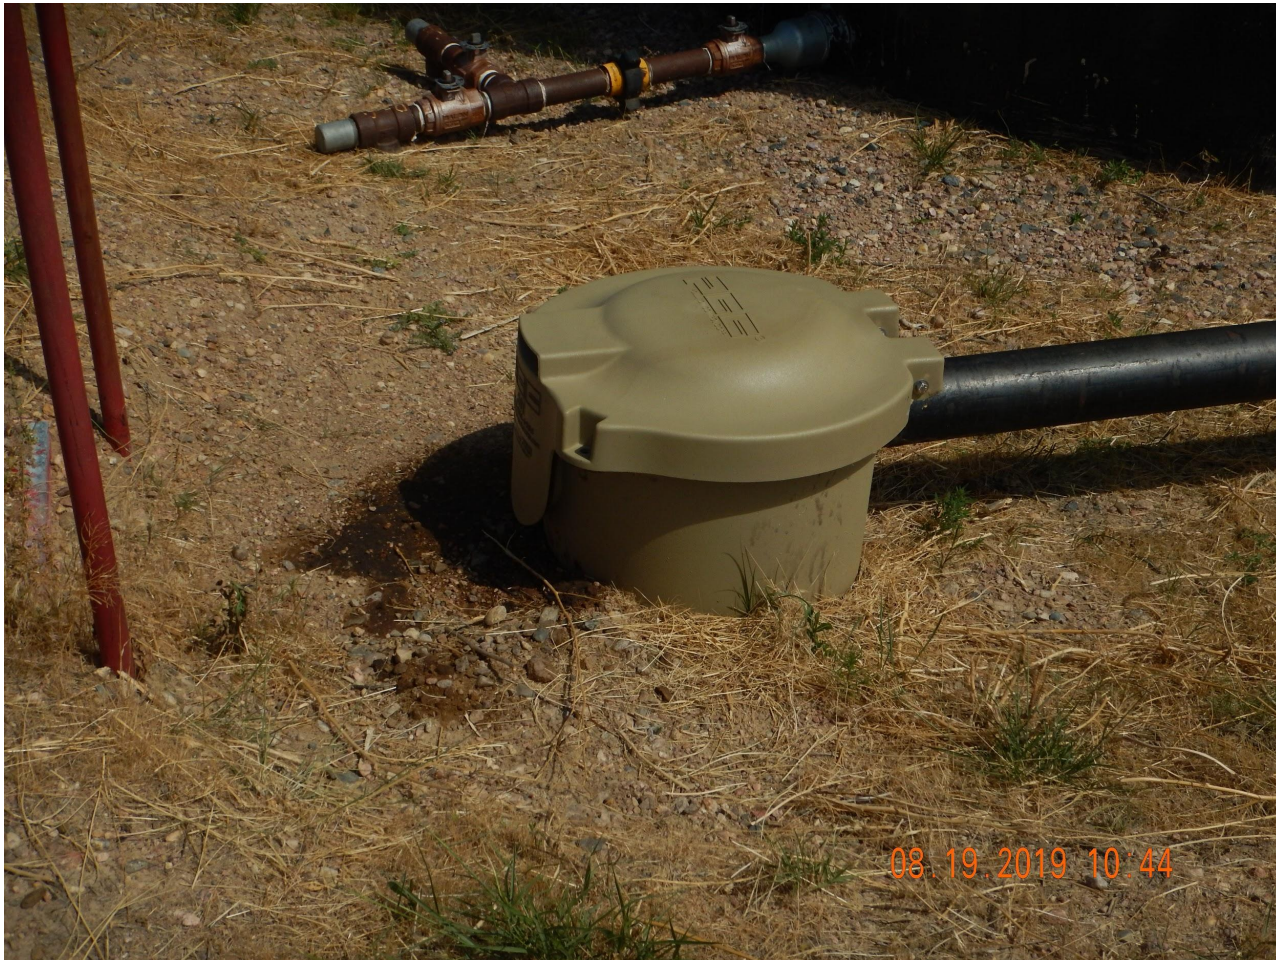
**Photo 9.** Photo taken from the load line bucket. Photo illustrates stained soil around bucket.

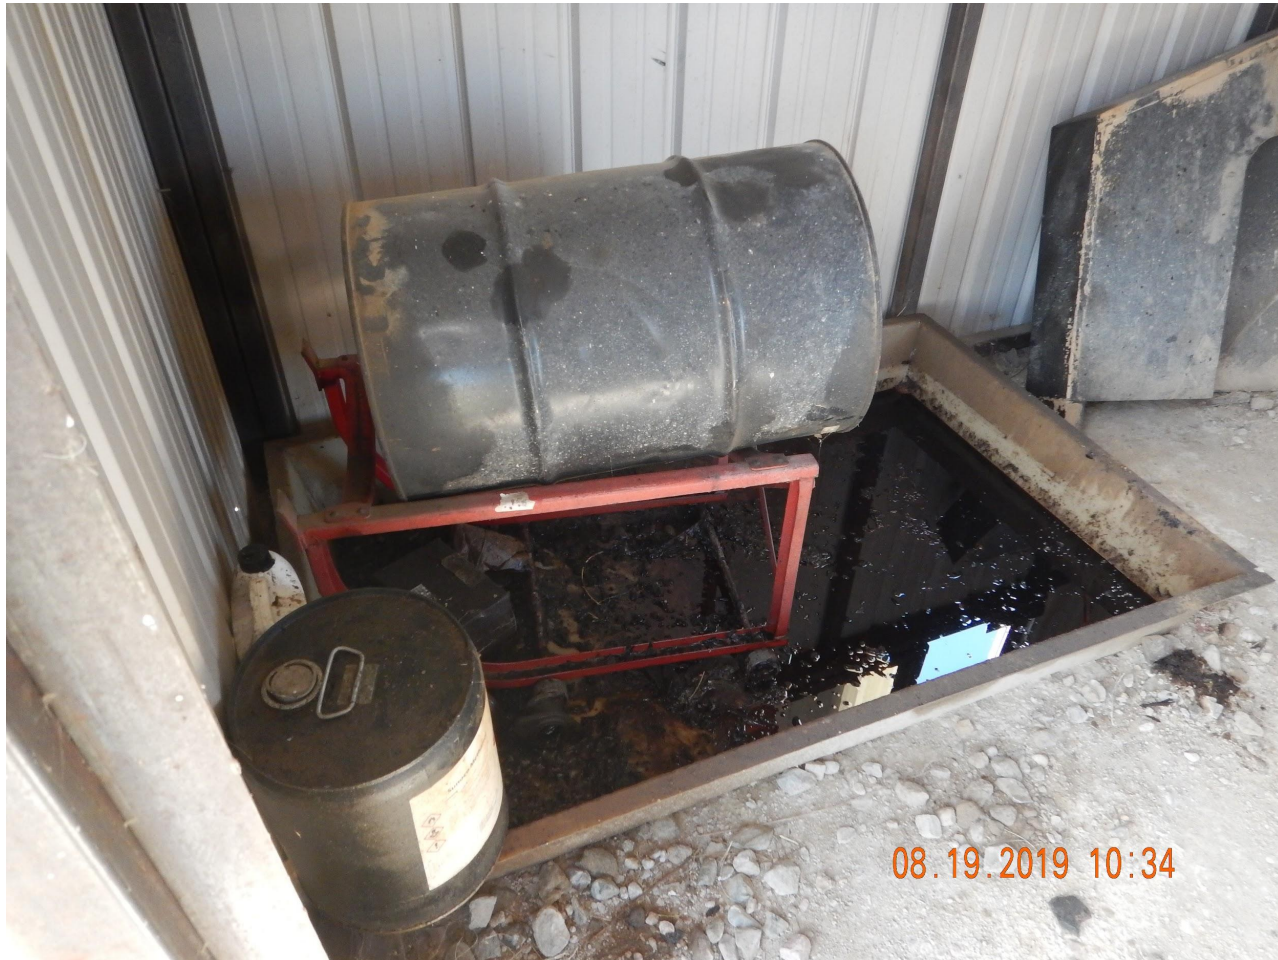
**Photo 10.** Photo taken from the pumping unit engine house. Operator has not removed the unused day barrel.
