Inspection Photos

08/20/2019

Operator: BISON OIL & GAS II LLC # 10661

Location ID: 454166

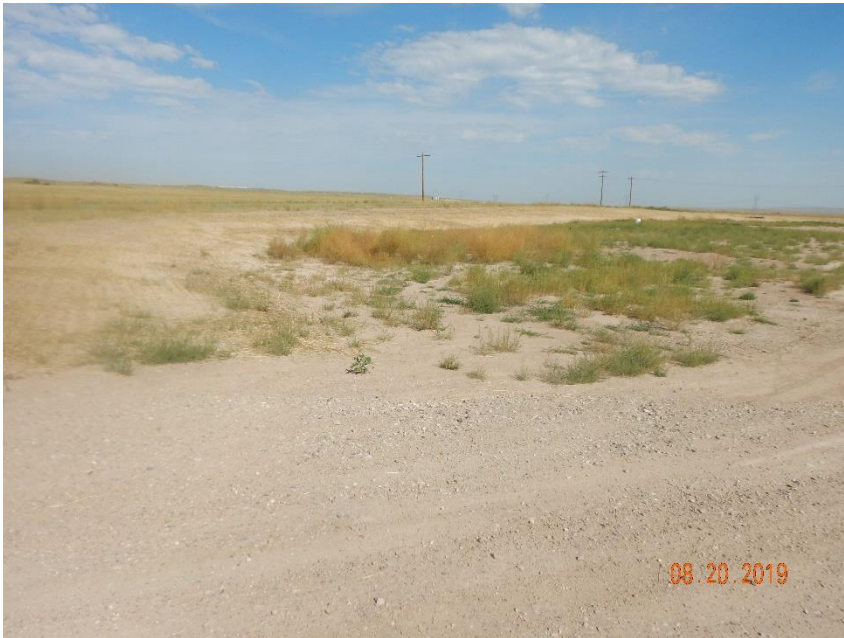
Photo 1: Photo taken from the south end of the location, facing northwest. Photos 1-4 provide an overview of the location from northwest, northeast, east, to southeast. Photo also shows weed establishment on the location.

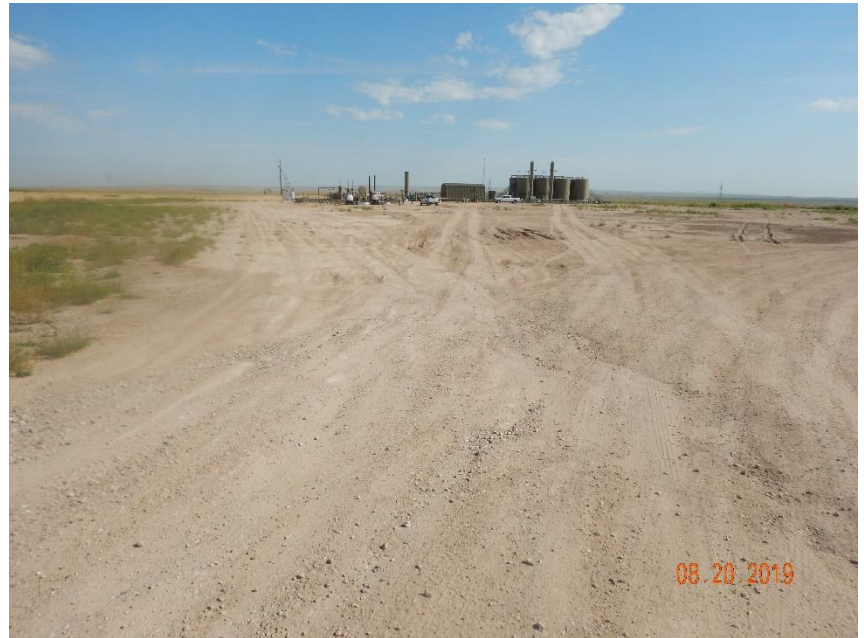
Photo 2: See comments under photo 1.

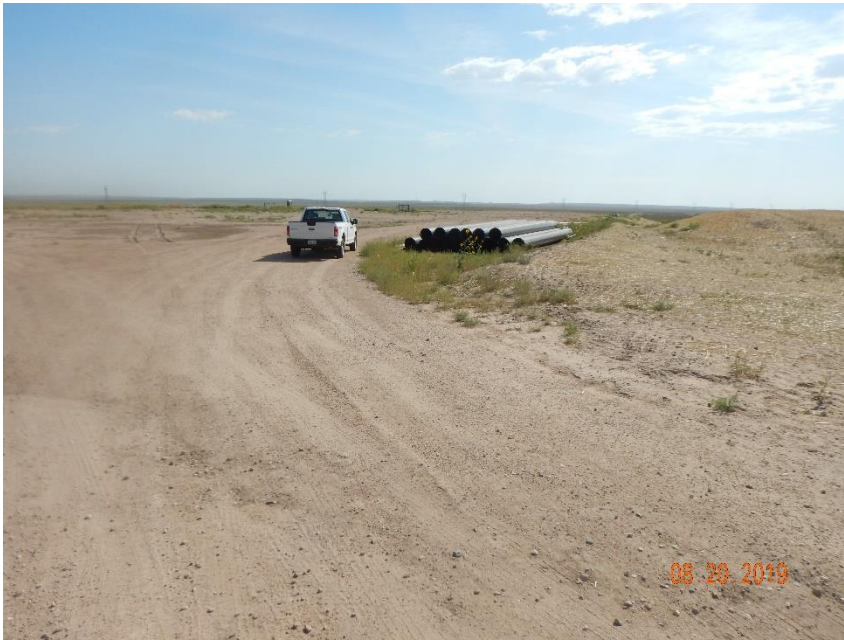
Photo 3: See comments under photo 1. Photo also shows weed establishment on the location.

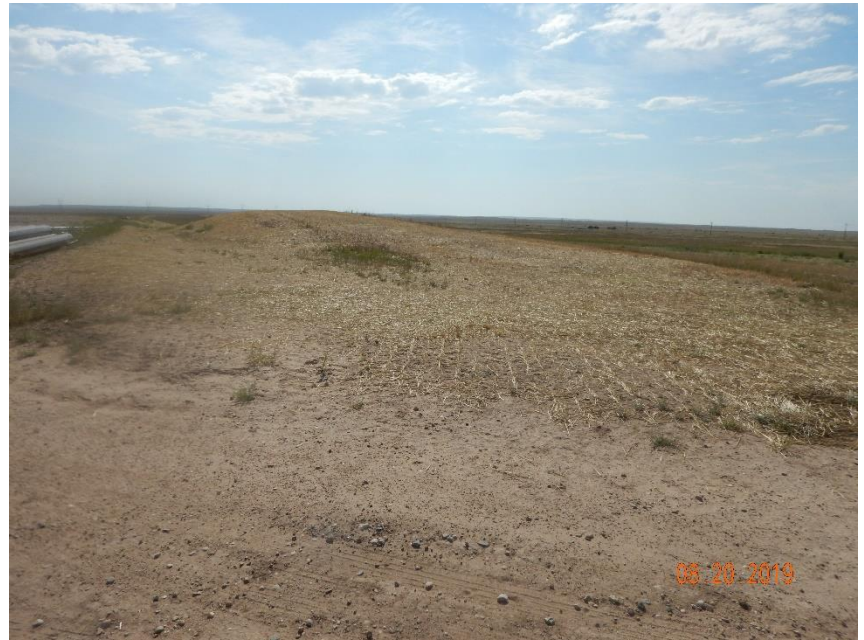
Photo 4: See comments under photo 1. Photo also shows topsoil berm.

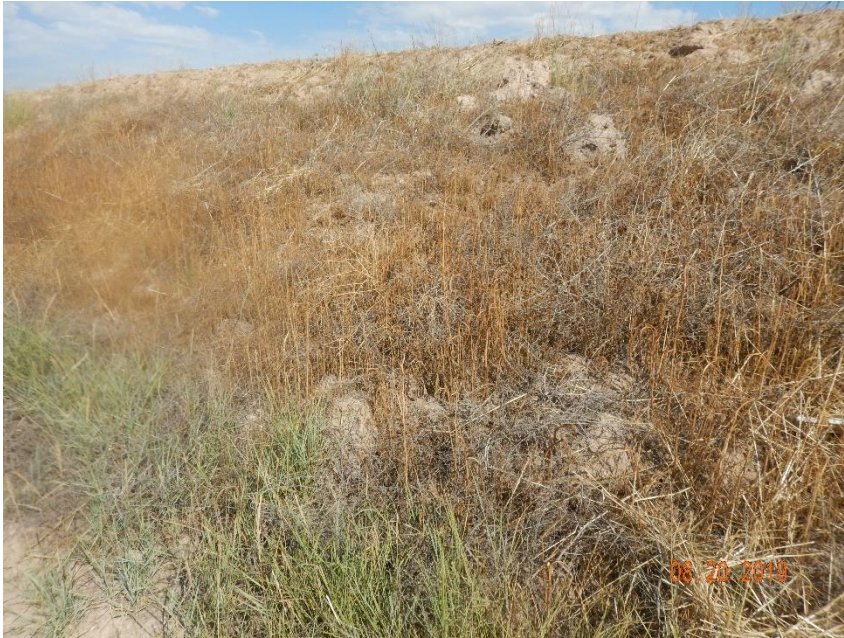
Photo 5: Photo taken from the south end of the topsoil stockpile. Weedy vegetative establishment on the topsoil stockpile. Photo also show no BMPs have been installed on the south facing slopes of the stockpile in accordance with 1002.c

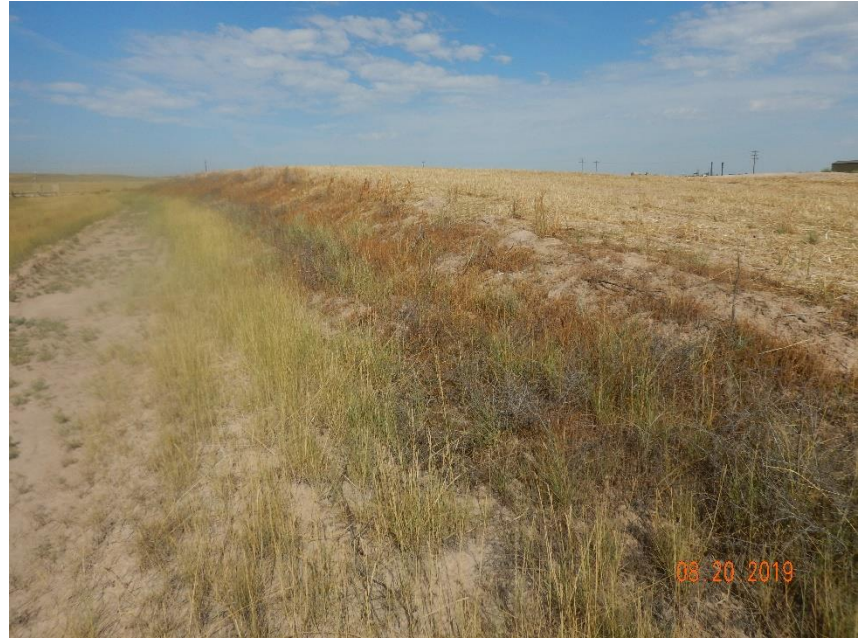
Photo 6: Continued from photo 5. Operator appears to be implementing BMPs to prevent weed establishment and to protect the stockpiled soils on the top, and northern facing slopes of the topsoil stockpile.

Operator does NOT appear to be implementing BMPs to prevent weed establishment and to protect the south facing slopes of the topsoil stockpile in accordance with 1002.c

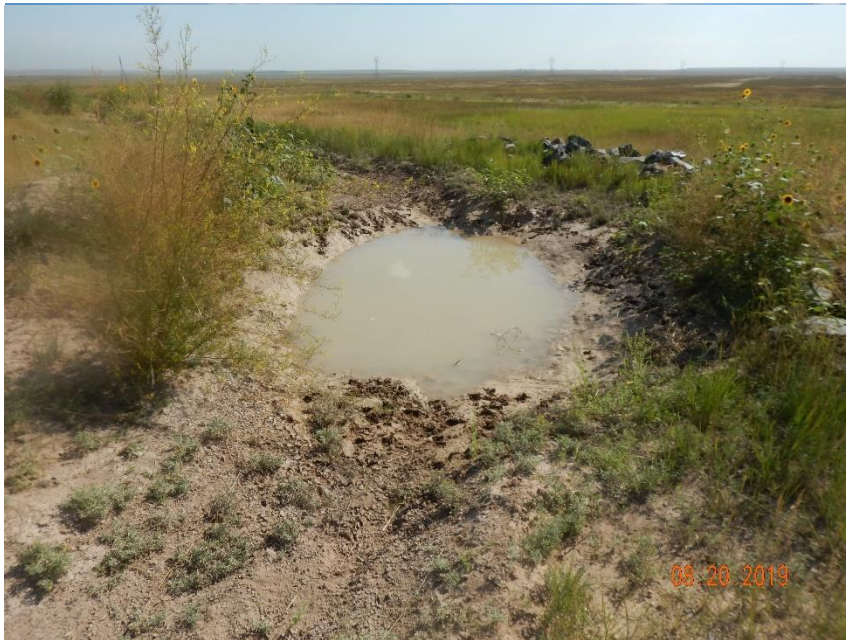
Photo 7: Photo taken from the sediment trap on the southeast end of the location. Photo shows weedy vegetative establishment at the BMP. Photo also shows BMP has not been installed in accordance with good engineering practices; Inlets/outlets insufficiently armored and are missing protections including, but not limited to, geotextile lining and rip-rap aggregate of appropriate sizes. Walls/berms at BMP insufficiently compacted/consolidated/stabilized.

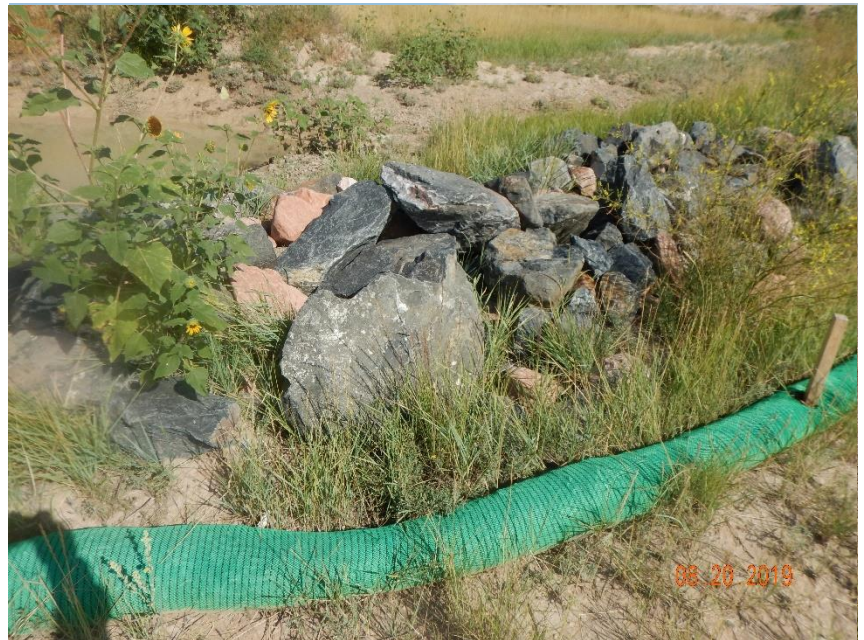
Photo 8: See comments under photo 7

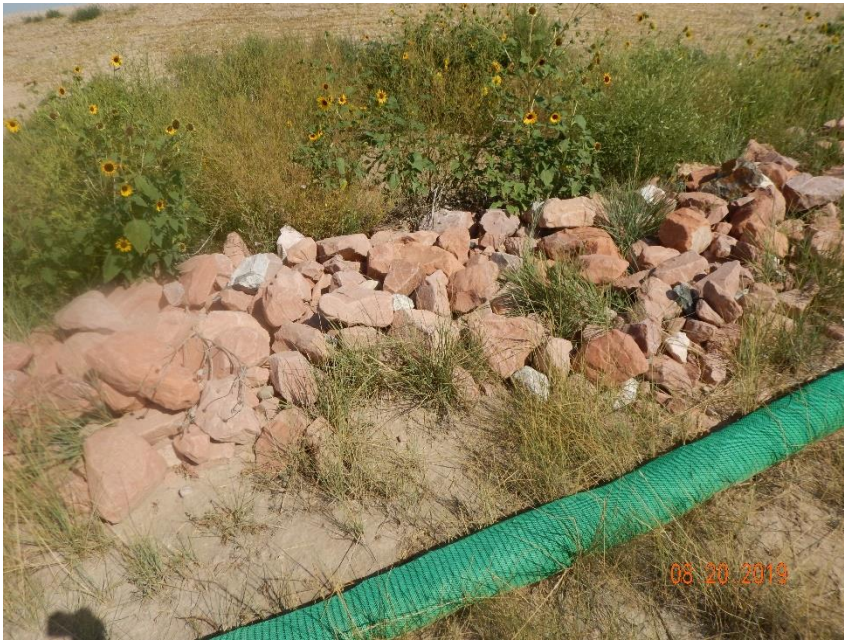
Photo 9: See comments under photo 7

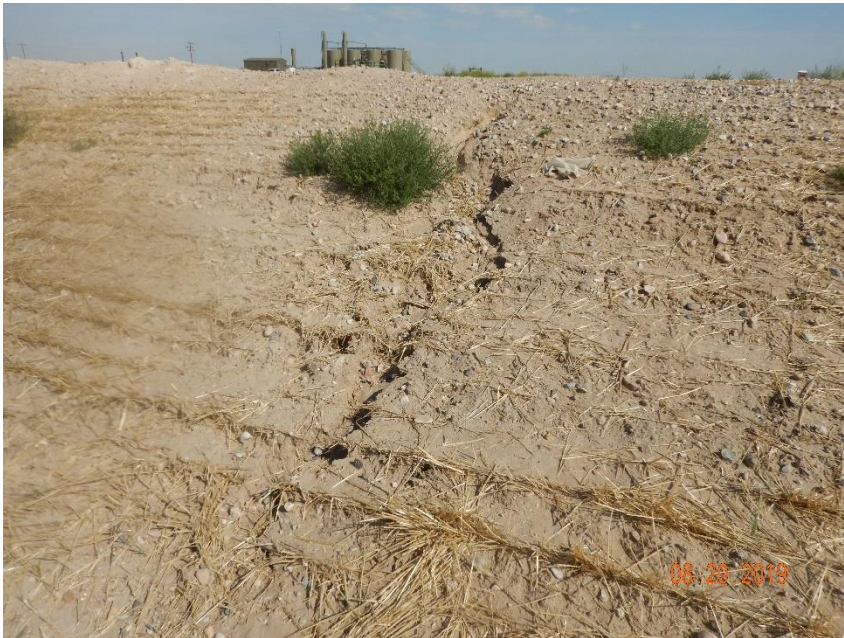
Photo 11: Photo taken from the south end of the pad. Photo shows erosion degradation on the slopes of the pad.

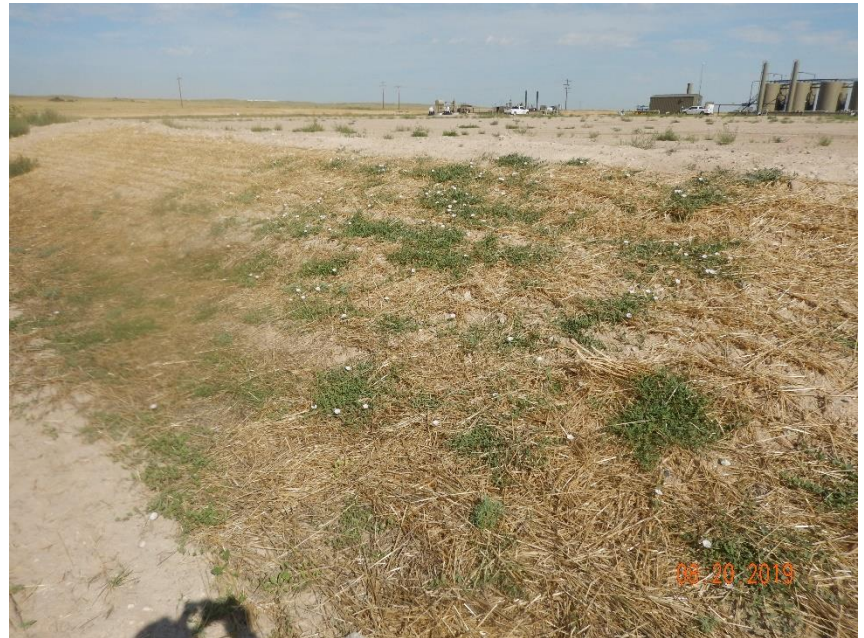
Photo 12: Photo taken from the south end of the pad. Photo shows noxious weed establishment (Field Bindweed) on the location.

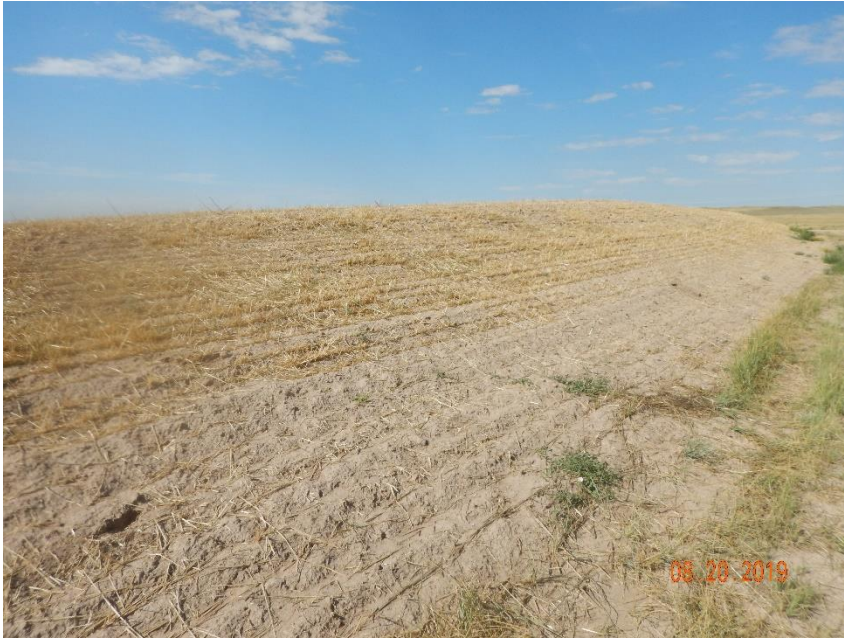
Photo 13: Photo taken from the north side of the soil stockpile. Photo shows Operator appears to be implementing BMPs to prevent weed establishment and to protect the stockpiled soils on the top, and northern facing slopes of the topsoil stockpile.

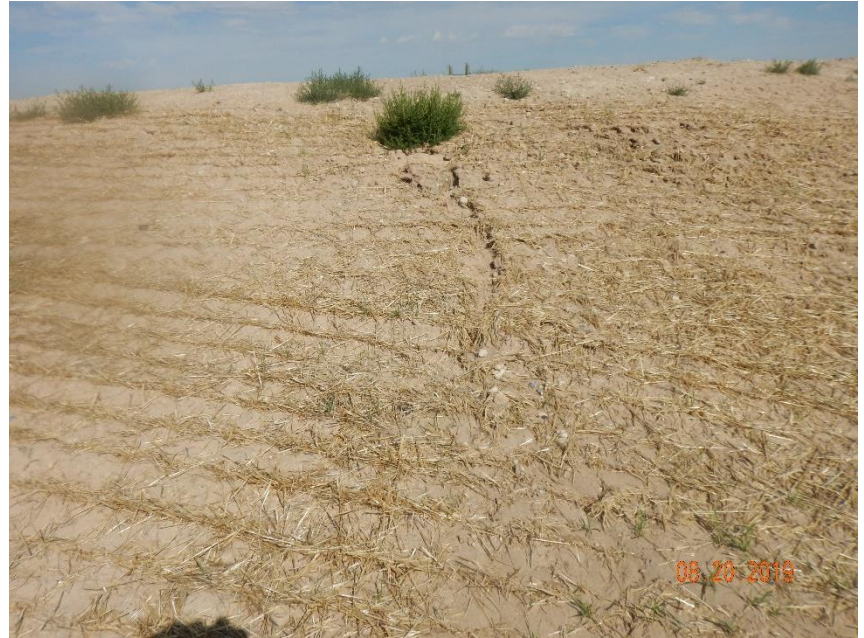
Photo 14: Photo taken from the south end of the pad. Photo shows erosion degradation on the slopes of the pad.

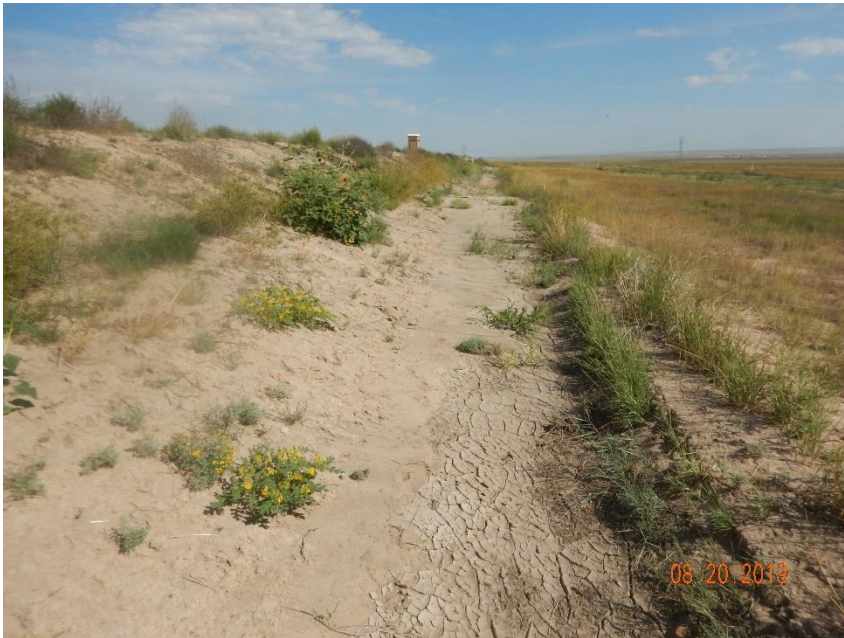
Photo 15: Photo taken from east end of the location, facing north. Photo shows stormwater ditch has not been constructed in accordance with good engineering practices, and has not been properly compacted/consolidated/stabilized. Photo also shows sediment due to stormwater erosion has filled the ditch.

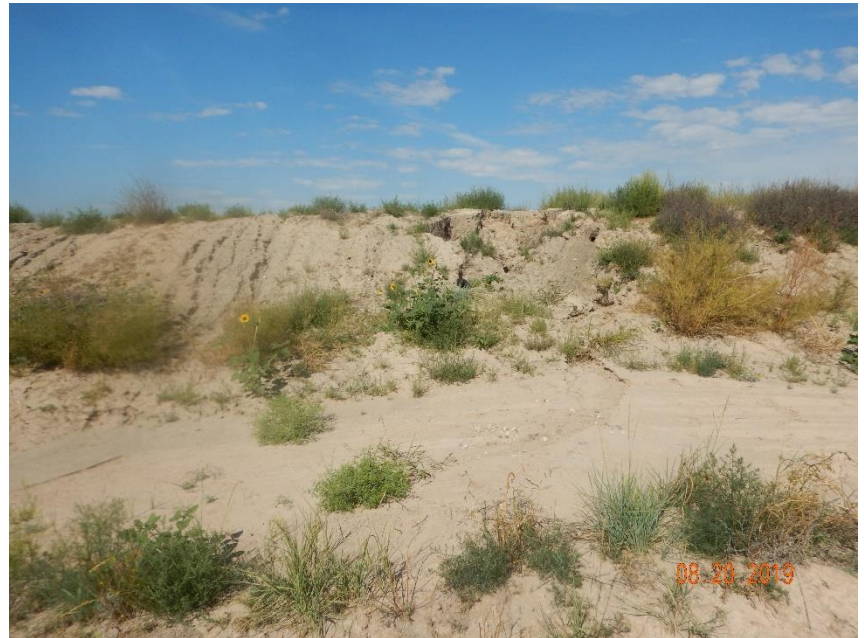
Photo 16: Photo taken from the east end of the pad, facing west. Photo shows erosion degradation on the slopes of the pad.

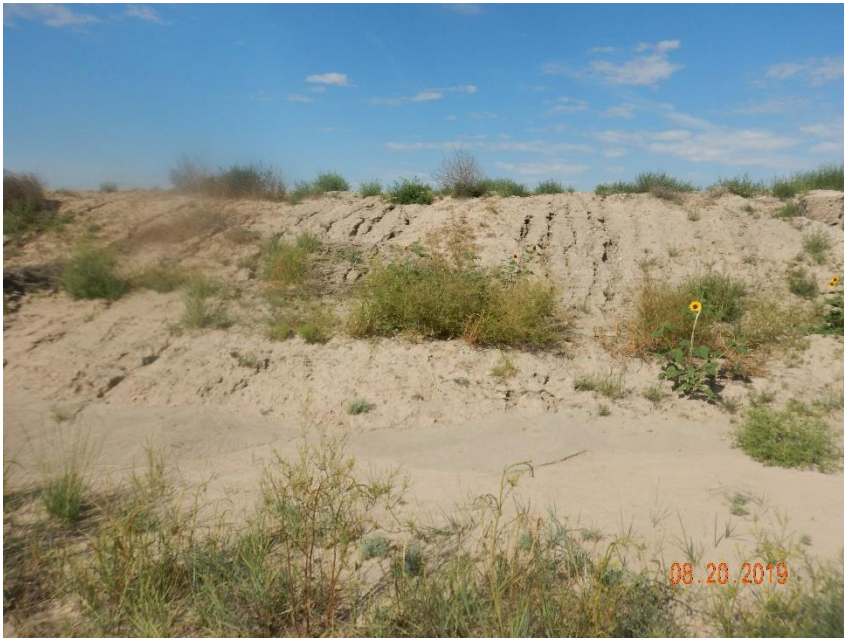
Photo 17: Photo taken from the east end of the pad, facing west. Photo shows erosion degradation on the slopes of the pad.

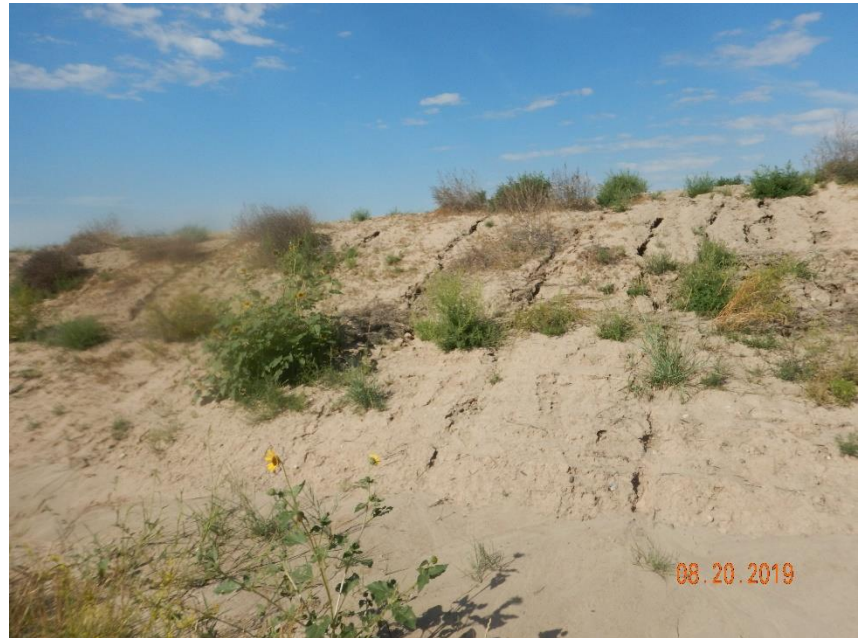
Photo 18: Photo taken from the east end of the pad, facing west. Photo shows erosion degradation on the slopes of the pad.

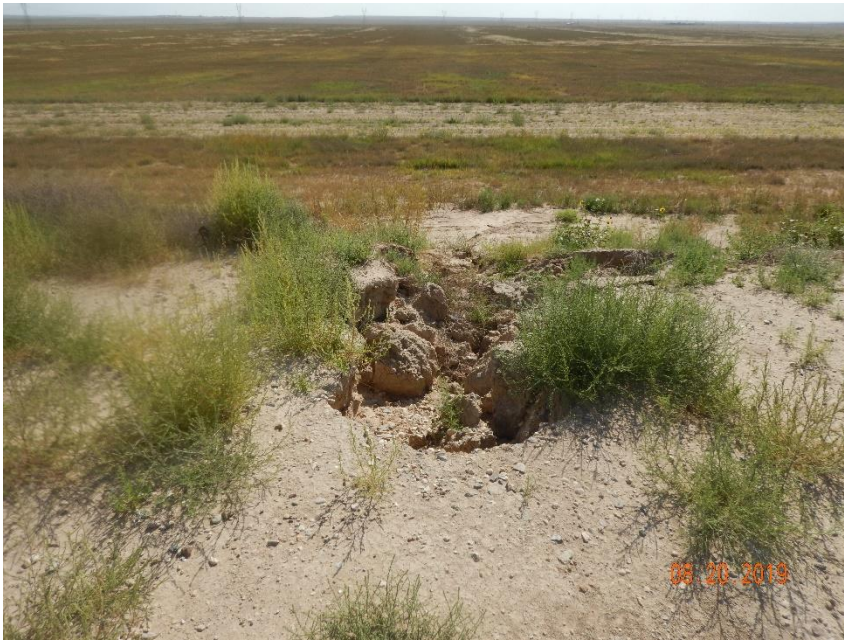
Photo 19: Photo taken from the east end of the pad, facing east. Photo shows erosion degradation on the slopes of the pad.

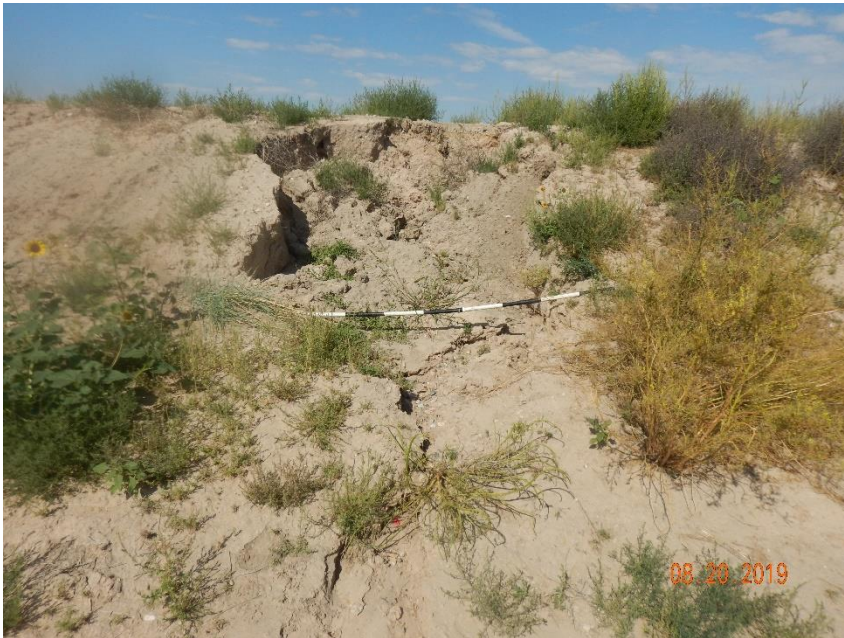
Photo 21: Continued from photo 20. Photo shows erosion degradation on the slopes of the pad. Two (2) meter Robel-pole in photo used for reference.

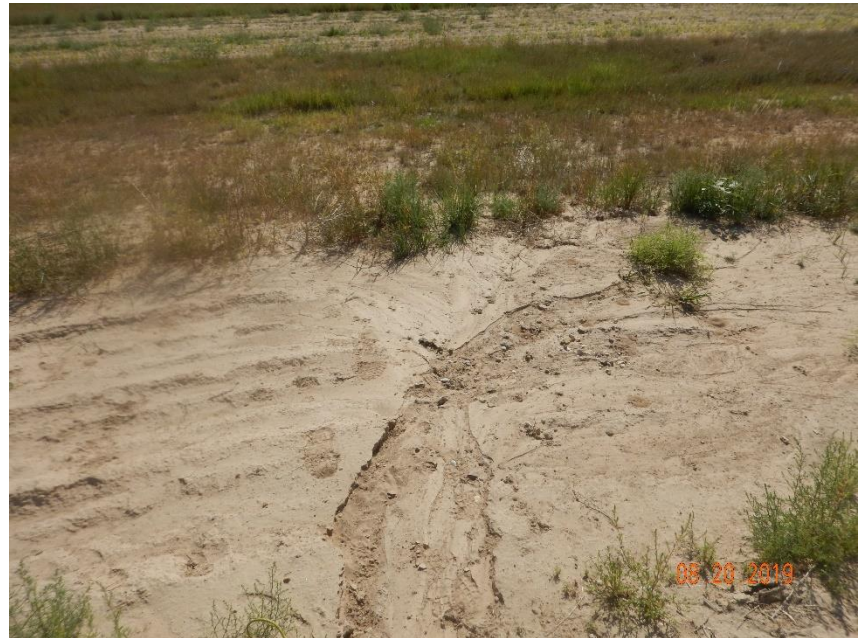
Photo 22: Continued from photo 21. Photo shows sediment has filled ditch. Photo also shows sediment discharge off location.

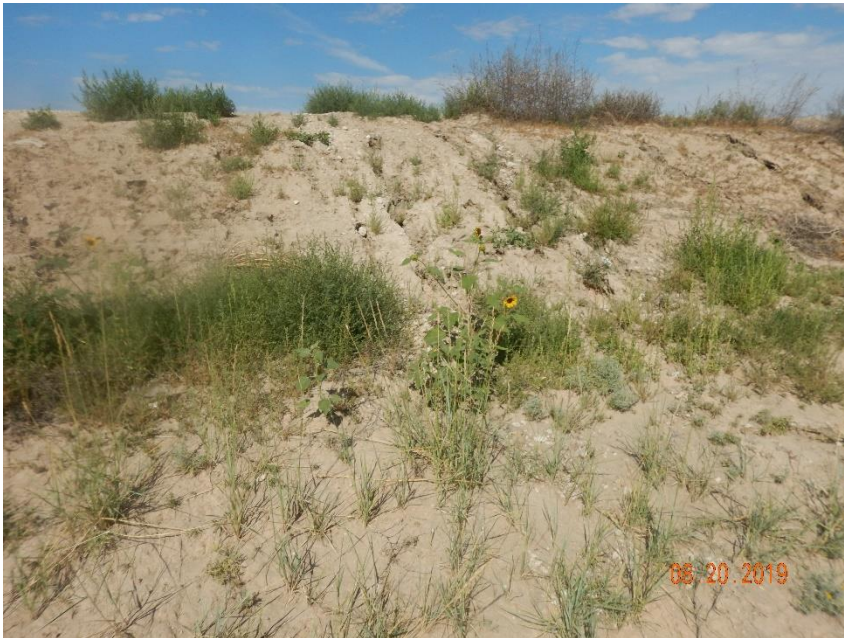
Photo 23: Photo taken from the east end of the pad, facing east. Photo shows erosion degradation on the slopes of the pad.

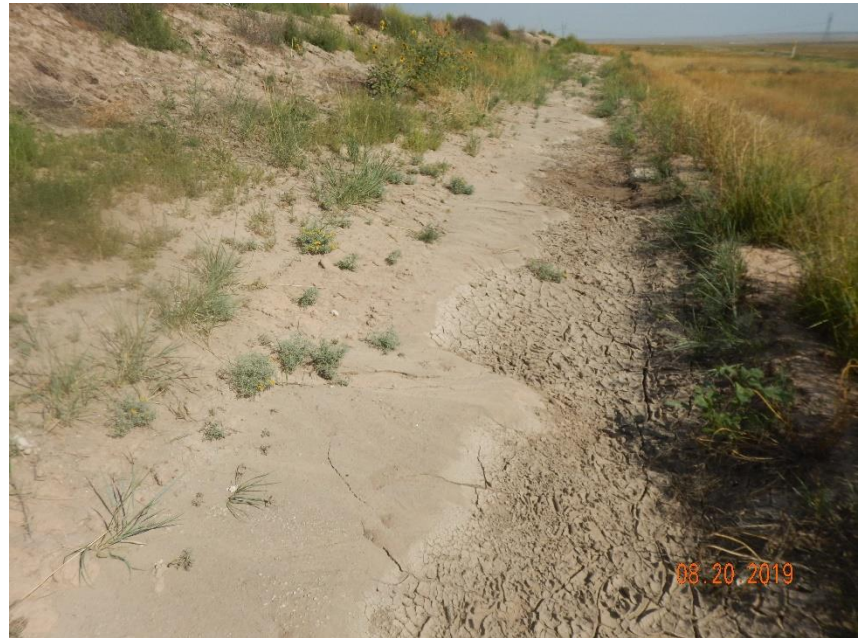
Photo 24: Photo shows sediment deposition has filled the stormwater ditch.

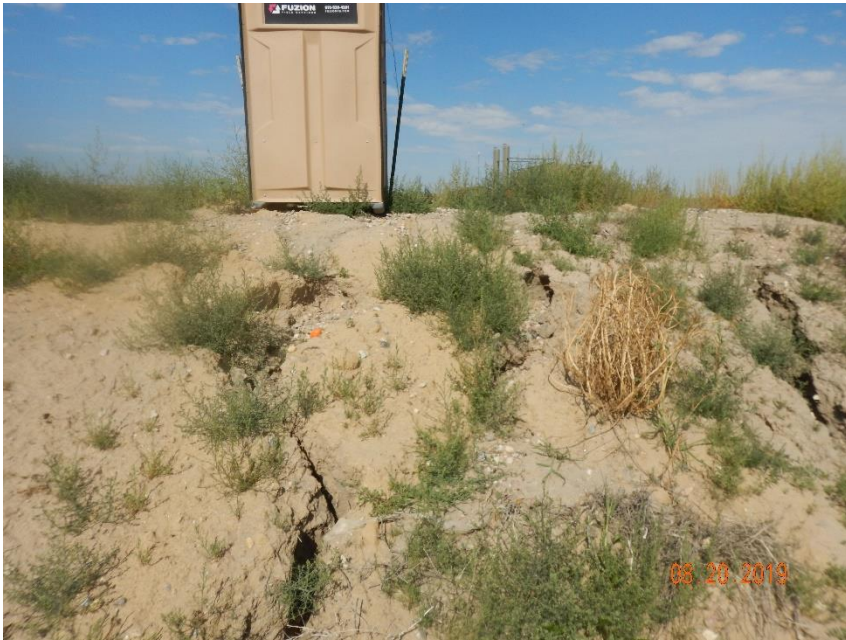
Photo 25: Photo taken from the east end of the location, facing west. Photo shows erosion degradation on slopes is beginning to cut under the porta-john on the east end of the location. Erosion degradation is compromising the stabilization of the porta-john and may result in tipping and spilling contents.

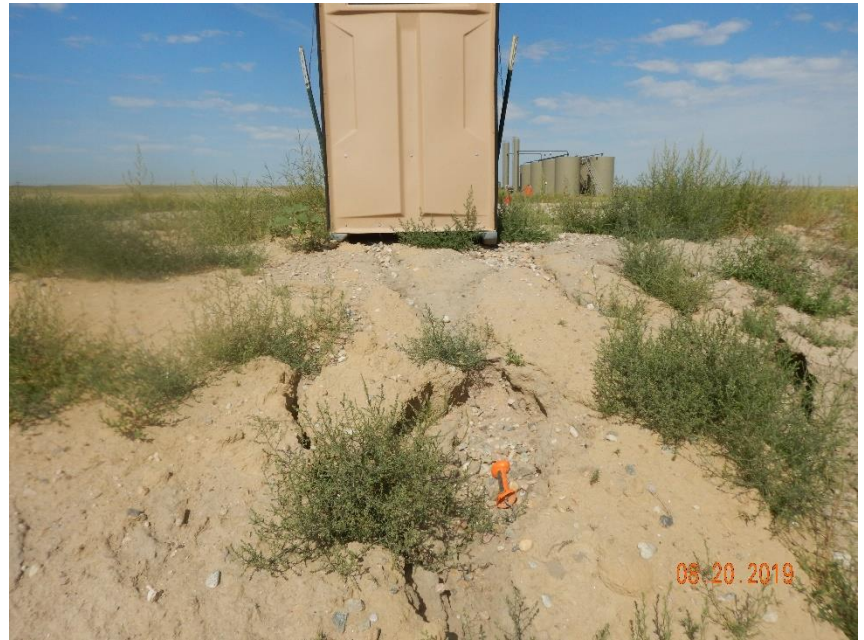
Photo 26: Continued from photo 25.

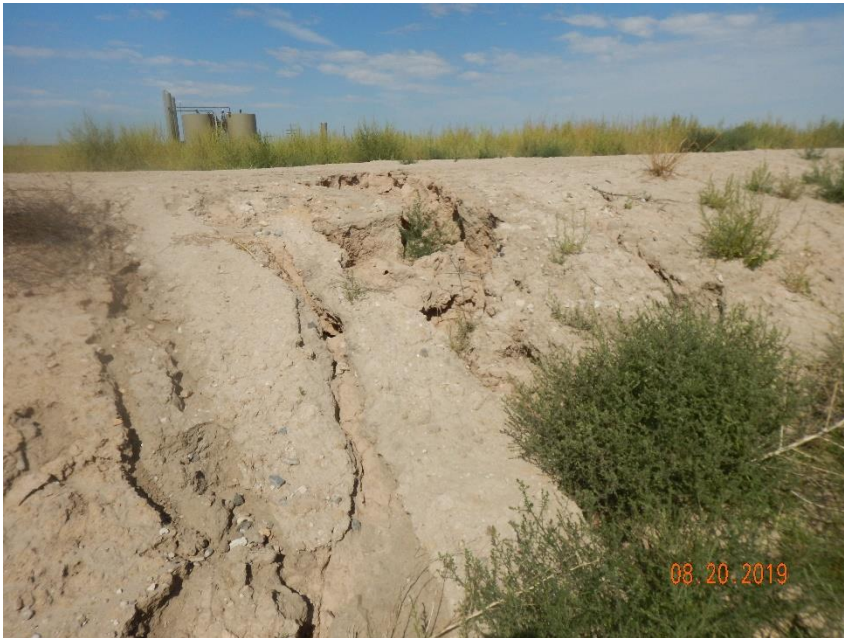
Photo 27: Photo taken from the east end of the pad, facing east. Photo shows erosion degradation on the slopes of the pad.

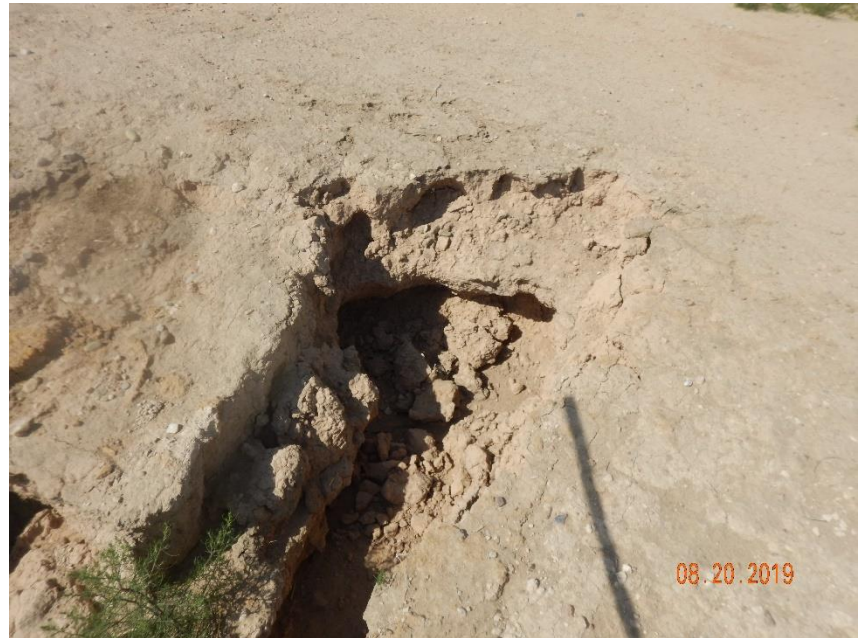
Photo 28: Photo taken from the east end of the pad. Photo shows erosion degradation on the slopes of the pad.

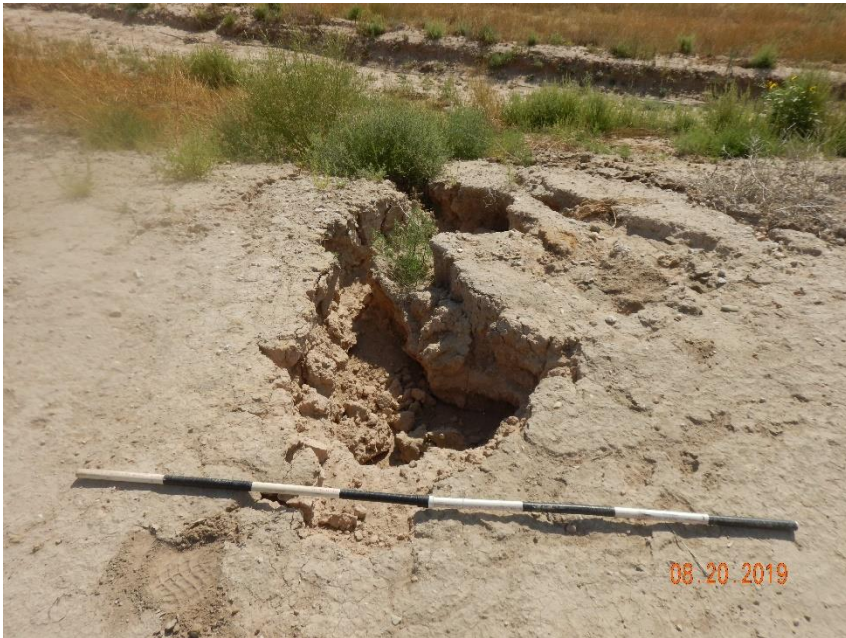
Photo 29: Photo taken from the east end of the pad, facing east. Photo shows erosion degradation on the slopes of the pad. Two (2) meter Robel-pole in photo used for reference.

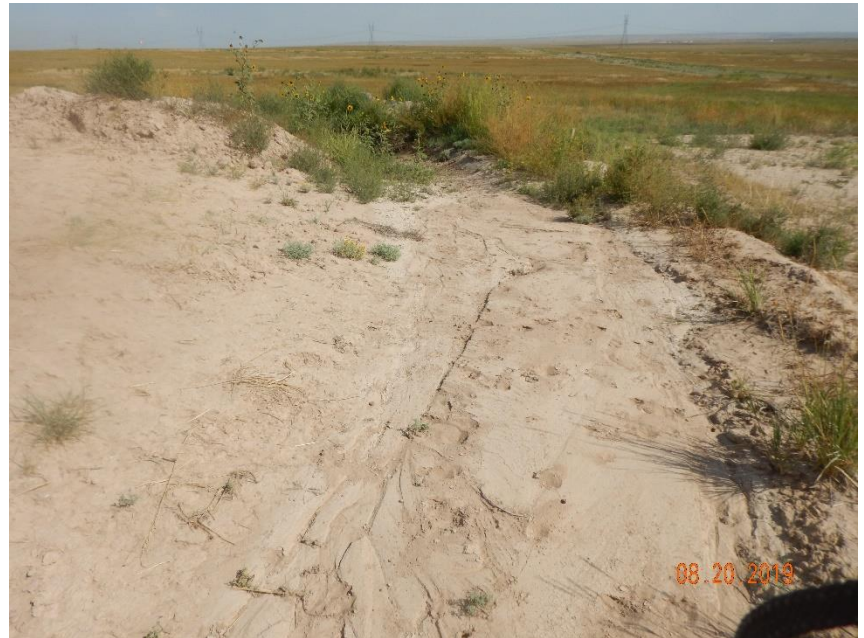
Photo 30: Photo taken from the northeast end of the location, facing north. Photo shows stormwater ditch has filled with sediment. Photo also shows sediment trap. See comments under photo 7 for comments regarding sediment traps on location.

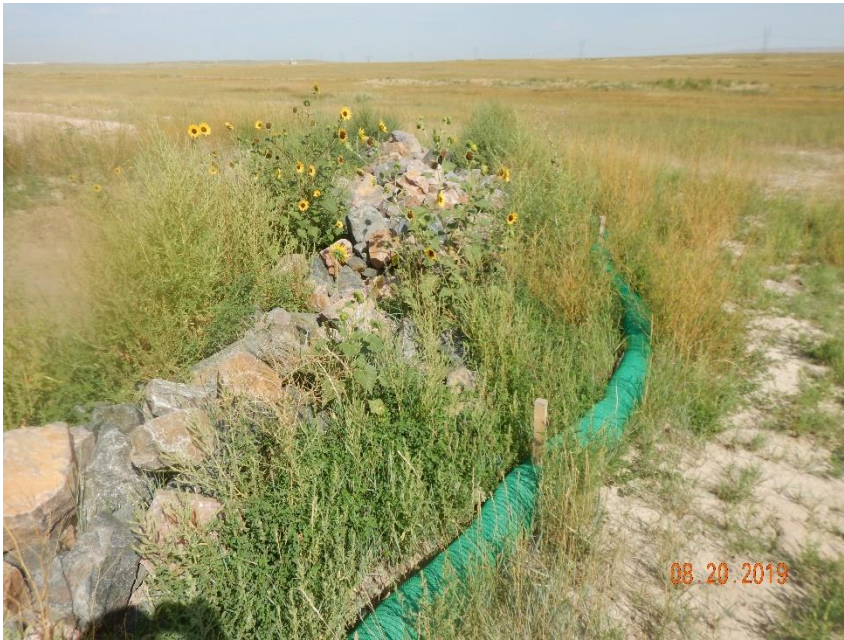
Photo 31: Continued from photo 30. See comments under photo 7.

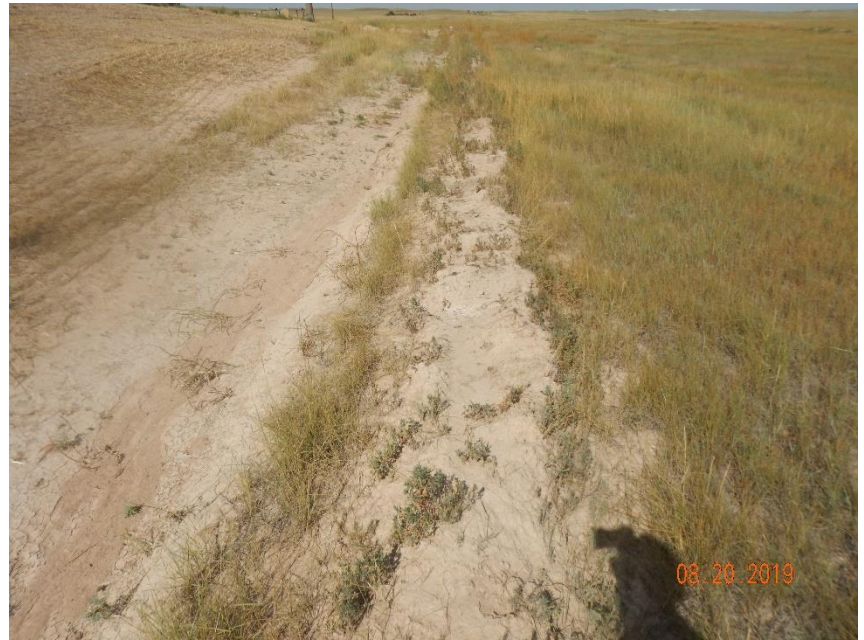
Photo 32: Photo shows perimeter stormwater ditch on the north end of the location. Photo shows stormwater ditch has not been constructed in accordance with good engineering practices, and has not been properly compacted/consolidated/stabilized. Photo also shows sediment due to stormwater erosion has filled the ditch.

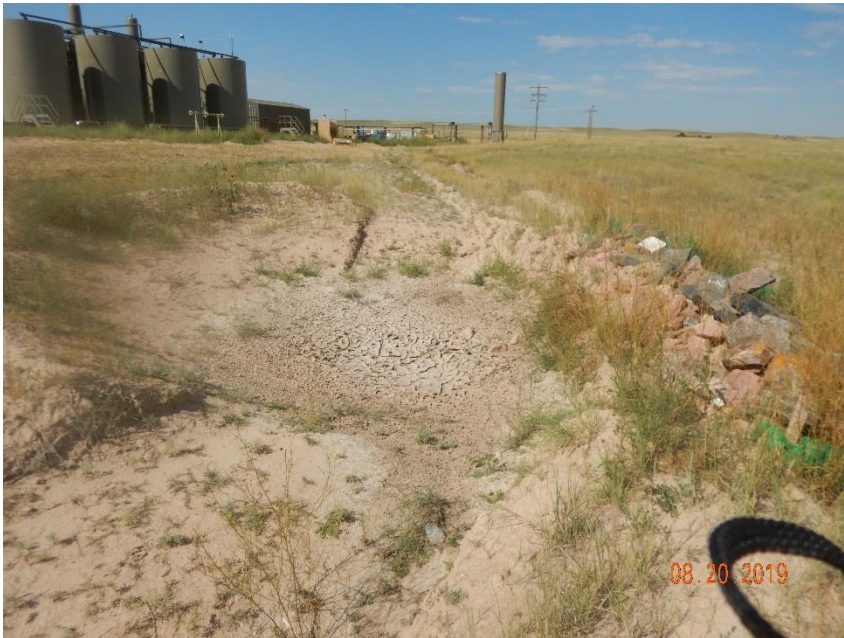
Photo 33: Photo of sediment trap on the north end of the location. See comments under photo 7. Photo also shows that the outlet of the sediment trap has been constructed at the same elevation as the adjacent ditches and berms, and will not allow for stormwater discharge.

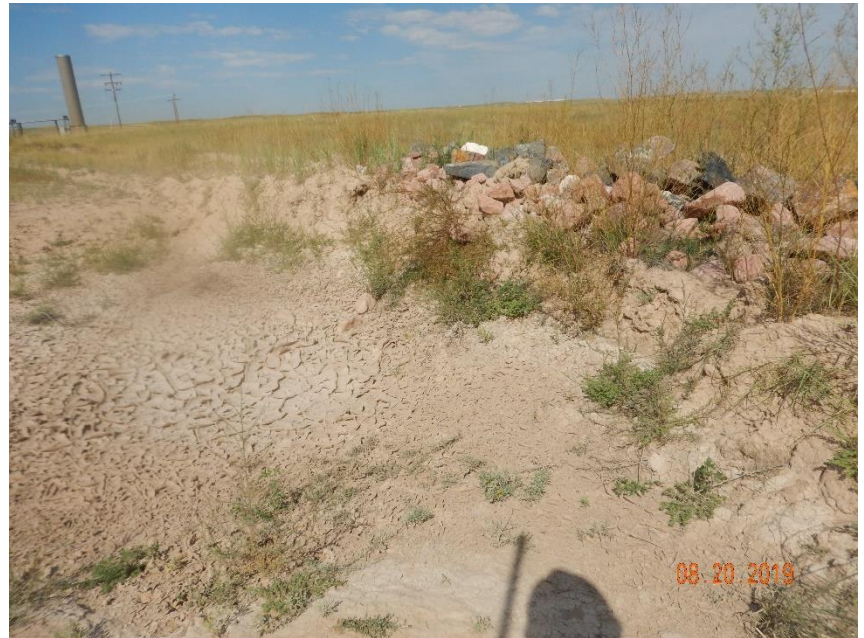
Photo 34: See comments under photo 33.

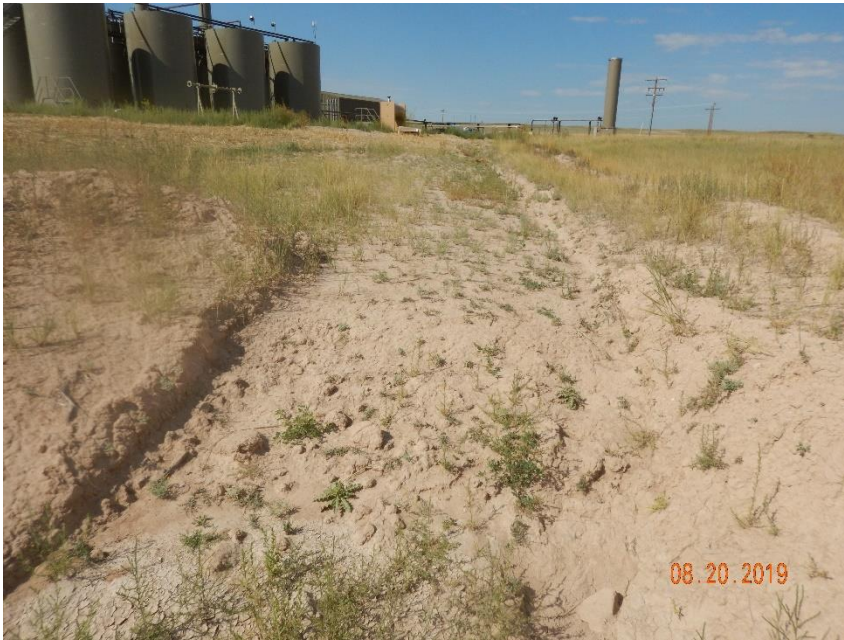
Photo 35: See comments under photo 33.

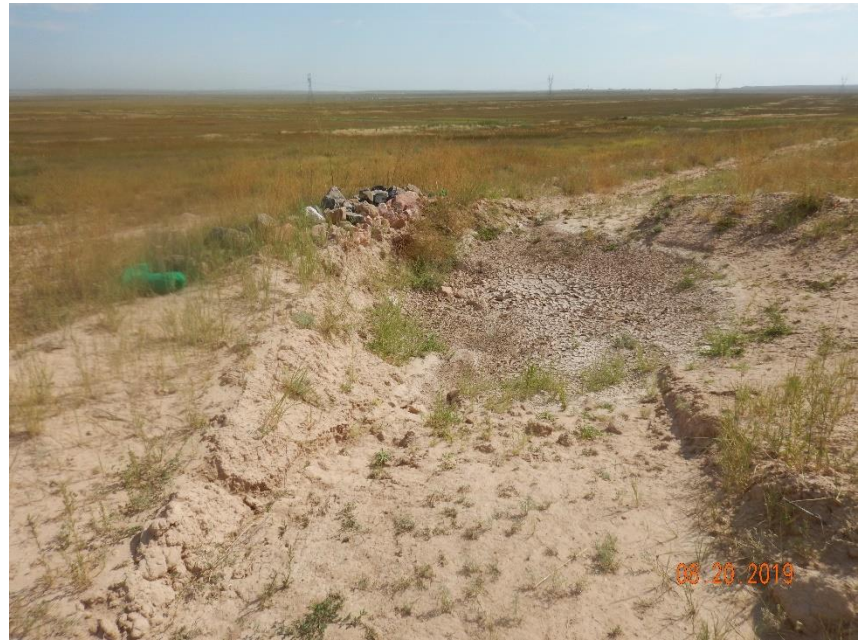
Photo 36: See comments under photo 33.

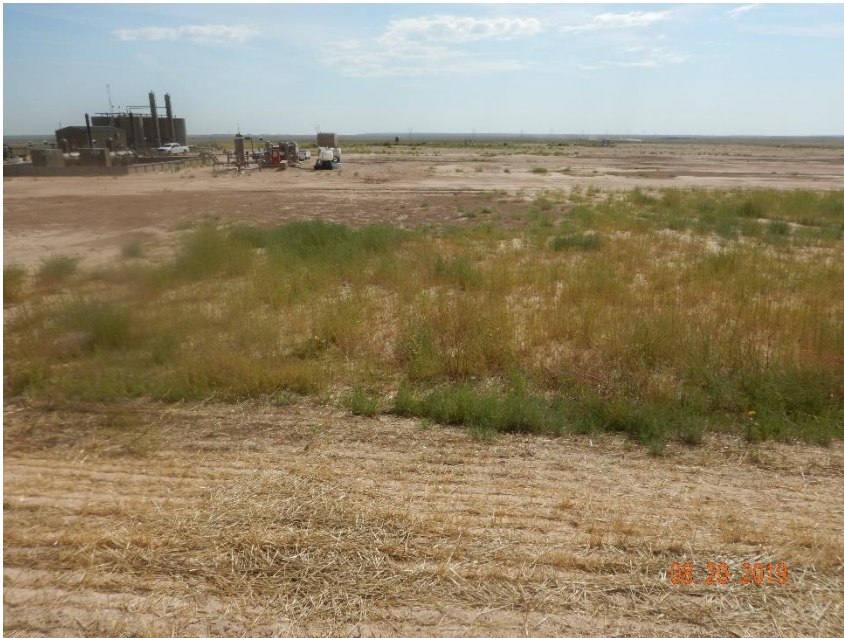
Photo 37: Photo taken from the west end of the location, facing east. Photo provides an overview of the location. . Photo also shows weed establishment on the location.

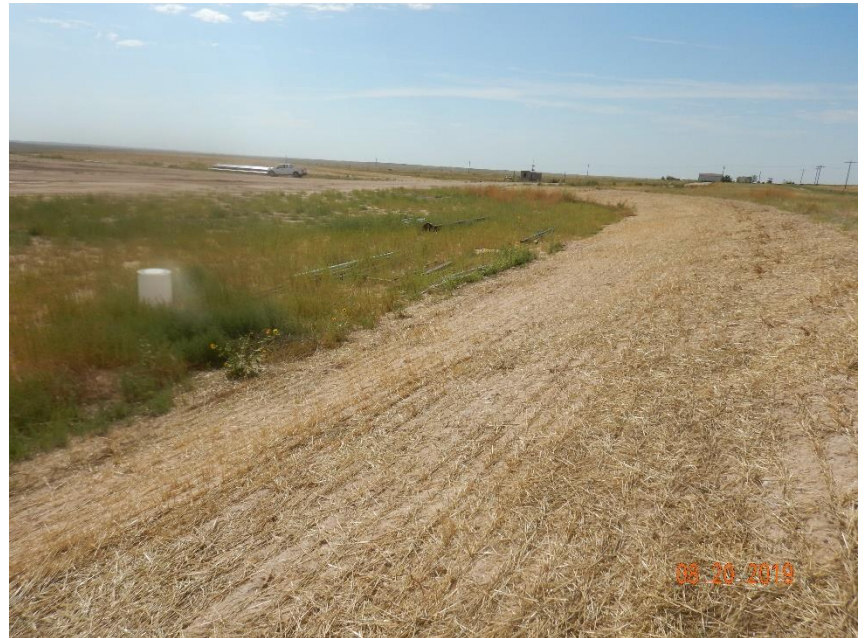
Photo 38: Photo taken from the west end of the location, facing southeast. Photo provides an overview of the location. Photo also shows weed establishment on the location.

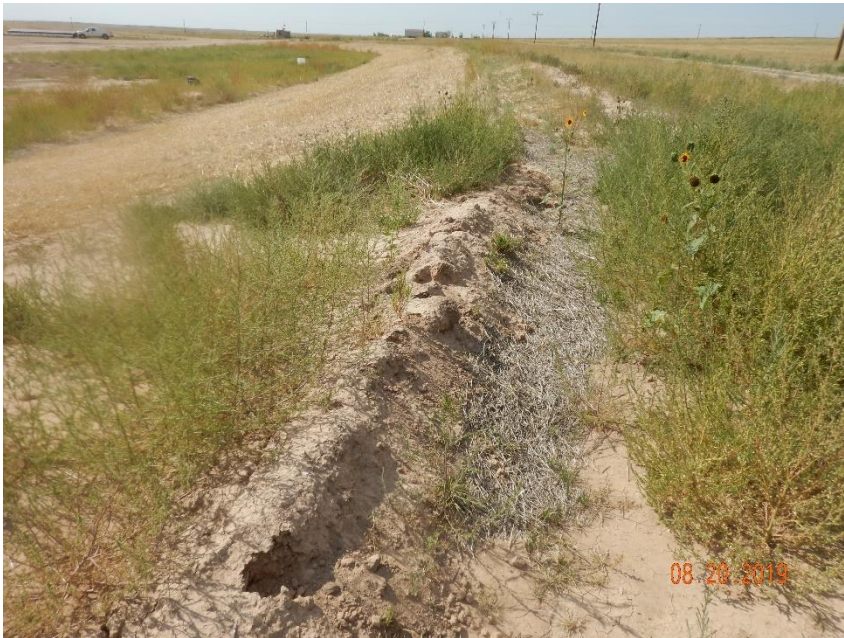
Photo 39: Photo shows perimeter stormwater ditch on the west end of the location. Photo shows stormwater ditch has not been constructed in accordance with good engineering practices, and has not been properly compacted/consolidated/stabilized. Photo also shows sediment due to stormwater erosion has filled the ditch.

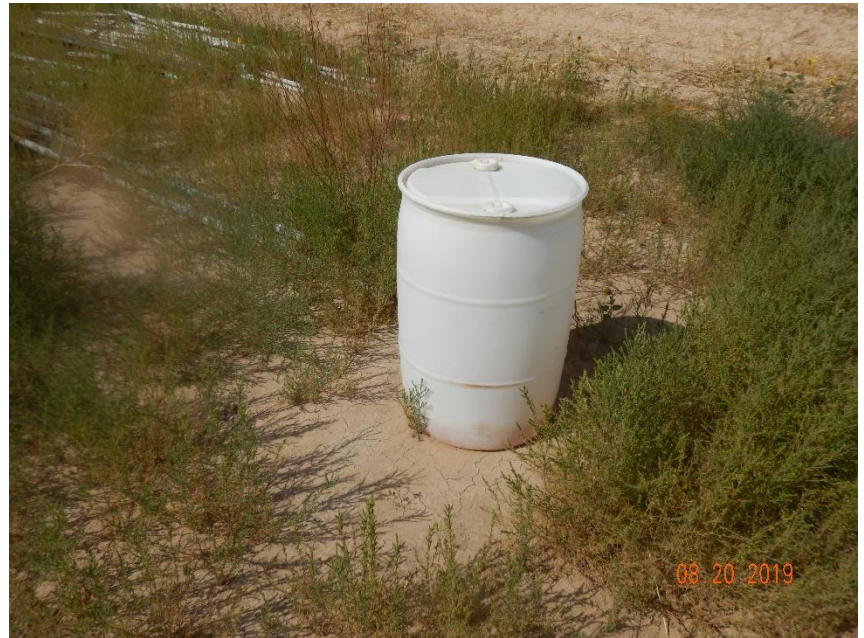
Photo 40: Photo taken from the west end of the location. Photo shows plastic barrel identified in the previous inspection has not been placed into secondary containment, or removed.

Container also missing required labelling; Unable to clearly identify contents.

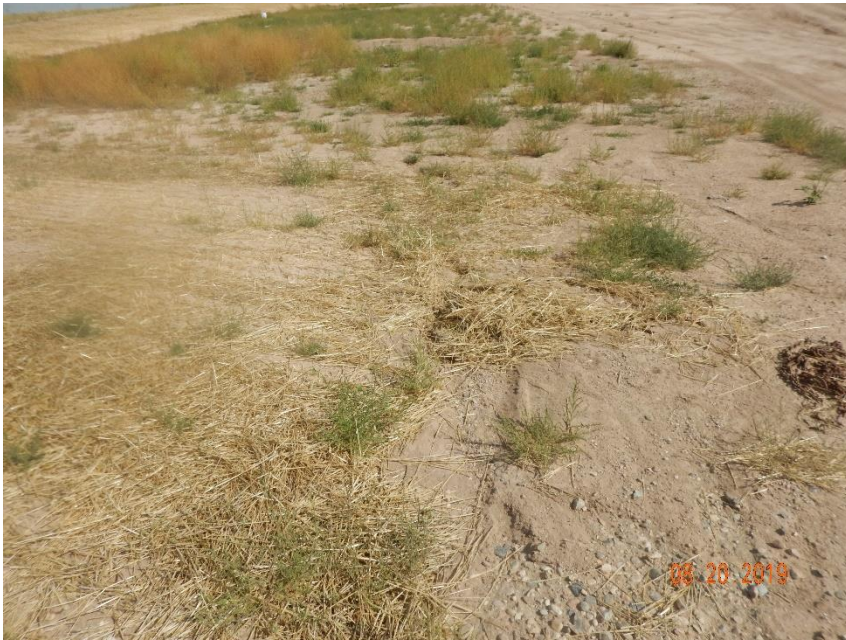
Photo 41: Photo taken from the southwest end of the pad, facing north. Photo shows stormwater runoff from the access road is beginning to cause erosion on the pad.
