Inspection Photos

08/20/2019

Operator: BISON OIL & GAS II LLC # 10661

Location ID: 454166

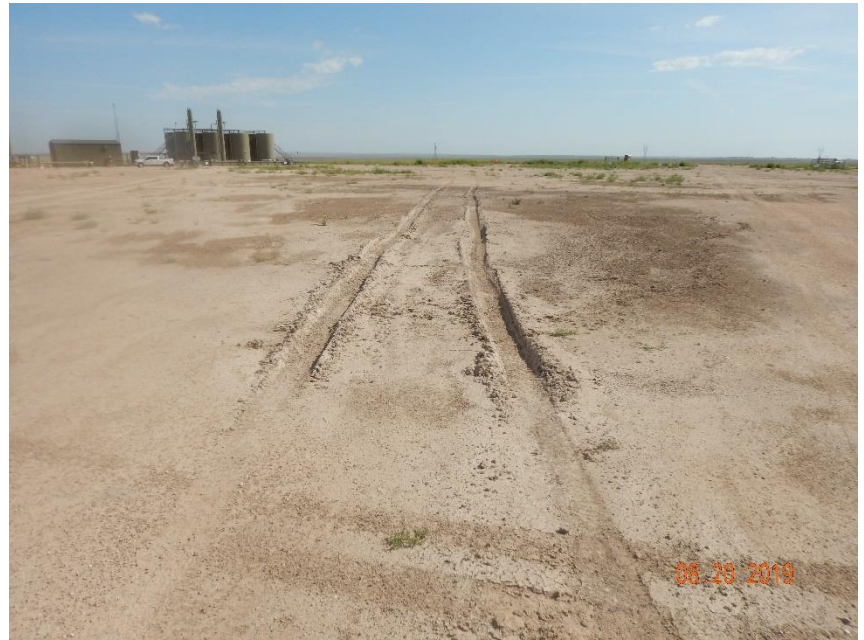
Photo 42: Photo taken from the southern are of the pad, facing northeast. Photo shows evidence of stormwater ponding on pad and vehicle tracking. Insufficient stormwater controls in place to allow for sediment laden free stormwater discharge from the location. BMPs need to be in place to 1) mitigate ponding, 2) prevent potential industrial pollutant contact and 3) to allow for sediment laden-free stormwater discharge from the location.

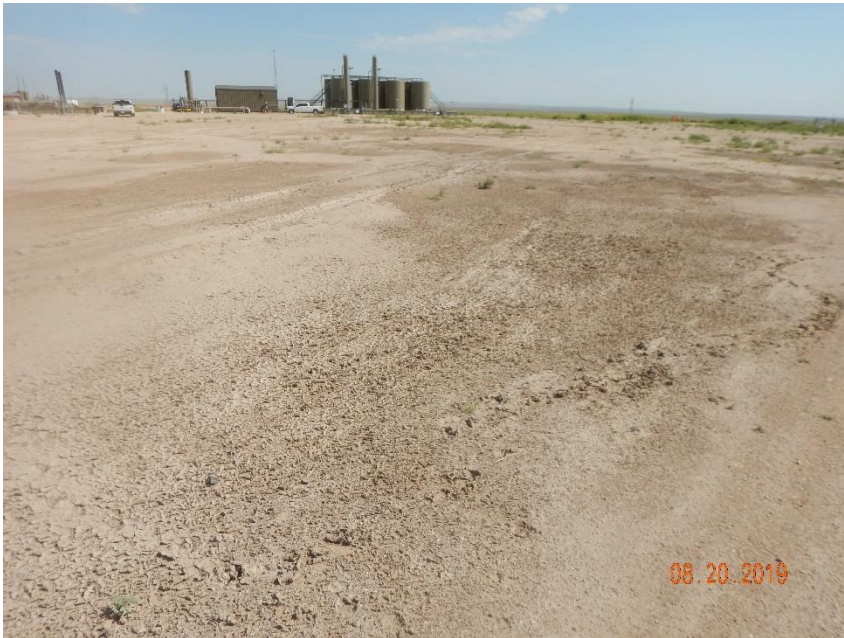
Photo 43: See comments under photo 42.

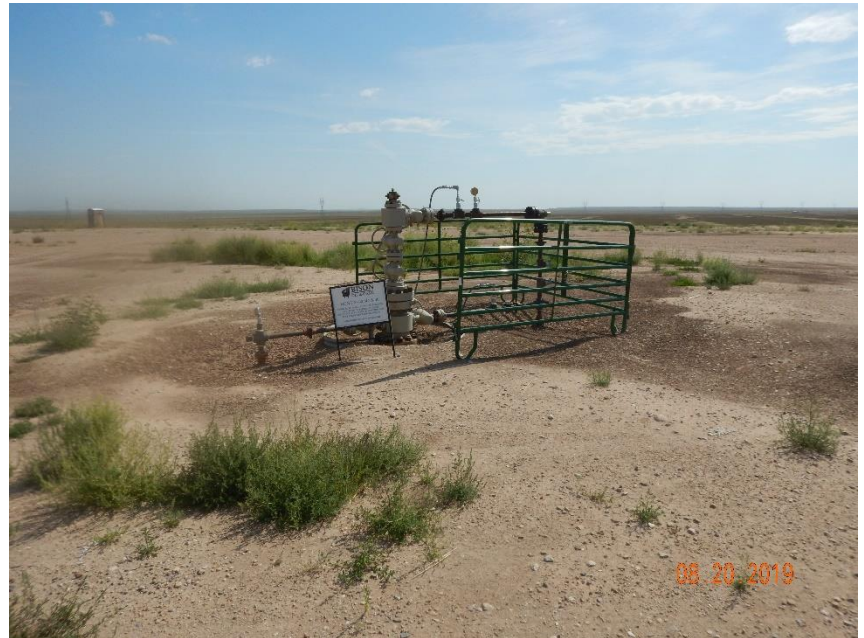
Photo 44: Photo taken from the Hunt 8-60 6C-5-10 well. Photo shows weed establishment on location and evidence of stormwater ponding at well. See comments under photo 42.

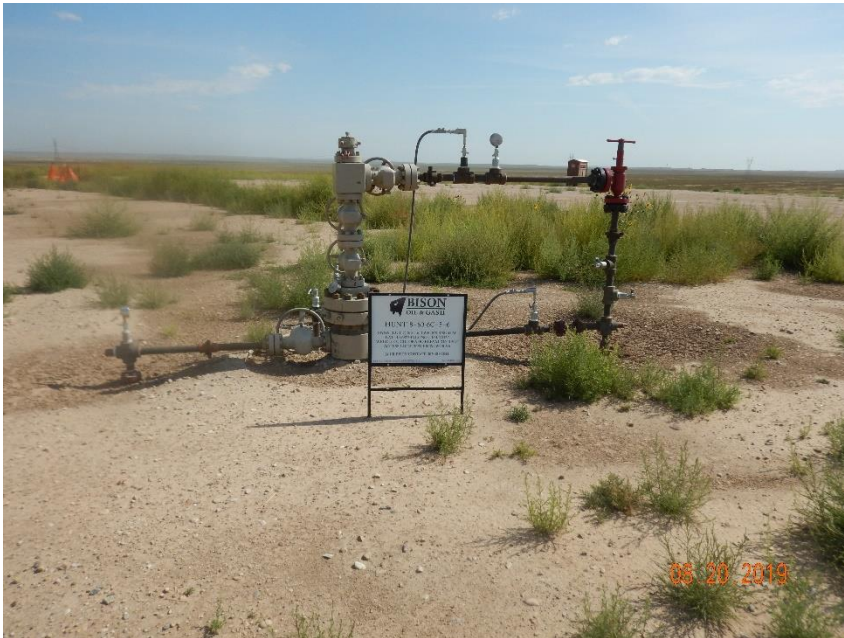
Photo 45: Photo taken from the Hunt 8-60 6C-5-6 well. Photo shows weed establishment on location and evidence of stormwater ponding at well. See comments under photo 42.

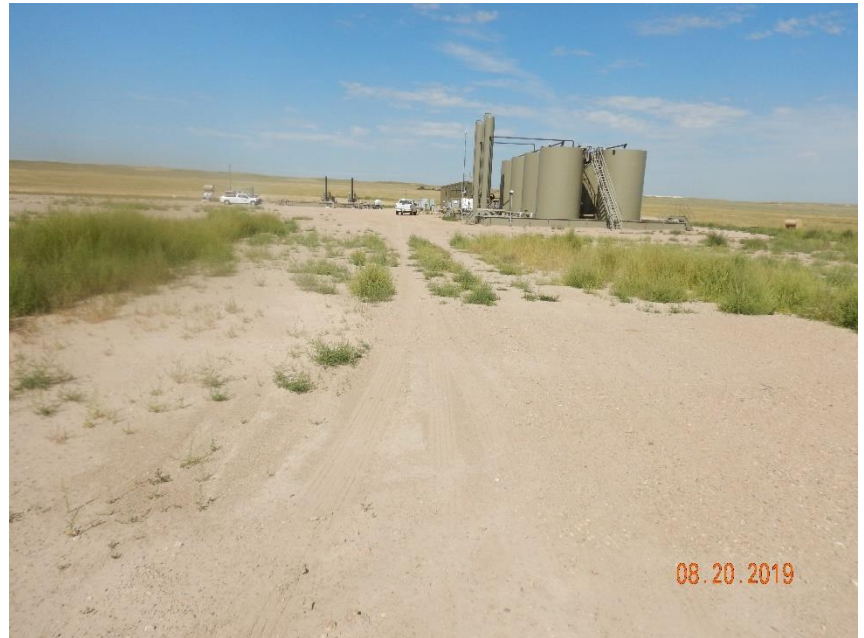
Photo 46: Photo taken from the northeast end of the pad, facing west. Photo shows areas where previous inspection documented contaminated soils. Photo shows contaminated soils appear to have been removed. Photo also shows weed establishment on location.

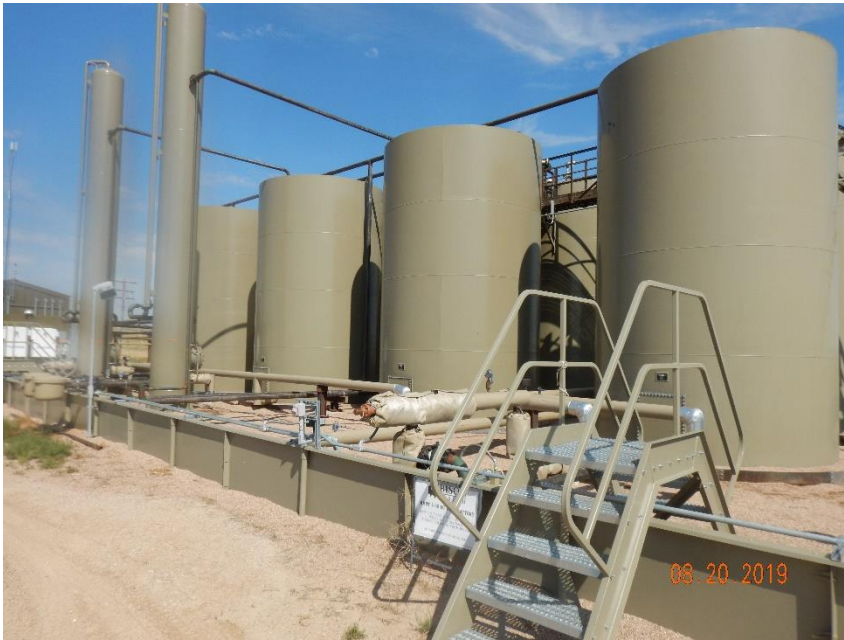
Photo 47: Photo taken from the tank battery. Photo shows tanks missing required labeling in accordance with 210.b

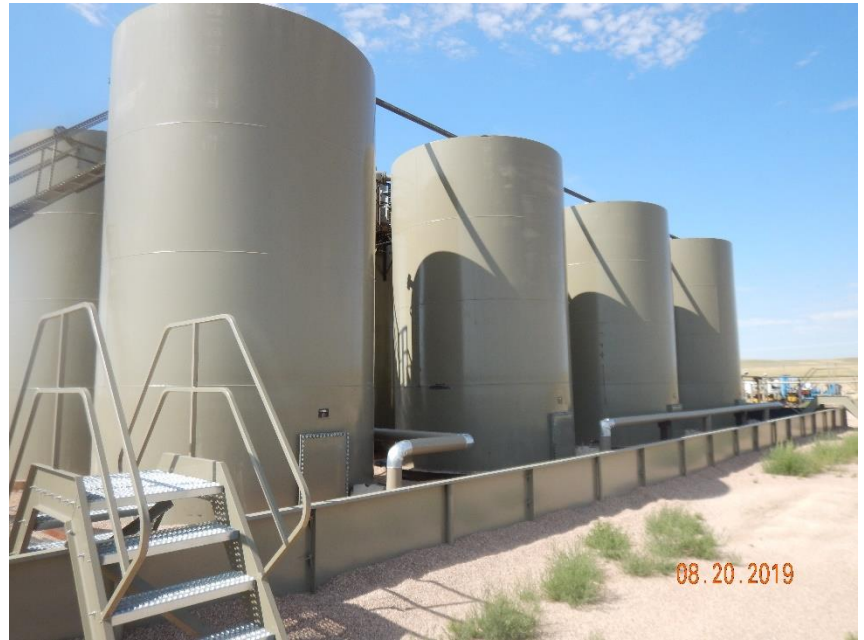
Photo 48: Photo taken from the tank battery. Photo shows tanks missing required labeling in accordance with 210.b

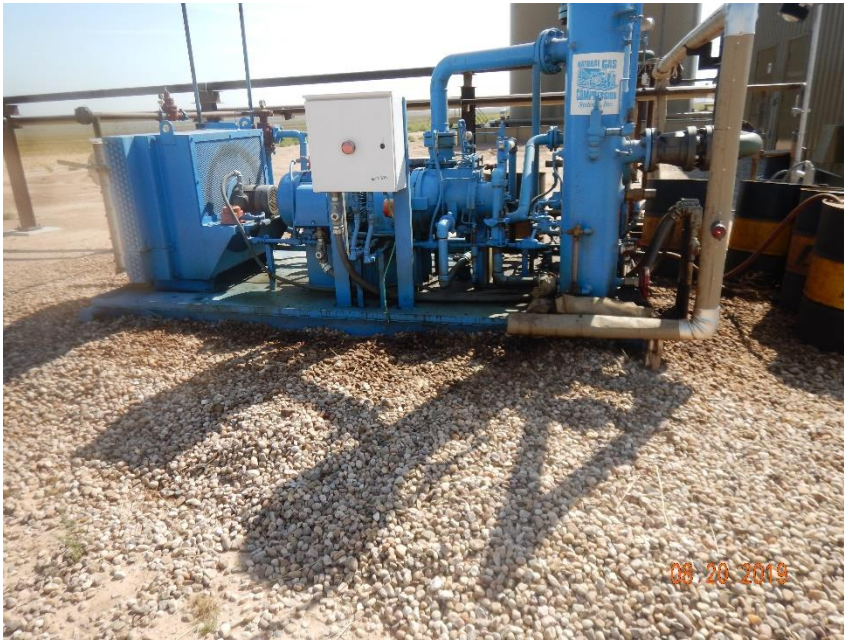
Photo 49: Photo taken from equipment on the north end of the location. Photo shows stained soils at base of equipment.

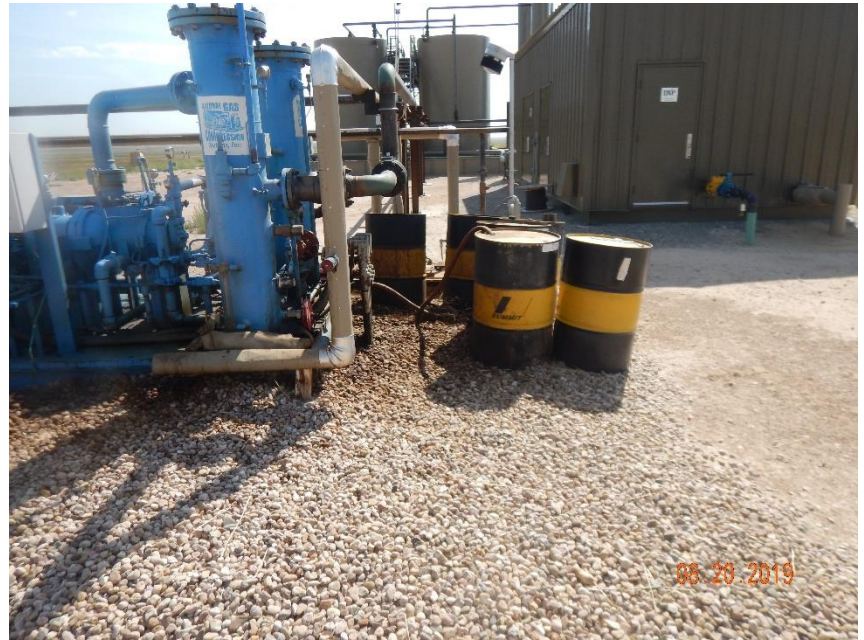
Photo 50: Continued from photo 49. Photo shows seven (7) barrels without secondary containment. Photo also shows stained soils at base of equipment, and around barrels.

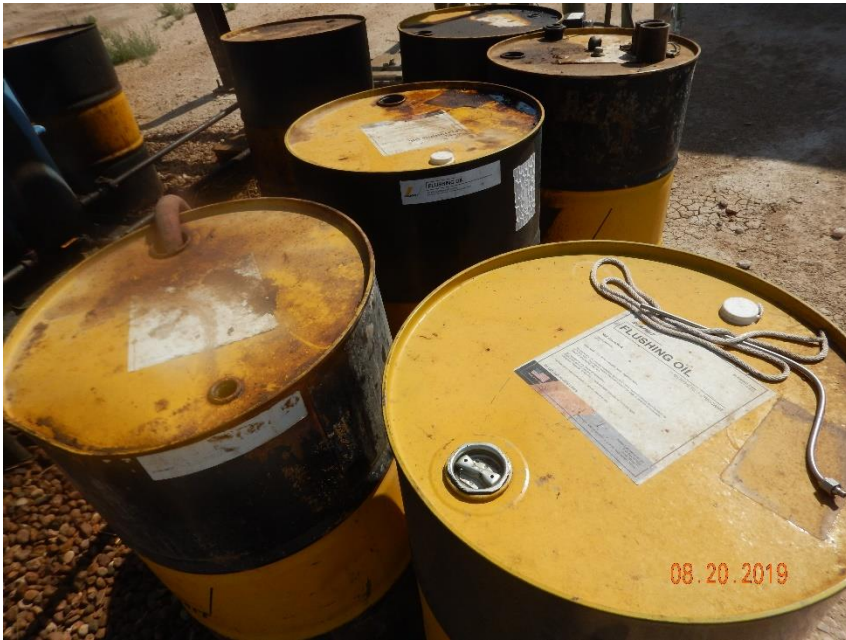
Photo 51: Continued from photo 50. Photo shows the seven (7) barrels without secondary containment. Photo shows labeling on majority of the barrels is illegible.

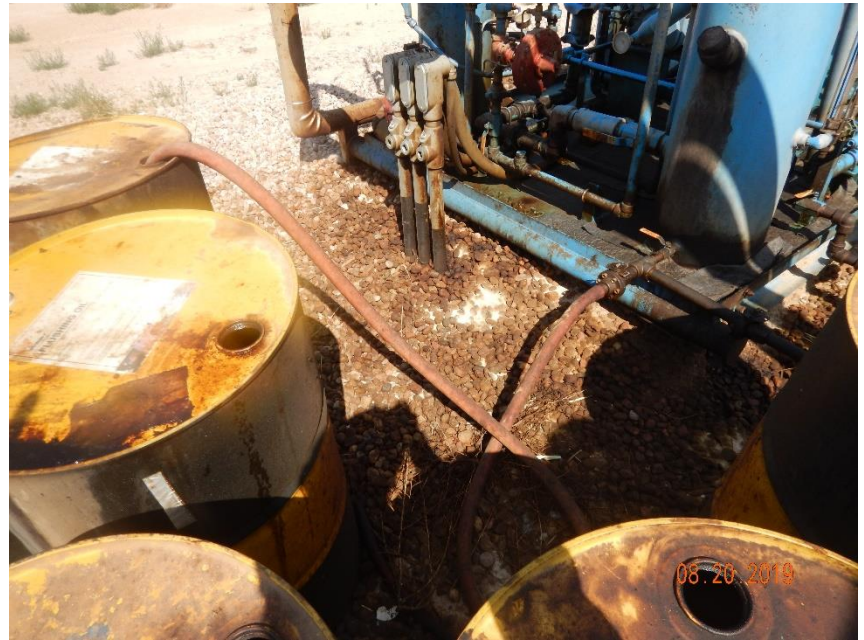
Photo 52: Continued from photo 50. Photo shows stained soils at base of equipment, and around barrels without secondary containment.

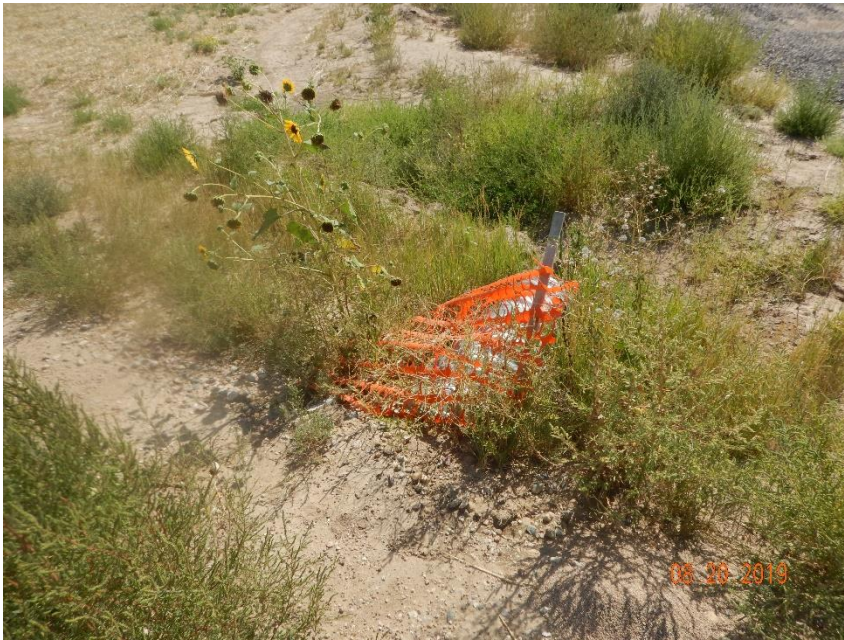
Photo 53: Photo taken from culvert along access road. Photo shows culverts have been installed without sufficient inlet/outlet protection/armoring
