McLaughlin 68
API: 05-103-40191
Inspection: 679705137

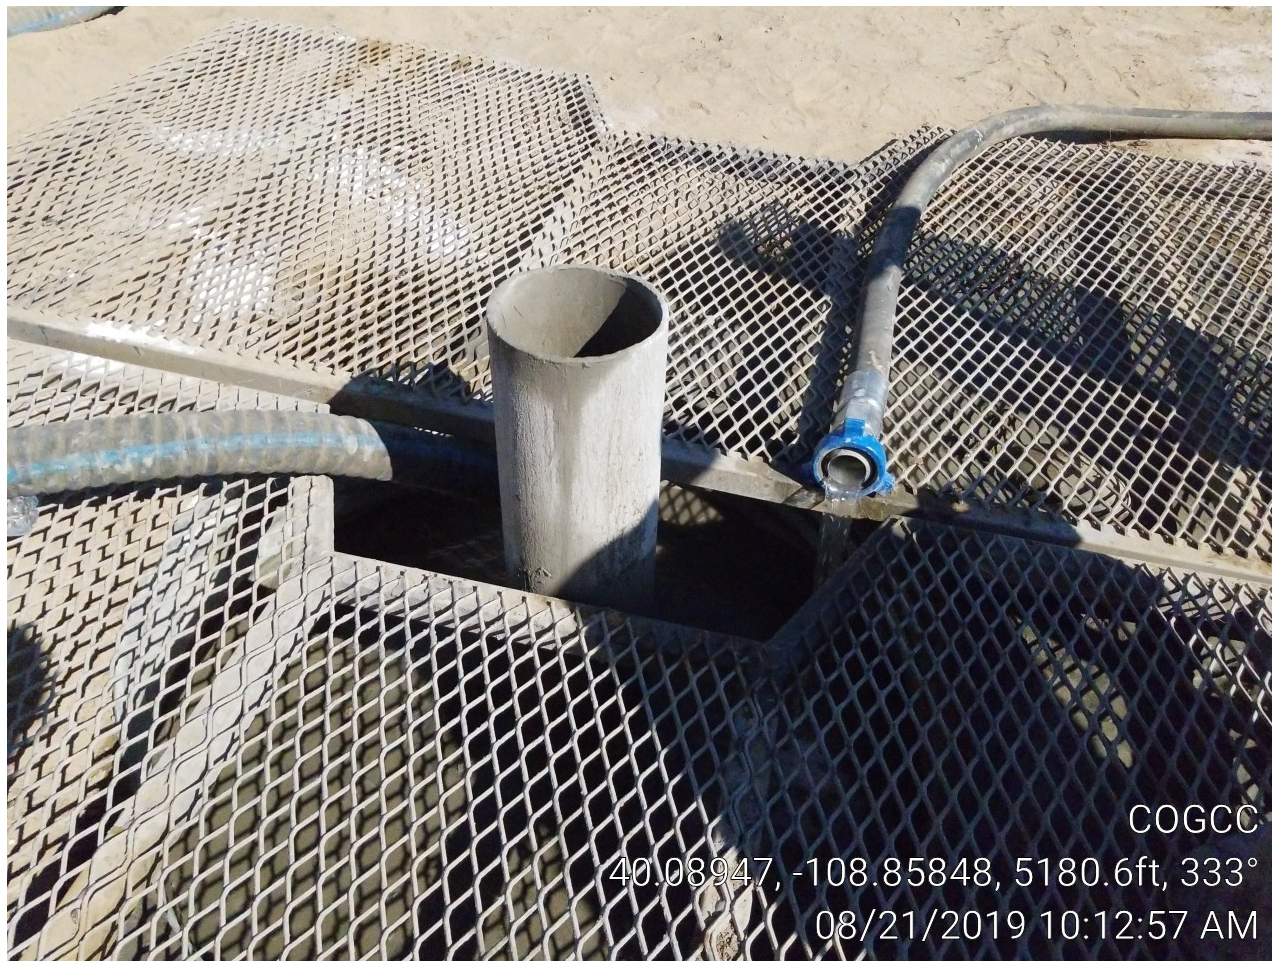
Photo 1. Well head.

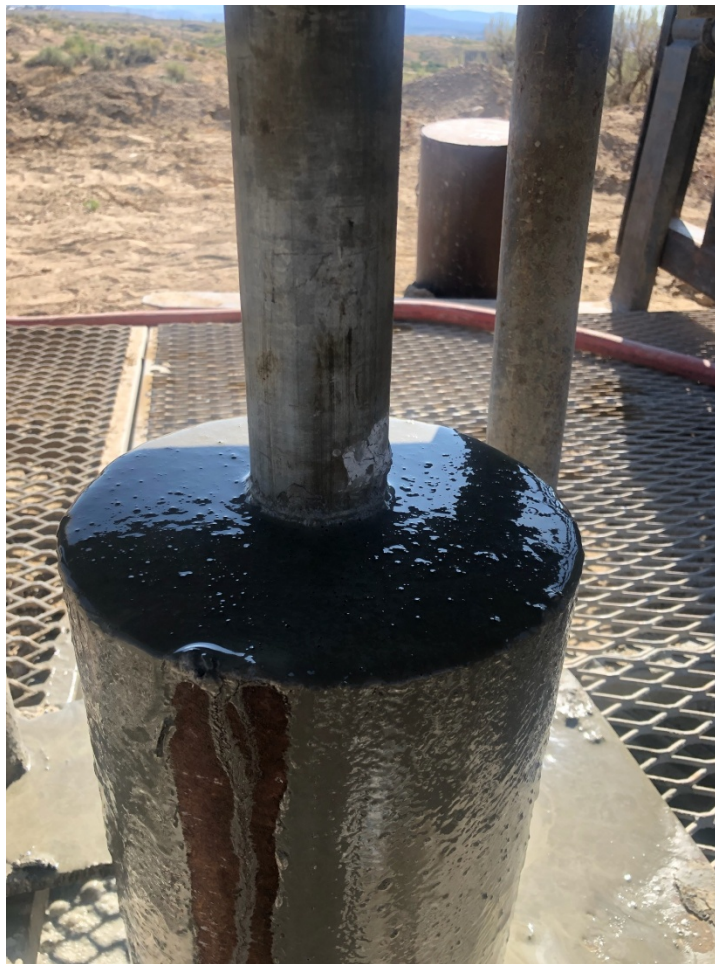
Photo 2. Well head with cement to surface & cement string not removed yet.
