Inspection Photos  
Operator: BP America  
Location/API #: 067-08216  
Date: 8-19-2019

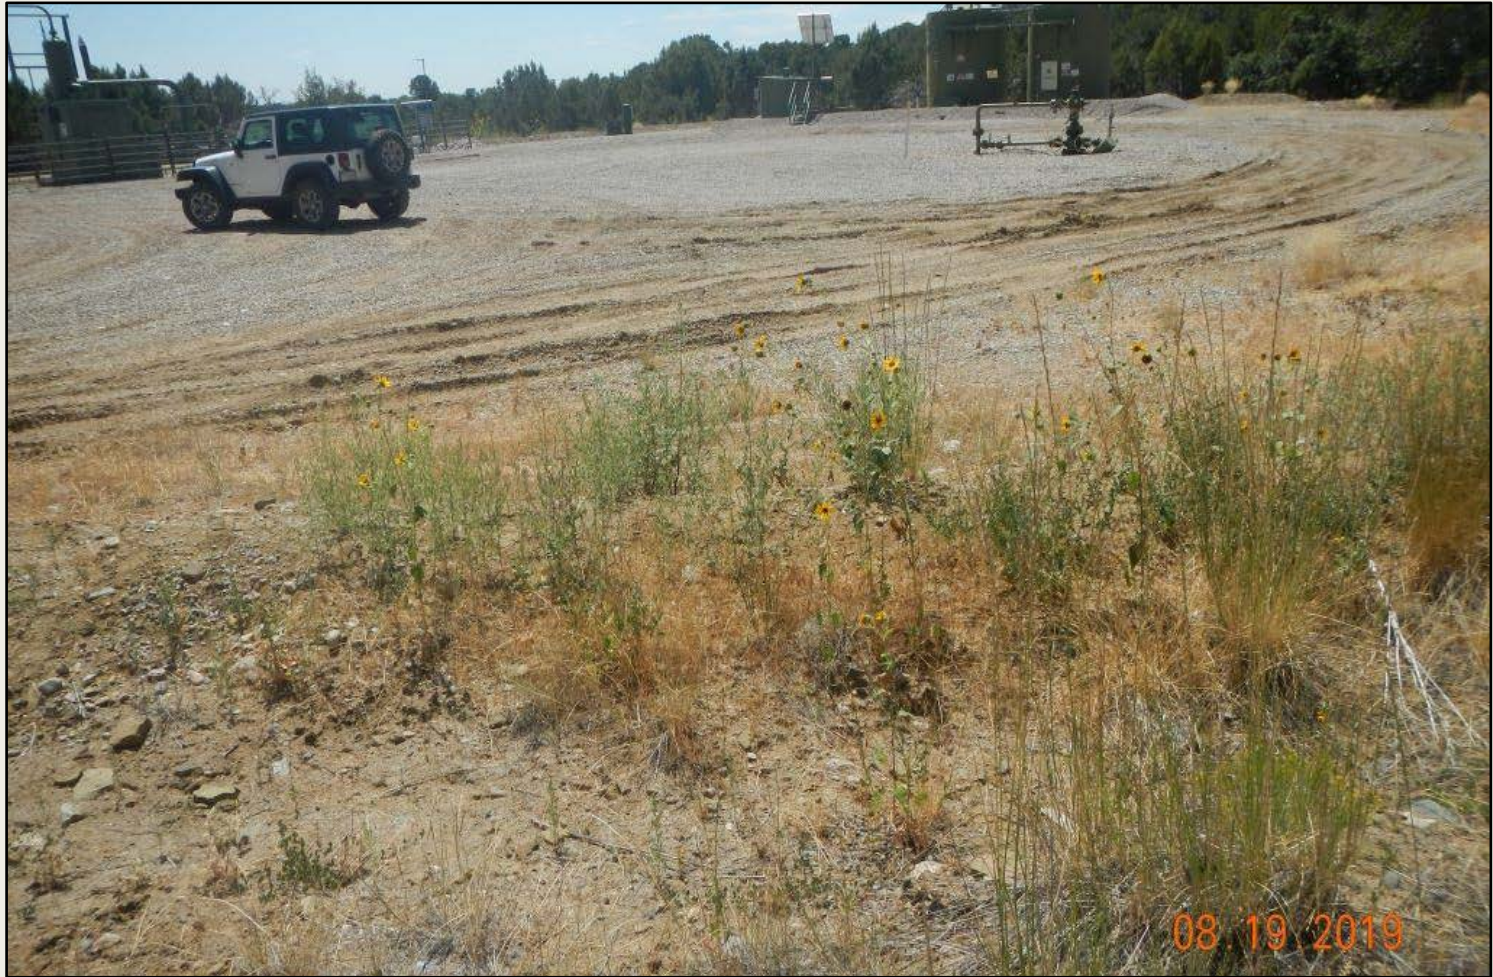
Photo 1. View of the project area from the northeastern corner facing center.

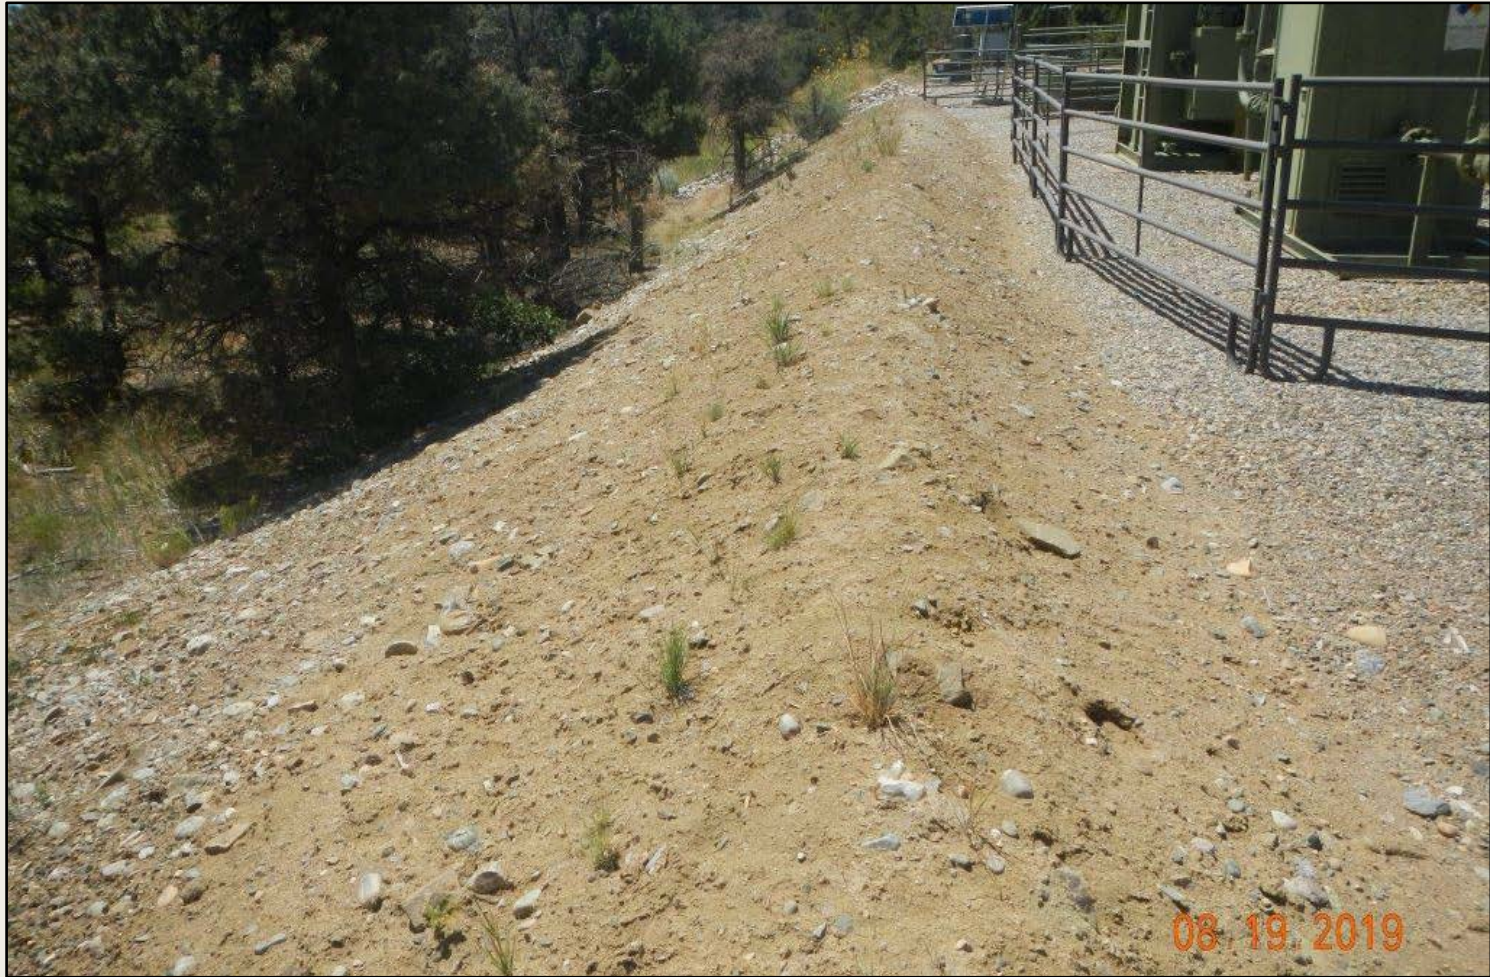
Photo 2. View of southern fill slope facing westward. Revegetation is sparse/young, but appears to be progressing. Some hydromulch remains on soil surface.

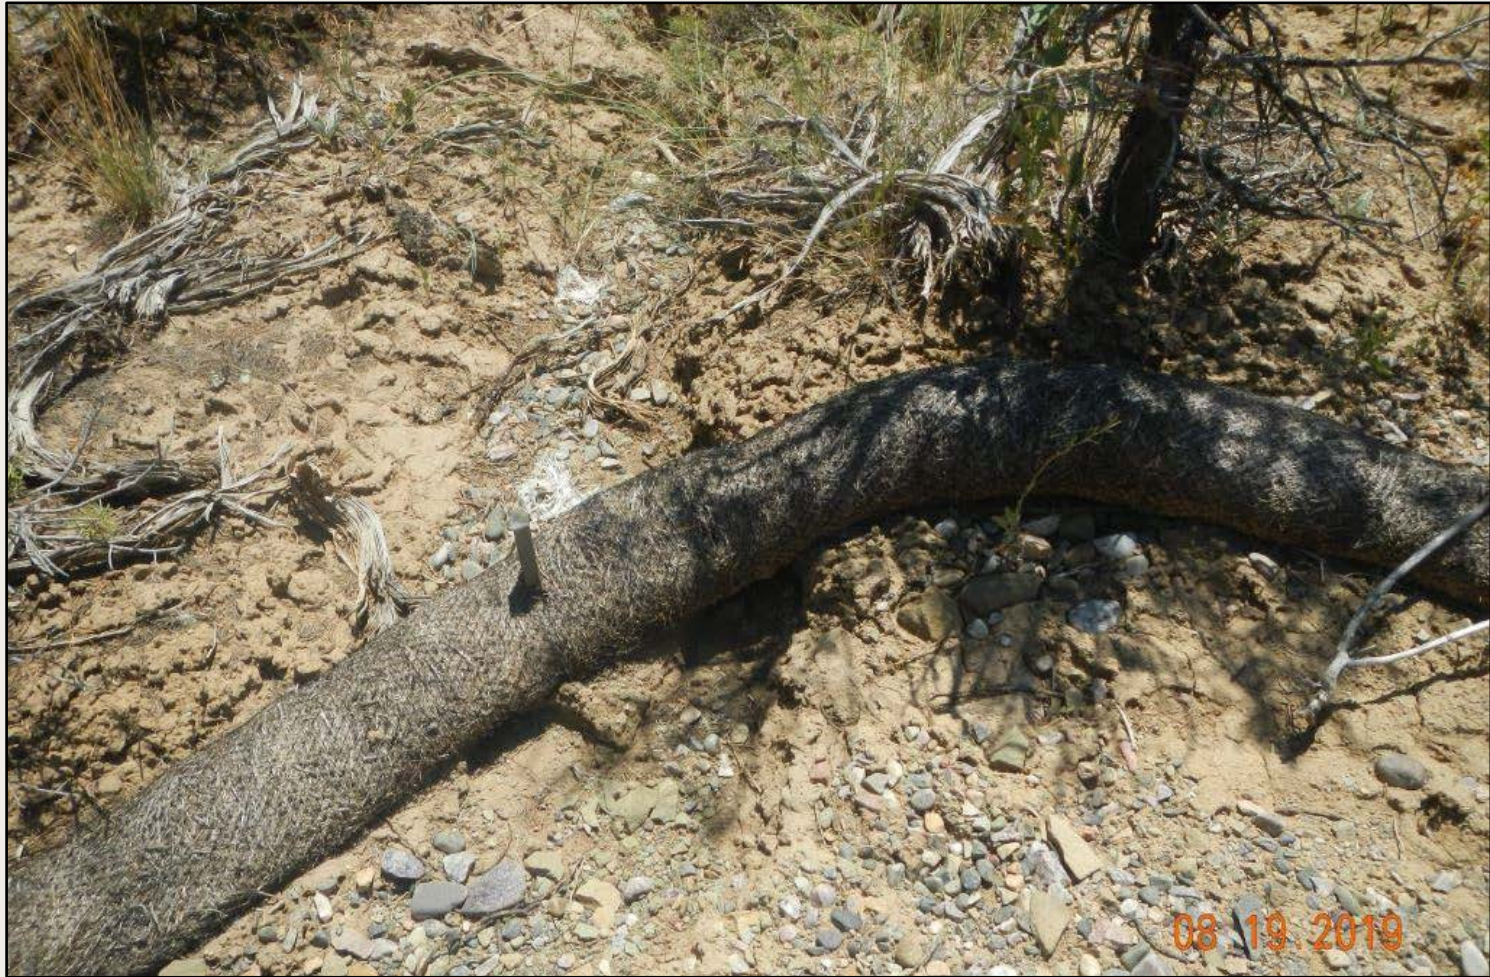
Photo 3. View of wattle in the southern project area that is no longer functioning. This is not an appropriate BMP for this area.

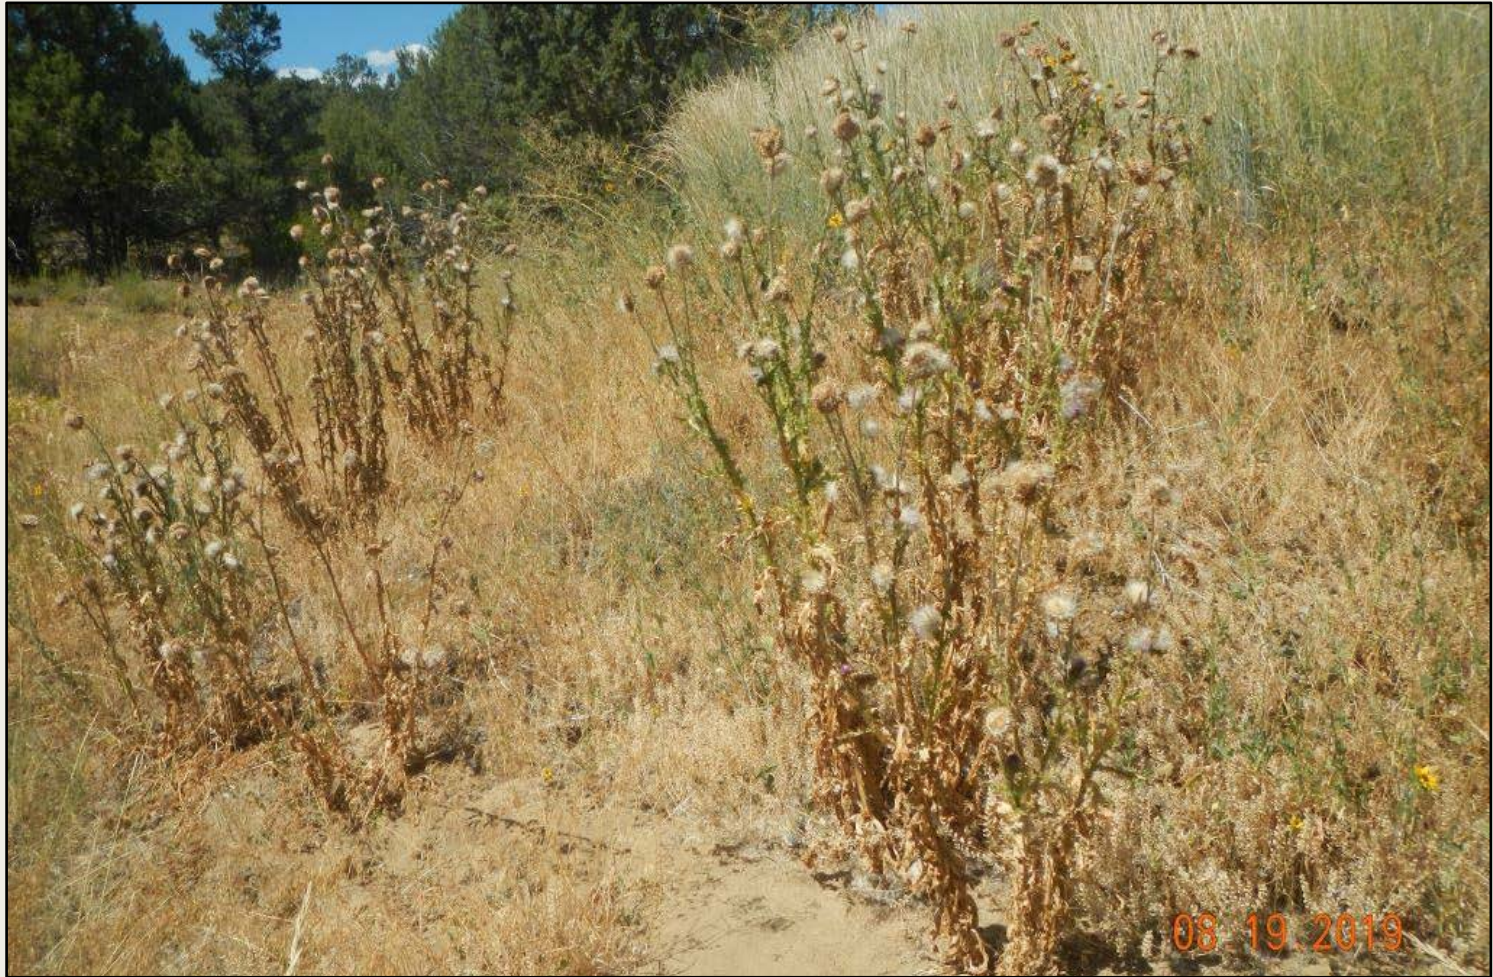
Photo 4. View of musk thistles within the southwestern project area.

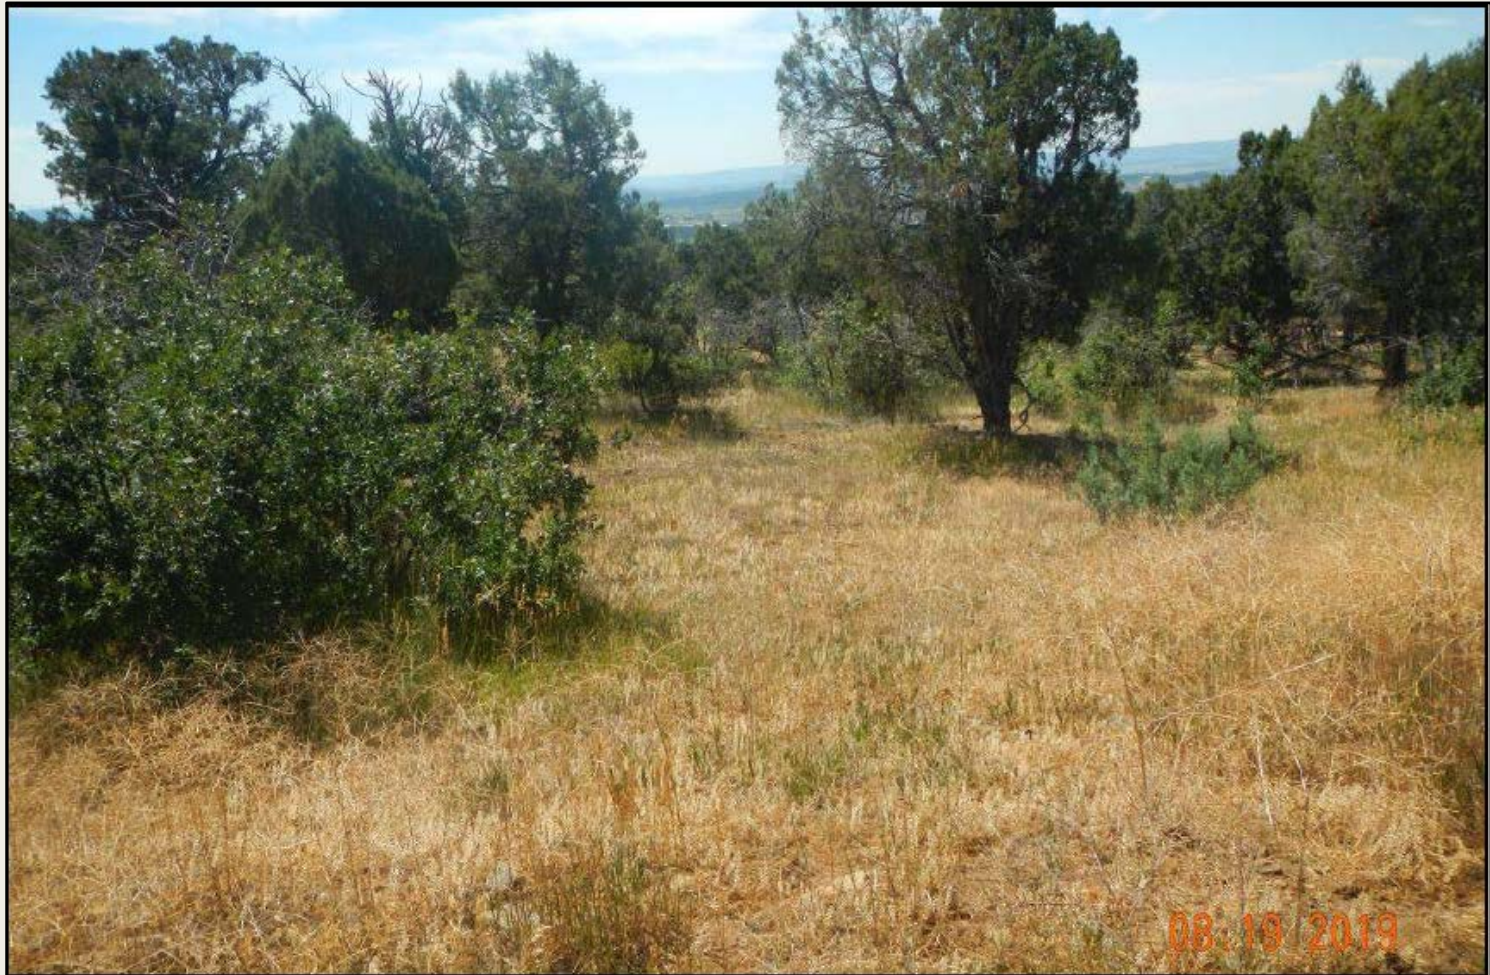
Photo 5. View of reference area vegetation facing southward.
