MARALEX RESOURCES, INC.– 53255
API# 05-045-06376 ALBERTSON #15-1
Inspection Date : 8/20/2019

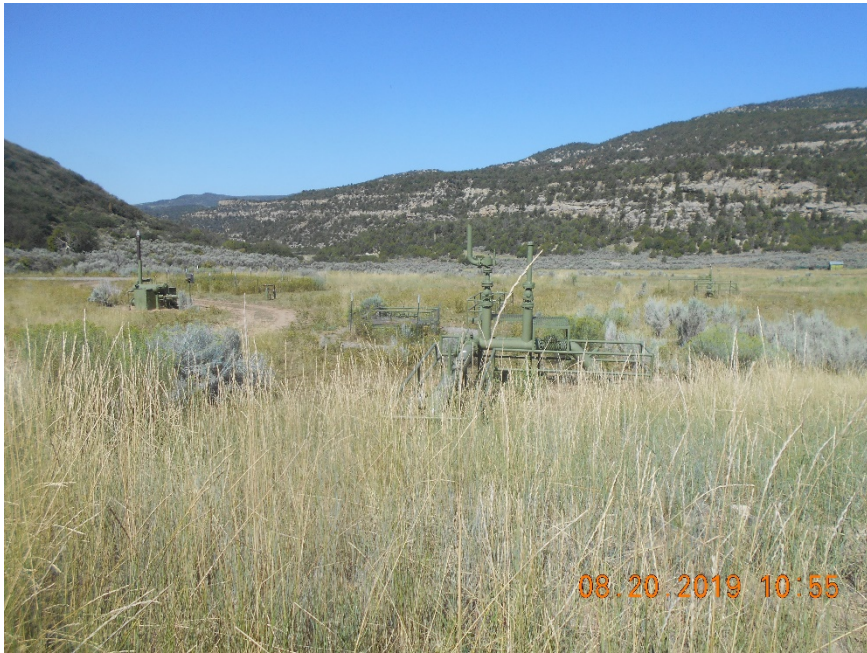
Location overview looking W.

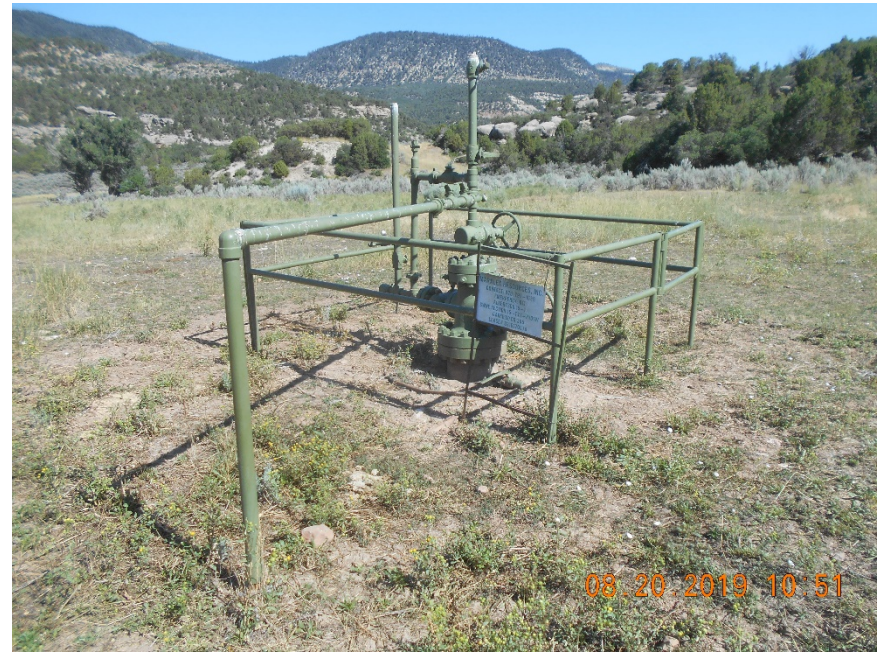
Wellhead with fence and sign

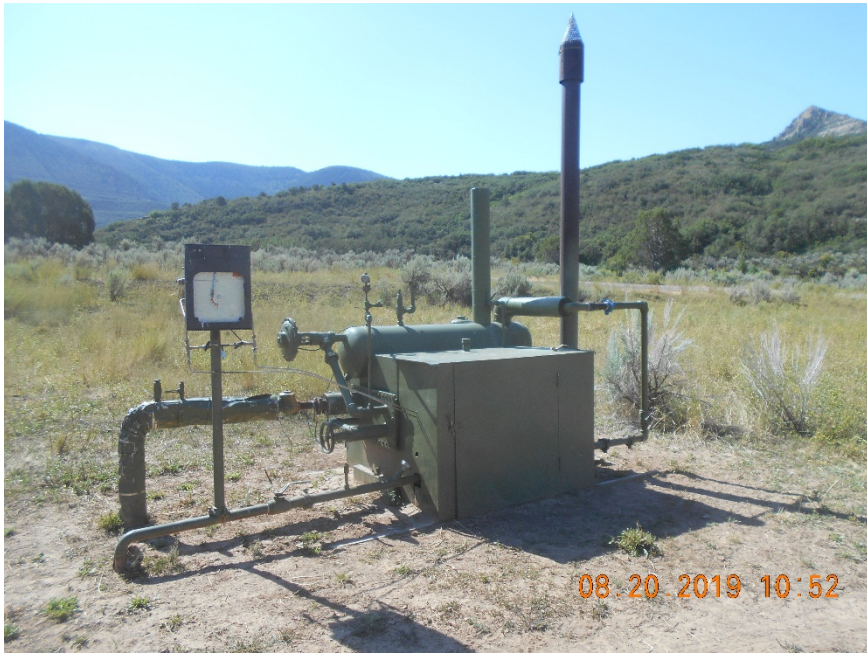
Separator and meter

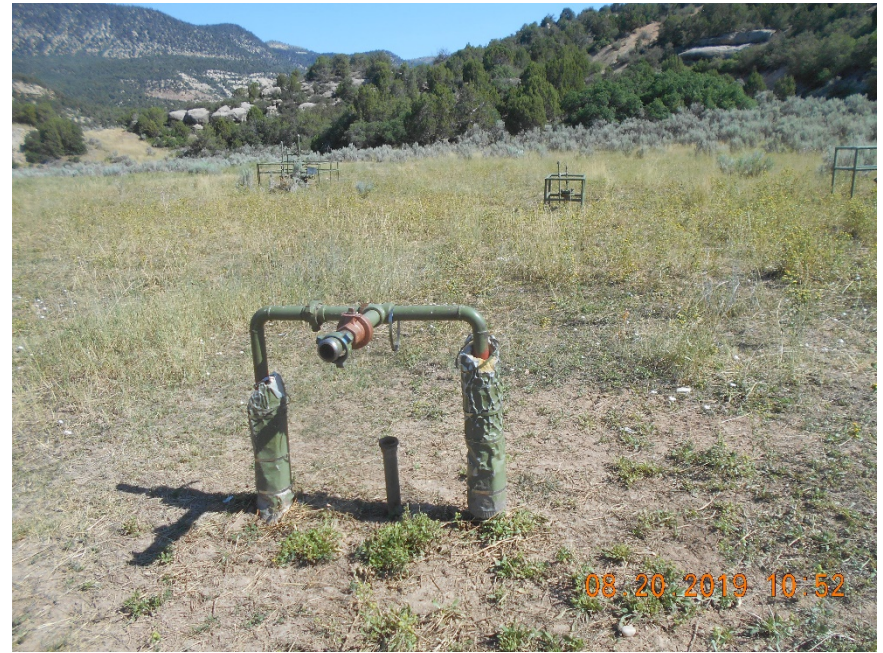
Flowline riser disconnected.
Disconnected flowline risers not LOTO.

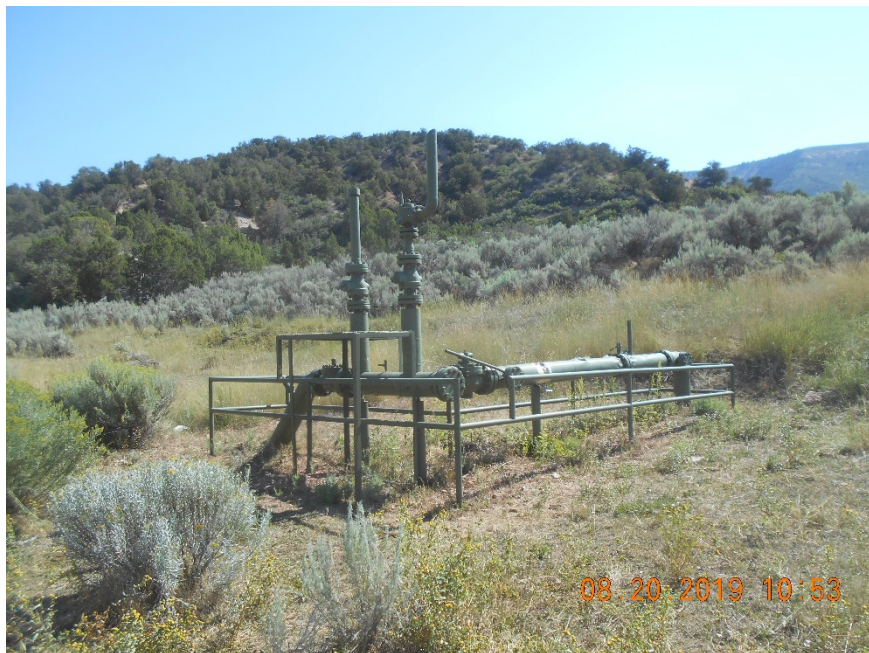
Flowline riser with fence

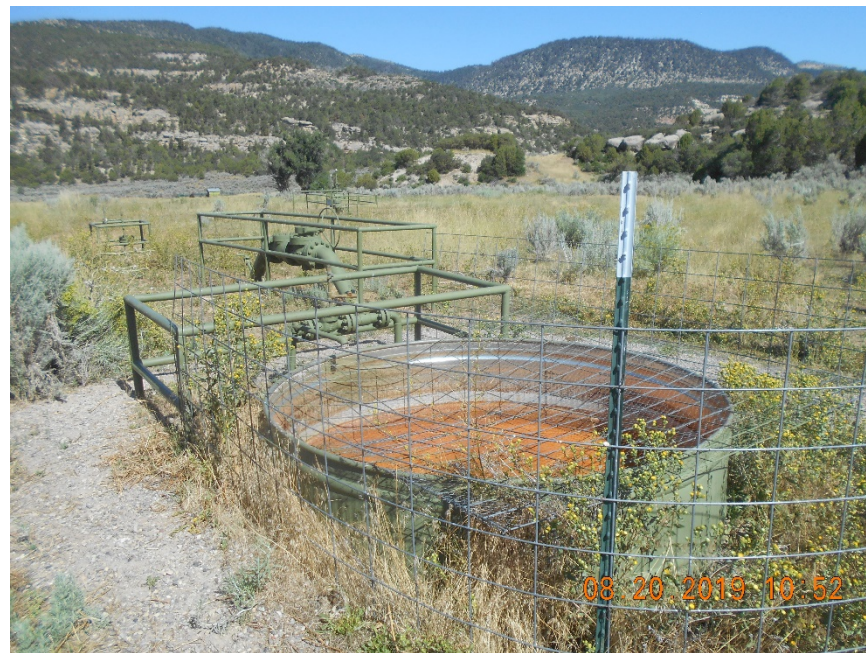
**Blowdown tank with fence and netting.
Flowline risers with pipe fencing in background.**

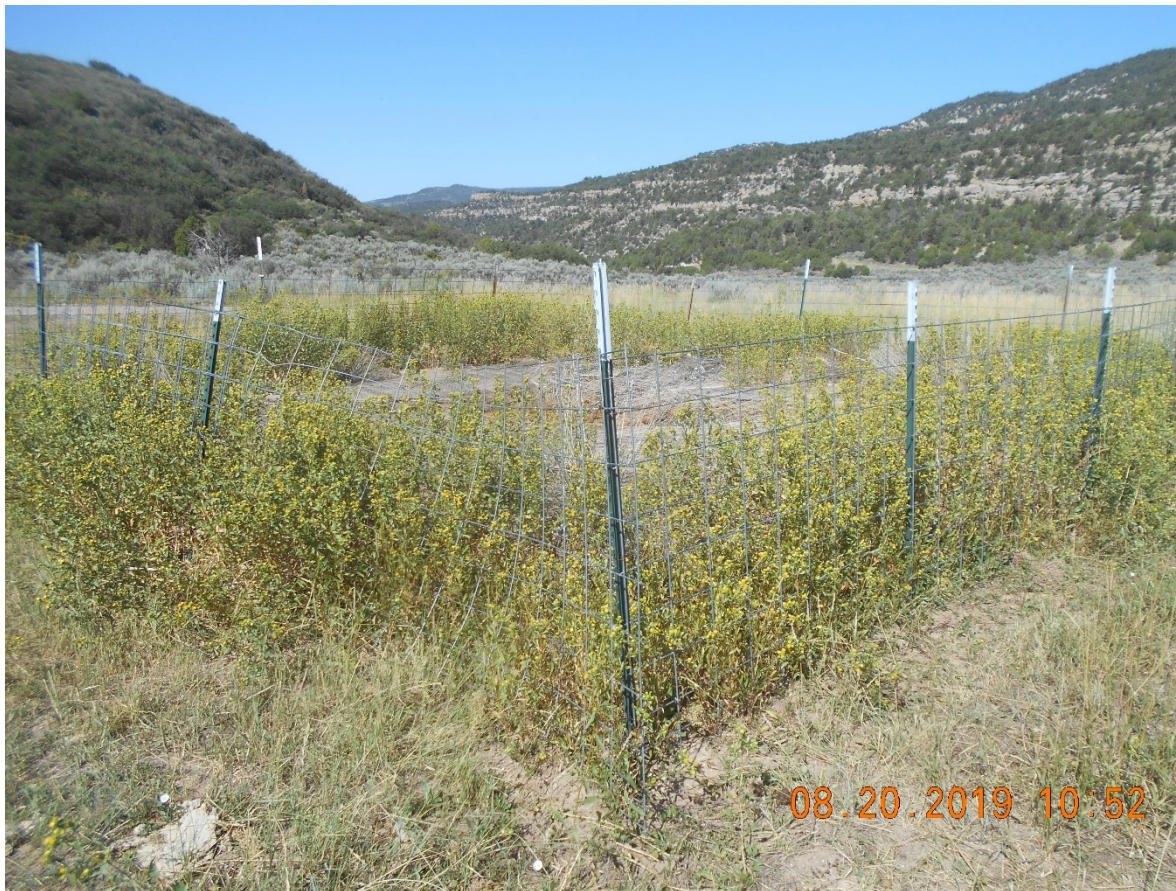
Blowdown pit with fence and netting.
No weed control inside fence. Holes in netting.
