Inspection Photos
Operator: BP America
Location/API #: 067-08898
Date: 8-21-2019

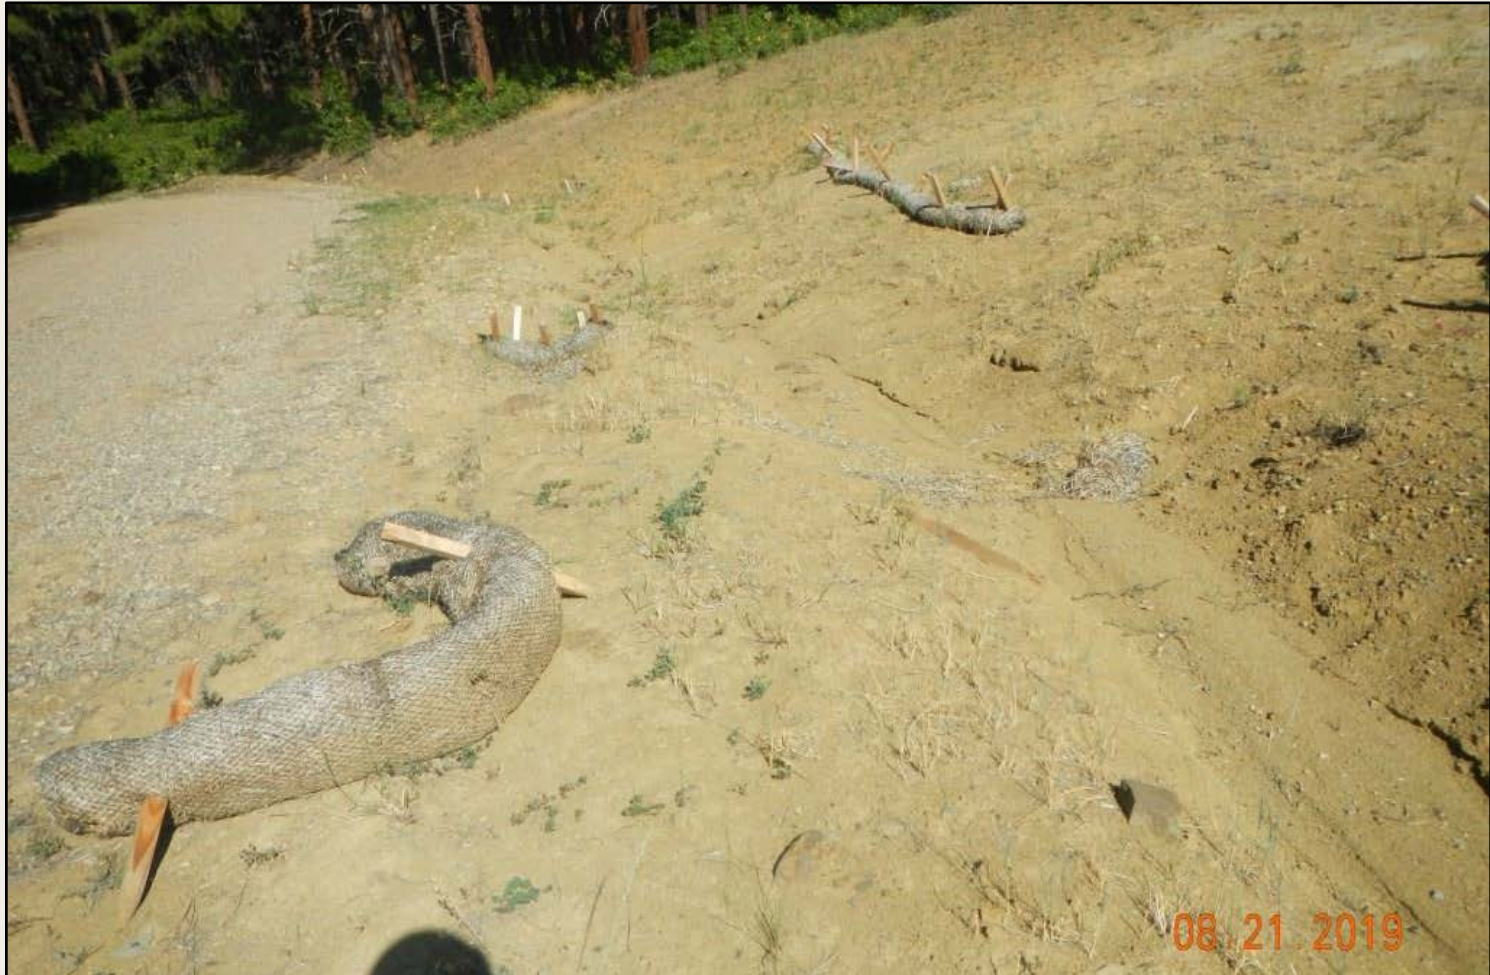
Photo 1. View of wattles out of place, full of sediment, and erosion occurring at the well pad entrance.

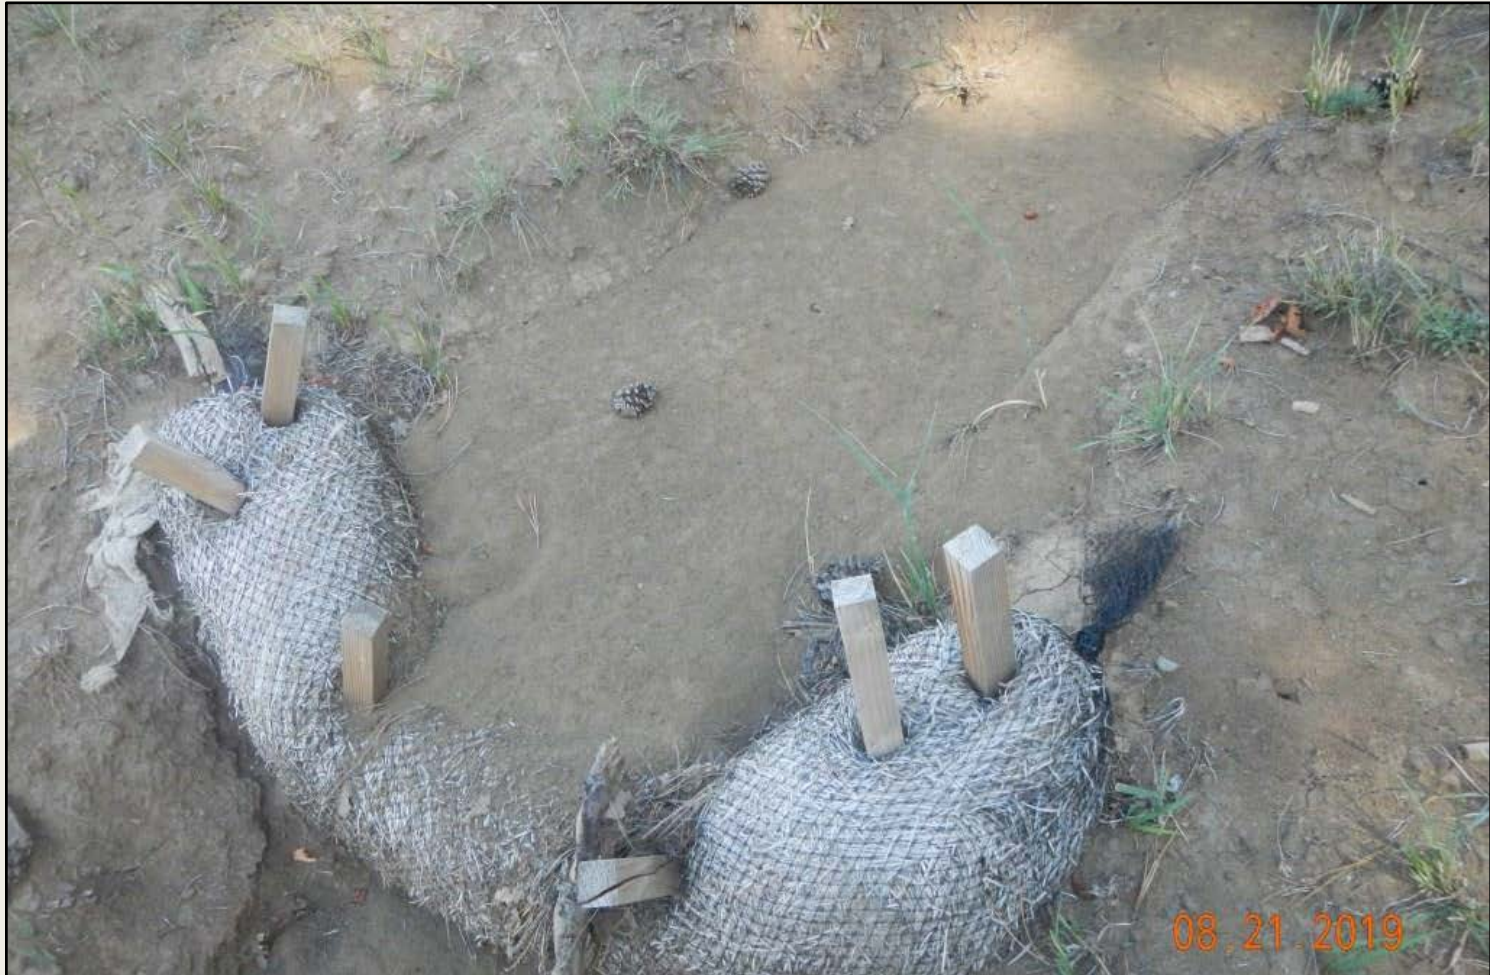
Photo 2. View of failed wattle, sedimentation, and erosion within the southeastern project area.

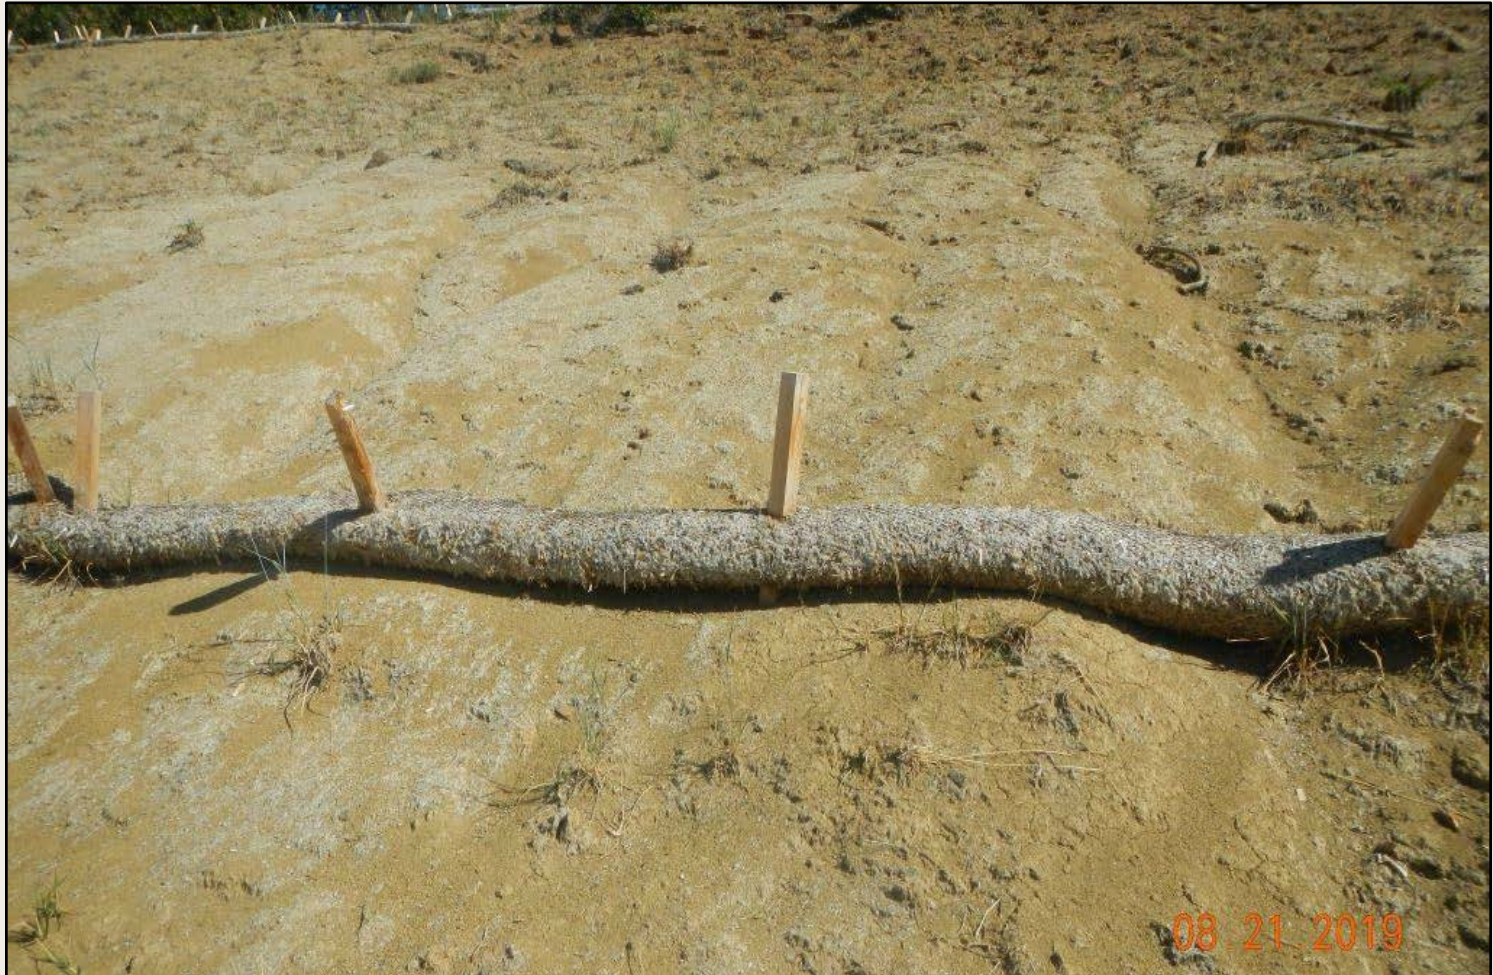
Photo 3. View of hydromulch, sparse revegetation, and wattle on well pad cut-slope.

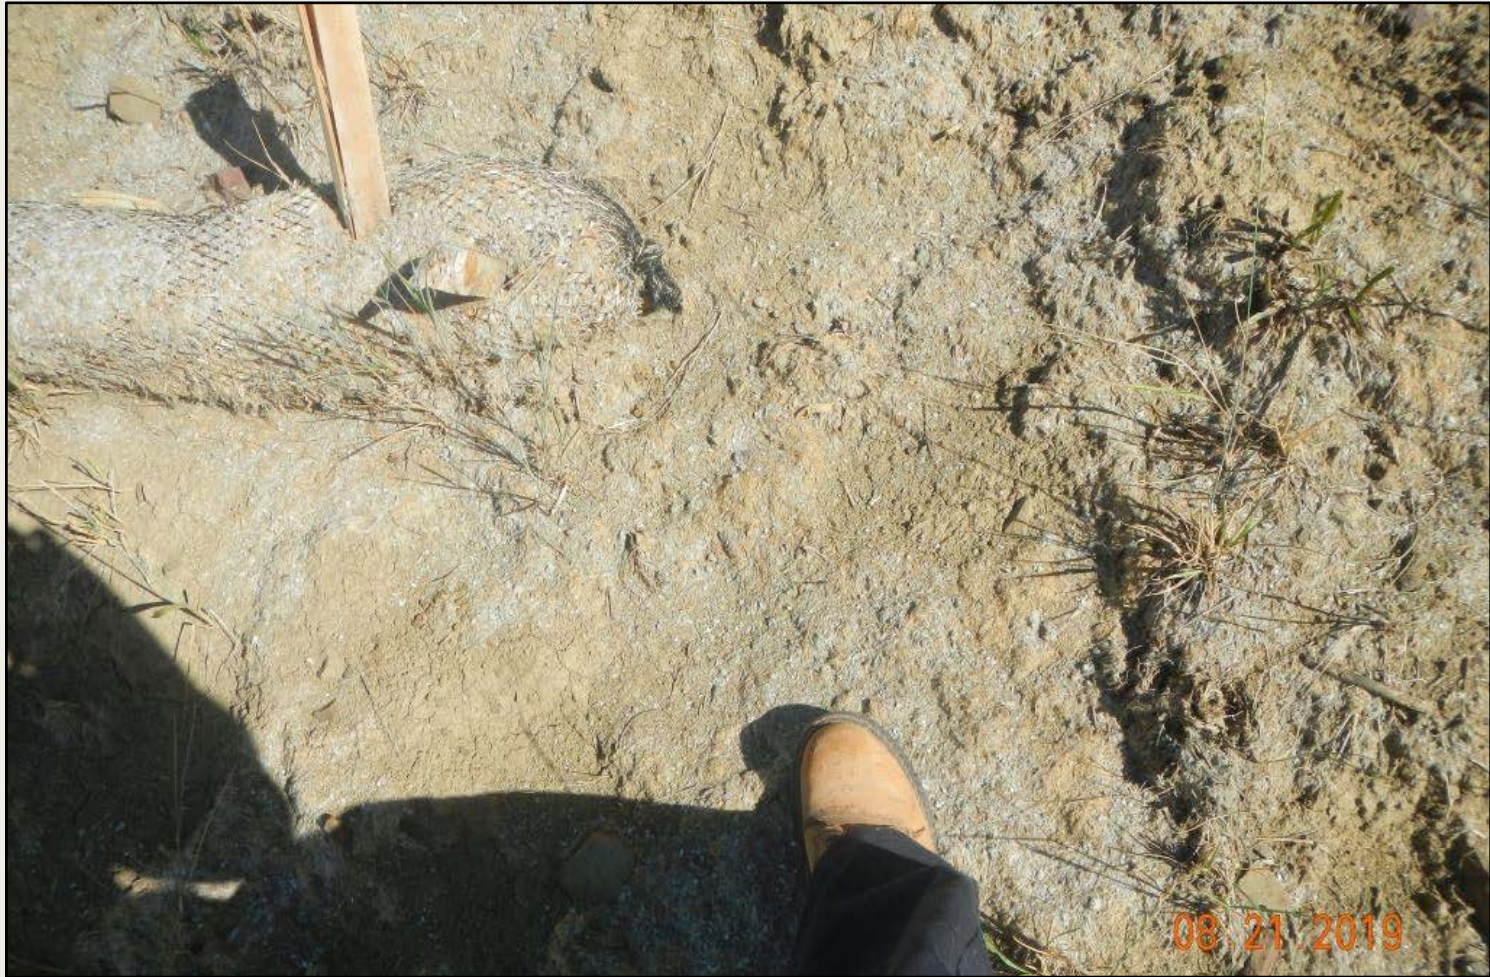
Photo 4. Birdseye view of revegetation on the well pad cut-slope, which remains sparse and grazed. Livestock exclusion appears needed.

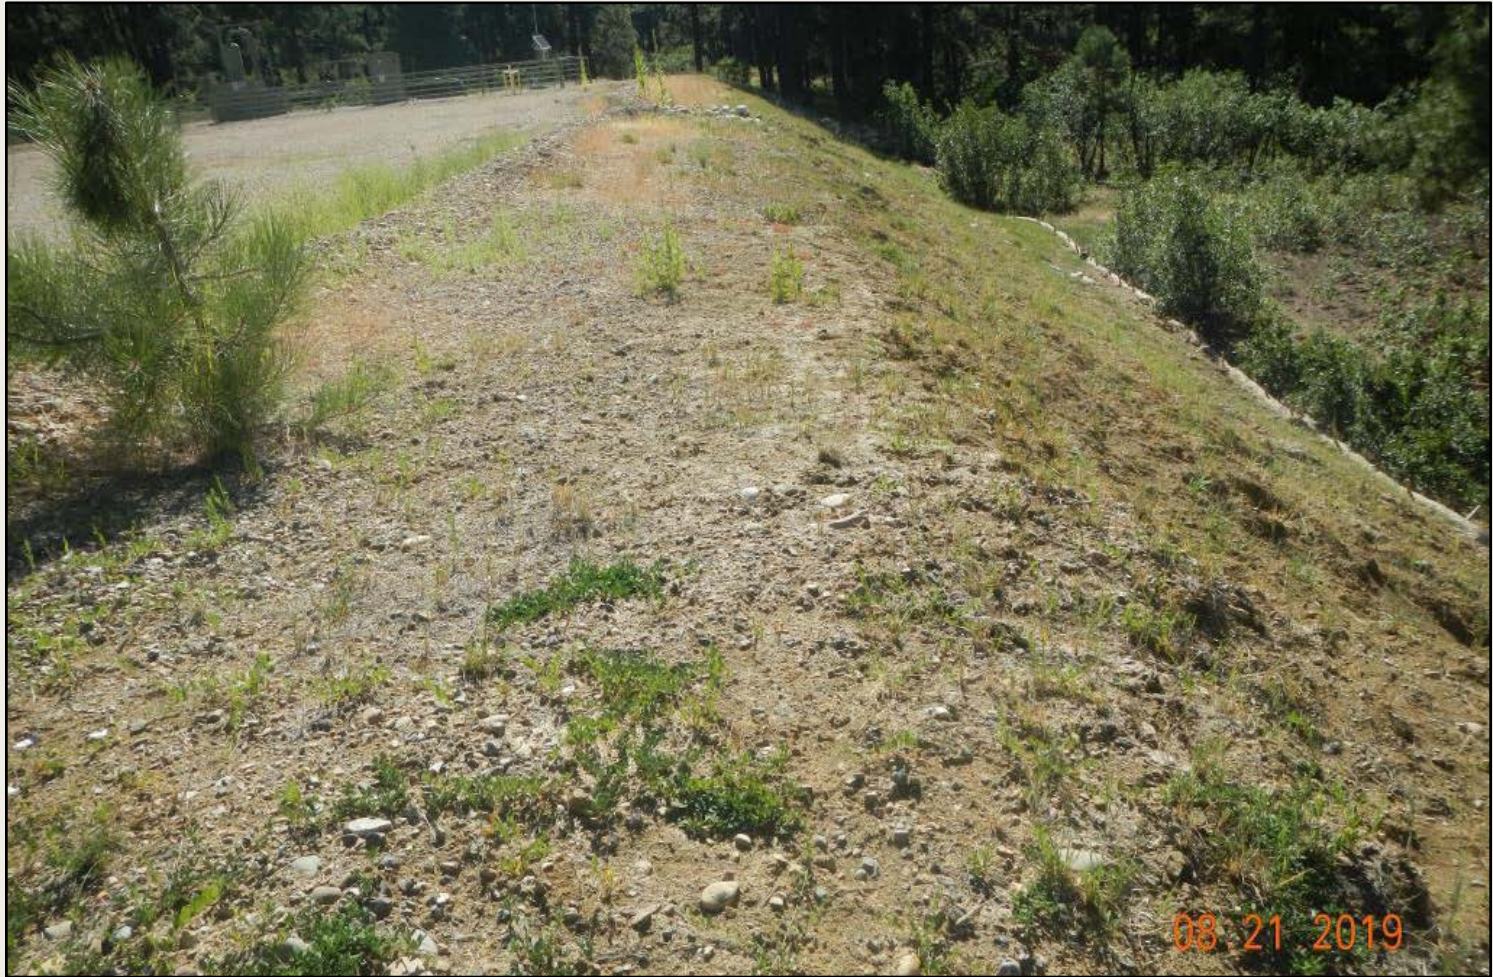
Photo 5. View of the western fill slope from the northwestern edge facing southward. Well pad berm is in place.

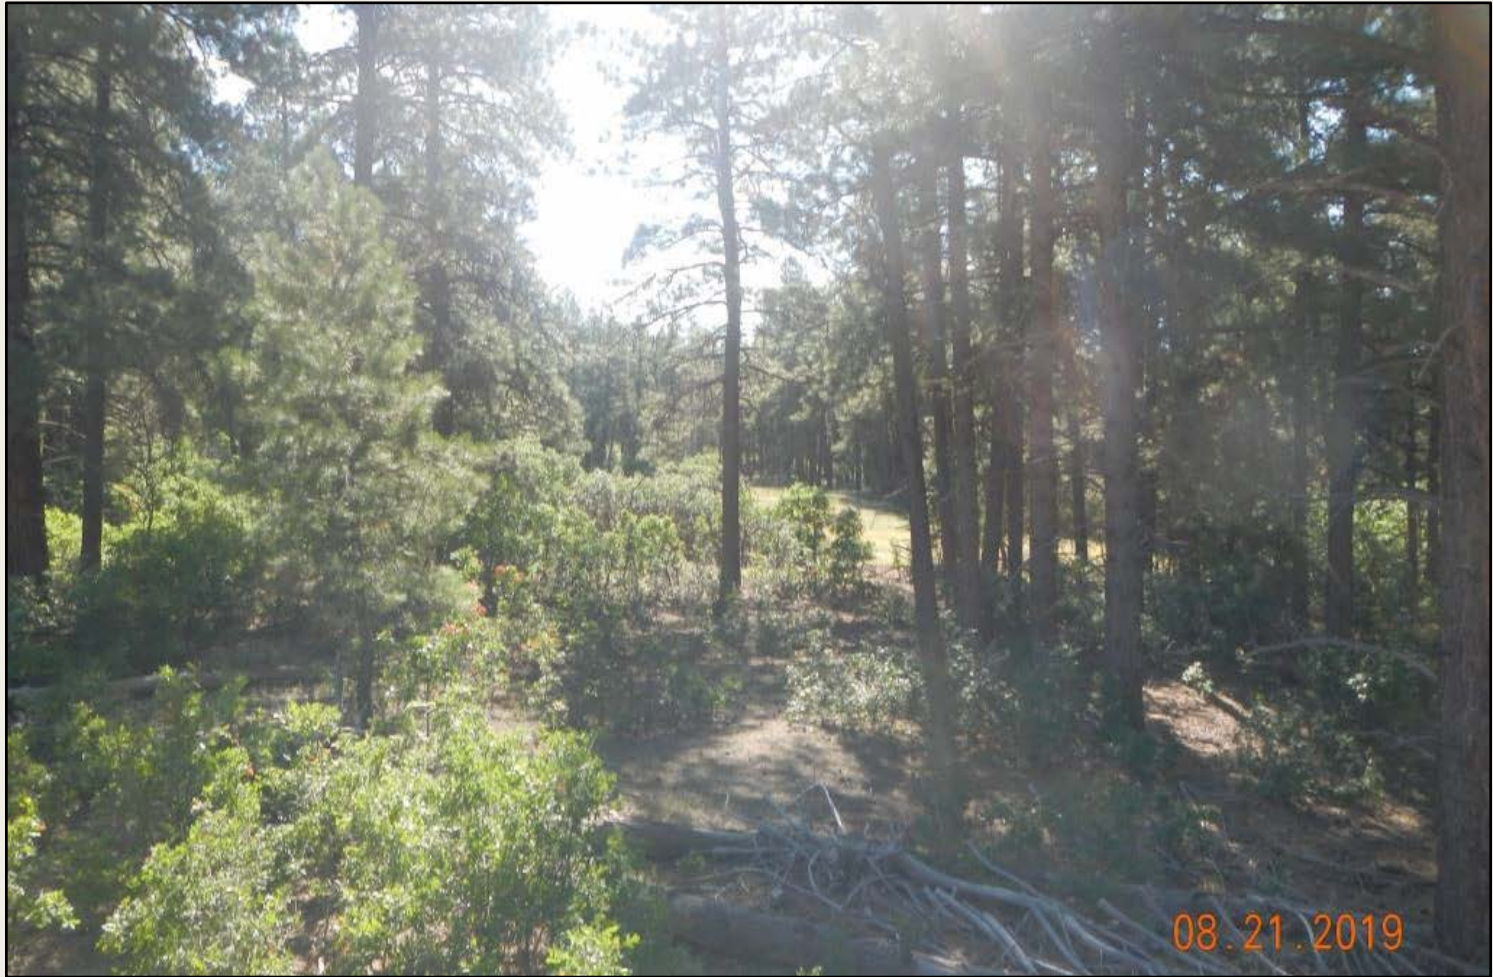
Photo 6 View of reference area vegetation facing southward.
