Inspection Photos
Location Name: Carl A Miller A #2
Location ID: 317739

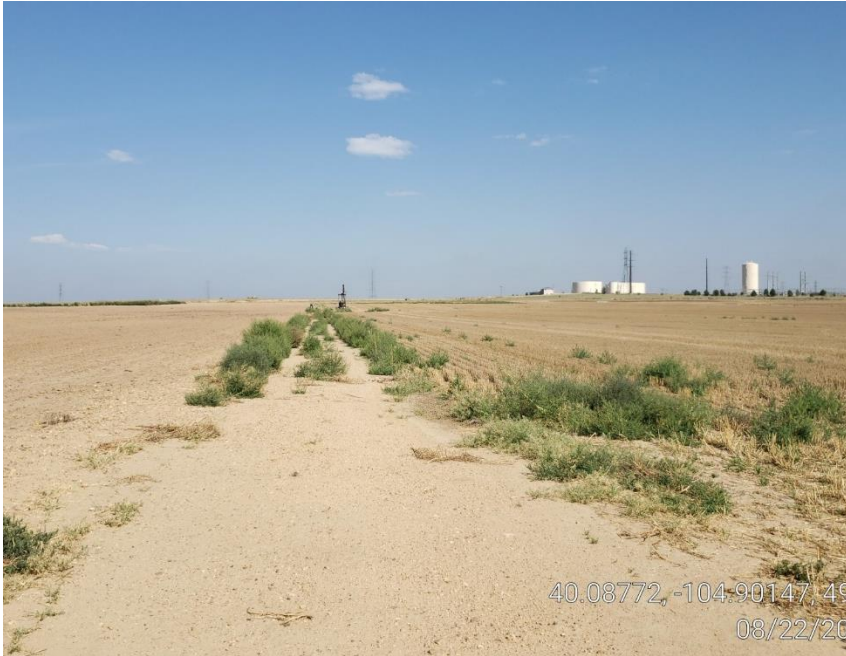
Photo #1 Weeds growing on lease access road.

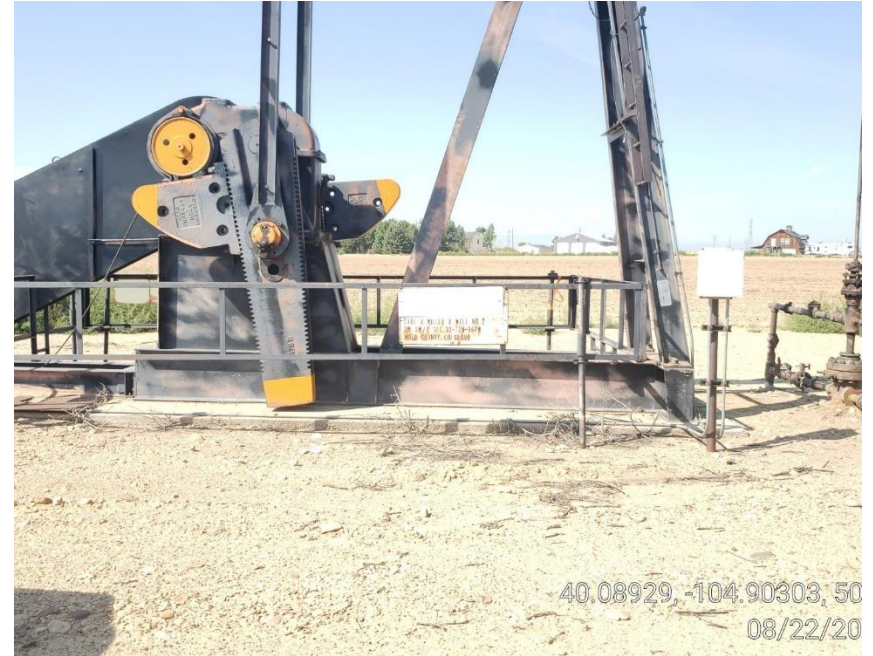
Photo #2 Wellhead sign beginning to fade

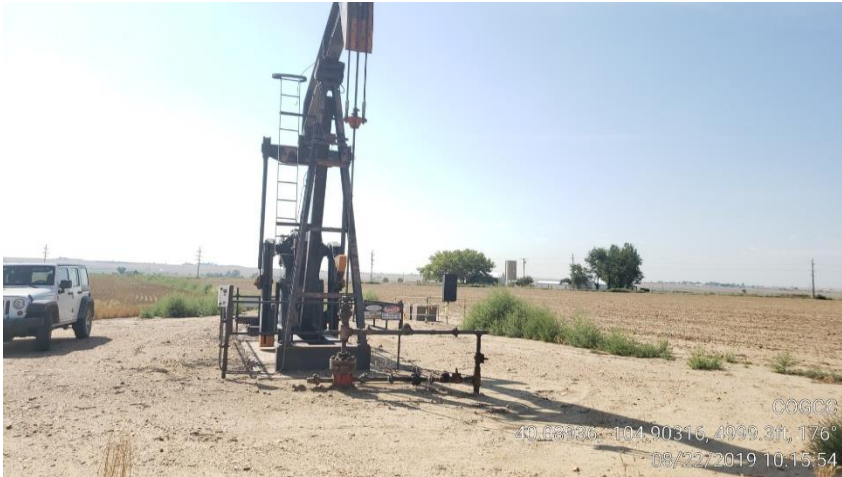
Photo # 3 Wellhead/Pump jack Weeds growing around wellsite ROW.

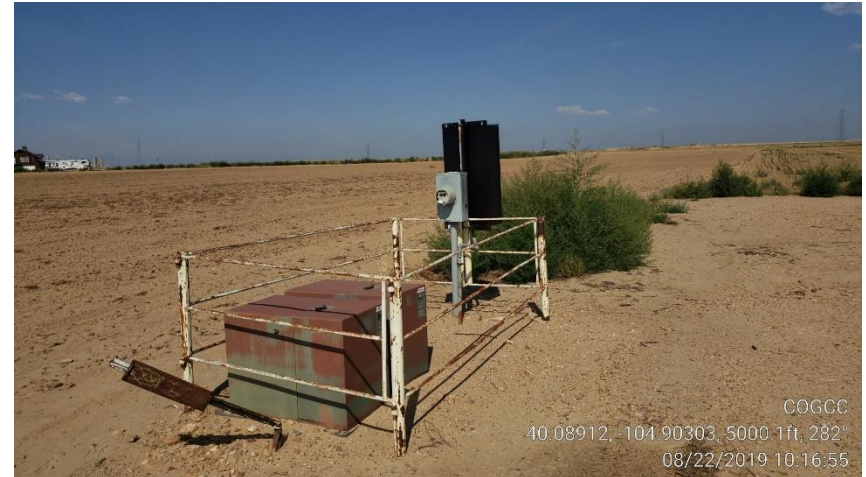
Photo #4 Weeds growing behind Electric control pane and transformer.

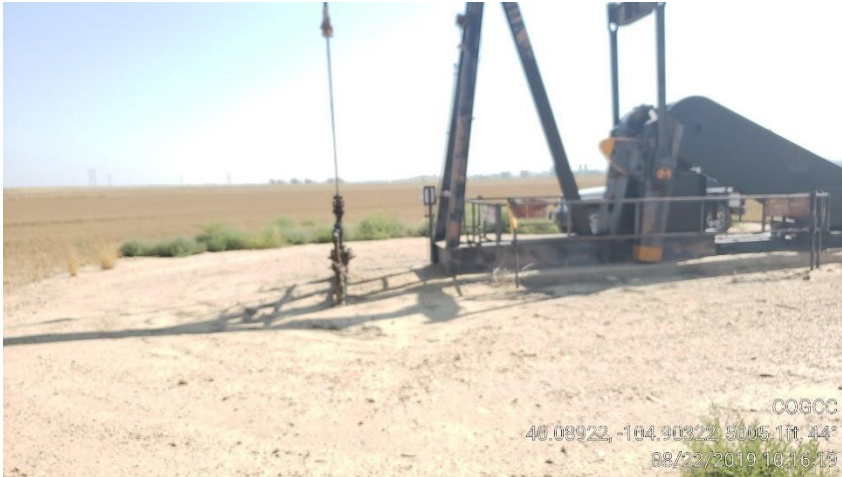
Photo # 5 Weeds growing around wellsite ROW wellsite ROW.
