McLaughlin 67  
API: 05-103-40196  
Inspection: 679705178

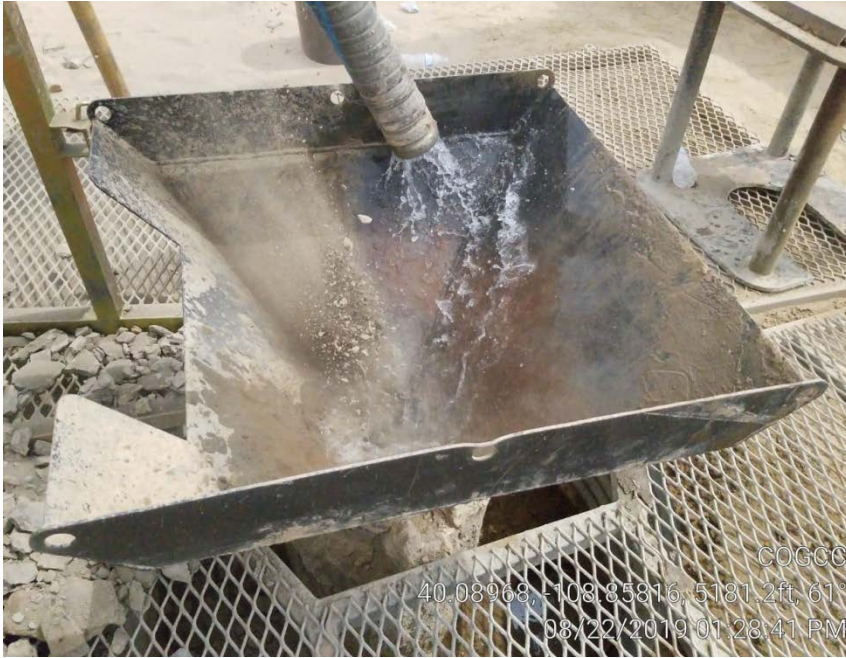
Photo 1. Shale rock loading of bore hole.

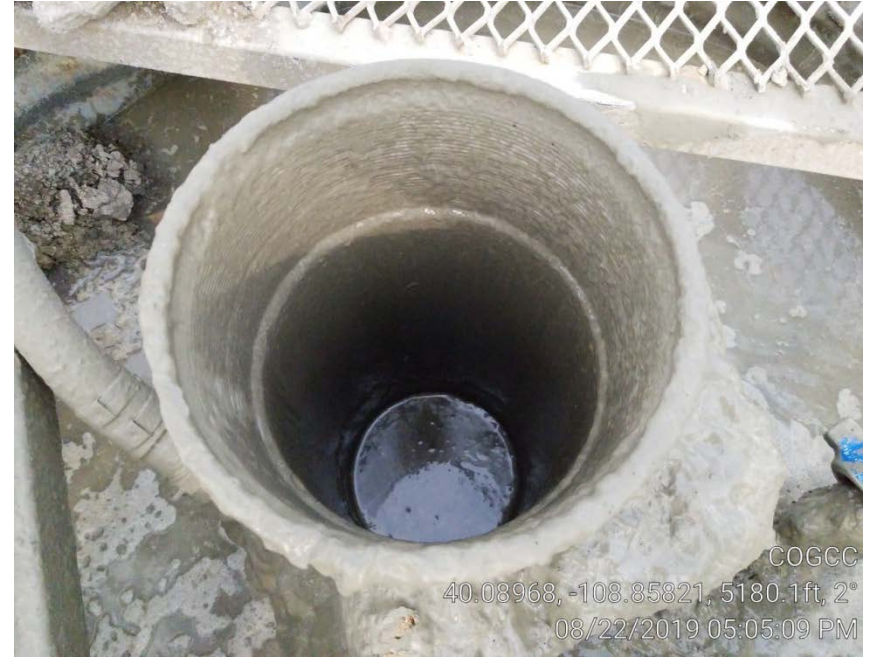
Photo 2. Top of cement.
