Inspection Photos
Location Name: LILLI UNIT-68N58W /9NESE
Location #: 327156

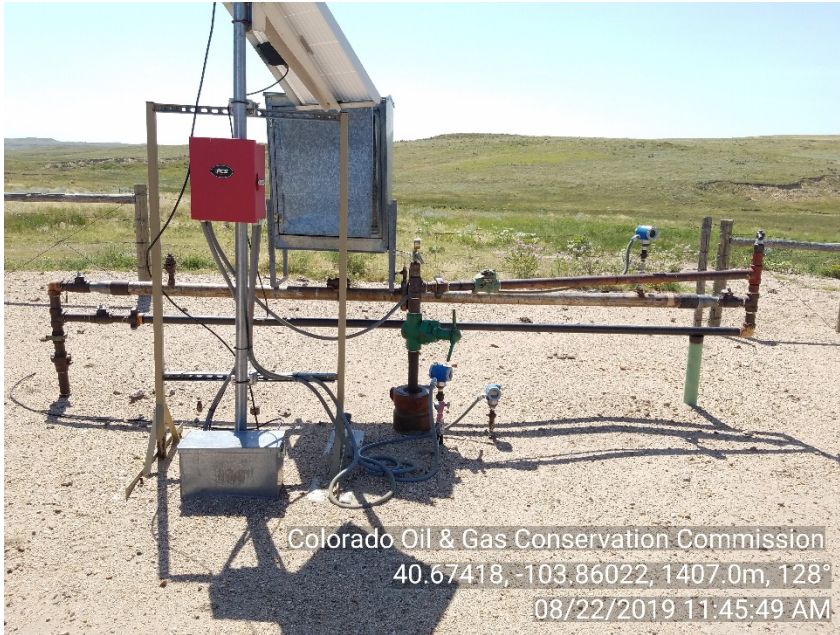
Photo #1
Lilli Unit 9-9 (05-123-14237) UIC - Injection Wellsite
UIC Annual Inspection
Not Injecting – Gas / Injection line: Shut
Shut-In | SI

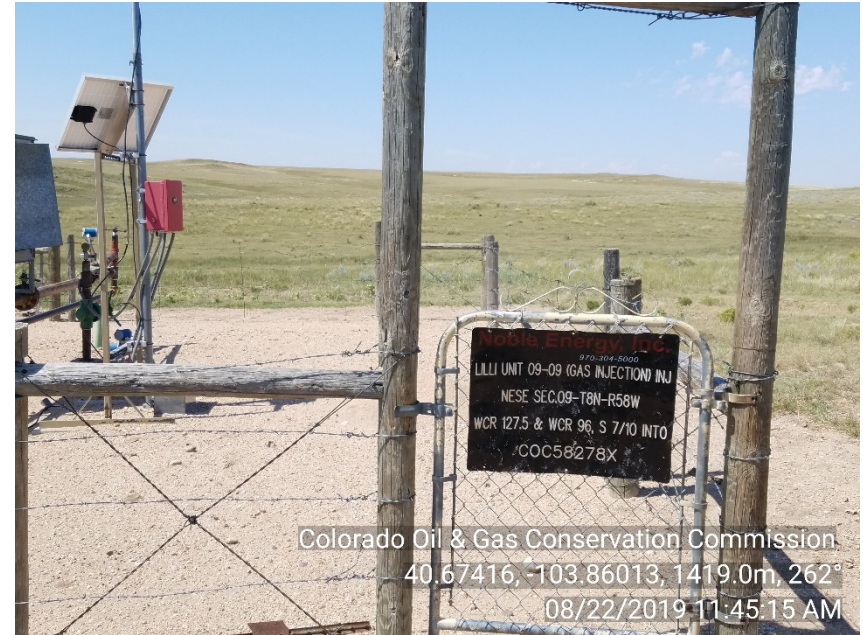
Photo #2
Lilli Unit 9-9 UIC - Injection Wellsite
Well sign

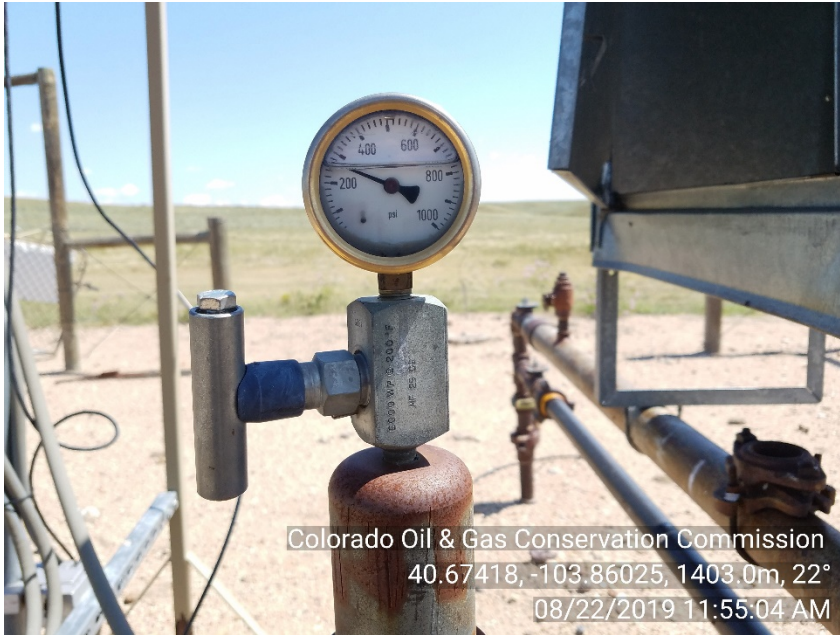
Photo #3
Lilli Unit 9-9 UIC - Injection Wellsite
Shut-In | SI
Tbg. Press: 260#

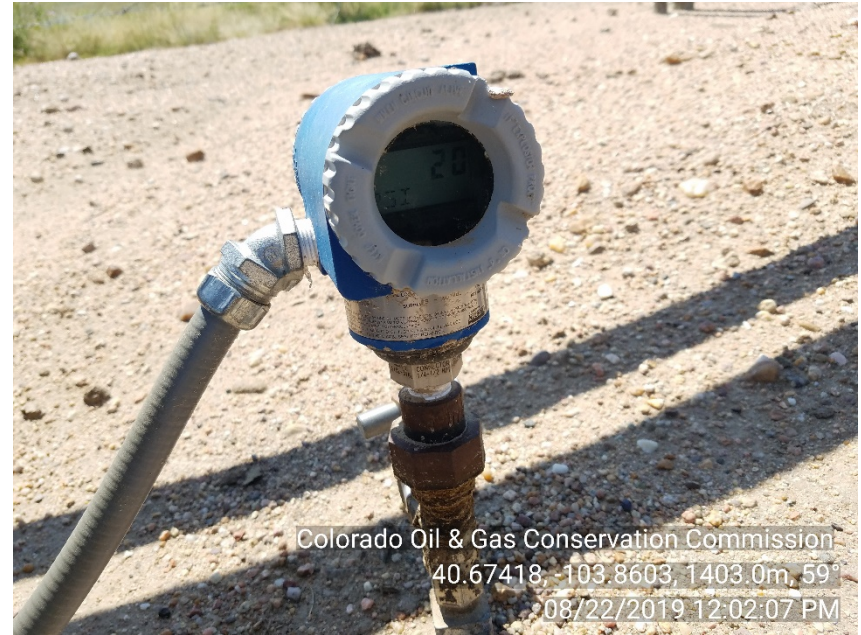
Photo #4
Lilli Unit 9-9 UIC - Injection Wellsite
Shut-In | SI
Csg. Press: 20#

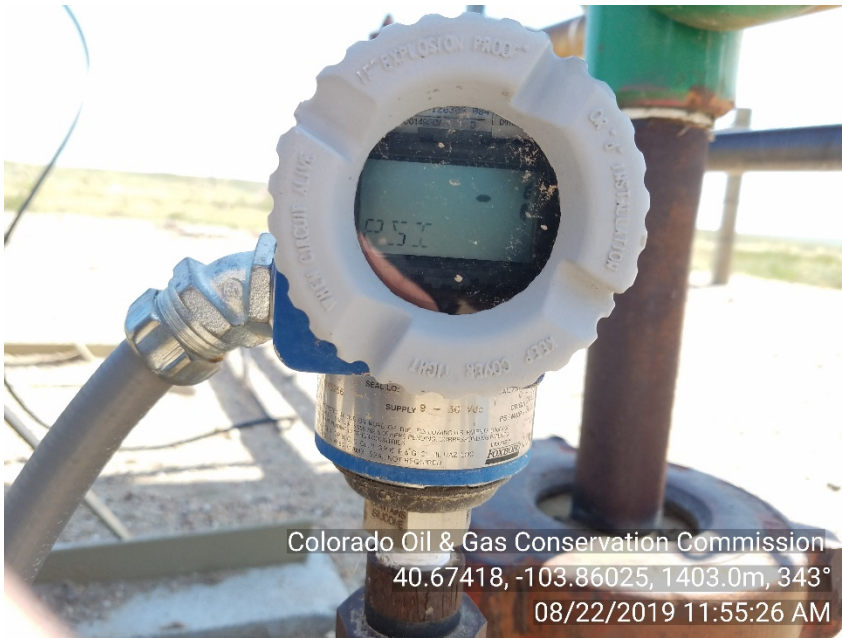
Photo #5

Shut-In | SI

Bradenhead Press: (-1#)

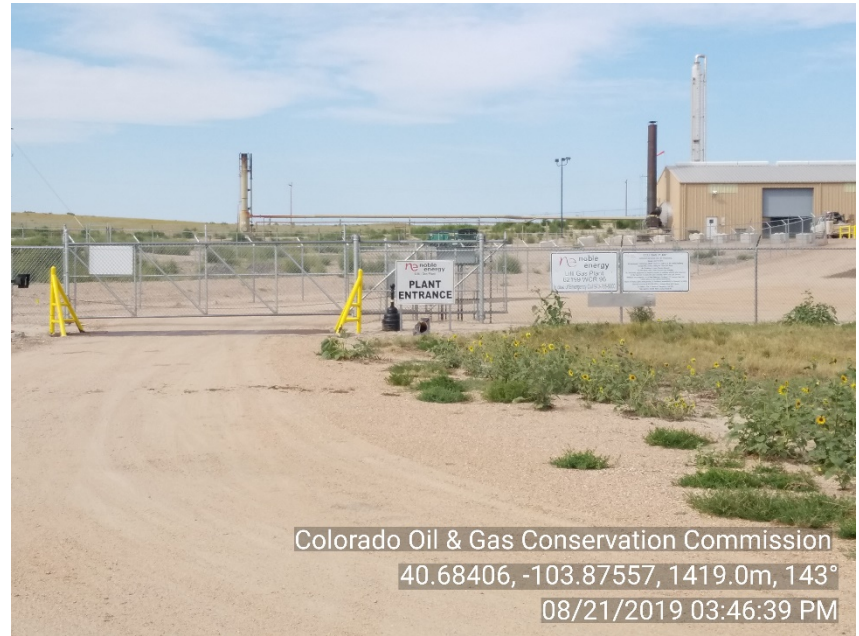
Photo #6

Facility Sign | Entrance

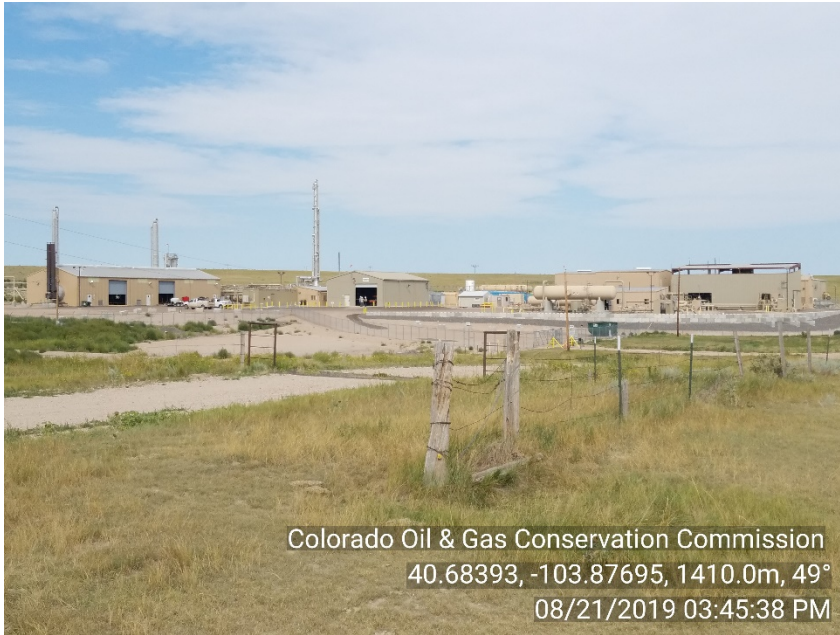
Photo #7

Facility view

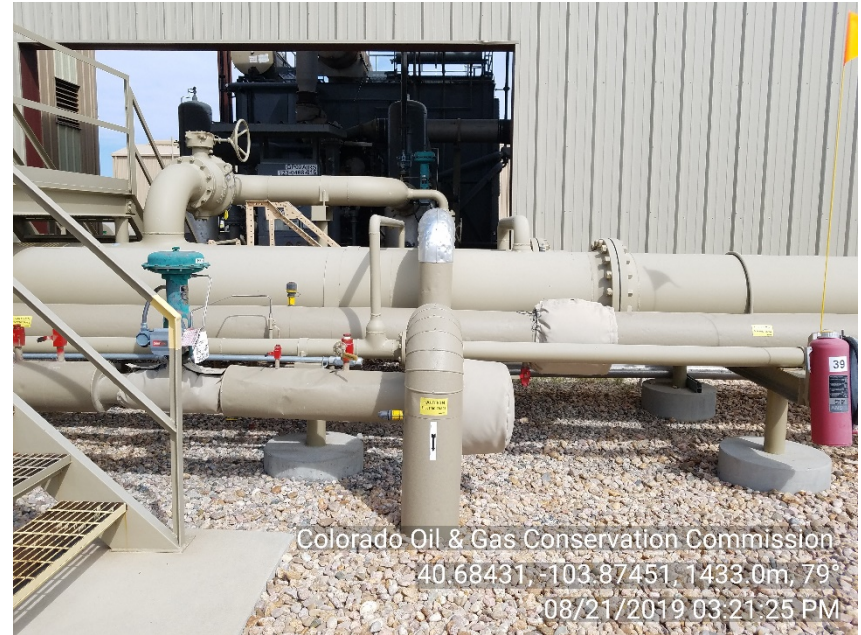
Photo #8

Gas Injection Compressor | Discharge line

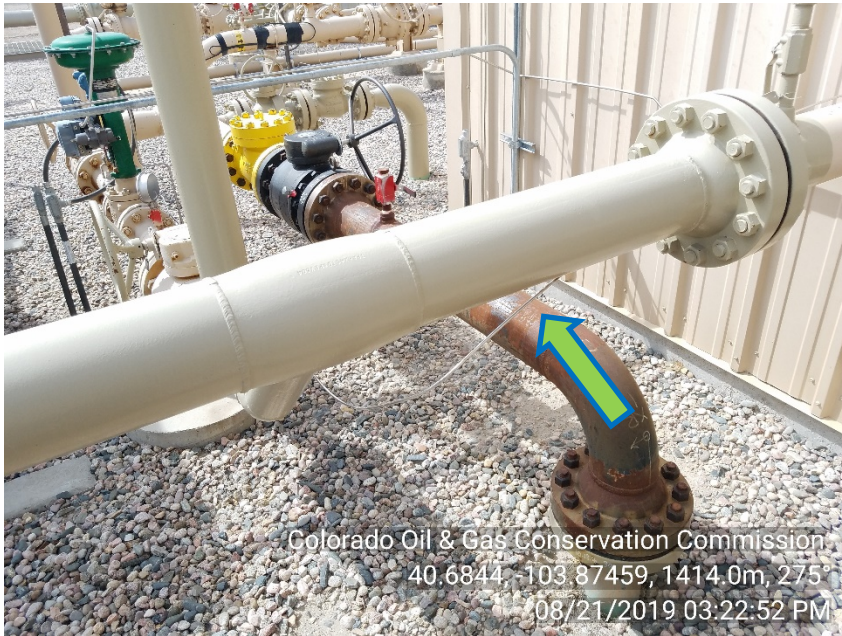
Photo #9

Gas Injection discharge line header

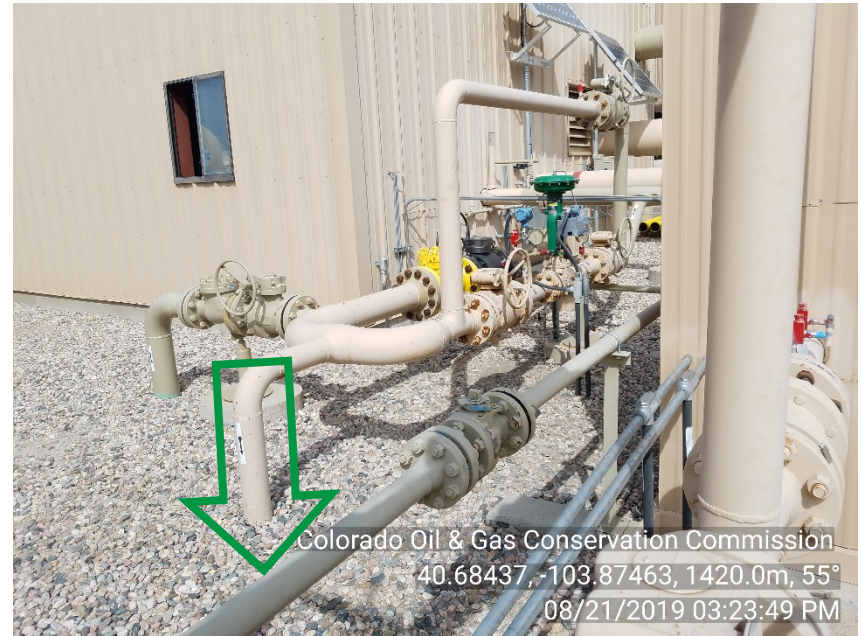
Photo #10

Gas Injection discharge line header

Final stage to UIC wells.
