# Interim Reclamation and Stormwater Inspection

August 21, 2019

Operator: KERR MCGEE OIL & GAS ONSHORE LP #47120

Location ID: 452820

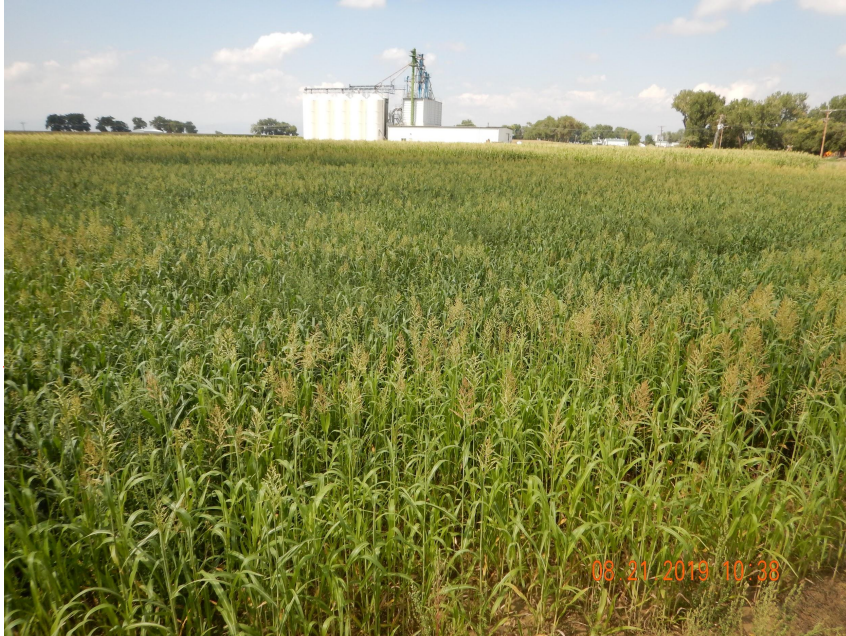
**Photo 1.** Photo taken from the well location, facing West. Photo illustrates the Operator has performed Interim Reclamation activities to reduce areas only needed for production operations.

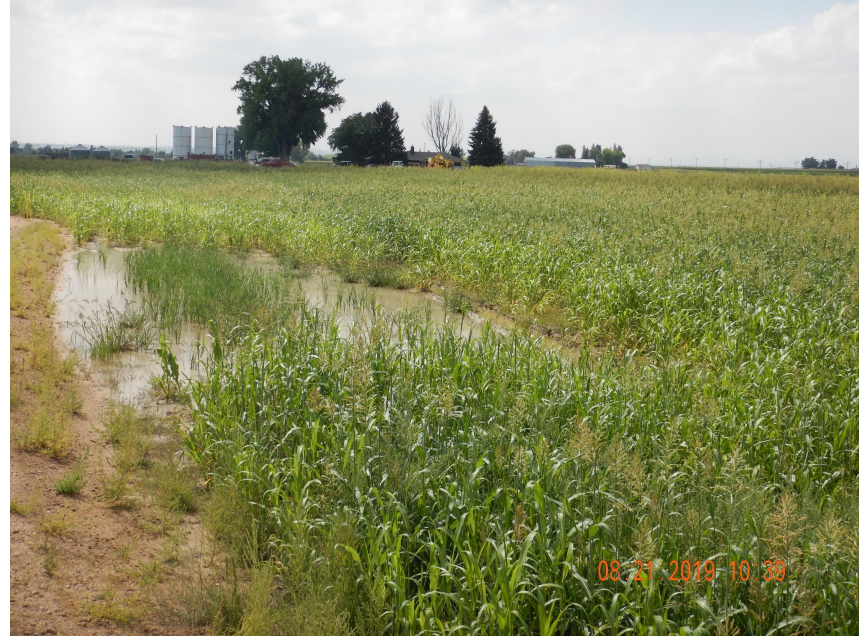
**Photo 2.** Photo taken from the well location, facing South. See comments under Photo 1.

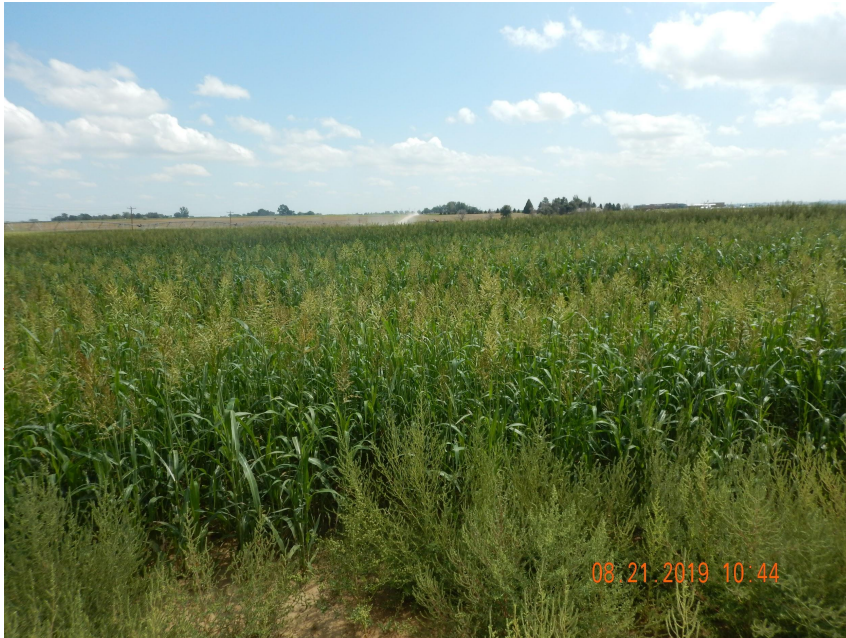
**Photo 3.** Photo taken from the well location, facing East.  
See comments under Photo 1.

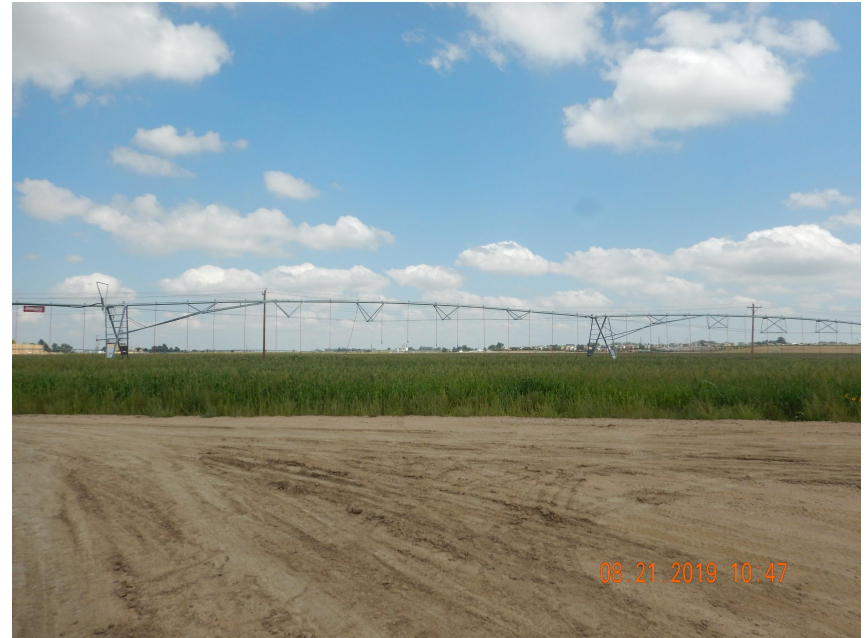
**Photo 4.** Photo taken from the well location, facing North.  
See comments under Photo 1.

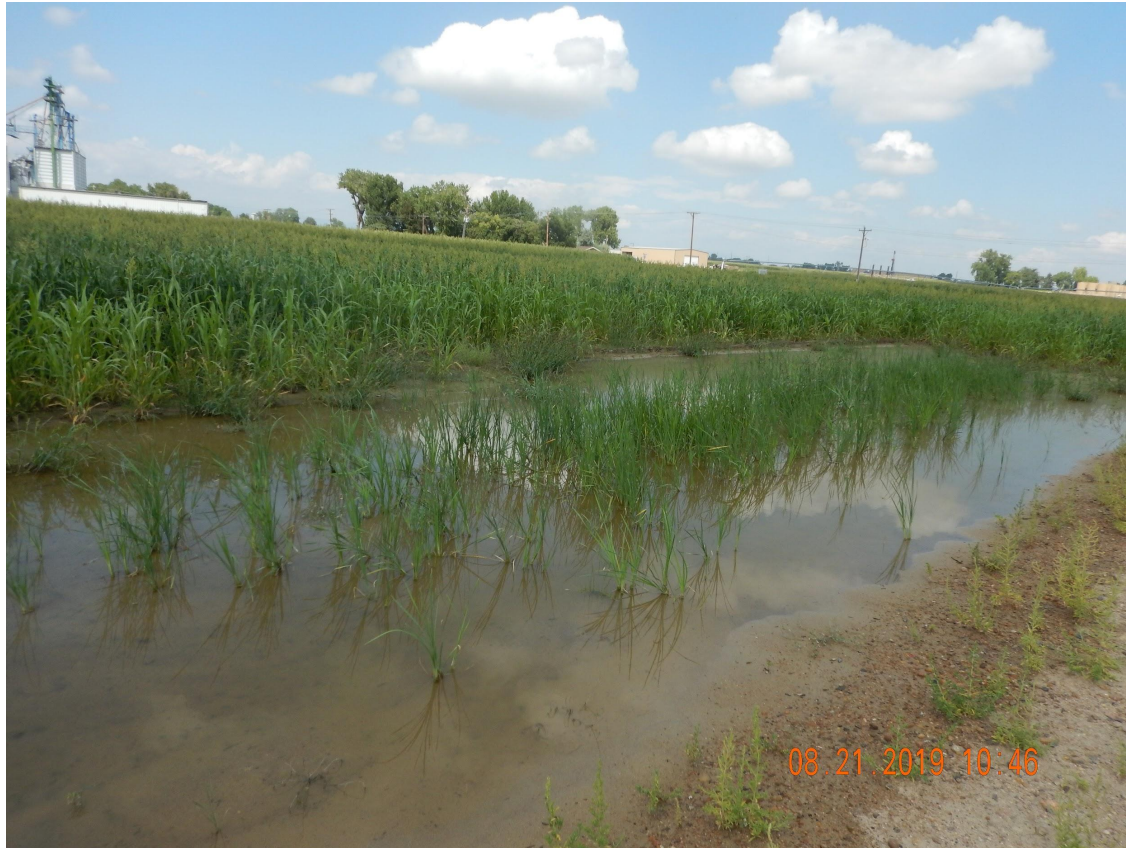
**Photo 5.** Photo taken from the well location, facing Northwest. Photo illustrates an area of pooled irrigation water. This pooling indicates Interim areas have not been properly contoured.

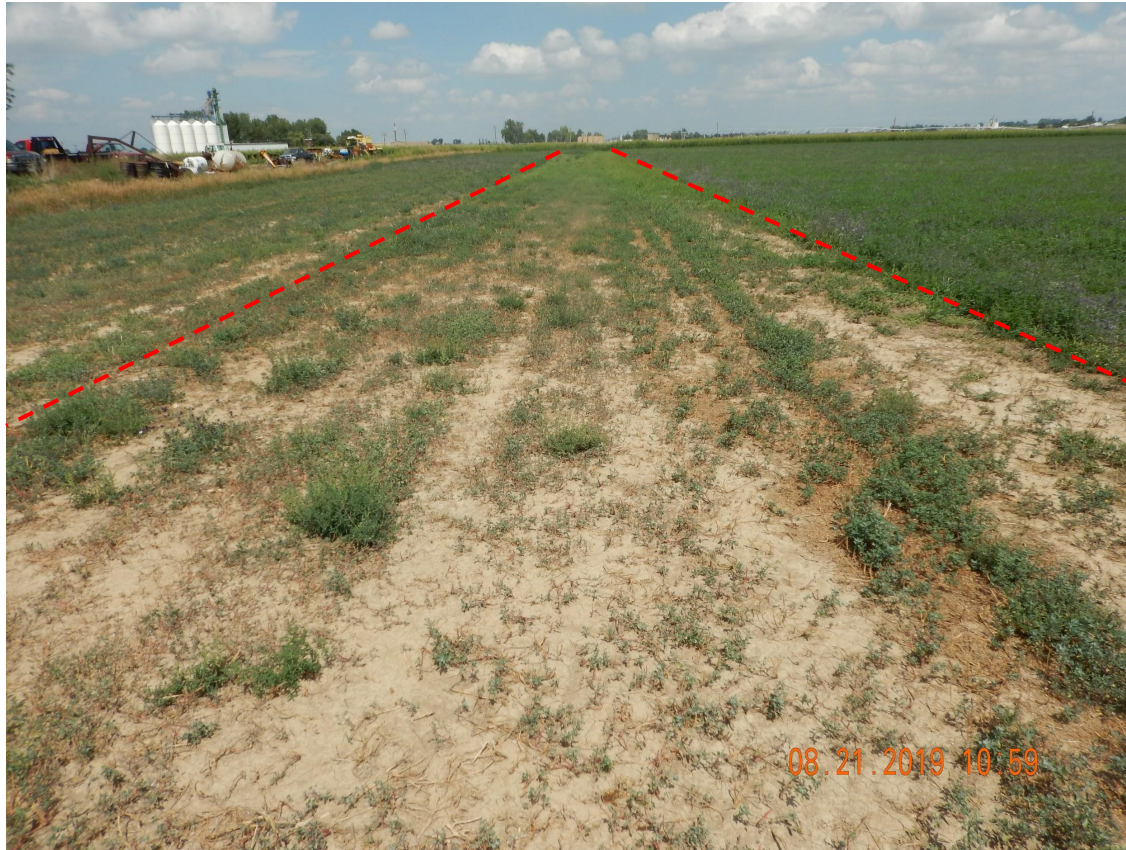
**Photo 6.** Photo taken from a section of the northern flowline, facing North. Photo illustrates an area of the flowline that has been planted with a grass mix. Alfalfa will be planted in the Spring of 2020.

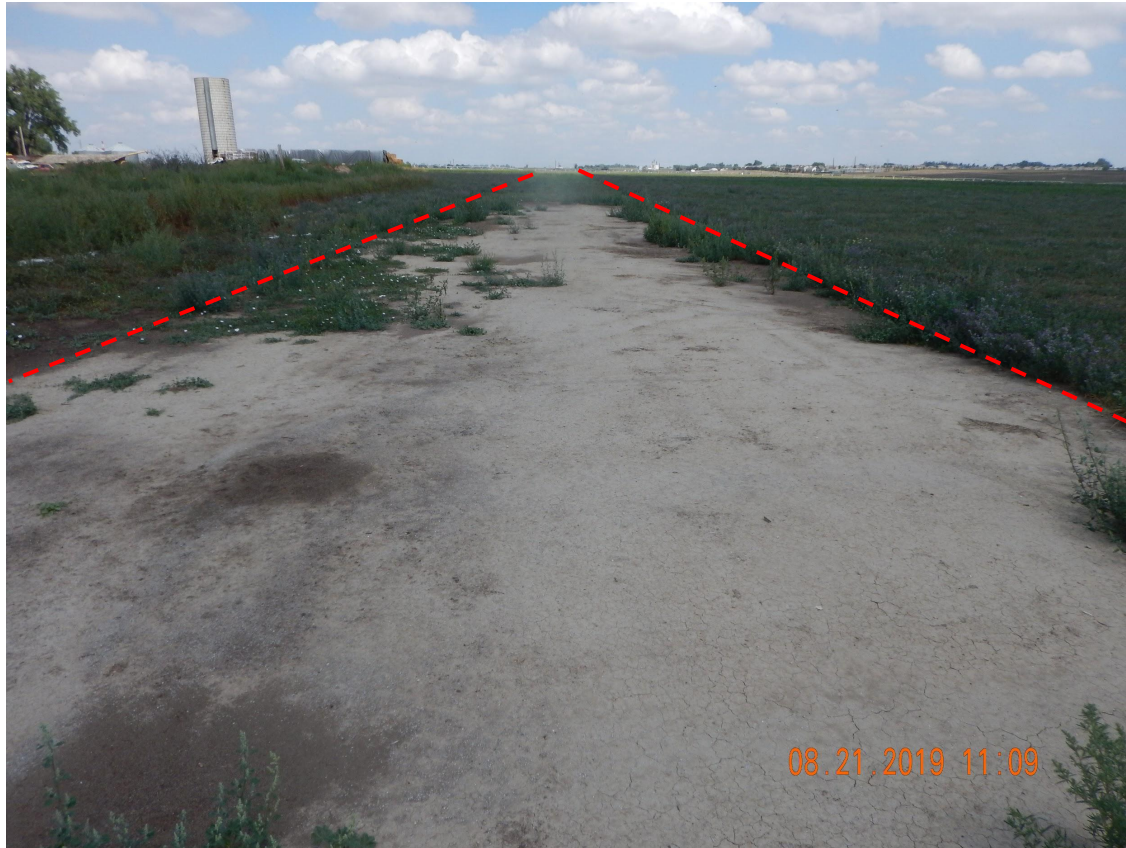
**Photo 7.** Photo taken from a section of the central flowline, facing North.  
Photo illustrates a significant bare patch with no vegetative growth.

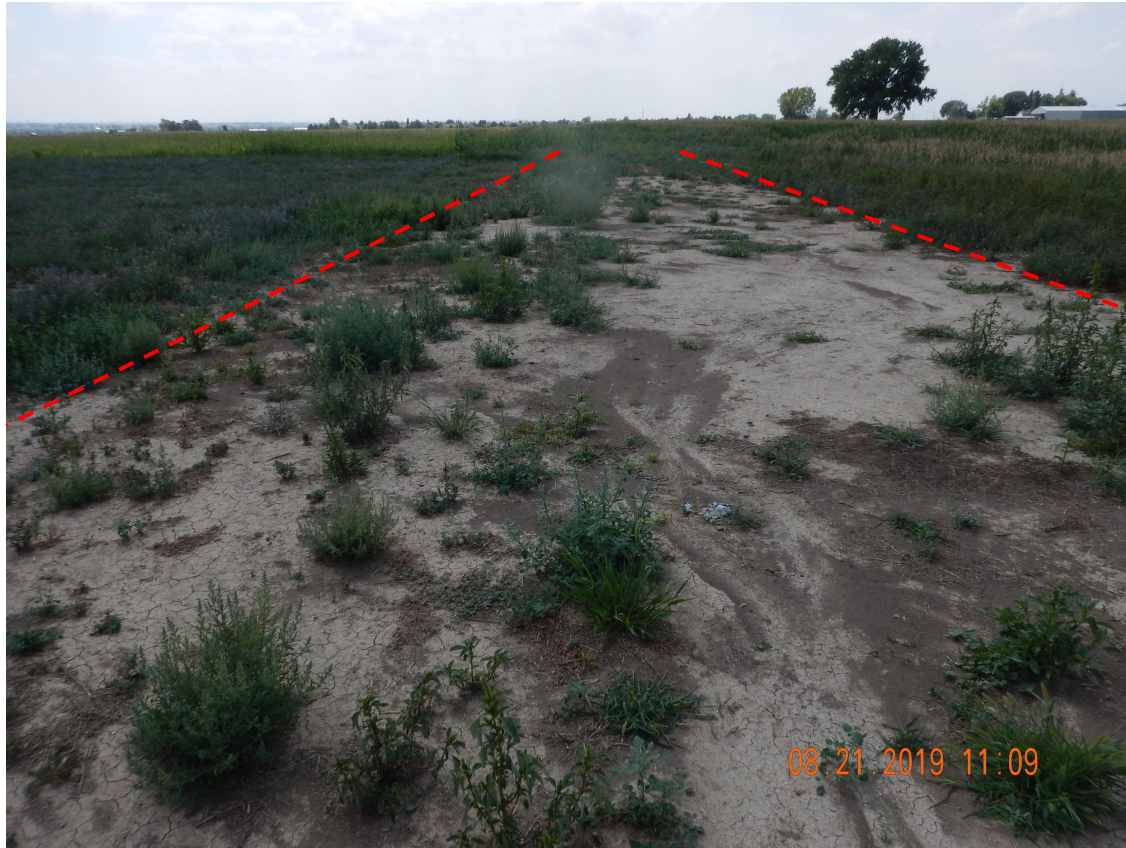
**Photo 8.** Photo taken from the previous central flowline area, facing South.  
See comments under Photo 7.

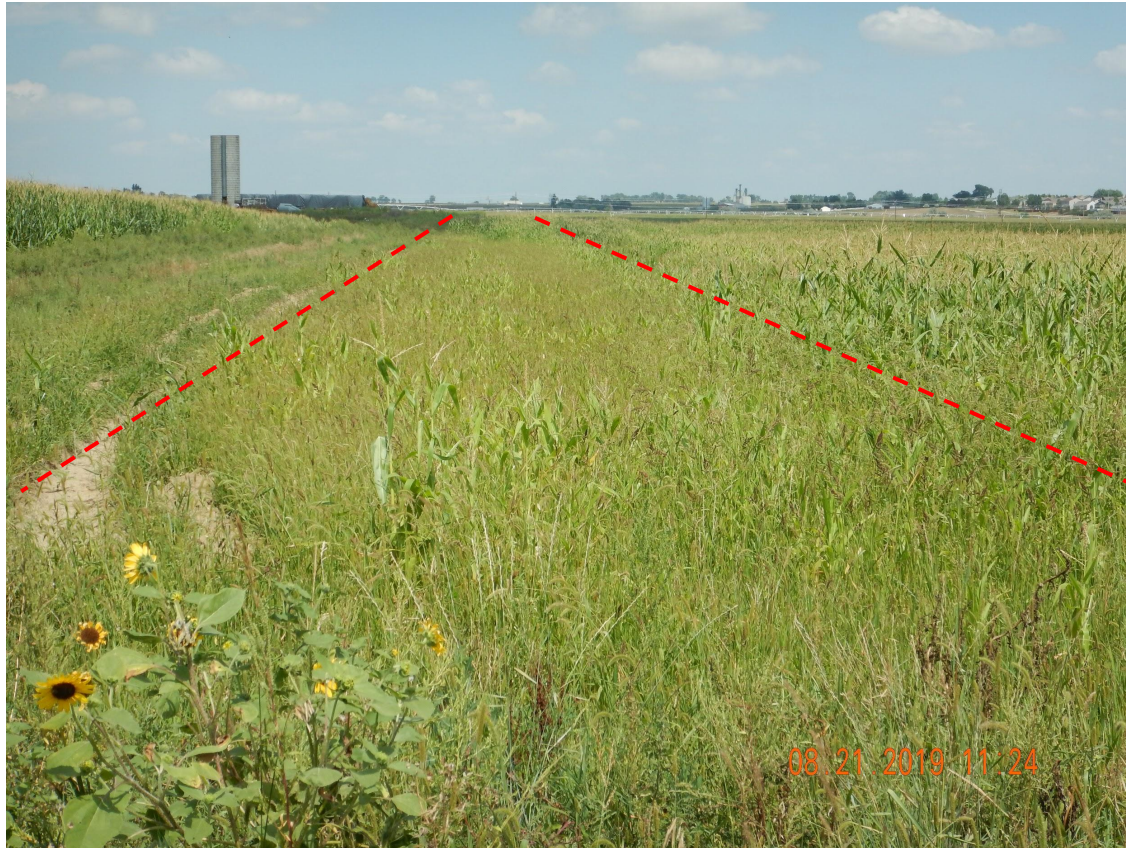
**Photo 9.** Photo taken from a section of the southern flowline, facing North. Photo illustrates an area of the flowline that has been planted in corn. Corn establishment was minimal with the primary growth of barnyard grass.

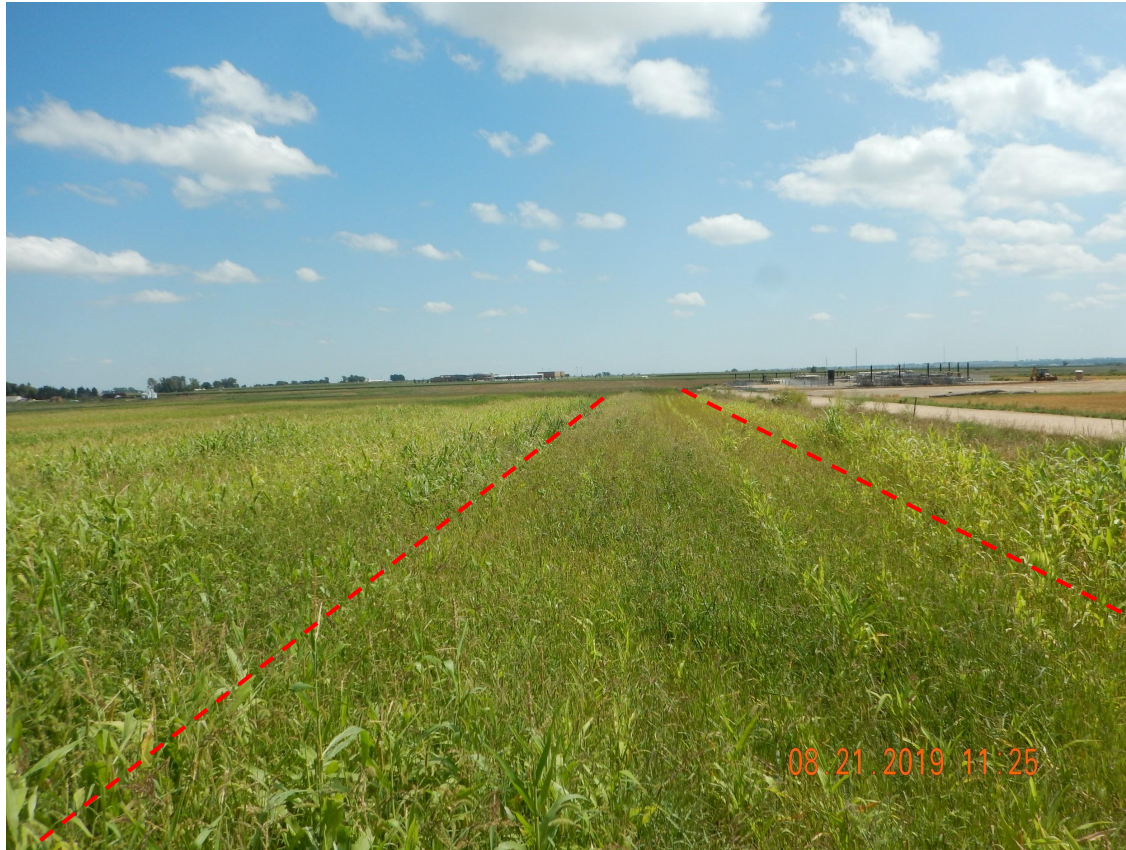
**Photo 10.** Photo taken from a section of the southern flowline, facing East.  
See comments under Photo 9.
