SPECIALITY RESTAURANT 7-6(E7OU) Location # 334188

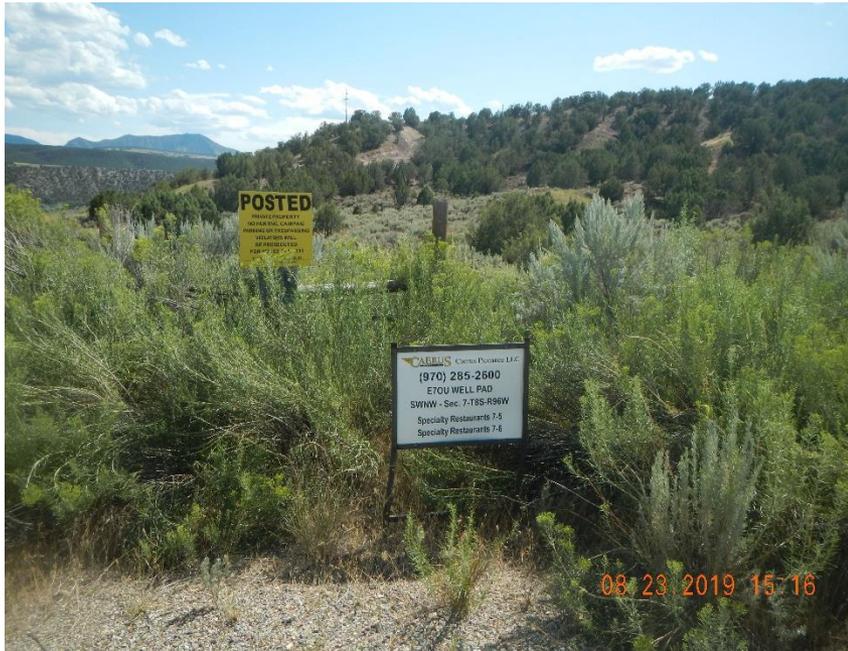
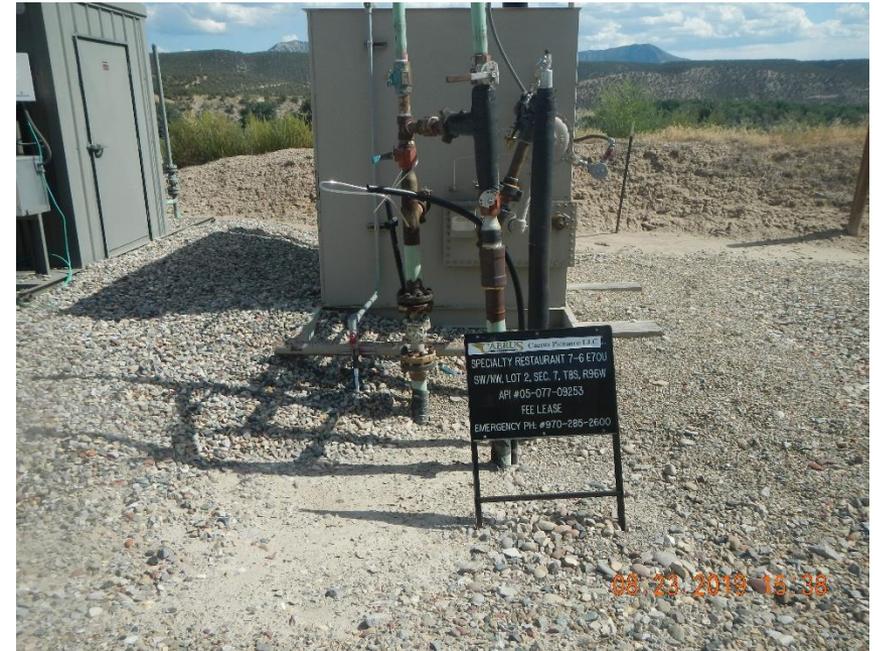
Sign at main entrance does not meet 210.b.(2)

Phone number for local emergency services (911 where available) and the public road used to access the site Not posted on battery sign.

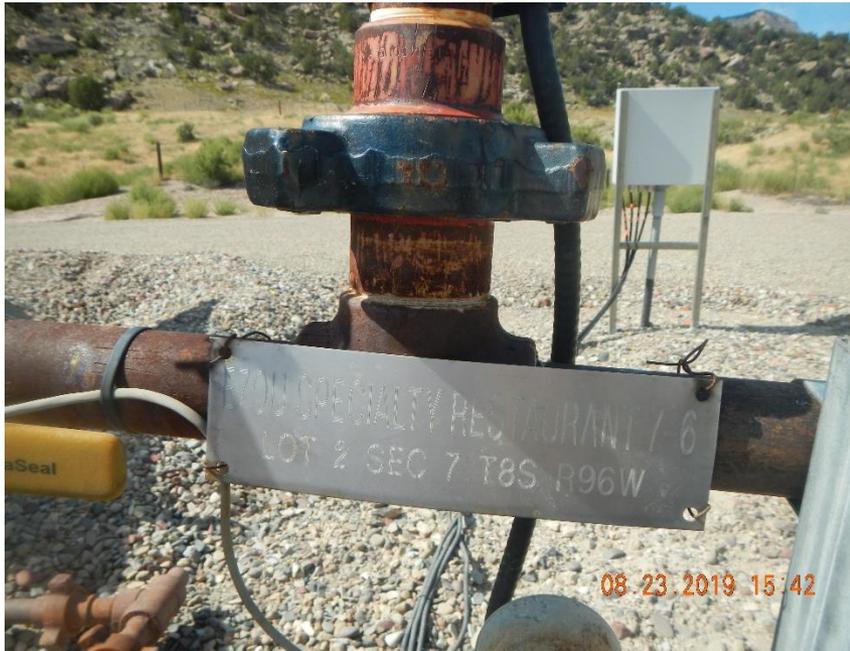
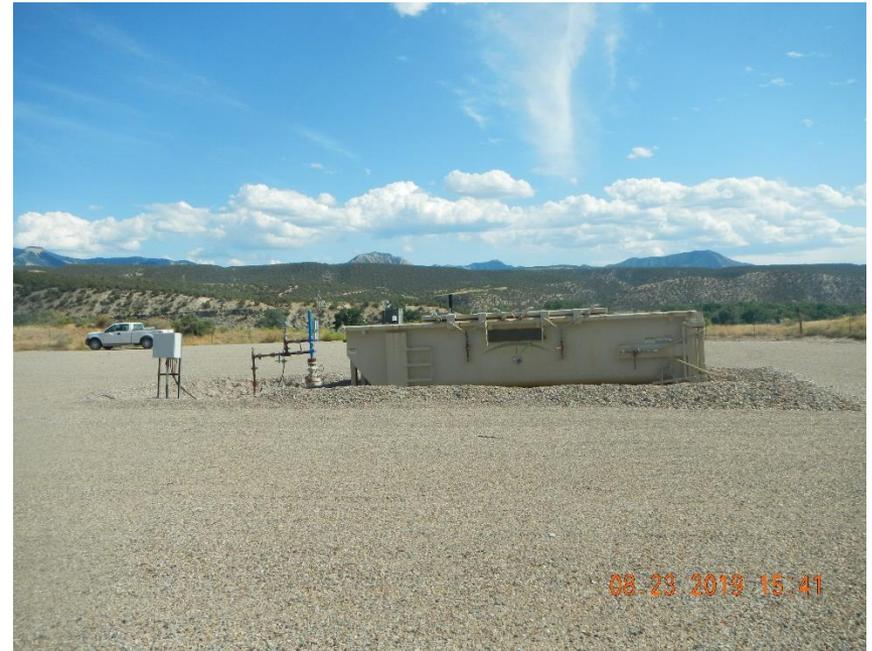
Well sign

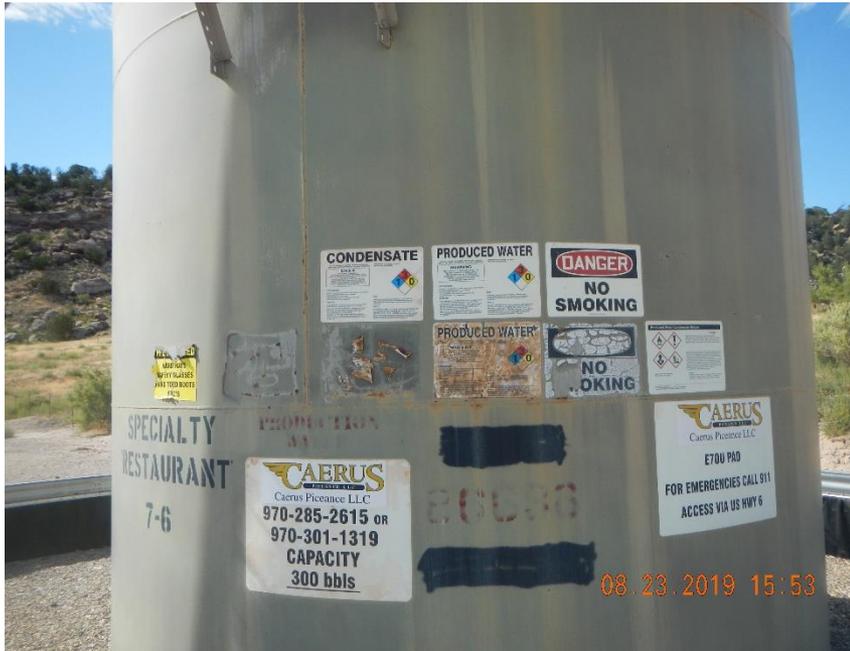
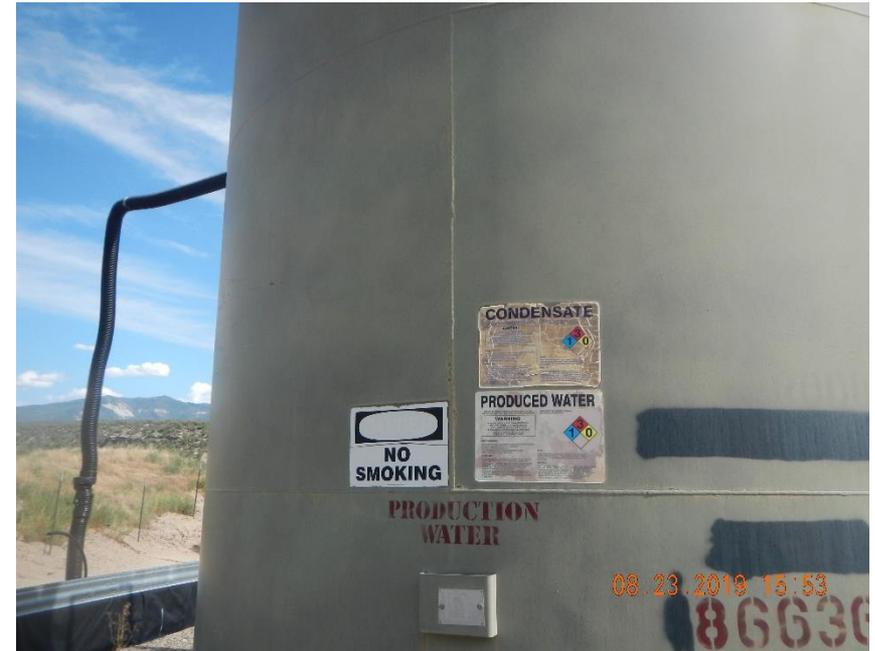
Old derelict labels on tank.

Tank is labeled for Condensate and Produced water.
Contents stenciled as Production water.

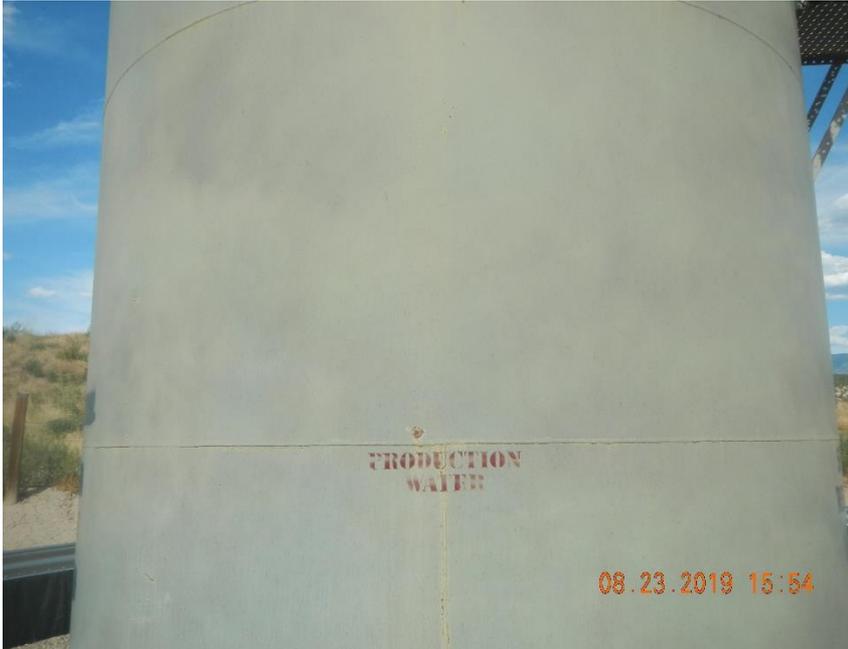
Contents stenciled as Production water.

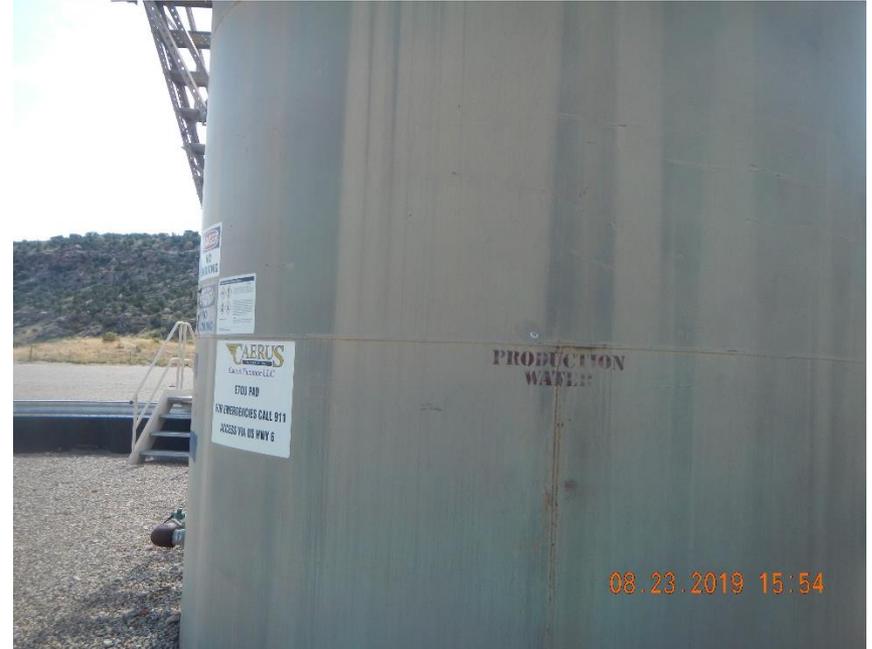
Contents stenciled as Production water.

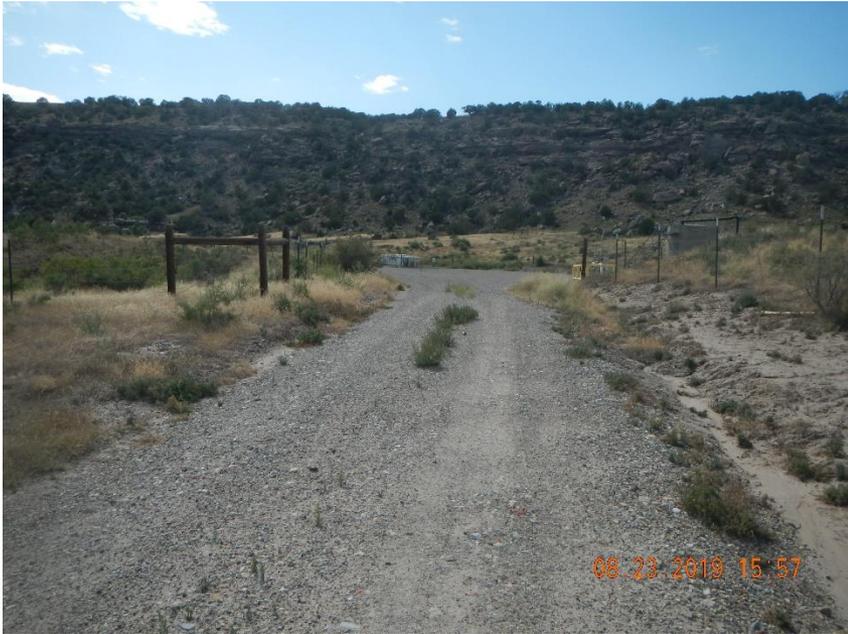
Weeds on lease road at entrance of location.

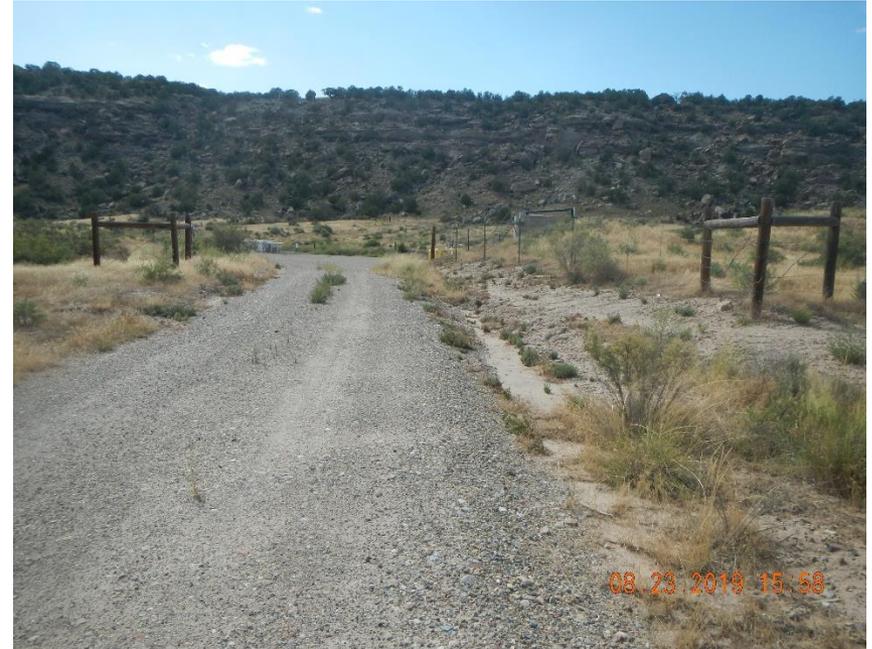
Sediment build up in ditch.

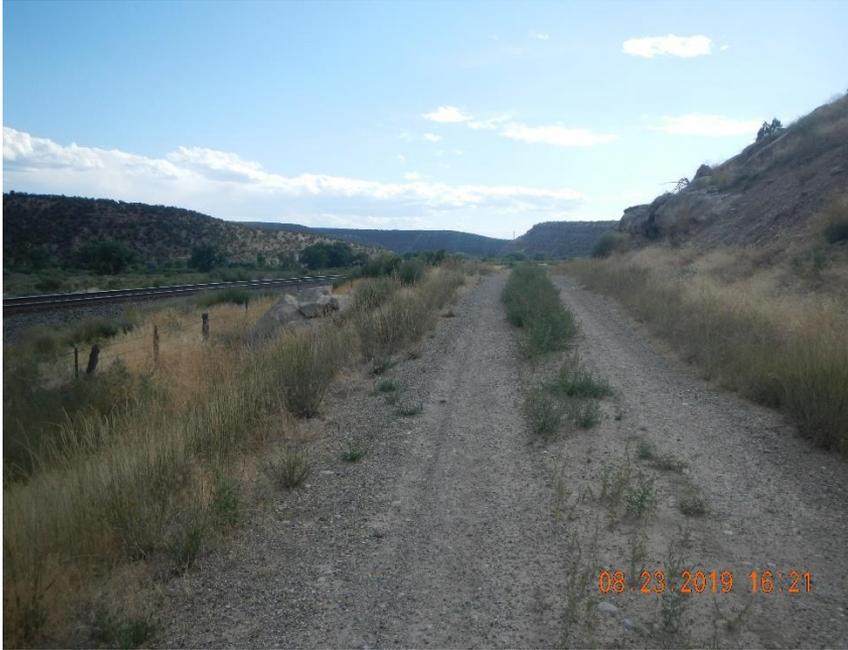
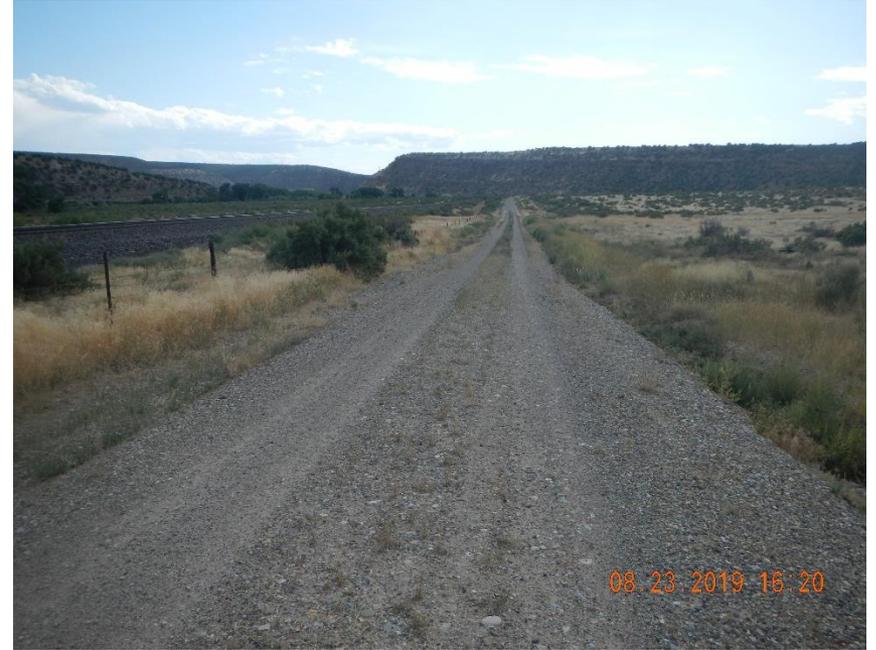
Weeds on lease road.

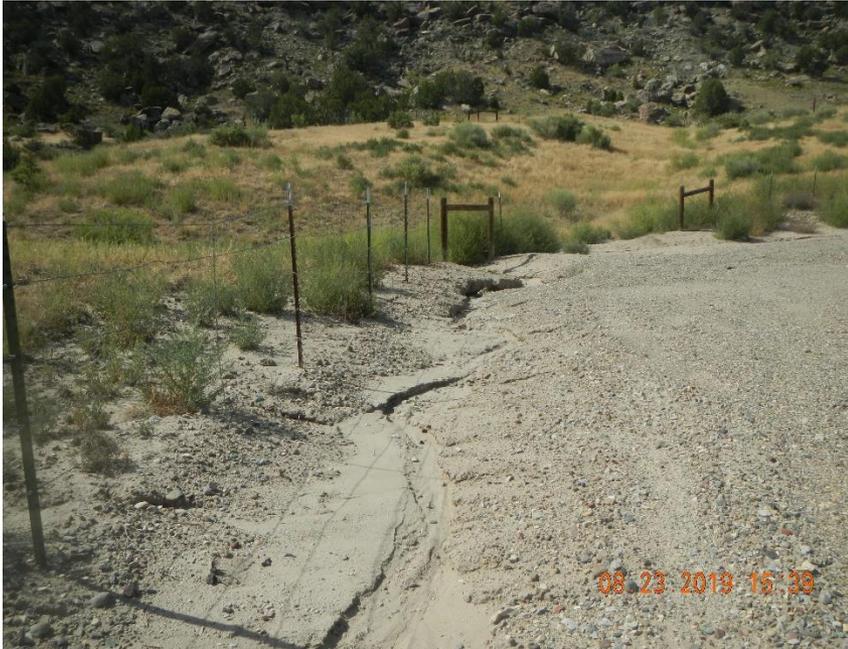
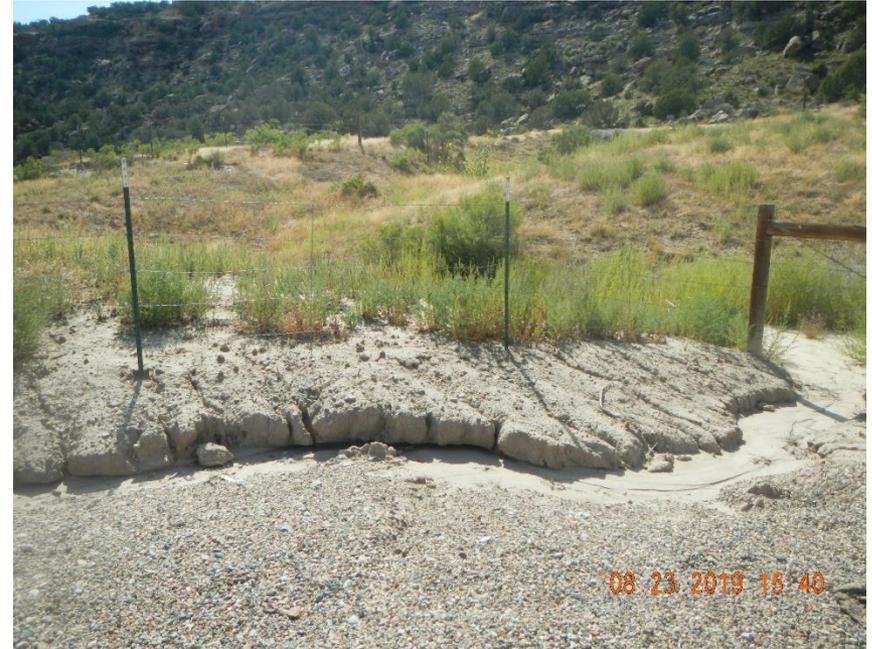
**Erosion and sediment movement of drainage ditch
around location perimeter.**

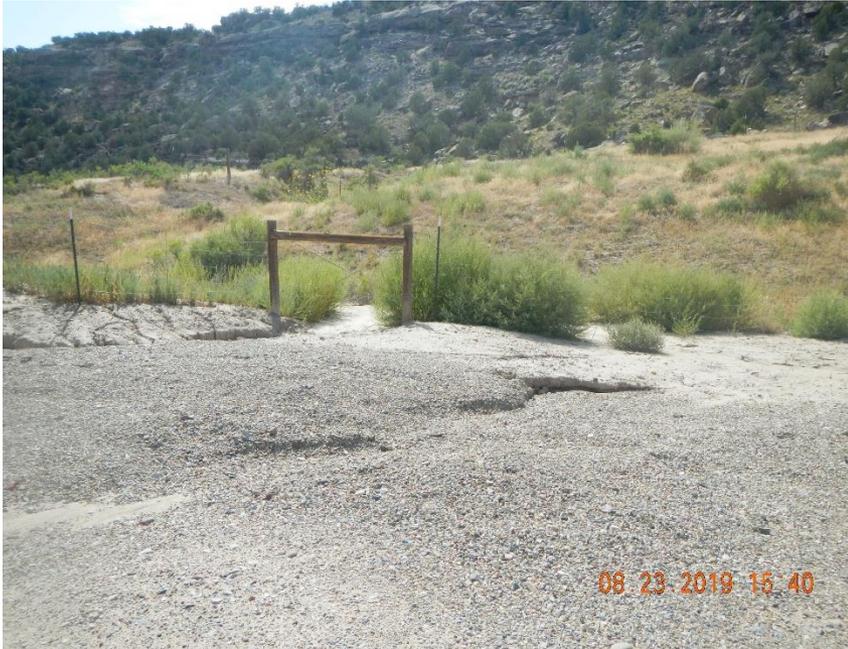
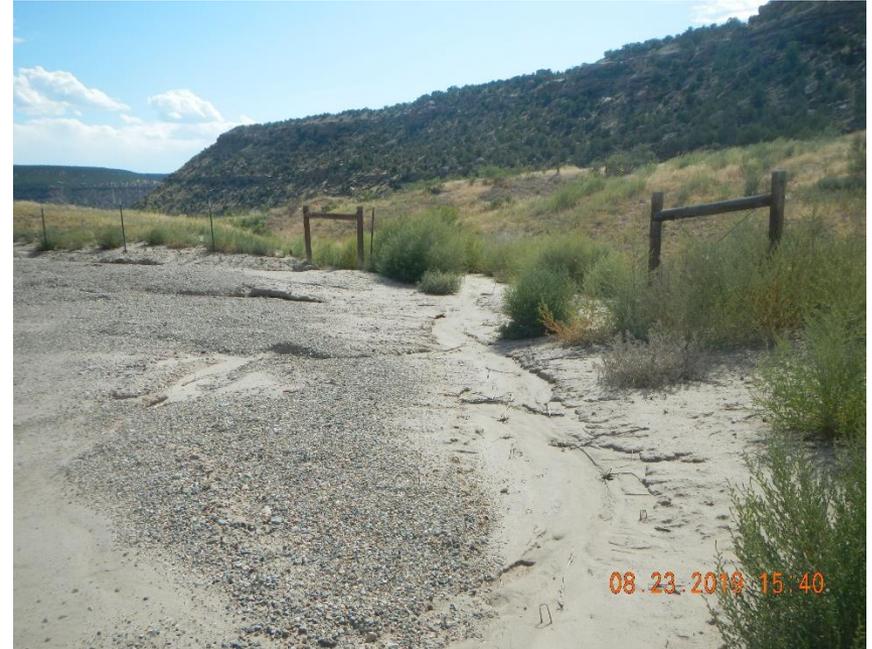
**Erosion and sediment movement of drainage ditch
around location perimeter.**

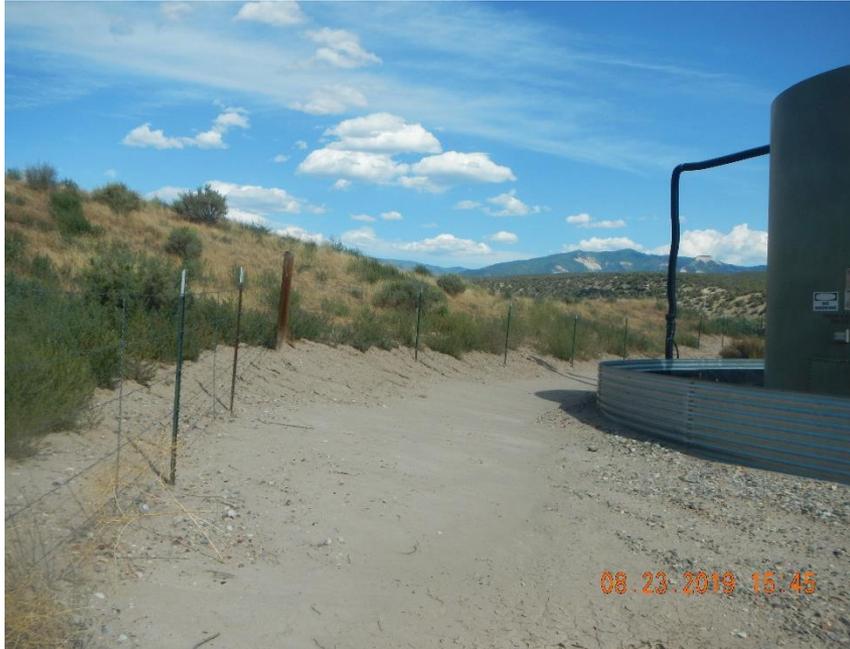
Erosion and sediment movement of drainage ditch around location perimeter.

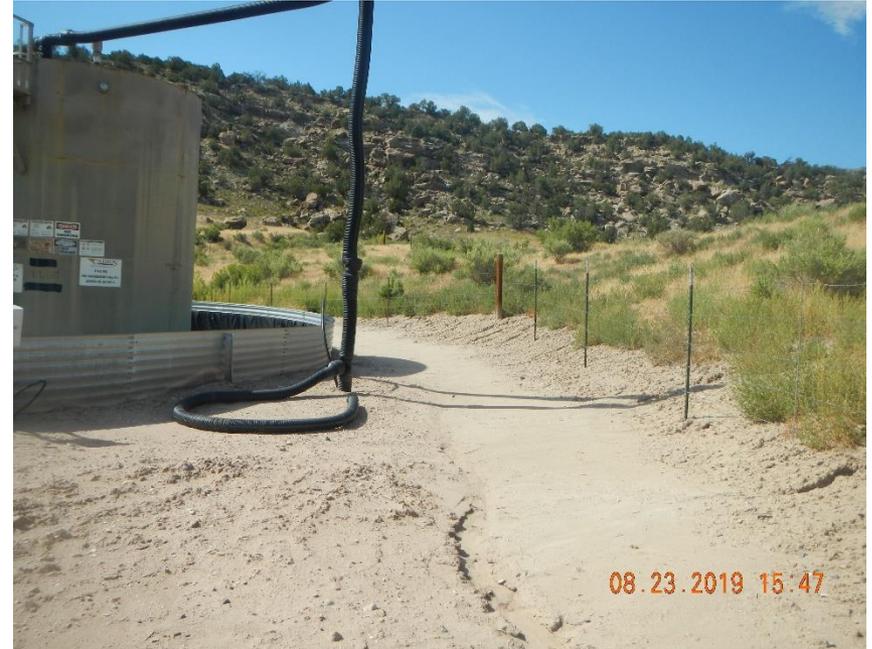
Erosion and sediment movement of drainage ditch around location perimeter.

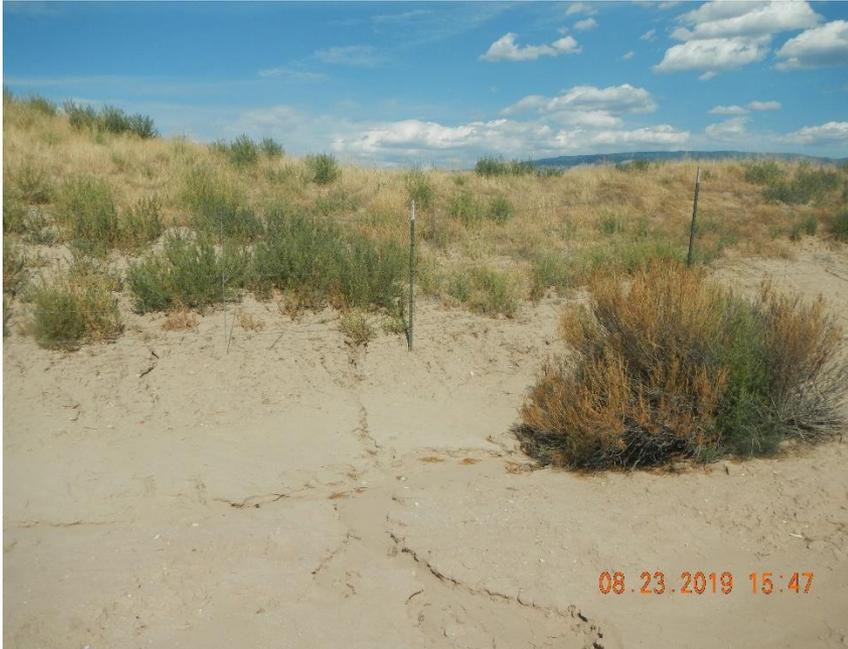
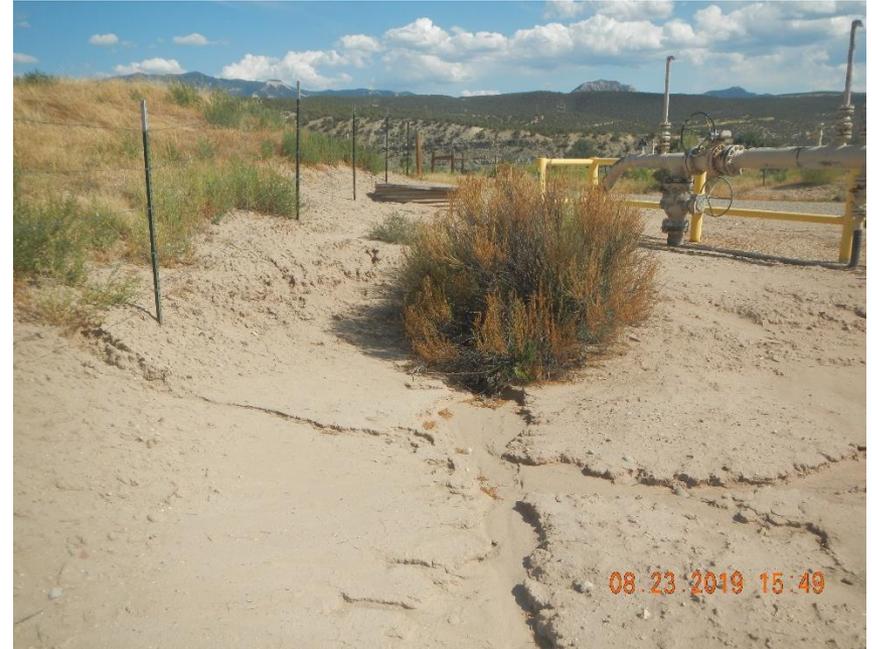
Washing and riling running on to location.

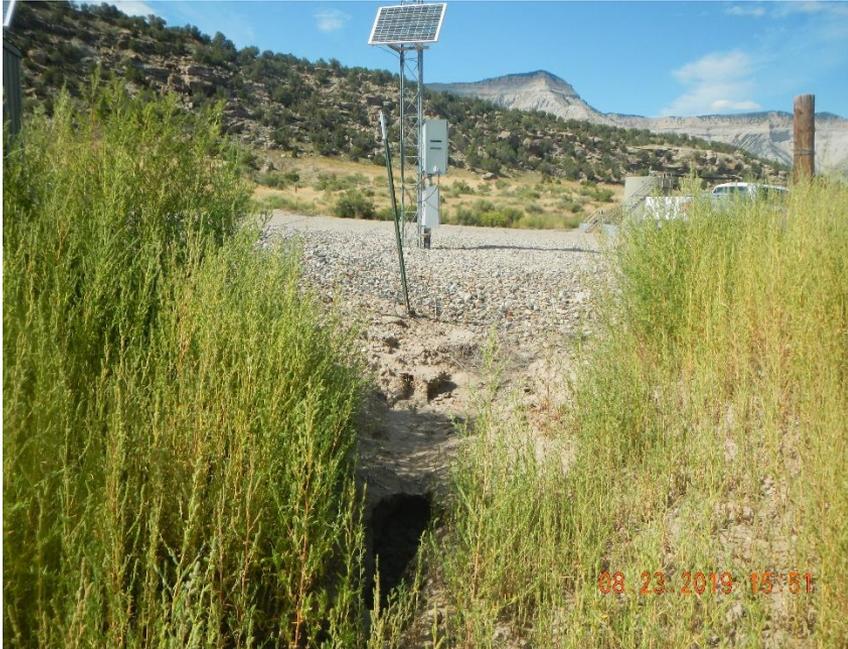
Erosion damage from run off behind separator and meter house.

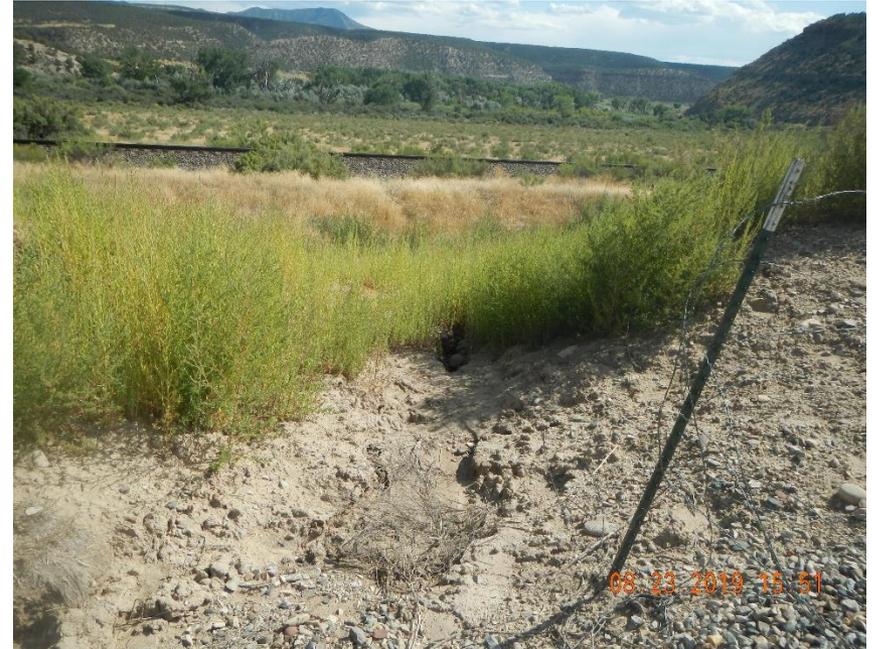
Erosion damage from run off behind separator and meter house.

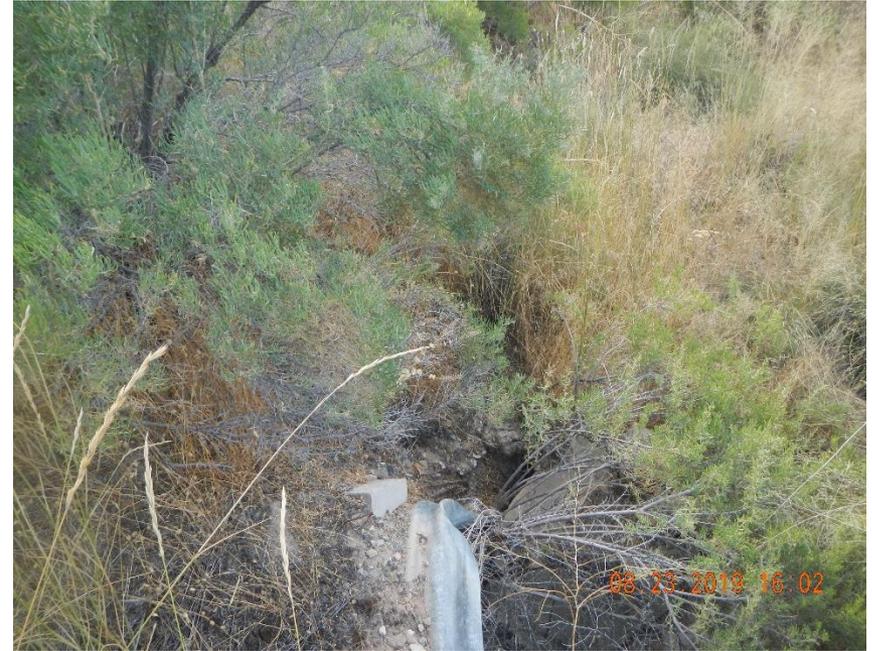
Culvert inlet needs maintained.

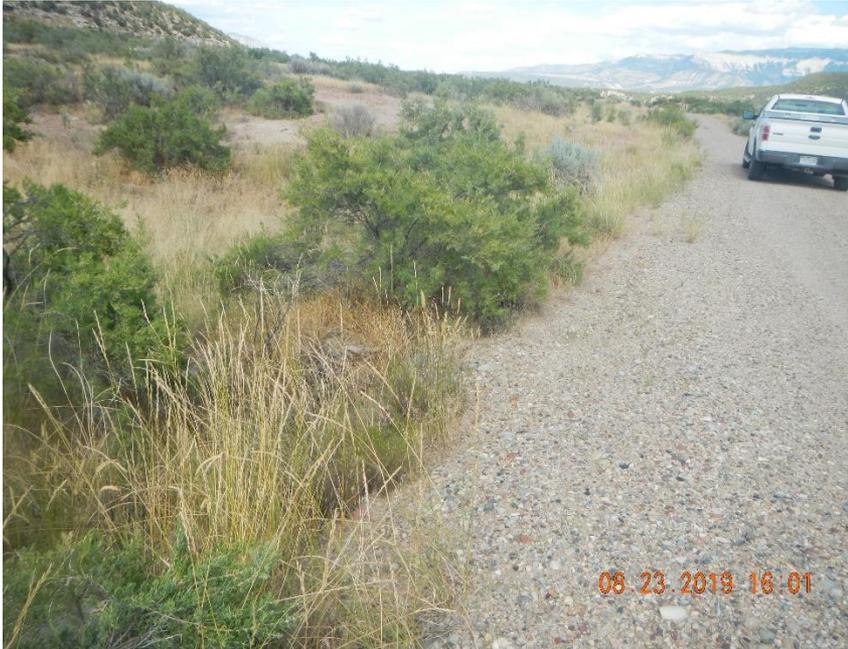
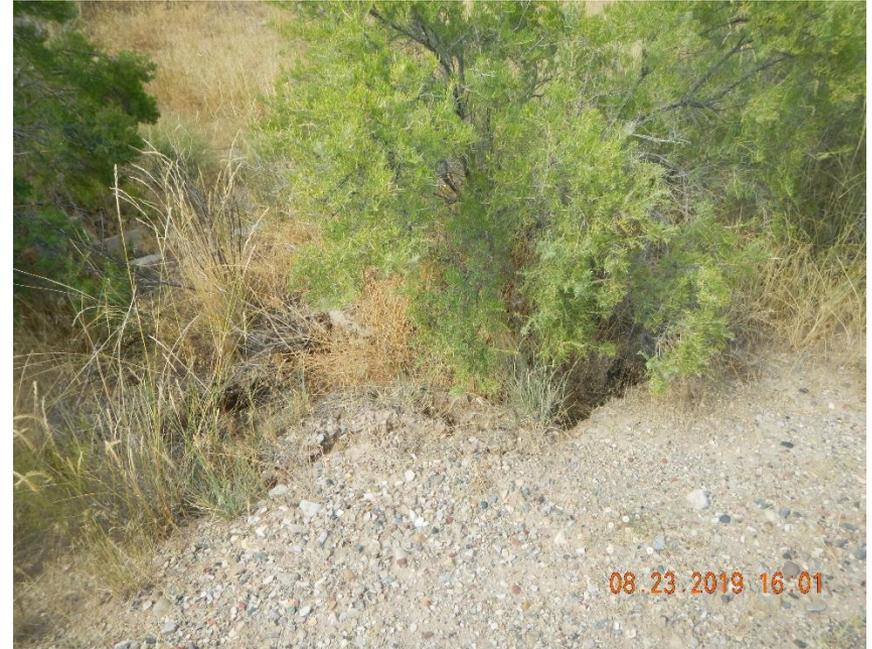
Subsidence of road shoulder at culvert.

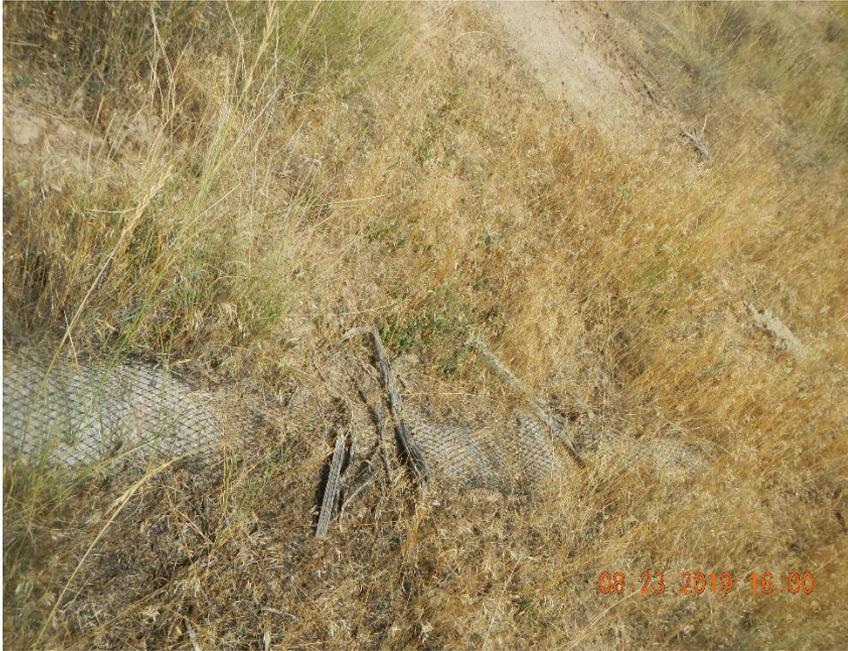
Derelict waddles in ditch along culvert.

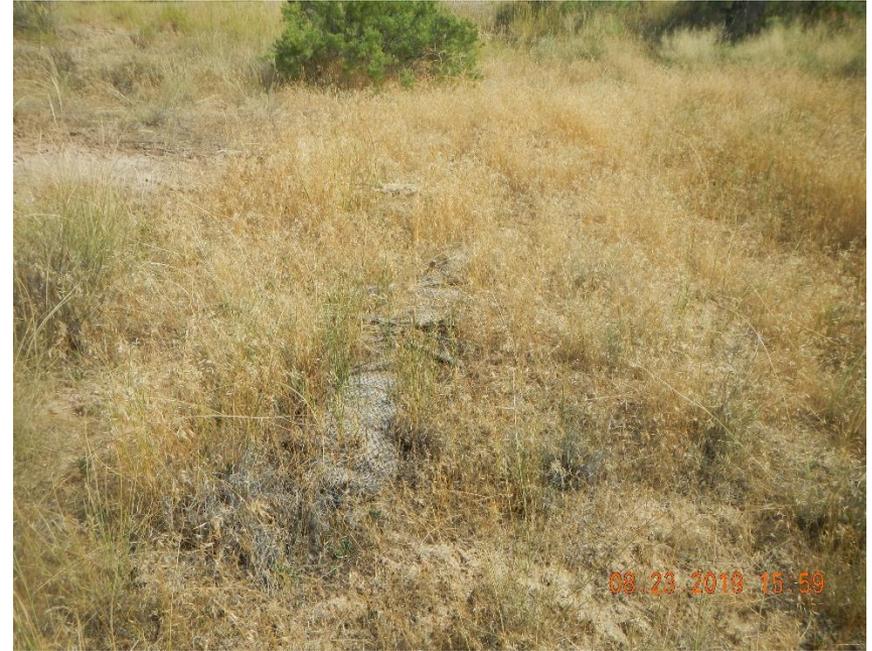
Derelict waddles in ditch along culvert.
