# Inspection Photos

08/26/2019

Operator: D90 ENERGY LLC # 10706

Location ID: 435480

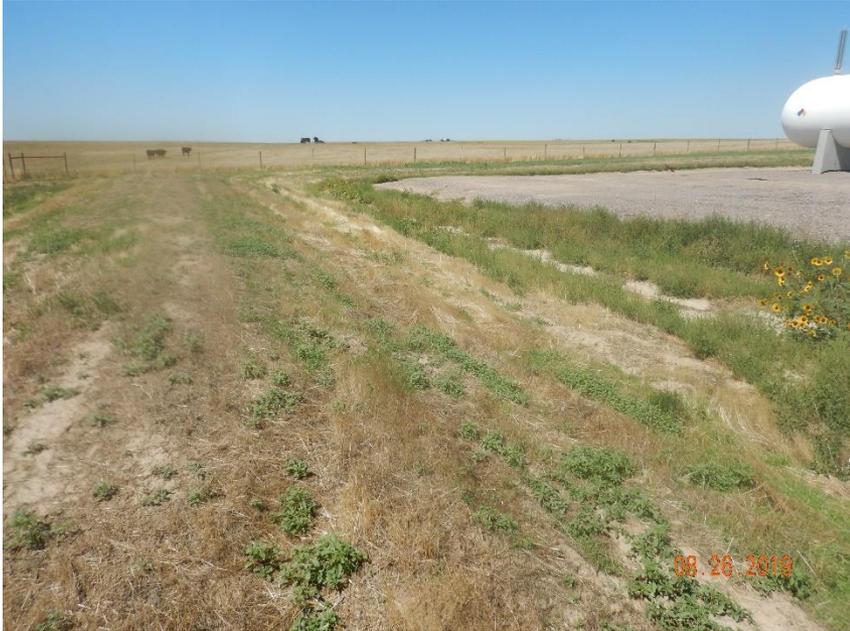
**Photo 1:** Photo taken from the south end of the location, facing west. Photos 1-3 provide an overview of the location from west, to north, to east. Photo also show the perimeter stormwater ditch on the location

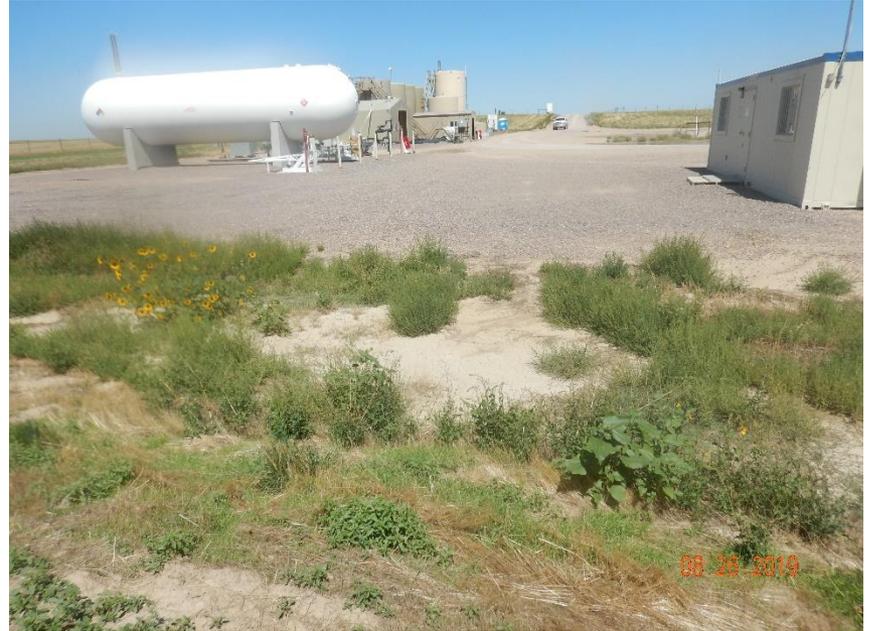
**Photo 2:** See comments under photo 1.

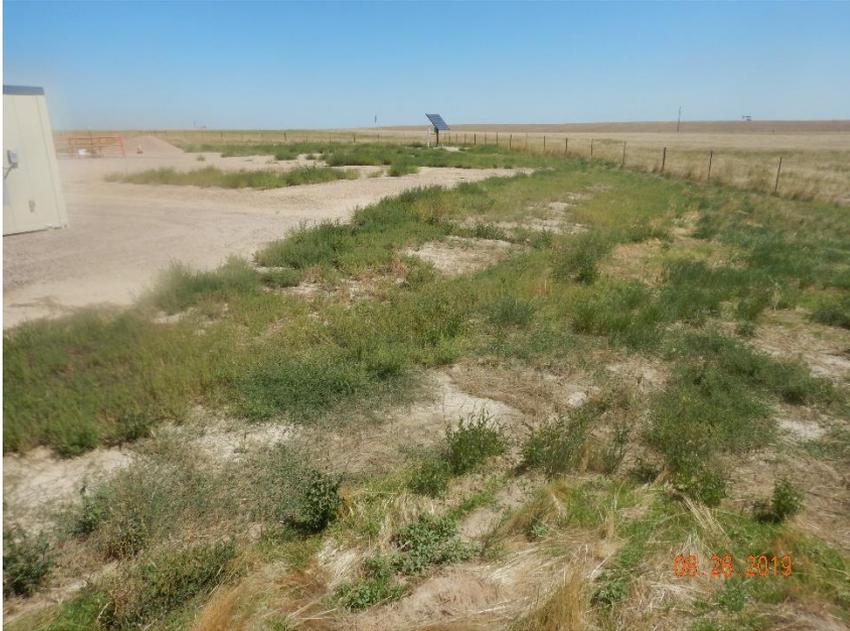
**Photo 3:** See comments under photo 1.

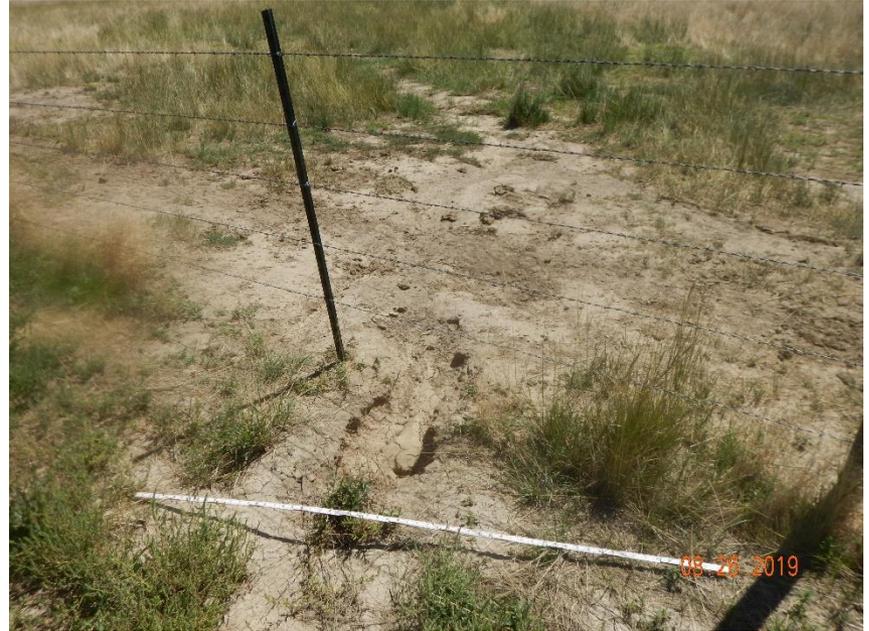
**Photo 4:** Photo taken from the perimeter fence on the south end of the location, facing southeast. Photo shows erosion degradation and sediment deposition due to sediment laden stormwater runoff from the location. Photo shows a headcut is beginning to form. 6 foot measuring stick for reference.

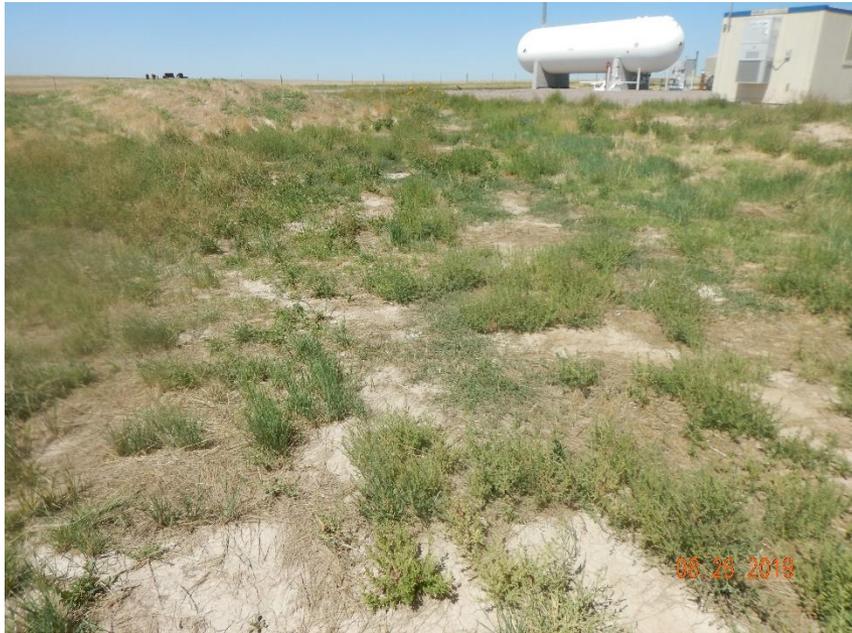
**Photo 5:** Photo south end of the location, facing northwest. Photo shows where perimeter stormwater ditch ends. Photo shows sufficient stormwater BMPs to allow for sediment laden free stormwater discharge from the location remains missing. Photo shows areas of sediment deposition that leads to the adjacent lands.

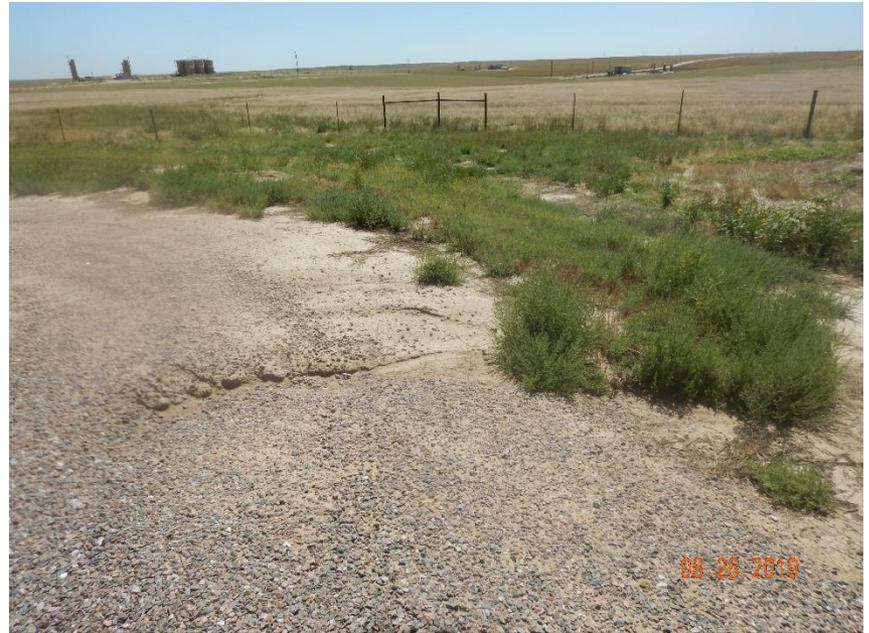
**Photo 6:** Photo taken from the south end of the pad. Photo shows stormwater erosion degradation on the location remains evident.

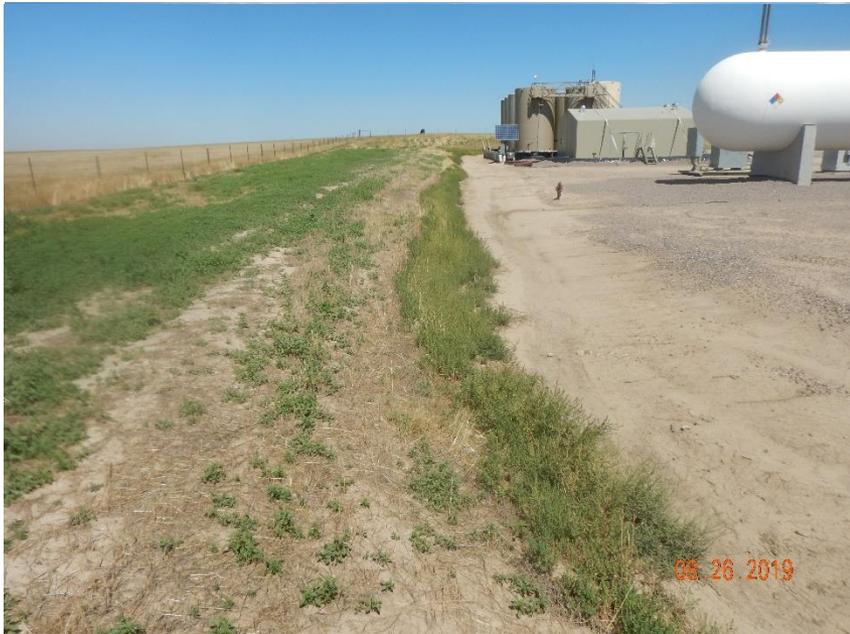
**Photo 7:** Photo taken from the southwest end of the location, facing north. Photo shows perimeter stormwater ditch.

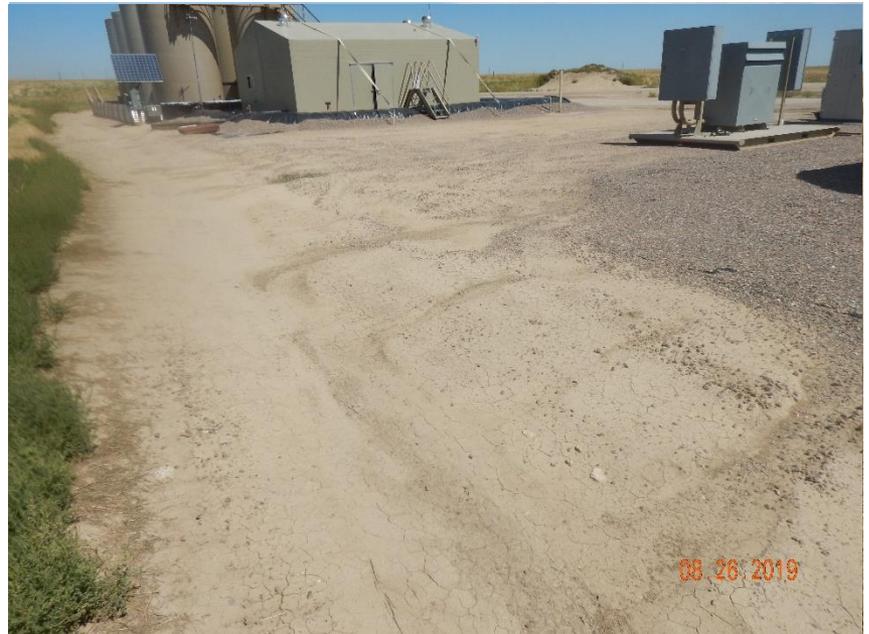
**Photo 8:** Photo taken from the perimeter stormwater ditch on the west end of the location. Photo shows stormwater erosion degradation on the location and sediment deposition into the ditch. No BMPs have been placed at the end of the ditch to prevent sediment from transporting off location.

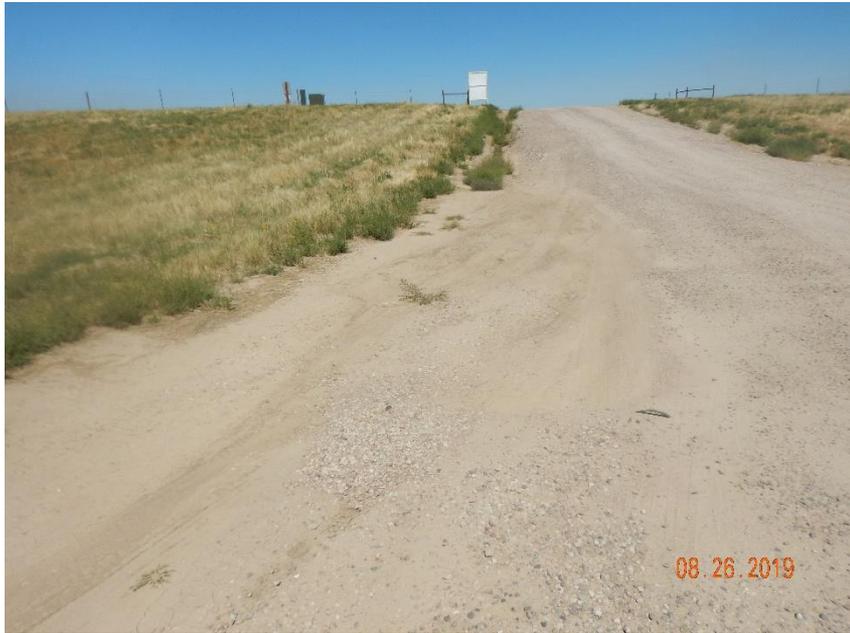
**Photo 9:** Photo taken from the north end of the location, facing north. Photo shows erosion degradation remains evident on the access road.

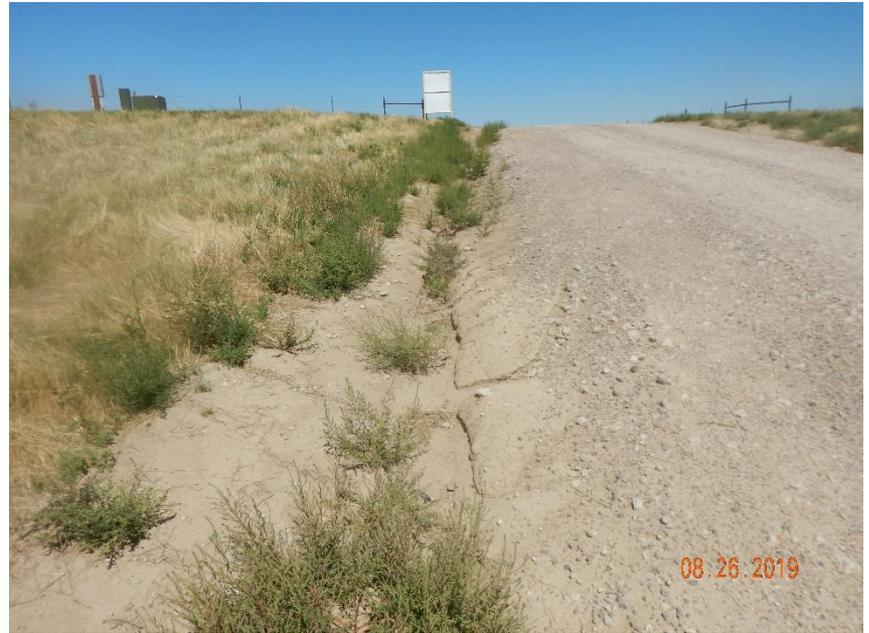
**Photo 10:** Continued from photo 9. Photo shows erosion degradation remains evident on access road and no BMPs have been installed.

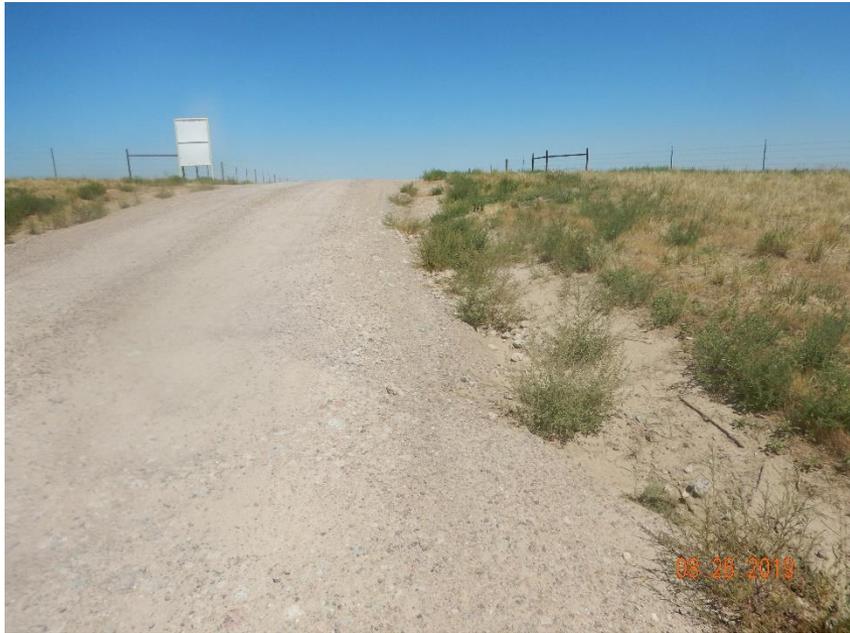
**Photo 11:** See comments under photo 10

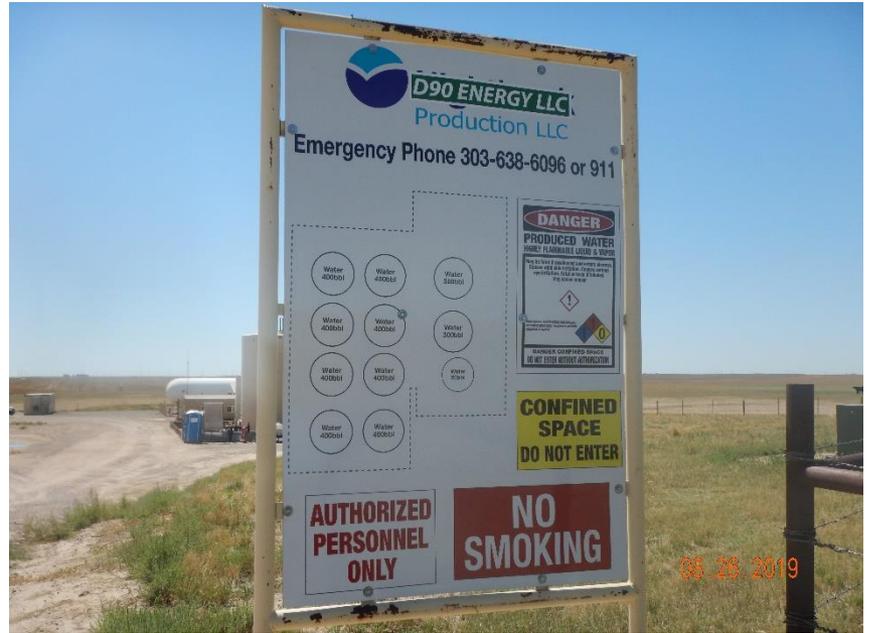
**Photo 12:** Photo taken from the sign at the location entrance. Photo shows sign identifying tanks on the location, their capacity and their contents. D90 has indicated that the were provided approval from inspector Sherman, that this signage will be sufficient per Rule 210.d.
