**Inspection Photos**  
**Location Name: A.D. Jeffers A#1**  
**Location ID: 323176**

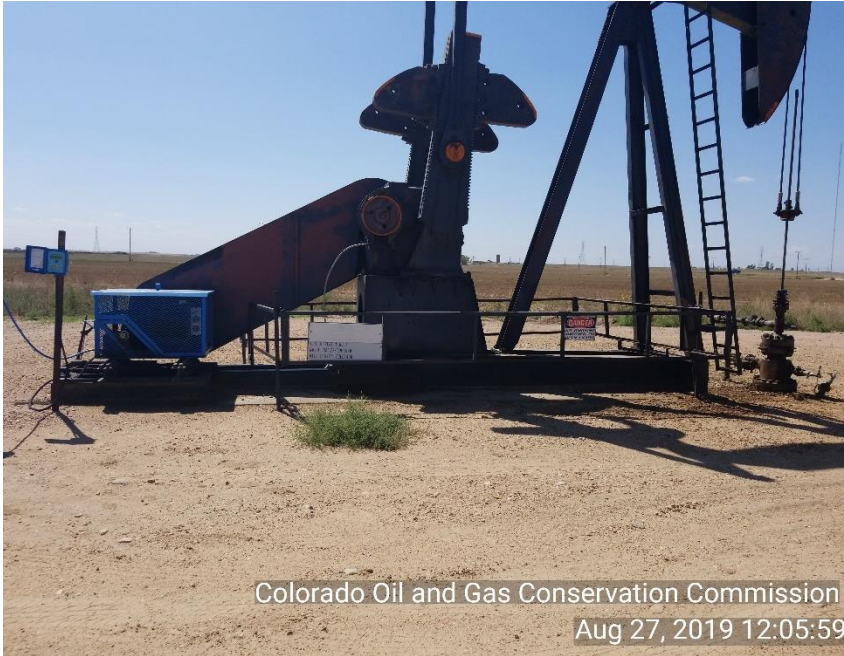
**Photo 1 WH sign**

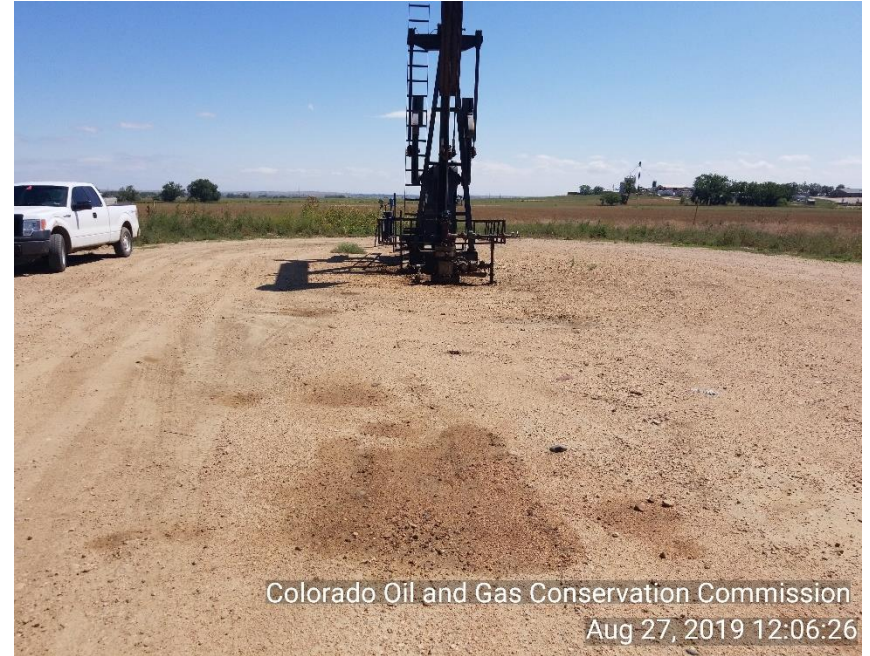
**Photo 2 WH and stained soil in front of PU**

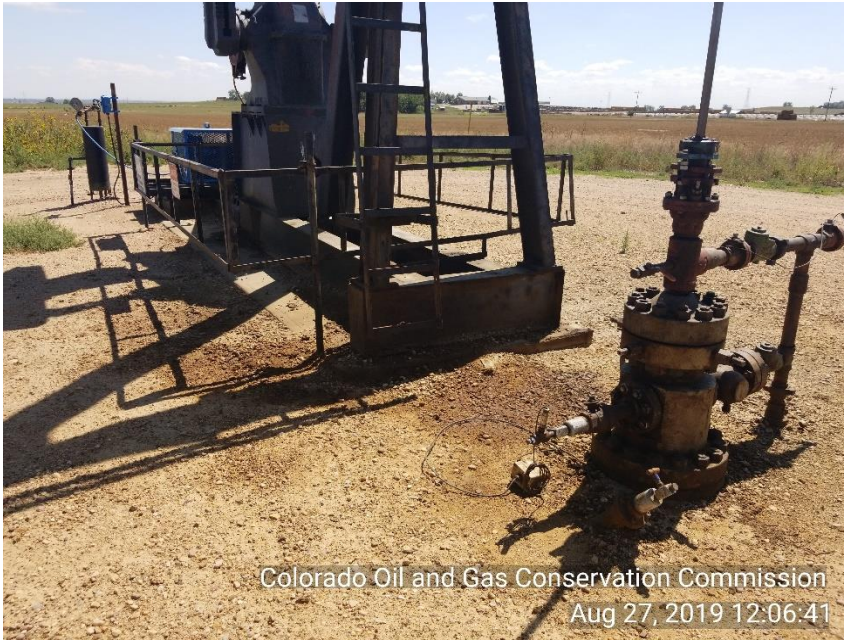
**Photo 3 Stained soil around WH and PU base**

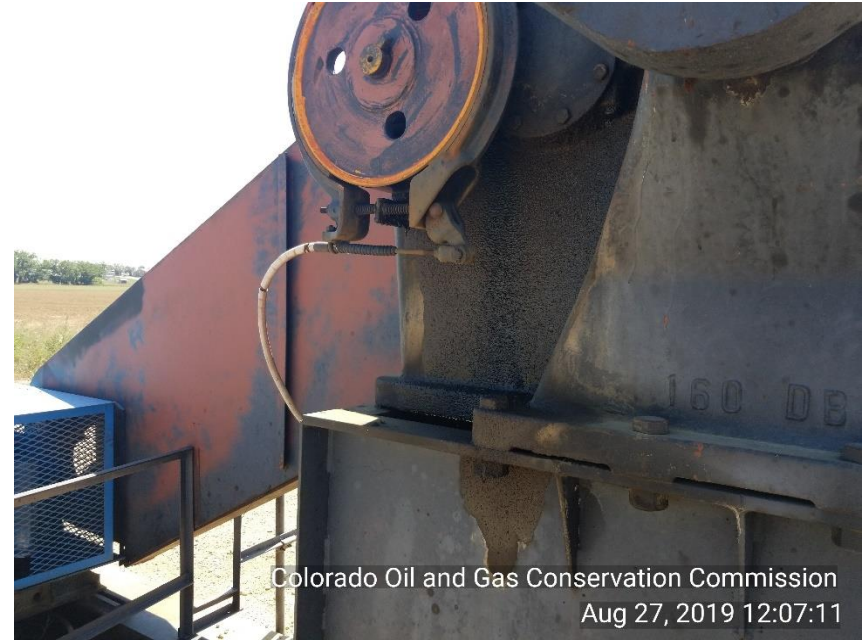
**Photo 4 Mechanical Issue: PU gear box appears to be leaking**

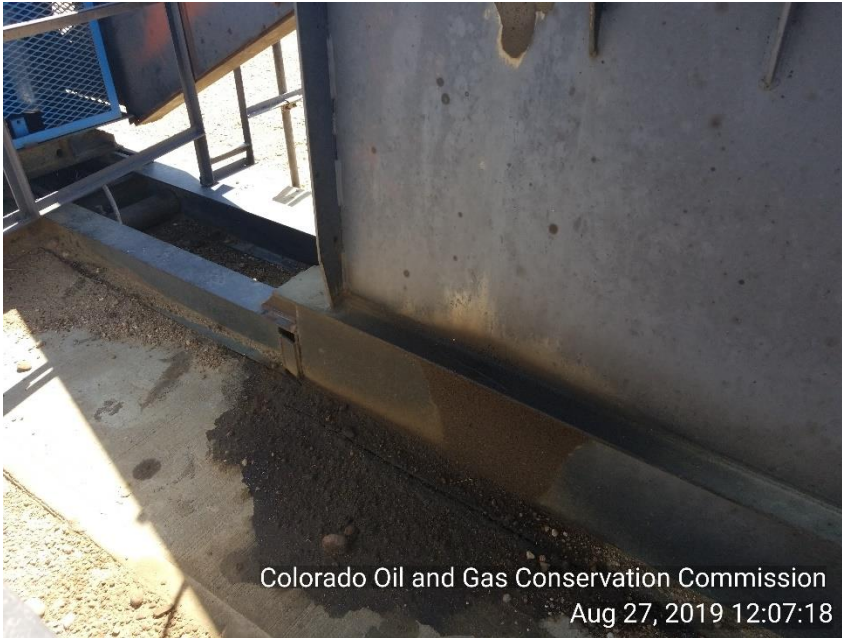
**Photo 5 Stained soil on PU base from what appears to be leaking gear box**

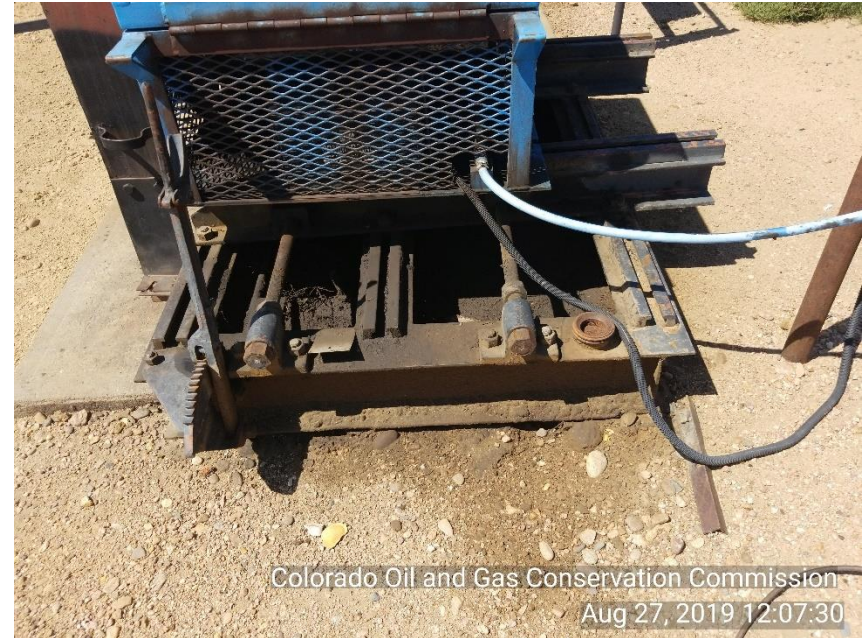
**Photo 6 Stained soil around and underneath PU motor.**

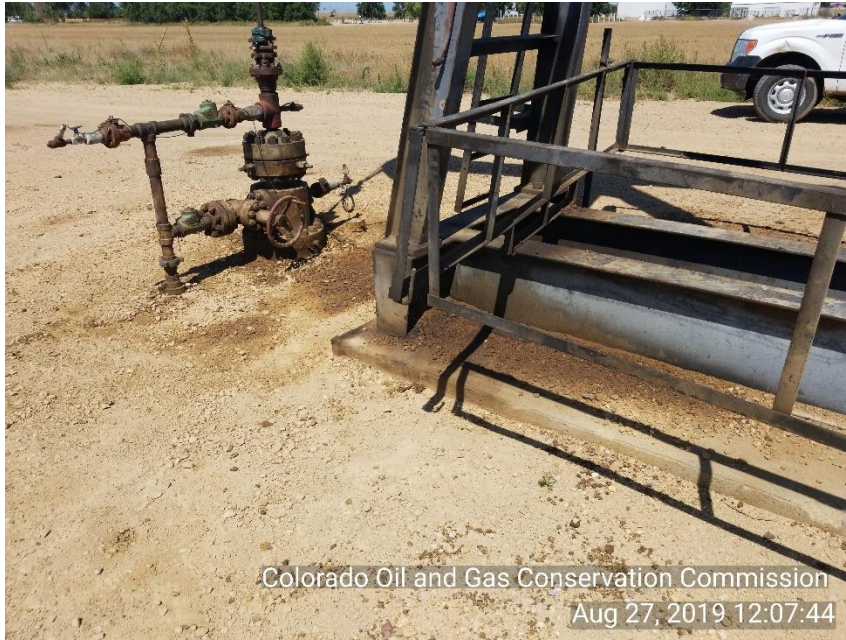
**Photo 7 Stained soil around WH and PU base**

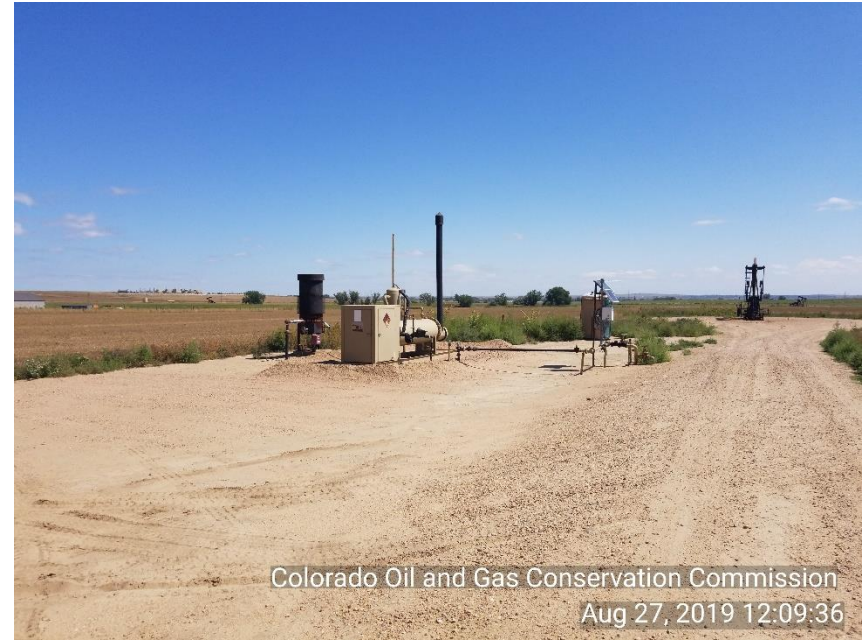
**Photo 8 Sep/meter run and ECD**

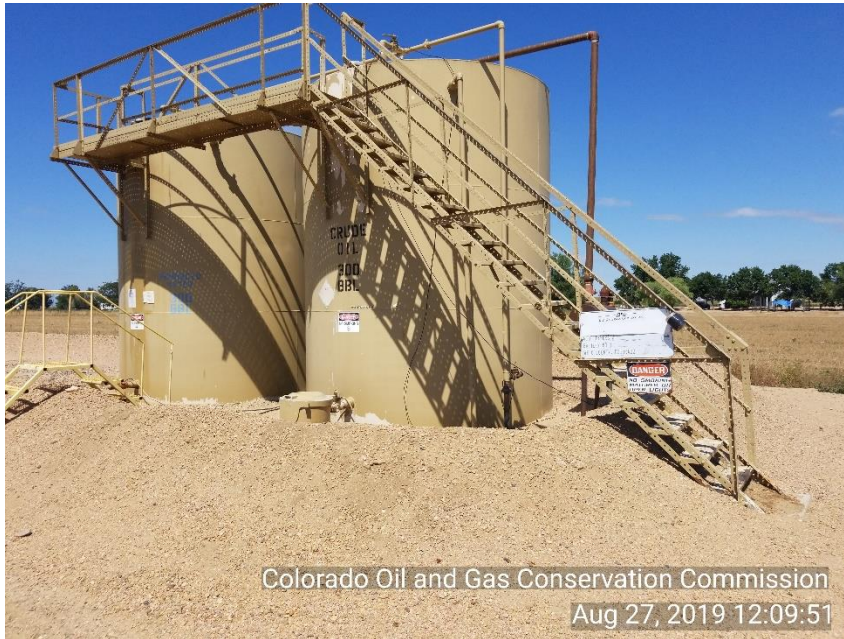
**Photo 9 TNK BTRY sign faded and not legible. NFPS placards faded and not legible.**

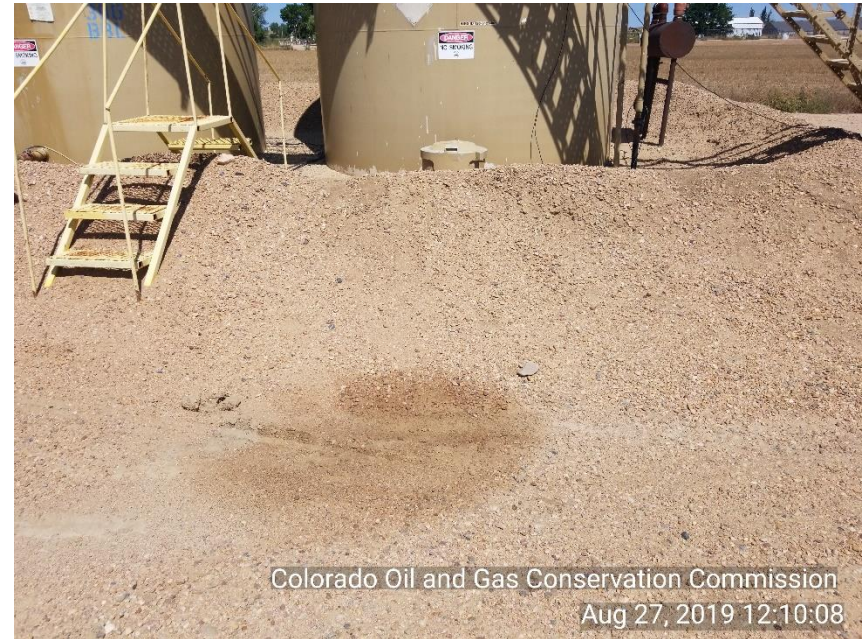
**Photo 10 Stained soil outside crude oil tank berm.**
