Inspection Photos

Loc#446527

Operator: Sandridge

Inspection Number: 692401283

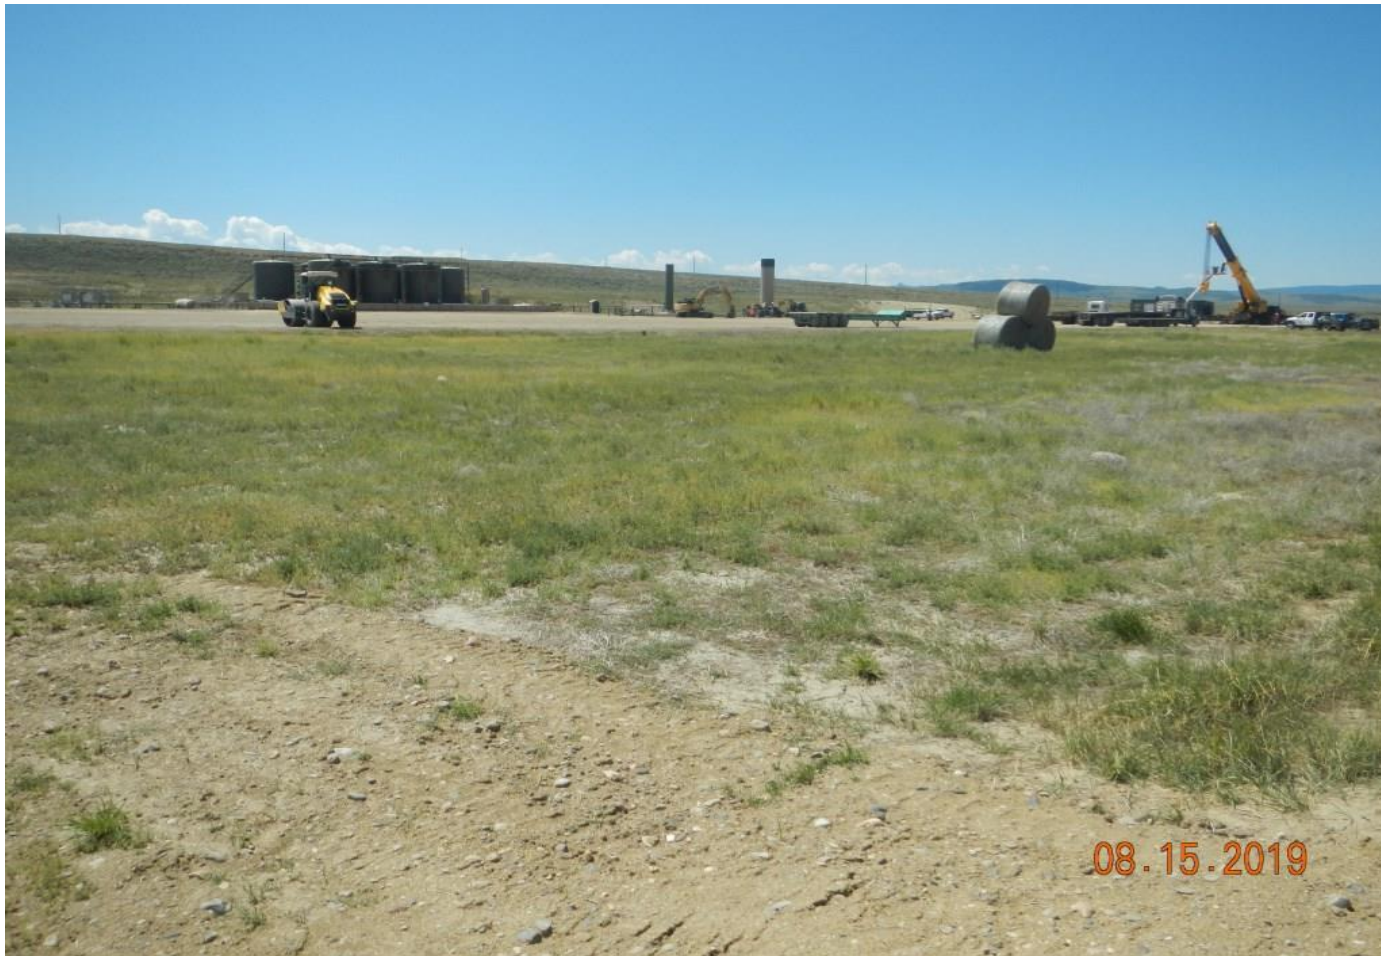
Photo#1:
Overview of Location to Southwest.

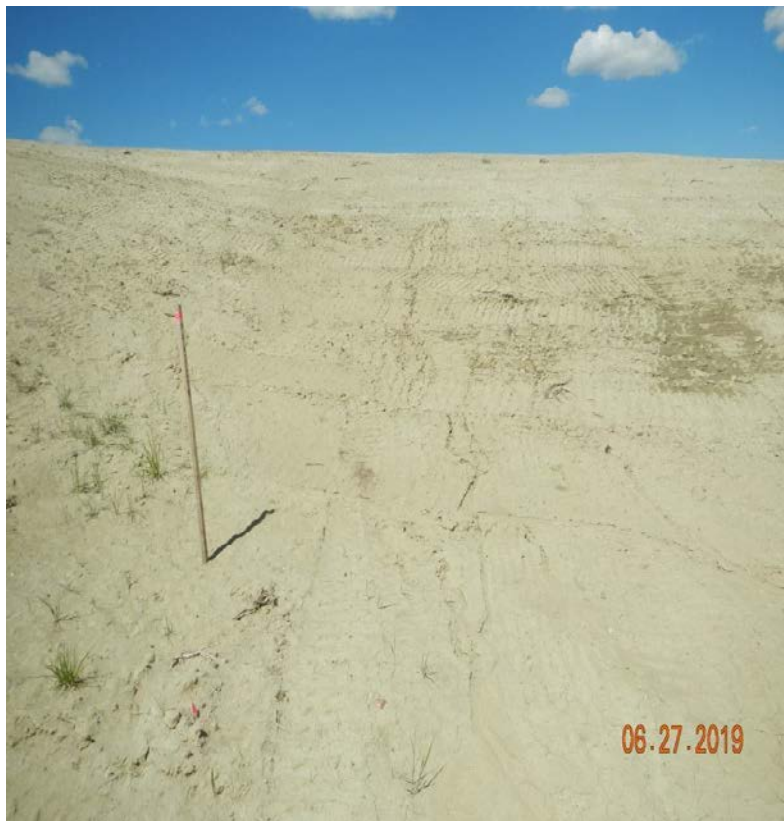
Photo#2: 6/27/19
Erosion initiating on Southwest corner of Cut slope

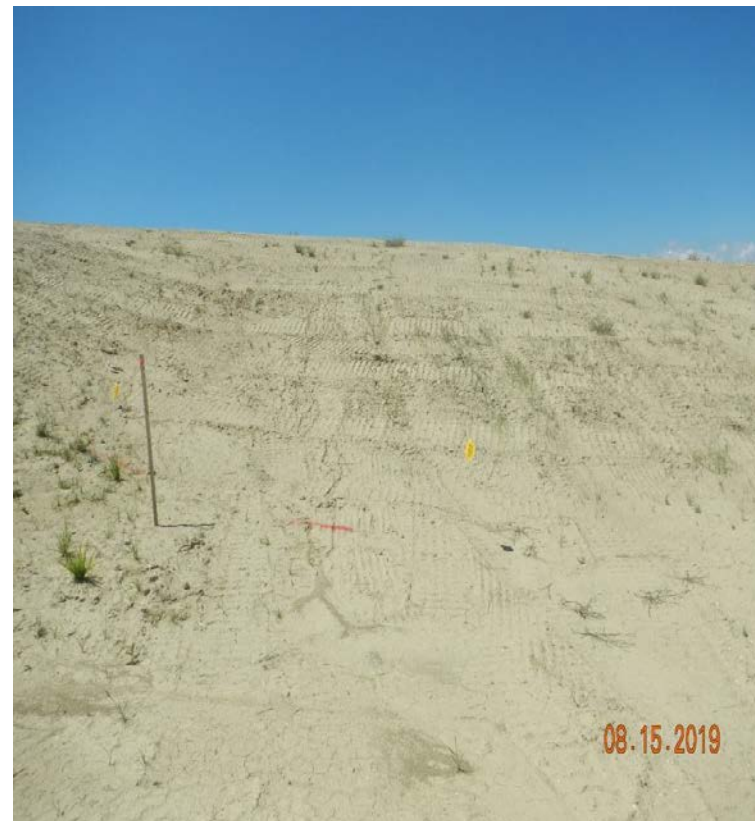
Photo#3: 8/15/19
Erosion initiating on Southwest corner of Cut slope.

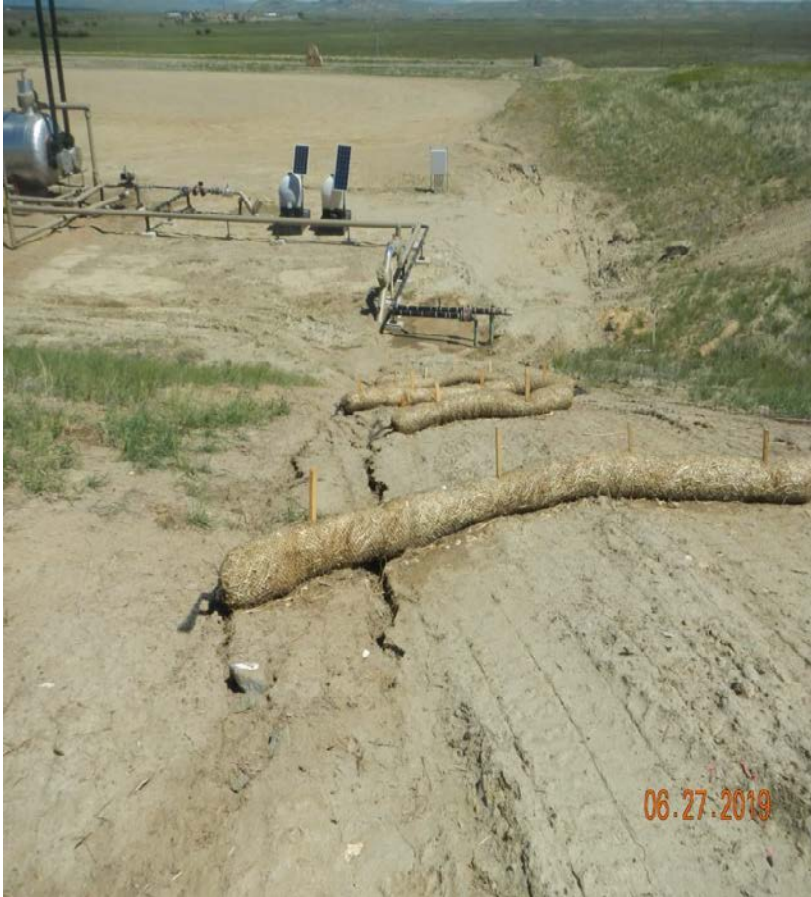
Photo#4: 6/27/19

BMPs have failed; erosion occurring on Southeast corner of cut slope.

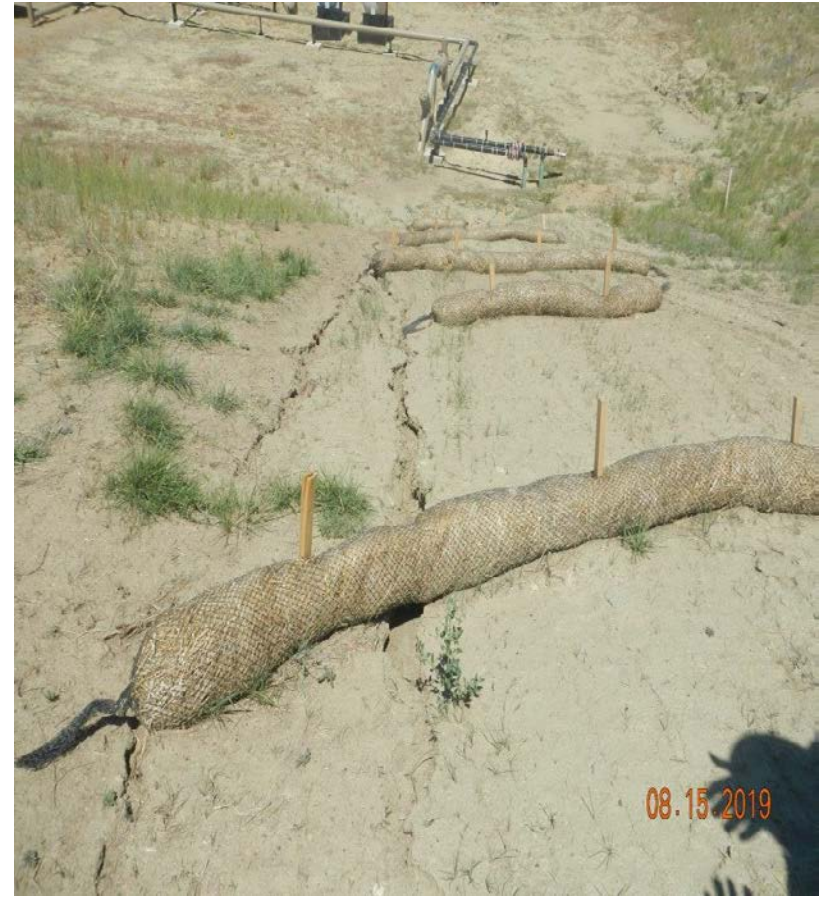
Photo#5: 8/15/19

BMPs have failed; erosion occurring on Southeast corner of cut slope.

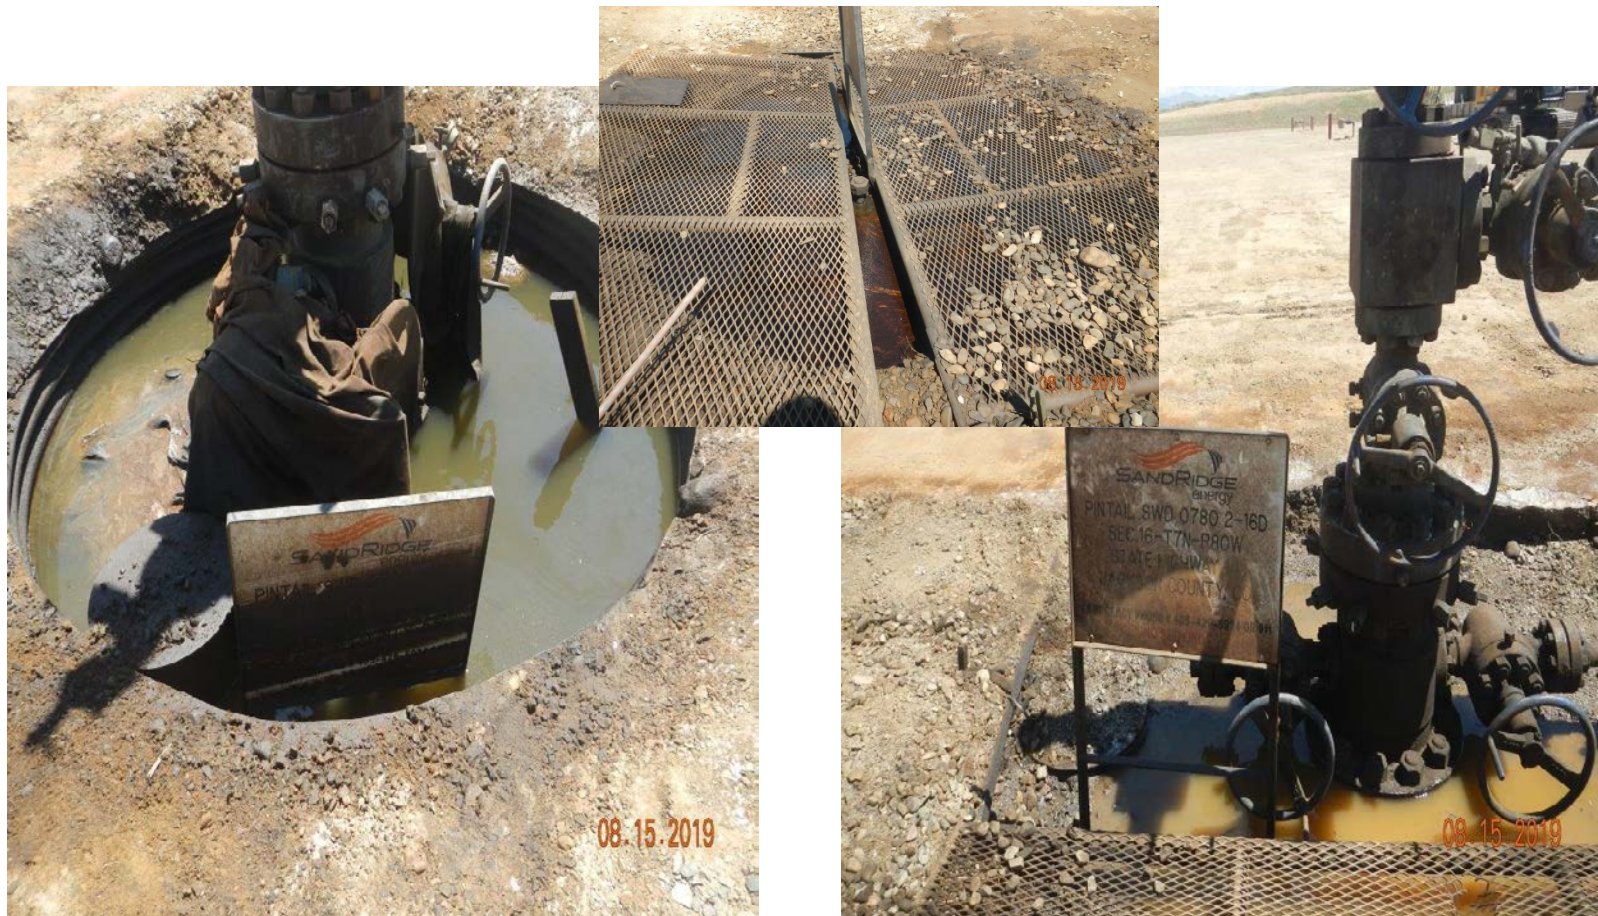
Photo#6:

Cellars of Wells were filled with what appears to be water topped with skim of Oily waste and other possible pollutants.

Photo#7:
